**HAFOD ROAD SYSTEM
ARCHAEOLOGICAL RECOMMENDATIONS**
Record No. 35904

Commissioned by: Forest Enterprise

**Report by: K Murphy BA MIFA
Archaeoleg Cambria Archaeology
The Shire Hall
Carmarthen Street
Llandeilo
Carmarthenshire
SA19 6AF
01998 823121**

HAFOD ROAD SYSTEM ARCHAEOLOGICAL RECOMMENDATIONS

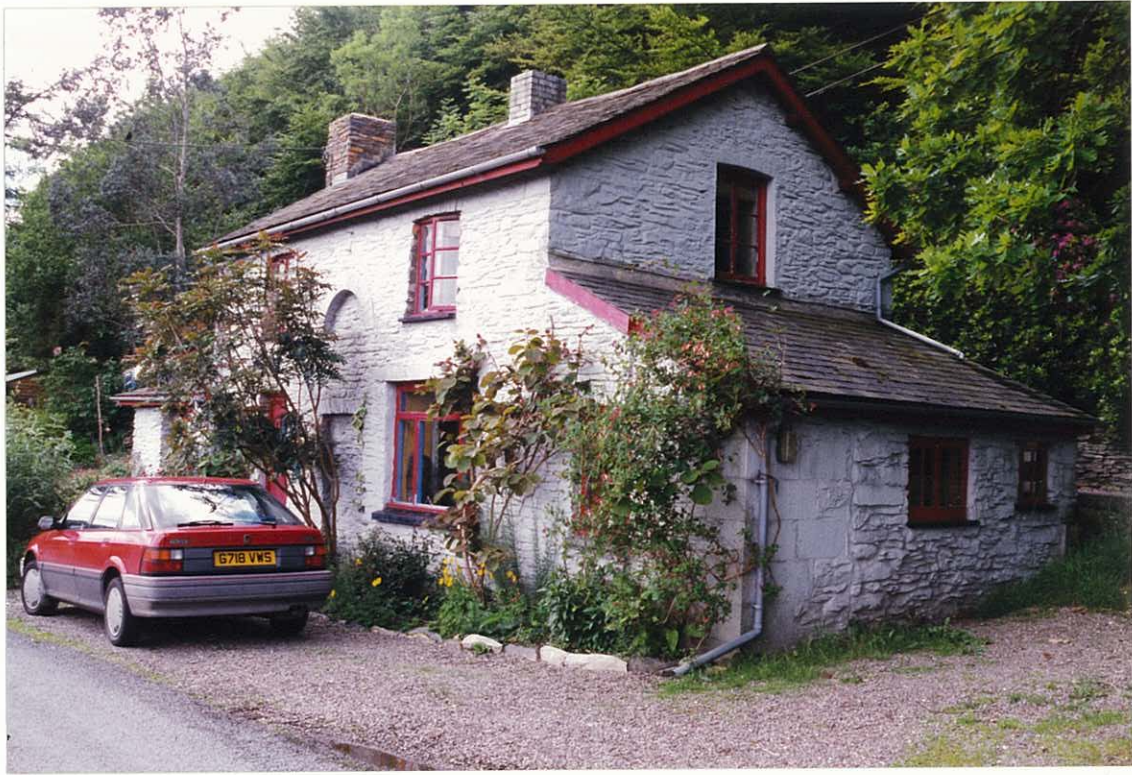
1

19760 Upper Lodge (on road 33048, gate posts 33093). 2-storey stone-built lodge in good condition. Not affected by road improvements.

Recommendations: None

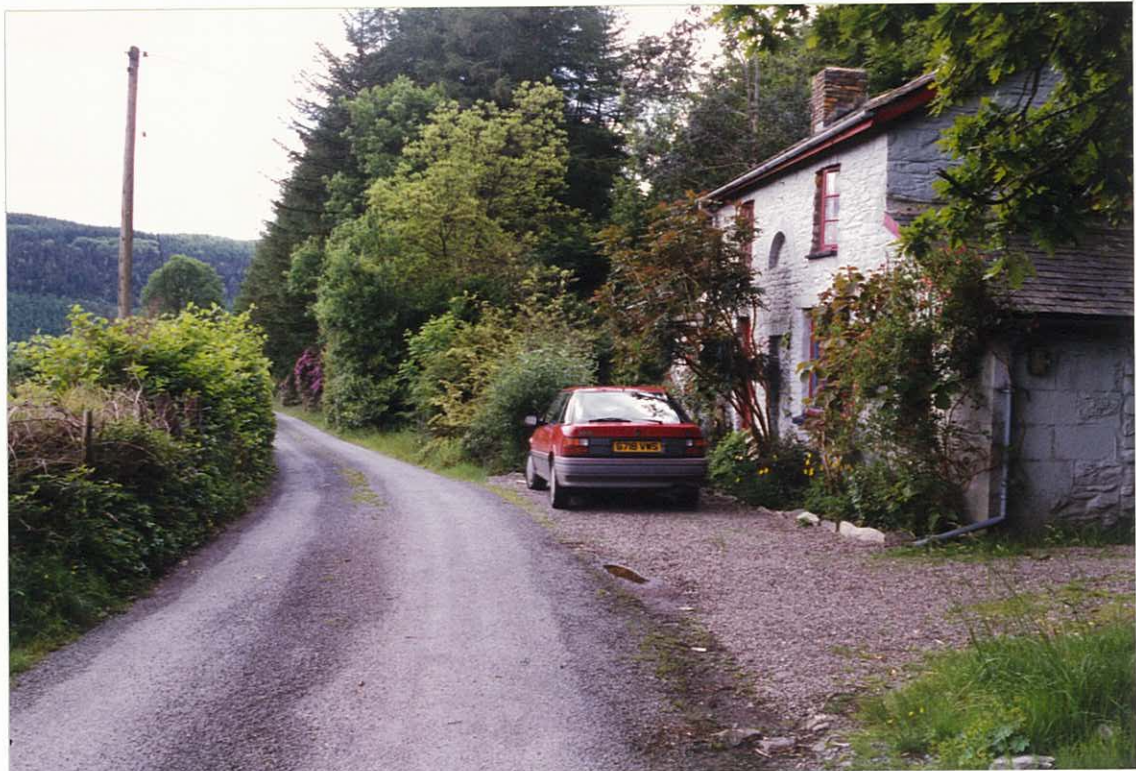
2

33093 Upper Lodge Gates (on road 33048, Upper Lodge 19760)). The gate posts here were similar to those on the Lower Lodge (24591-92). The superstructures have now gone, but a foundation stone of the north pier lies hard against the lodge's south wall. Part of the foundation of the south pier was removed during road renovation and removed to Hafod stables for safe-keeping. The road (33048) close to the Upper Lodge and over the foundation of the south pier is of tarmac.

Recommendations: An archaeological watching brief should be maintained should it be considered necessary to undertake any ground works that may further damage the foundations of the south pier.

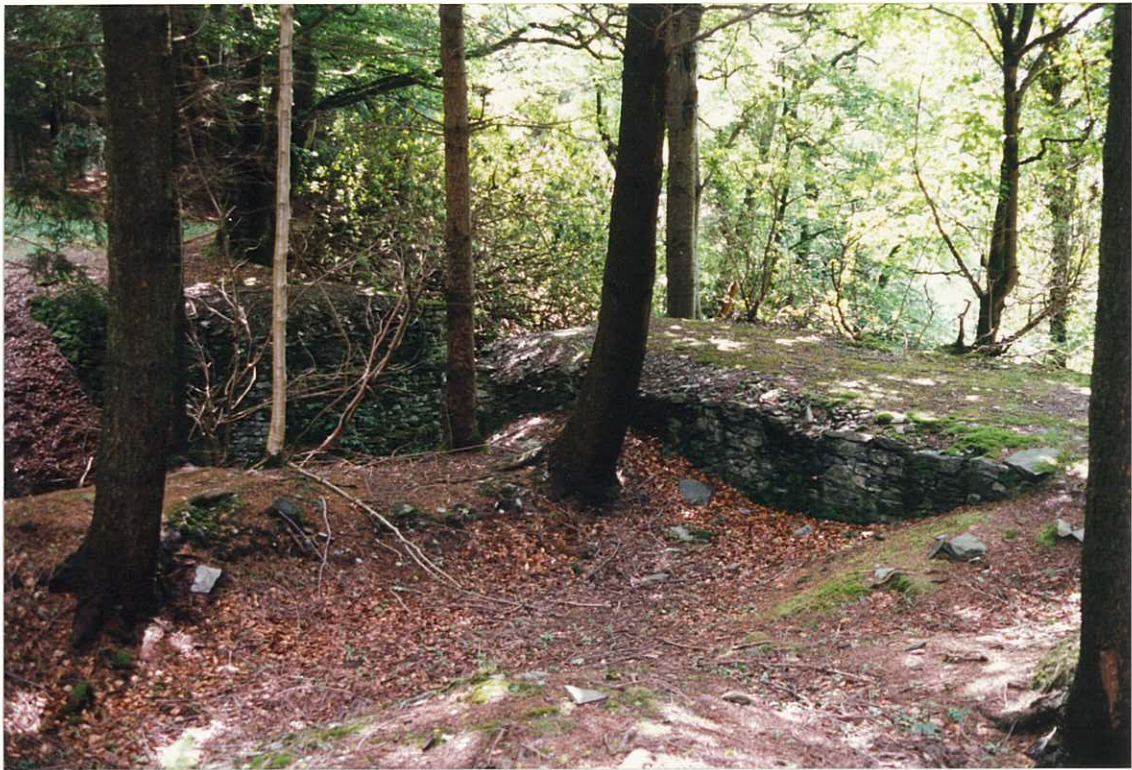
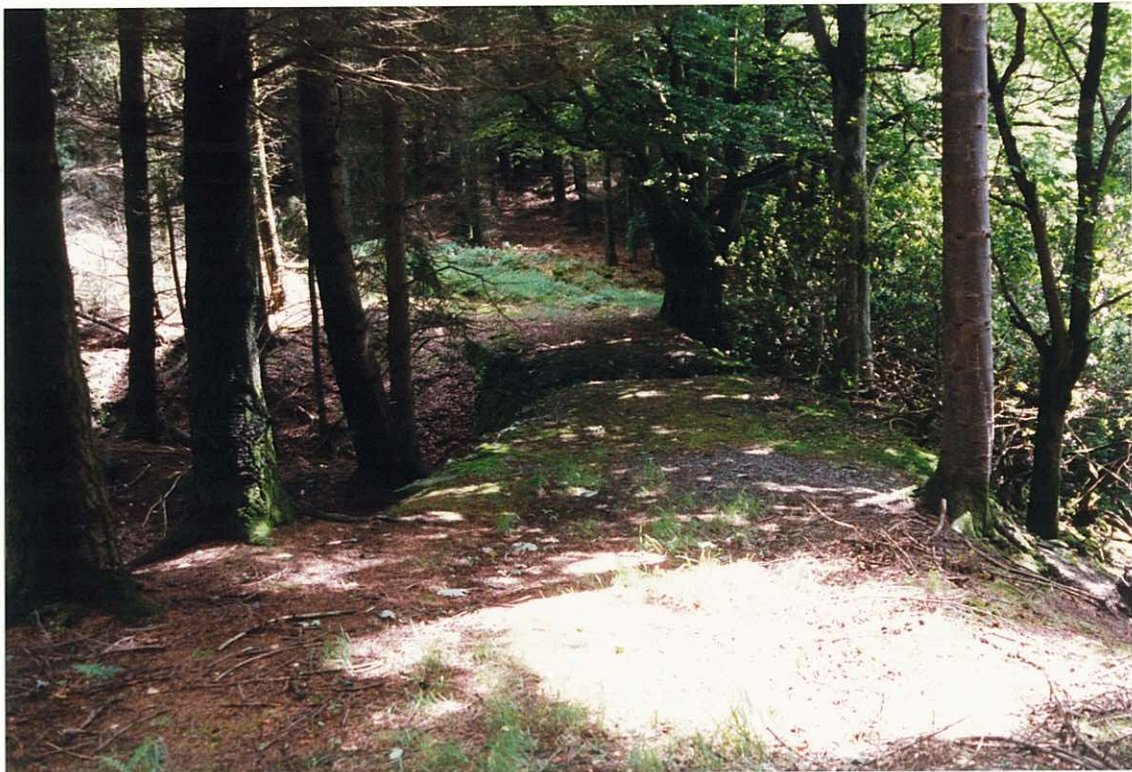
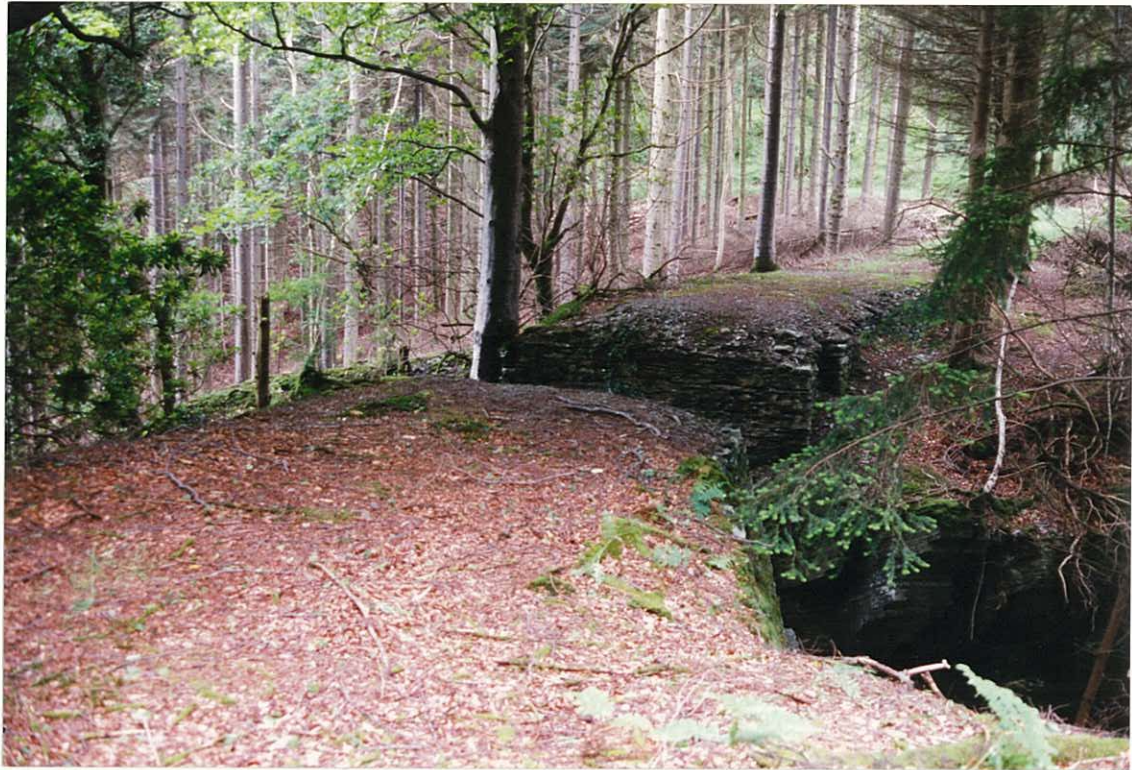
19761 Pont Newydd and 33045 leat (on carriage drive 33044). Bridge constructed in 1814. The bridge remains comprise two massive stone-built bridge abutments with approach causeways. The causeway on the north side overlies the leat. The function of this feature is uncertain, but it may have been designed as part of the picturesque landscape to divert water over the Peiran Falls at a different angle.

Recommendations: Any plans to conduct any form of engineering works on the bridge abutments must be preceded by a full archaeological survey which will include further recommendations.

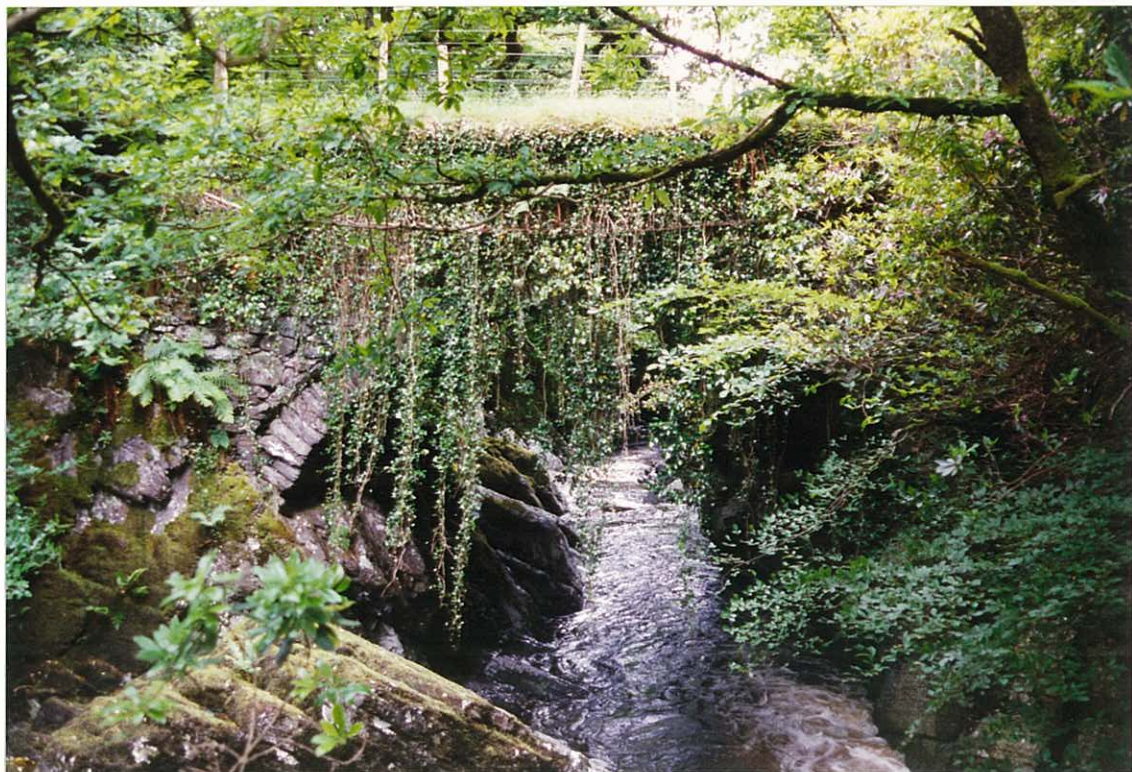
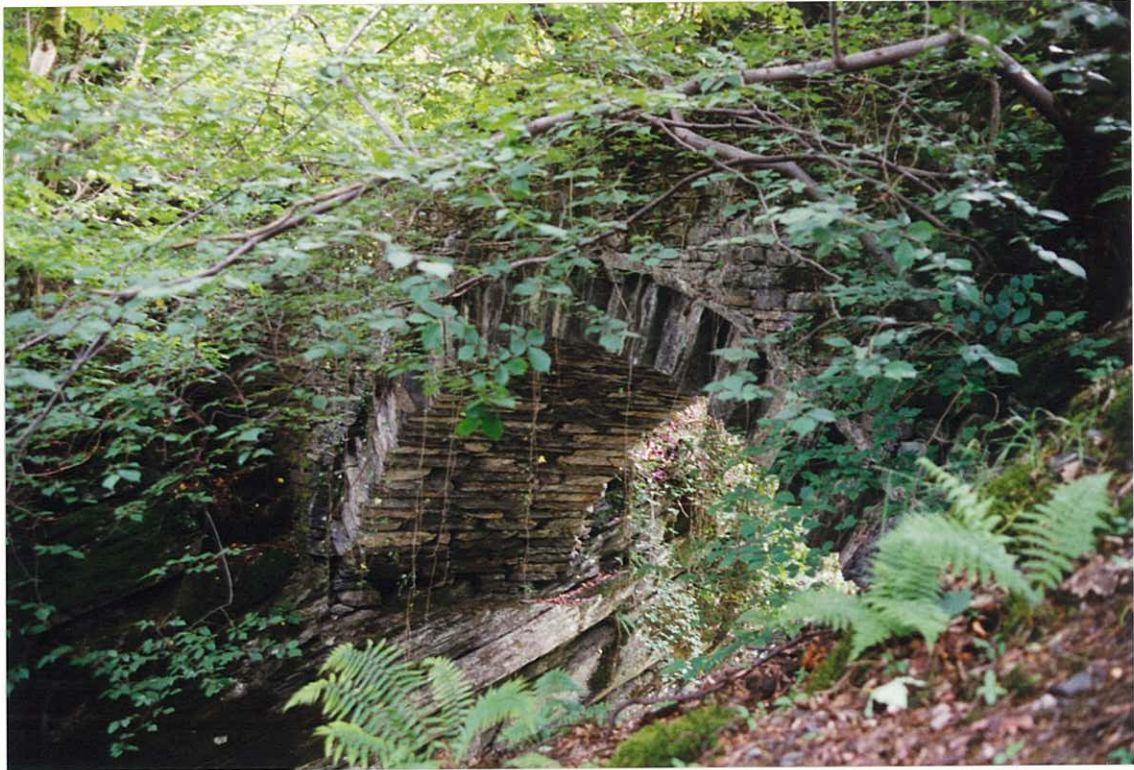
19763 Pont Dologau. Possibly built pre-1787. A stone-built single arched bridge with a span of c. 8m. Built across a gorge on the Ystwyth. The parapets have been removed to allow for a road width of c. 2.5m. A concrete deck is reported to have been laid over this bridge (Roger Hallett, pers. comm.). The whole structure appears to be in fair condition, though some stones have been dislodged on the north side. A sign at the approach states that the bridge is an unsafe structure.

Recommendations: This is an important element in the Hafod landscape. If this bridge is to be permanently closed to vehicles, a programme of restoration accompanied by appropriate recording should be considered. If not, then measures should be taken to ensure the bridge's survival.

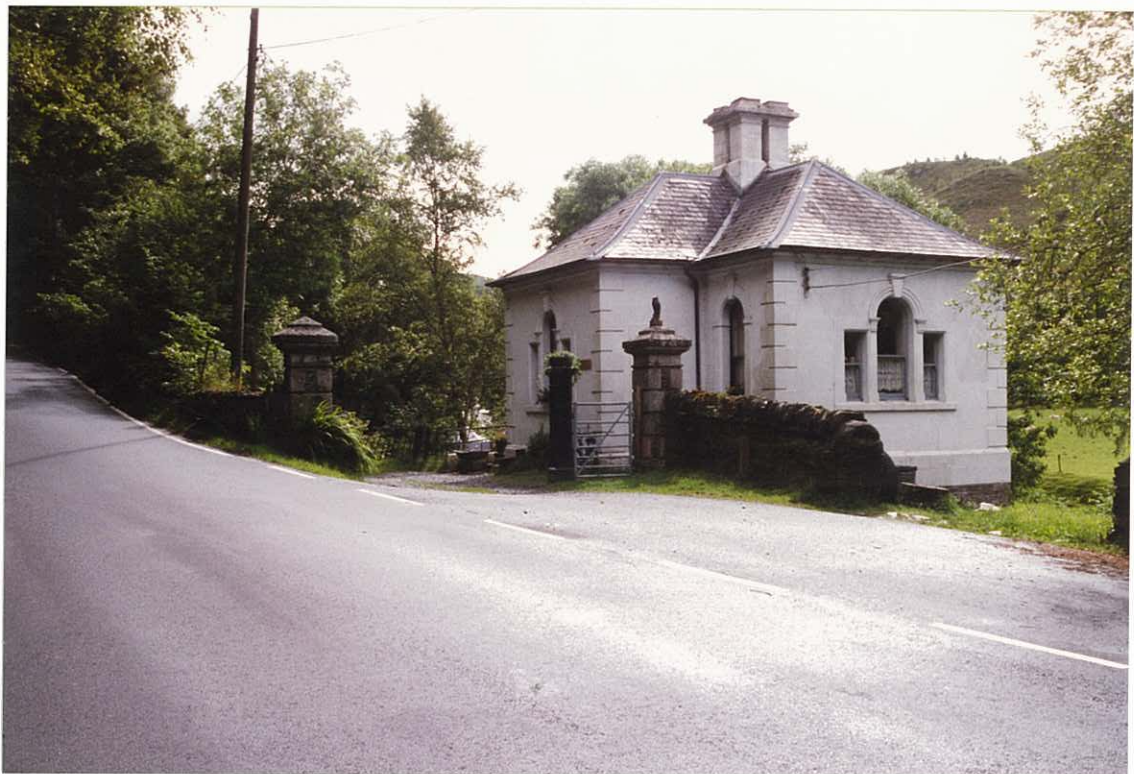
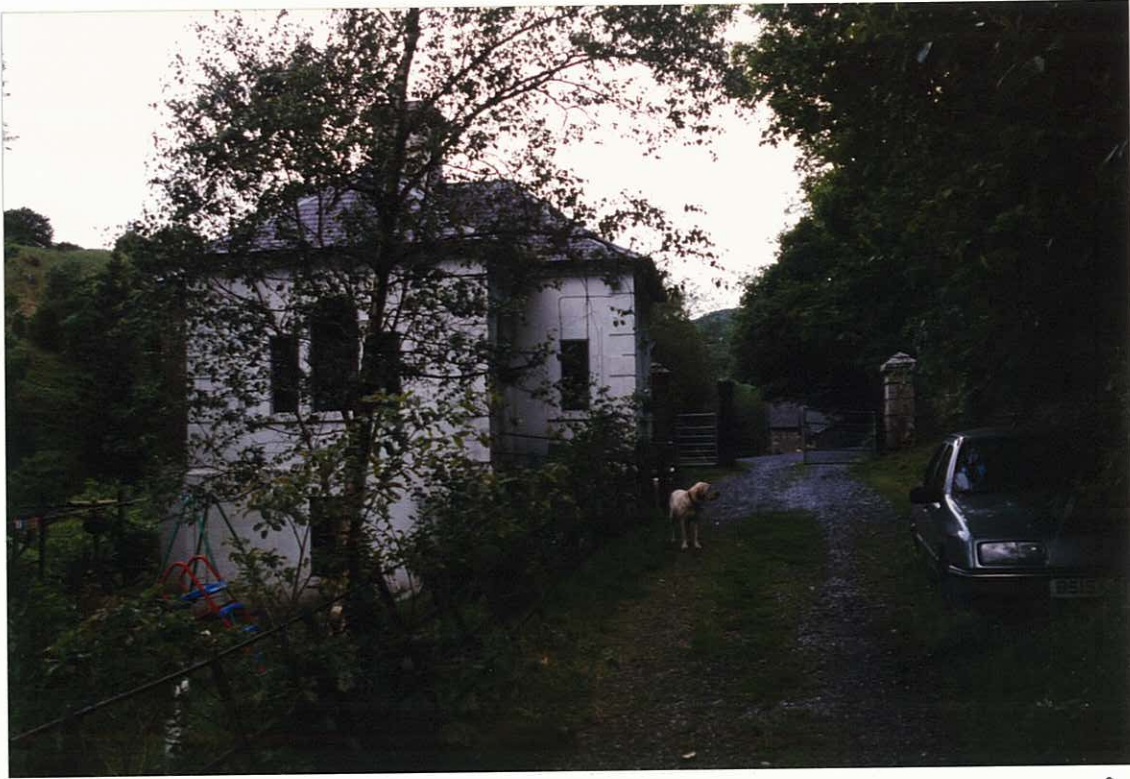
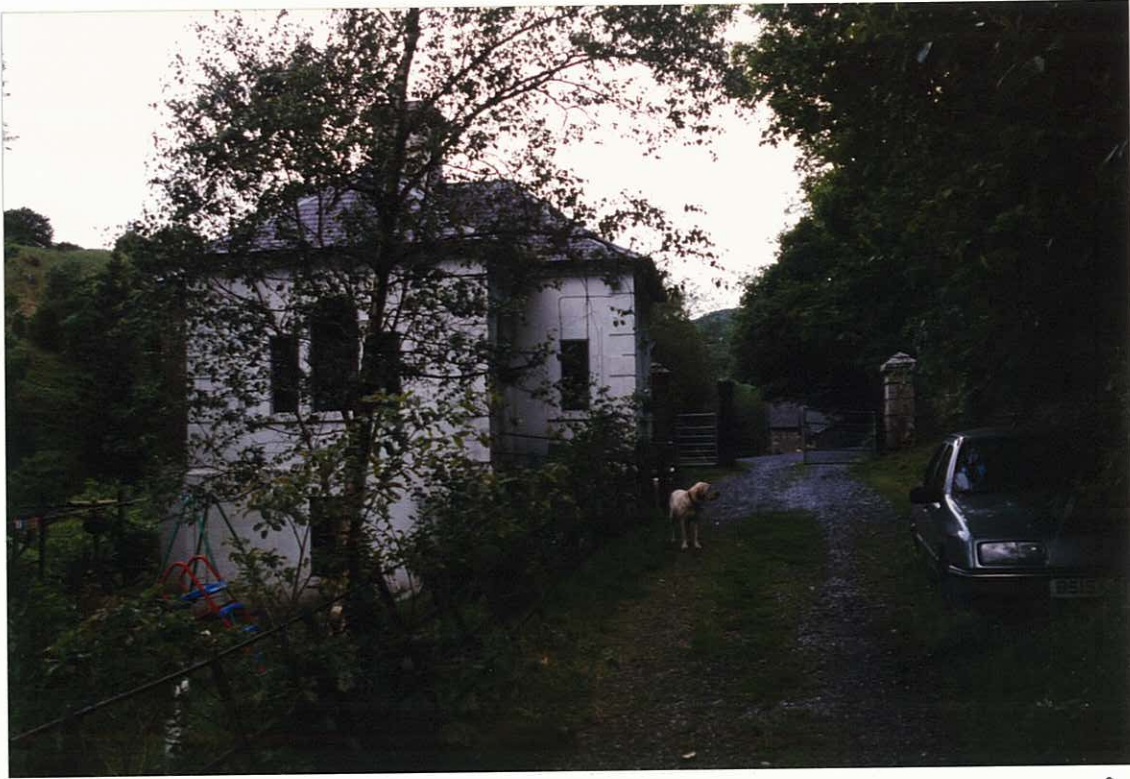
24591 Lower Lodge (on road 32980). Built c. 1850 in Italianate Classical style. 2-storey, built into steep slope on south side of road/drive (32980) with main entrance on first floor. In good condition.

24592 Lower Lodge Gates (on road 32980). Contemporary with lodge 24591. Two stone square built pillars of rubble with rusticated quoins and a cast-iron gate post between. The cast-iron post has recently been re-erected in its original position. The cast-iron gates - one for vehicles one for pedestrians - lie against a wall to the north, and have been replaced by a modern farm gate.

Recommendations: It would be desirable if the original gates could be repaired and re-hung. Any work on the road must be designed to ensure that no damage occurs to this structure. All work will require Listed Building Consent.

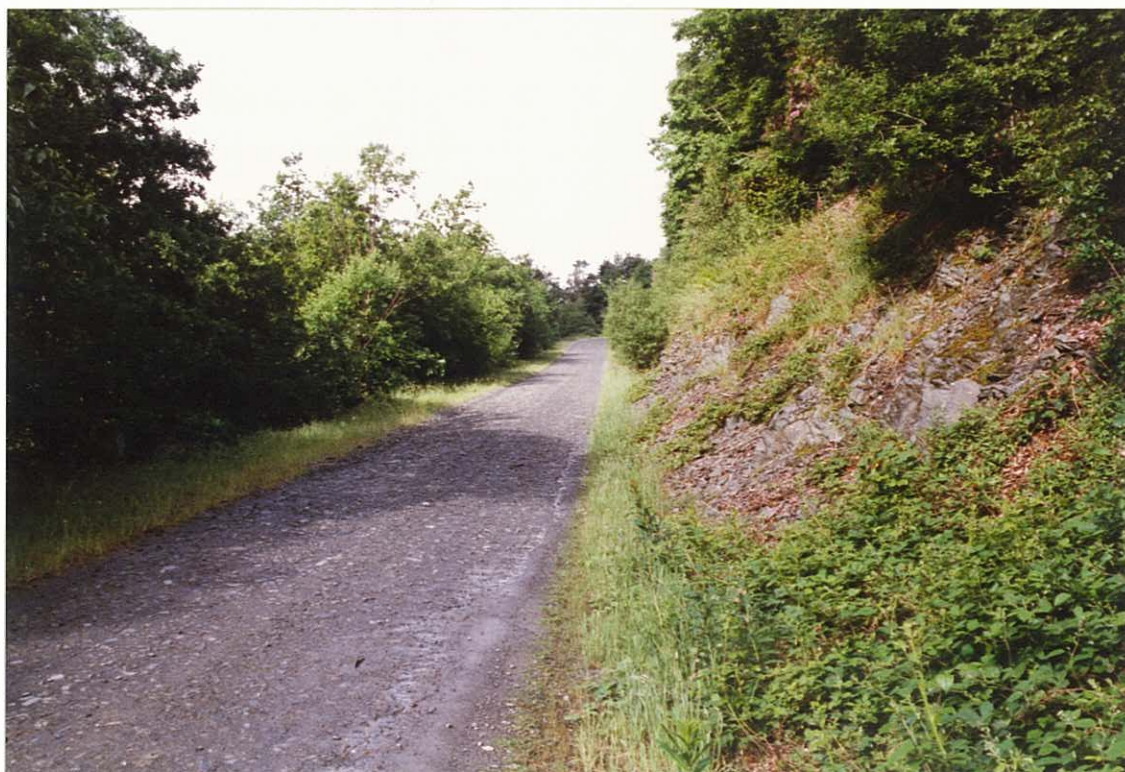
12

32963 Road. From the Pontrhydygroes-Devil's Bridge road down to Hafod Mansion. Established by 1796. This forestry road maintains the line but not the character of the original carriage drive. This road runs diagonally down a steep valley side from west-east on a constructed terrace or shelf; this is now up to 9m wide and has a modern drain on its up-slope, northern, side and culverts running beneath it. This terrace has

been machine dug - there is an excavated scarp on the up-slope side up to 8m high, the spoil from which has been dumped on the down-slope side. The forestry road seems to have been constructed on an agger or causeway on the terrace. The surface of the road consists of hard-core. At the exit on to the public road a wide turning area has been created. There may originally been a gate or lodge (known as Red Gate) at the public road exit, but no evidence either documentary or physical survives. There are no surviving original drive elements on this road.

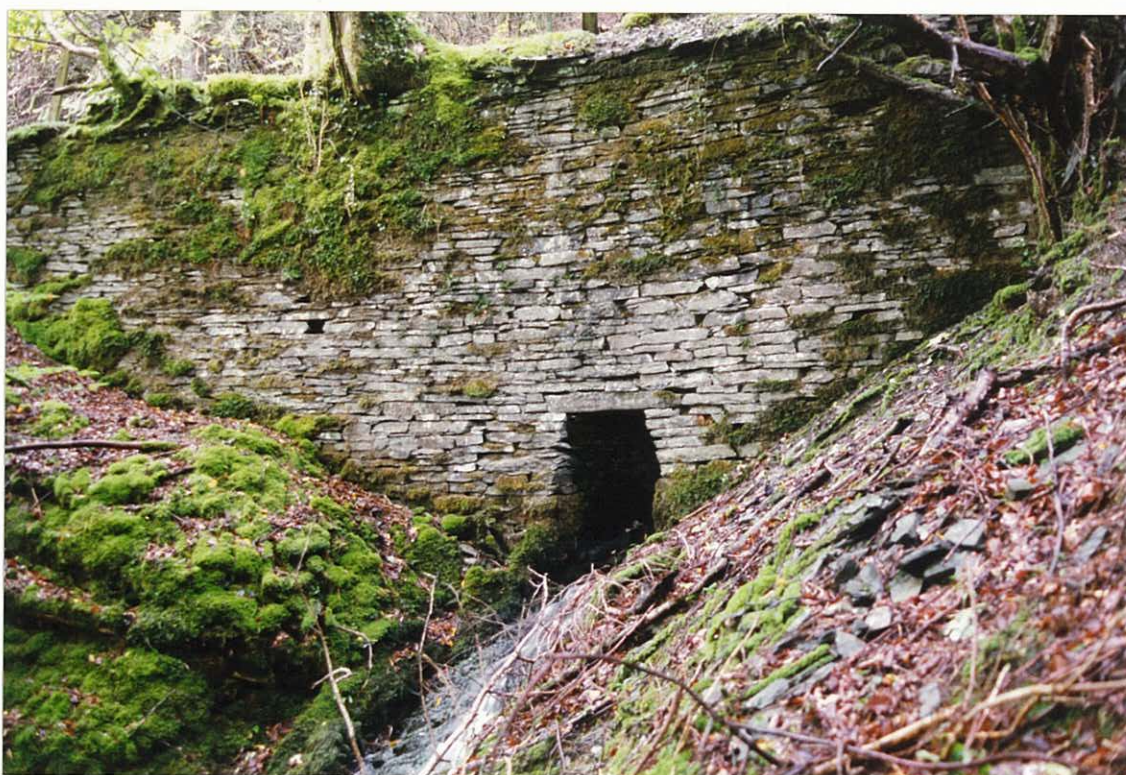
13

32964 Bridge (on road 33064). Stone-built bridge of late 18th-century or early 19th-century date. The road (33064) over the bridge is c. 3m wide. The bridge parapets have been removed to accommodate this width of track for forestry purposes. The stream beneath the bridge is in a square-section culvert. On the north side culvert capping slabs and stones in the retaining wall above are beginning to be displaced. On the south side, because of the slope on which the bridge is built, there is a high retaining wall. Here the wall and culvert is in fair condition.

Recommendations: If this structure is to be retained, some rebuilding/restoration work will be required in the foreseeable future. The removal of the parapets has allowed water to enter the core of the structure, promoting decay. Capping of the walls will assist in halting this decay. A programme of recording should be undertaken with any repair work.

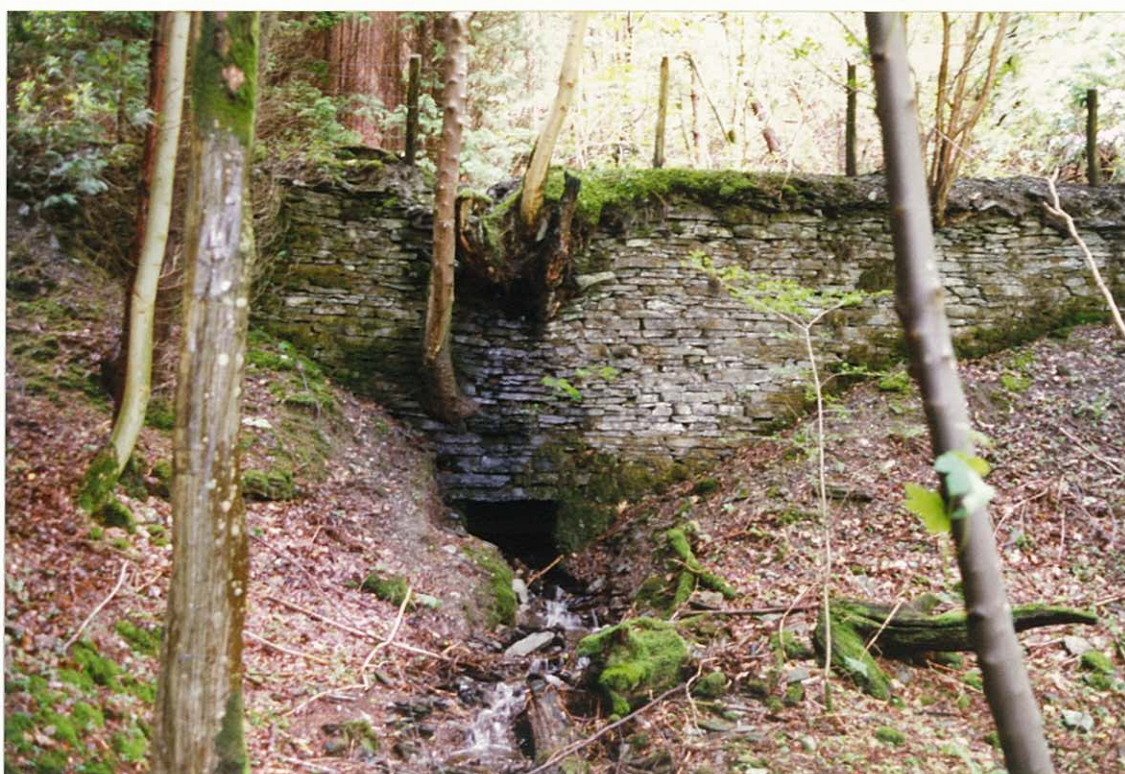
14

32968 Bridge (on road 33064). Stone-built bridge of late 18th-century or early 19th-century date. The road (33064) over the bridge is c. 3m wide. The bridge parapets have been removed to accommodate this width of track for forestry purposes. The stream beneath the bridge is in a square-section culvert. The culvert is becoming choked with debris on the up-stream, north, side. Trees have taken root in the high retaining wall on the south side and are causing considerable damage. The lintel slab over the culvert in the south wall has cracked and may soon fail.

Recommendations: If this structure is to be retained, some rebuilding/restoration work will be required in the foreseeable future. The removal of the parapets has allowed water to enter the core of the structure, promoting decay. Capping of the walls will assist in halting this decay. The trees rooted in the south side should be removed and the damage made good. The cracked lintel may need renewal or strengthening. A programme of recording should be undertaken with any repair work.

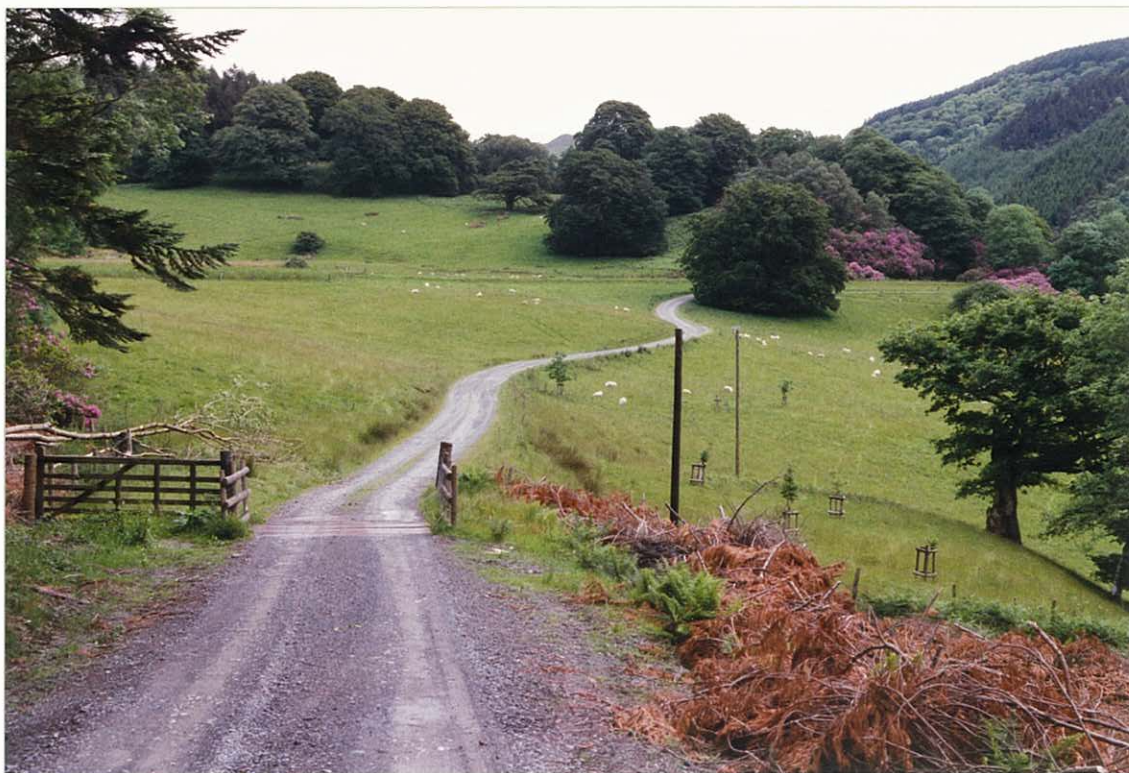
16

32975 Road. This forestry road follows a sinuous course contouring across meadows on a gentle slope to the south-west of the mansion and follows the course of a late 18th-century carriage drive. The forestry road has been cut into the slope and the resulting spoil dumped on the down-slope side to create a terrace c. 5m wide. A lip on the outer, south, edge of the terrace prevents stones from the hard-core surface spilling down the slope. There is a ditch/drain on the up-slope side. There is no evidence of any carriage drive features in this section of road.

Recommendations: If work is to be carried out on this section, then it is important that the outer lip to the road is maintained to prevent unsightly road-stone spilling down to the meadow slopes below.

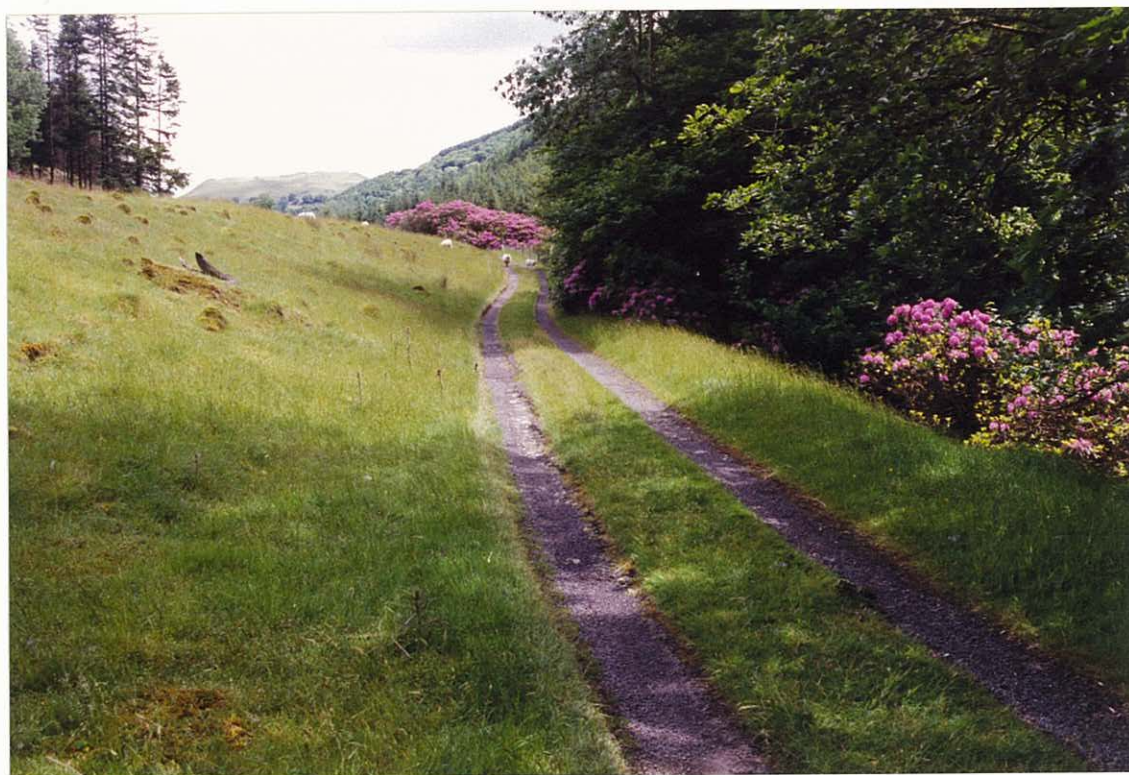
17

32976 Road. From close to the mansion site down to the kitchen garden. The north-eastern section of this road seems to have been in existence by 1796. This section runs diagonally down a steep slope from north-south on a cut terrace. After turning sharply to the west, the road follows the edge of break of slope. Here it is lightly engineered with short lengths of shallow cutting evident on its up-slope, north, side. It runs close to the ice house (26535) and passes over a culvert (35909) towards its western end. The road is partially covered with tarmac.

Recommendations: This road should be maintained in its current form.

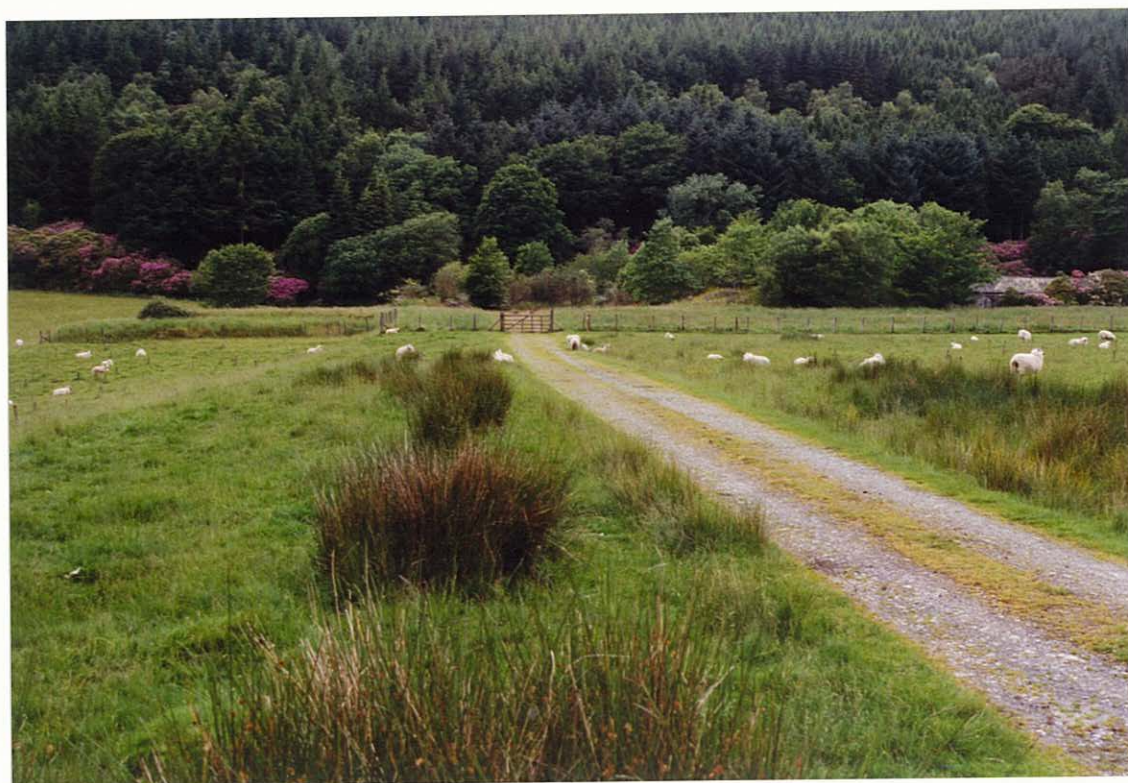
18

32977-78 Carriage drive and rock cutting. The carriage drive is situated on a formal terrace leading up to the mansion site of mid 19th-century date. At its southern end it passes through a rock cutting (32978). The drive is now has a partial hard-core surface, becoming overgrown; it is rarely used. The whole maintains its original form and character.

Recommendations: This drive should be maintained in its current condition.

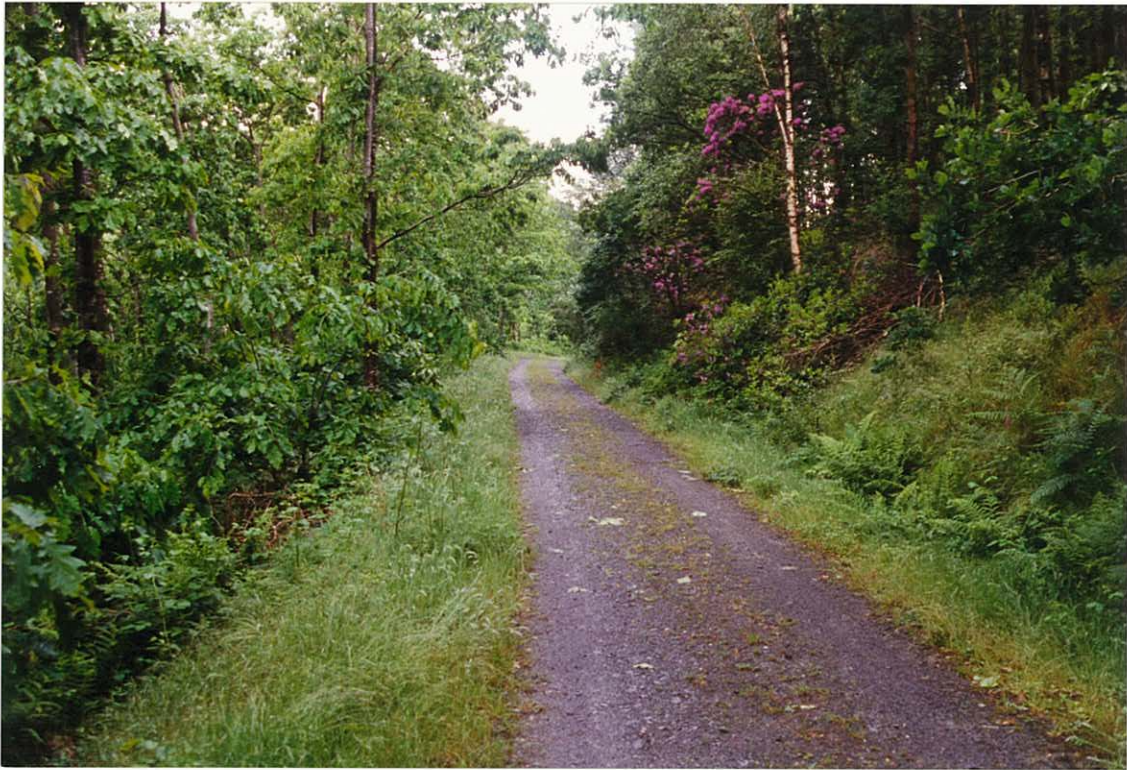
21

32980 Road (includes elements: site of lodge 33103, bridge 35905, lodge and gates 24591-92, site of lodge 35906). The course of this forestry road follows one of the first carriage drives on the Hafod estate (in existence by 1796). Prior to its conversion to a carriage drive it formed part of the public road system - the route from Pontrhydygroes to Cwmystwyth. See also road 33064. The only section now used as a forestry road is that to east of bridge 35905. From the Lower Lodge (24591) to the bridge 35905, the road runs on the flood plain of the Ystwyth at the base of a steep north-facing slope. At the extreme western end this slope is revetted with a mortared wall and a dry-stone wall laid herring-bone fashion. The road in this western section is in poor condition and is beginning to break up. To the east of the bridge (35905), the road climbs gently via a terrace built on the steep valley side. This terrace is 5m wide

and has been machine excavated and created. A modern drain runs on the up-slope side of the terrace with culverts draining beneath the road. A water-main follows the course of the road east from bridge 35905. There are no surviving original drive elements on this road east of bridge 35905.

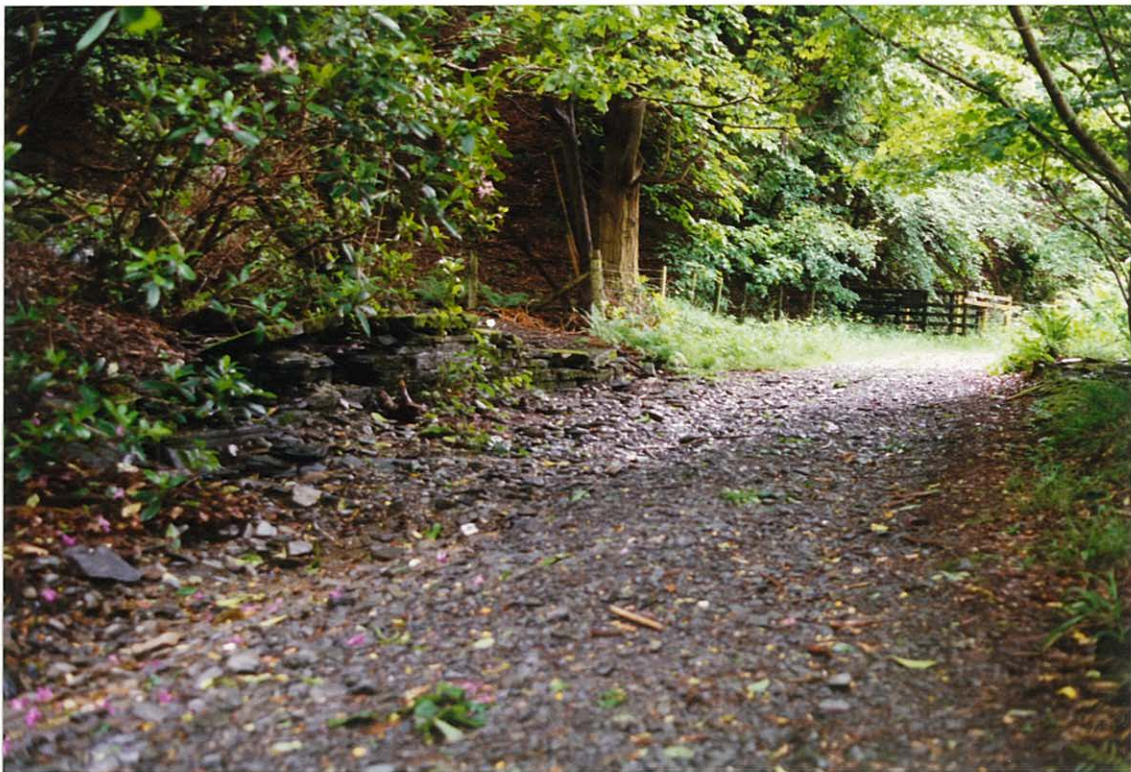
22

35905 Bridge (on road 32980). Small stone-built bridge of late 18th-century to mid 19th-century date. Constructed from mortared local stone with cut slate slabs (only one remaining *in situ*) capping low (0.6m) parapet walls. A block of oolitic limestone has been built into the fabric of the bridge. Parapet walls c. 4m apart. The stream

passed under the bridge in a square-section culvert. The culvert is choked on its upstream, north, side with gravel and rubble diverting flood water across the road. The hard-core road surface is beginning to break up. The whole structure is in poor condition and is urgent need of repair.

Recommendations: The culvert requires immediate cleaning; this could be done with a small mechanical excavator. The whole structure needs repairing/restoration and re-establishment of good road surface. Any repair/restoration should be accompanied by archaeological recording.

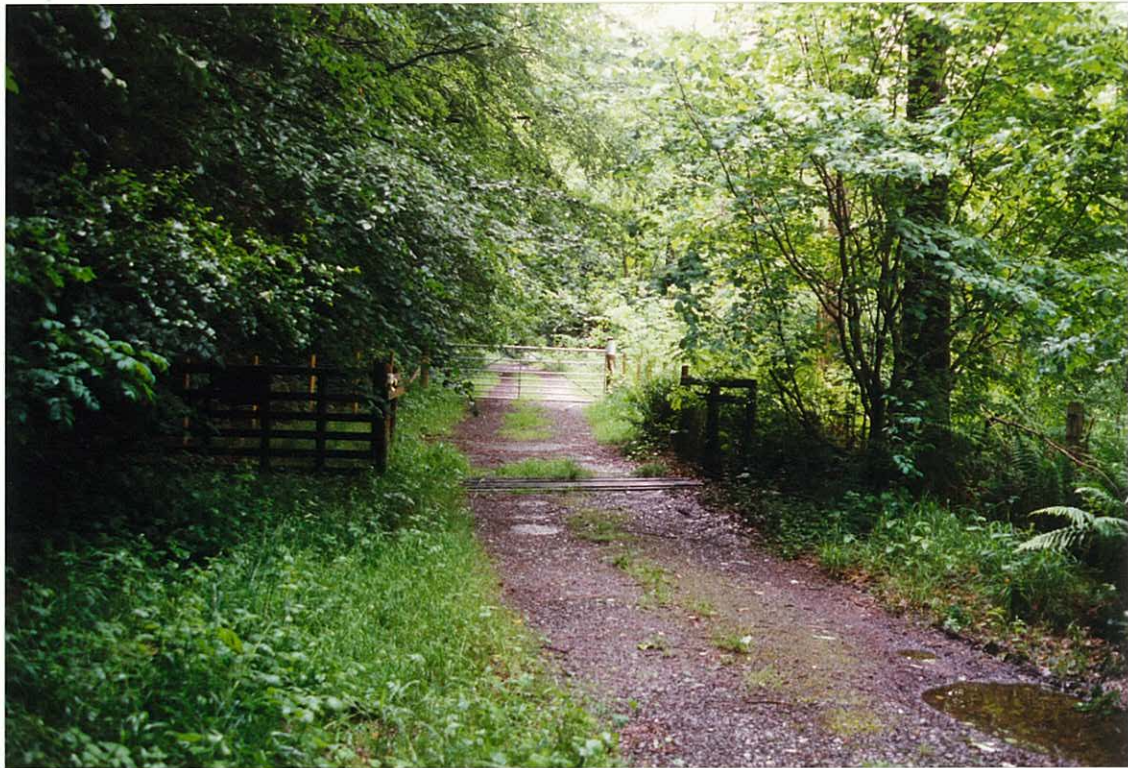
23

33103 Site of Lodge (on road 32980). Gate pillars or a lodge are marked in this location on the map accompanying Cumberland's *An Attempt to Describe Hafod* (1796). A cattle grid has been constructed on the approximate location of this site. Nothing of the lodge/gates now survives on the surface.

Recommendations: Road widening/upgrading should take account of the possibility that buried remains of this site may survive. Hard-core resurfacing of the track will not affect the buried deposits, but any engineering works that require below ground disturbance should be accompanied by an archaeological watching-brief.

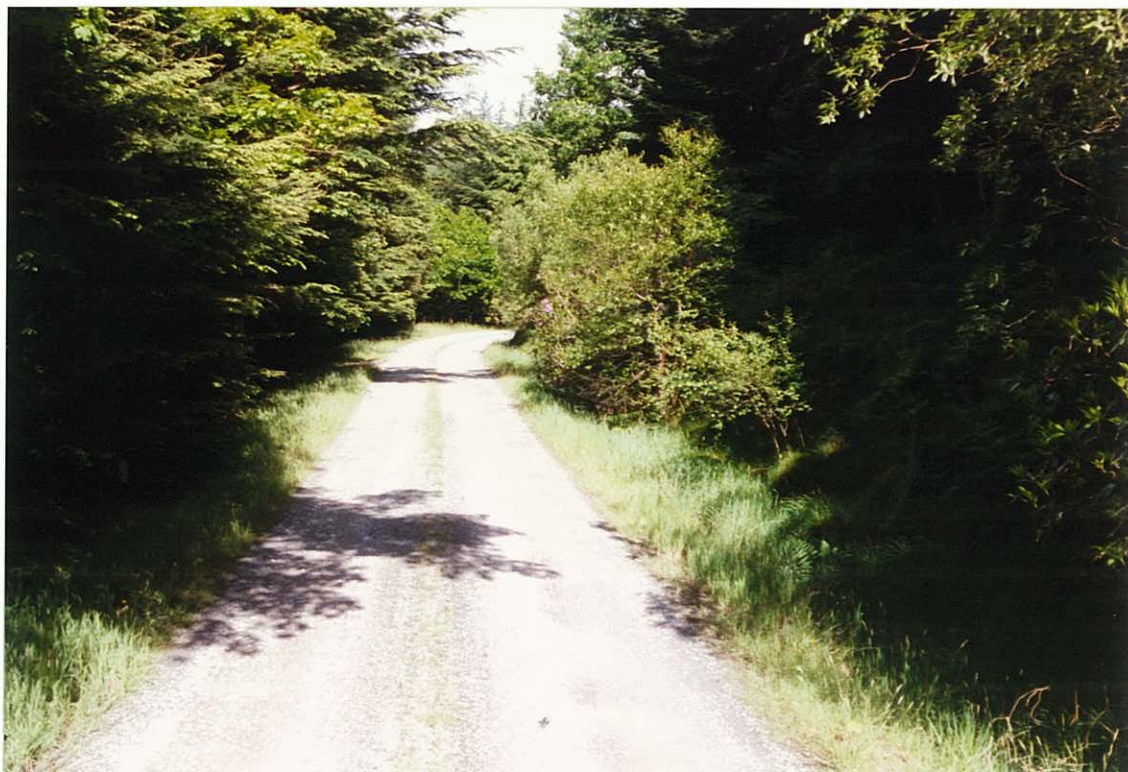
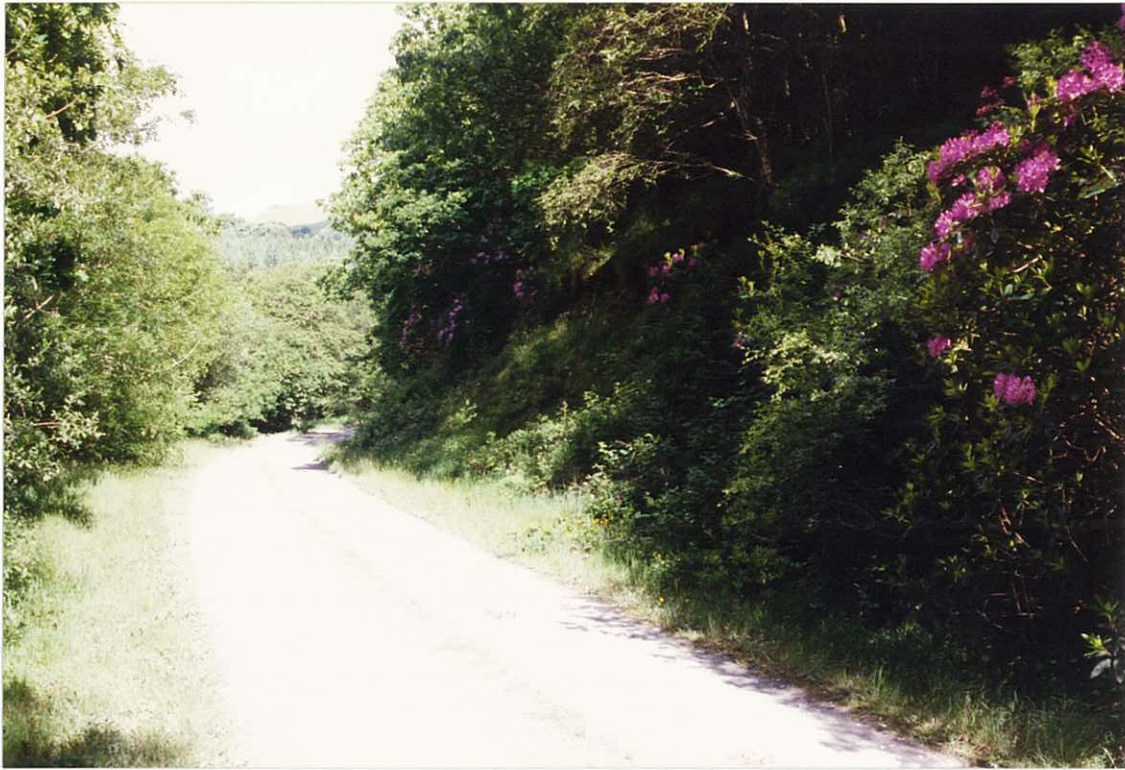
33004 Road (includes elements: track 32998, bridge 33002 and bridge 33091). A main forestry road leading from the Concrete Bridge (33091) west up a steep, north-facing valley side. For much of its course this modern road follows the course of an earlier track. At 32998 an earthwork terrace of this earlier track is visible on the down-slope side of the road. The modern road lies on a 7-8m wide terrace which has been cut into the up-slope side leaving a scar up to 10m high. The material from this cutting has been deposited on the down-slope side. A modern drain runs along the south side with culverts beneath the road. At two locations (33003, 33011) the line of the Gentleman's Walk has been truncated by the modern road cutting. The exits from these walks are now into mid-air at the top of the cutting.

Photos: 24 - showing exit of Gentleman's Walk 33003, 25 - showing exit of Gentleman's Walk 33011

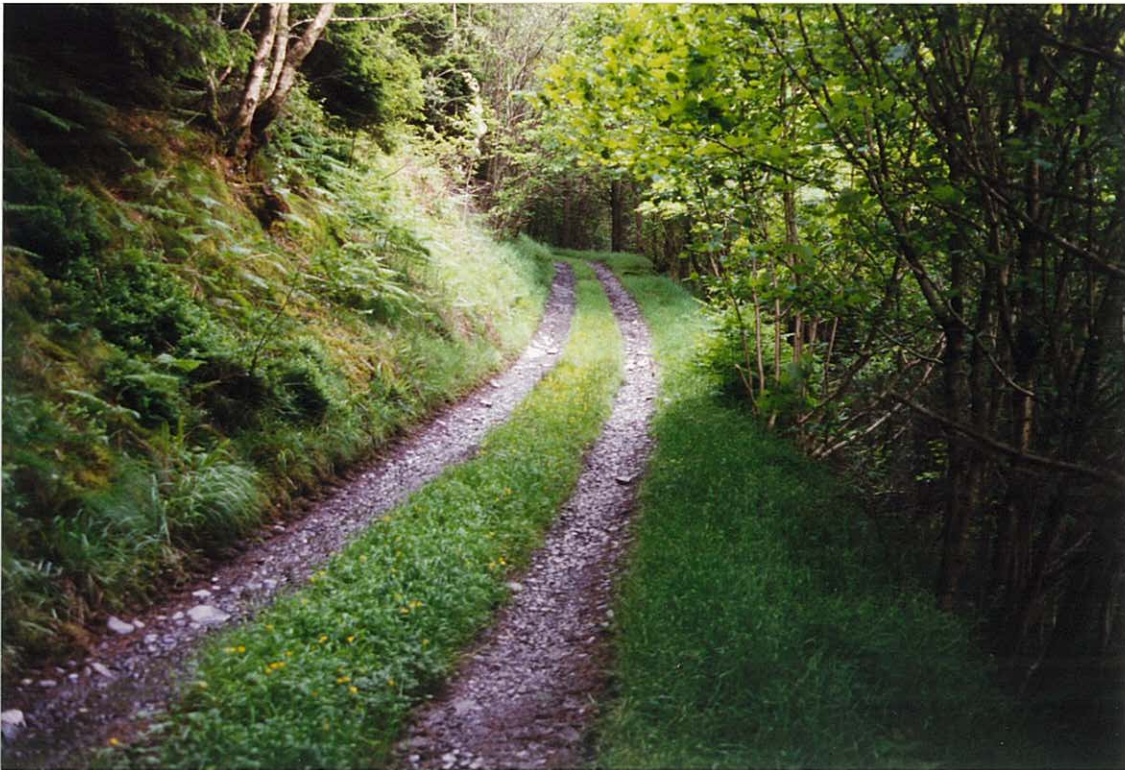
26

33023 Track (includes element: bridge 33031). A rough, hard-core track leading from bridge 33023 to Nant-y-Cau cottage. The track is c. 2.2m wide and has evidence of only light engineering work - a cutting on the up-slope, east, side in short sections. The track is only passable with ease in a four-wheel-drive vehicle.
