**HAFOD ROAD SYSTEM
ARCHAEOLOGICAL RECOMMENDATIONS**
Record No. 35904

Commissioned by: Forest Enterprise

**Report by: K Murphy BA MIFA
Archaeoleg Cambria Archaeology
The Shire Hall
Carmarthen Street
Llandeilo
Carmarthenshire
SA19 6AF
01998 823121**

HAFOD ROAD SYSTEM ARCHAEOLOGICAL RECOMMENDATIONS

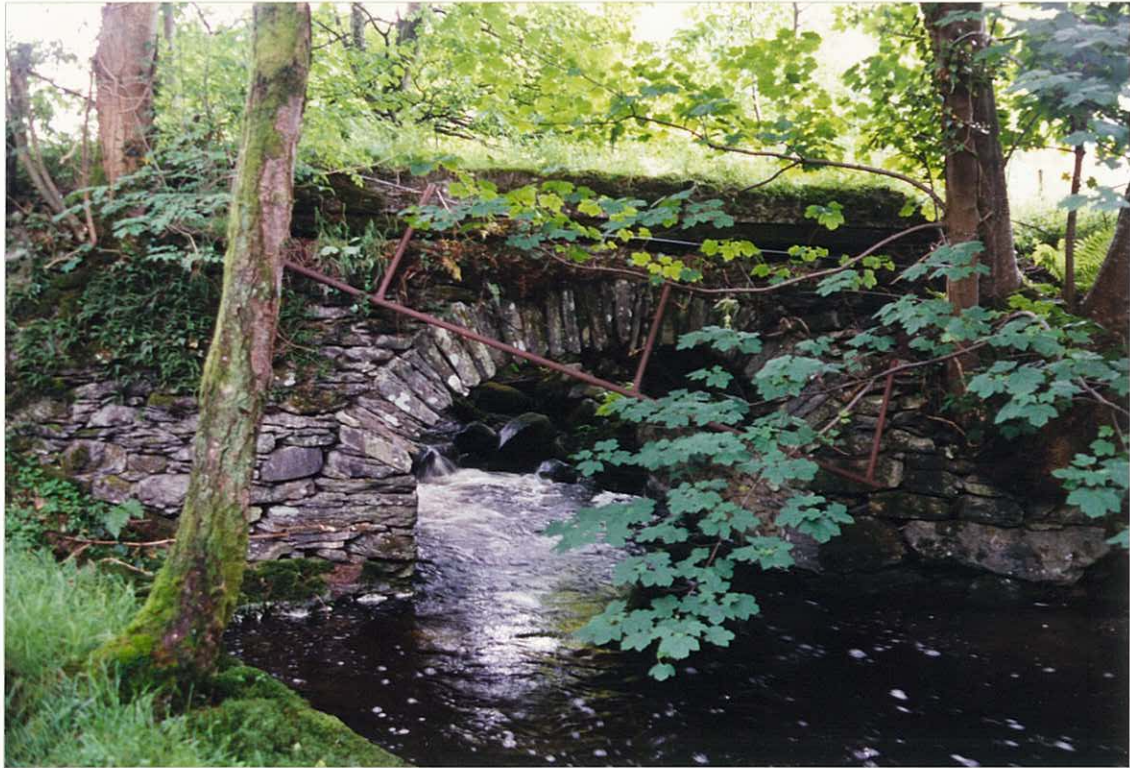
27

33031 Pont Nant Cau (on road 33023). Early 19th-century stone-built single-arched bridge. Parapets have been removed to allow access for modern vehicles and a concrete deck laid over the bridge. The arch has failed and may collapse in the near future.

Value: It is possible that this bridge has deteriorated too far to save it. If this is found to be the case, then programme of recording should take place prior to collapse.

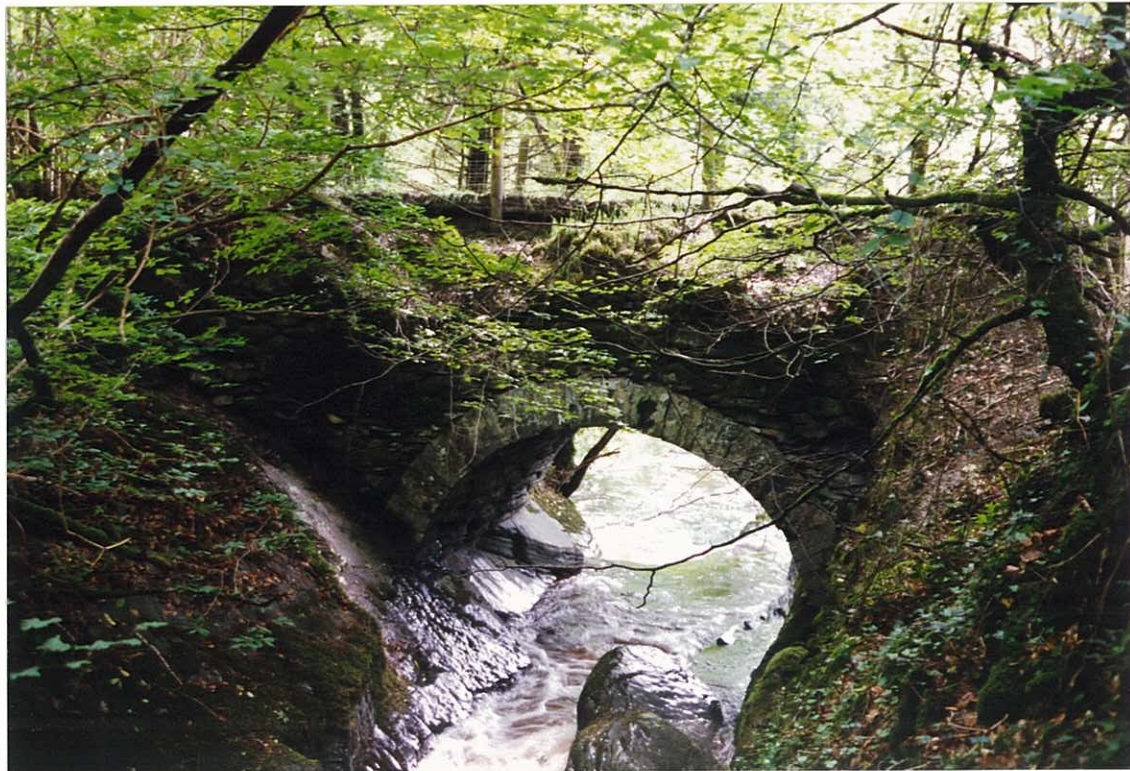
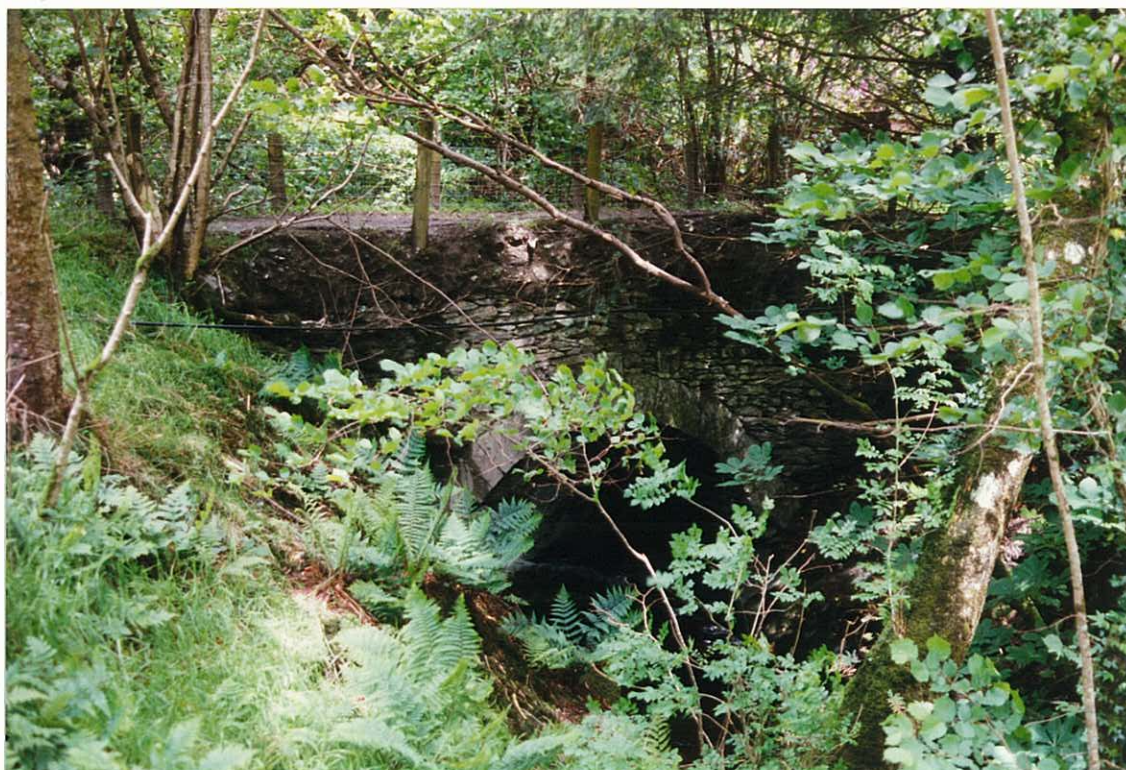
33032 Pont Nant Peiran (on road 33047). There is a bridge marked on the map accompanying Cumberland's description of Hafod; it is uncertain whether it is this bridge. Stone-built, single arched bridge with dressed stone voussoirs. Parapets have been removed to allow access for wide vehicles. This has resulted in road stone and spoil spilling down the side of the bridge. It is reported (Roger Hallett, pers. comm.) that a concrete deck has been laid over this bridge to help strengthen it. The wall on the north side of the bridge has started to collapse. The bridge is in poor condition.

Recommendations: An structural inspection of this bridge is required to ensure that it is sufficiently sound to take vehicular traffic. Immediate repair/restoration work is required to prevent the structure for deteriorating further. Any works should be accompanied by a programme of archaeological recording.

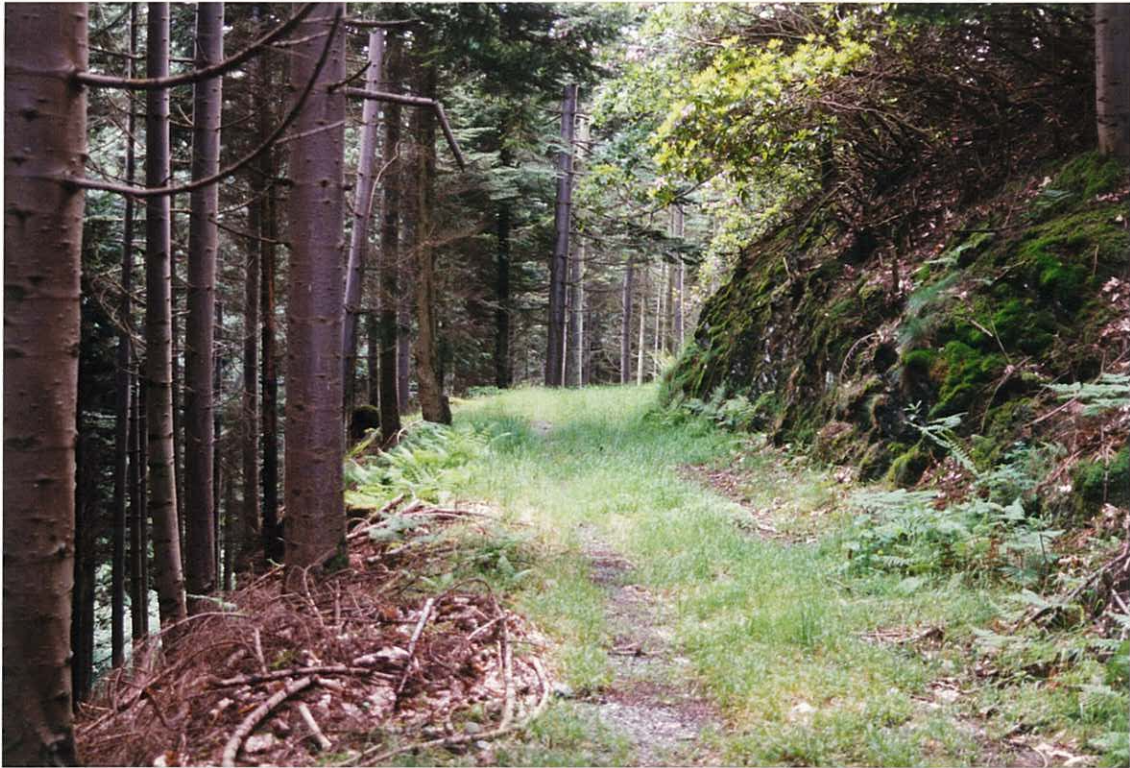
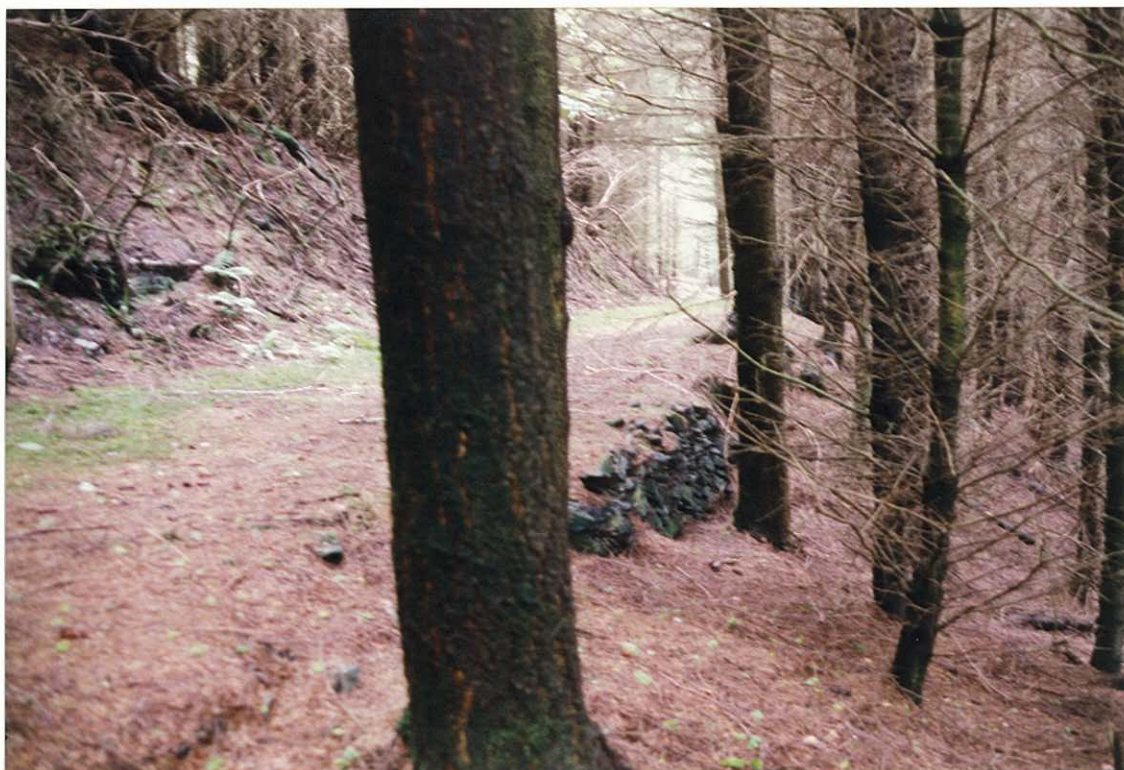
Constructed in 1814. This is the only carriage drive on the estate to have retained its original form and character. It leads off from road 33048 at its east end and follows the contours around the steep, generally south-facing, valley sides of first the Peiran and then the Ystwyth. It has no obvious modern surfacing material and no evidence of modern engineering works, although wheel ruts are present on the section to the west of Pont Newydd (19761). The drive has been cut into steep slopes - rock cut in places - with the resulting material thrown on the down-slope side to form a terrace c. 3.5m wide. To the east of Pont Newydd the down-slope side of the terrace is revetted with dry-stone walling for long sections, even on some relatively gentle slopes. On a sharp bend over-looking Pont Dologau, the drive negotiates a spur via a high rock-cutting and high revetment wall on the down-slope side. To the east of this point the up-slope terrace cutting is revetted in stone up to a height of 1.5m. The whole is in good condition though becoming blocked with fallen trees and encroaching rhododendron scrub.

Recommendations: It is important that the form and character of this early 19th-century carriage drive is maintained. Should it be necessary to use this drive for forestry extraction, then a intervention layer should be placed over the existing ground and a new road surface laid. Care must be taken that no damage occurs to the revetment/retaining walls and the rock cuttings (see elements listed above for separate recommendations).

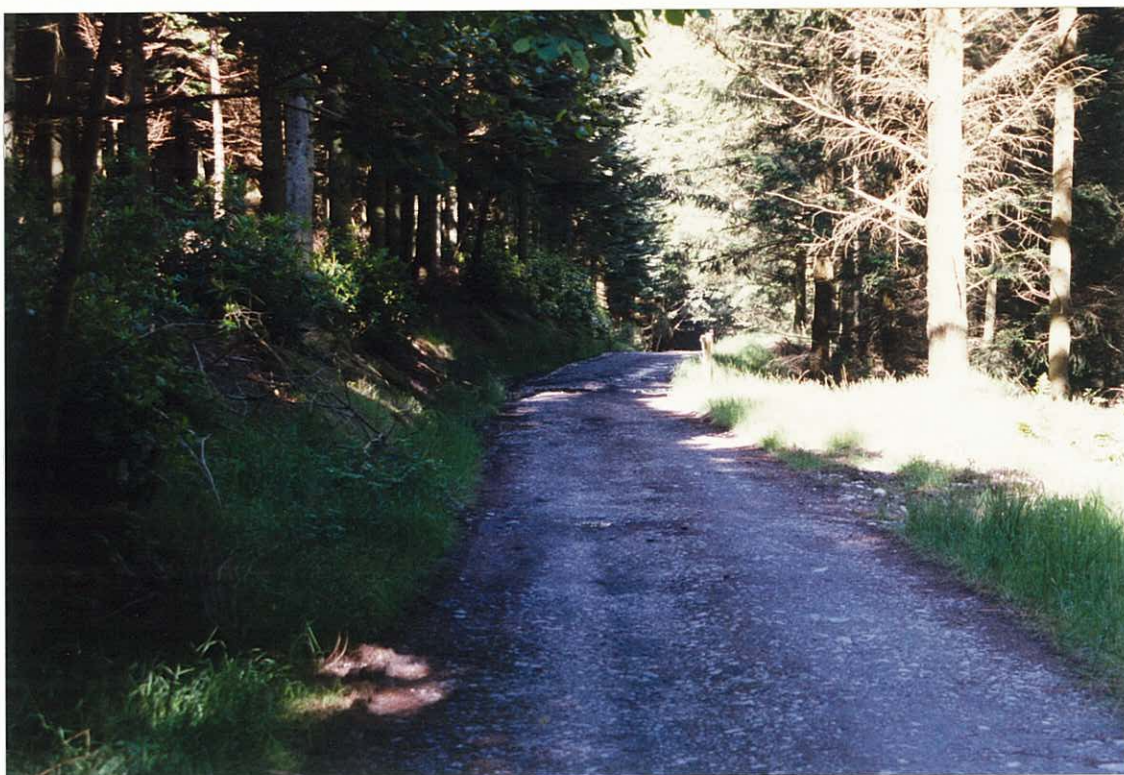
34

33047 Road (includes element Pont Nant Perian 33032) The road down to Pont Nant Peiran (33032) from road 33048. This early 19th-century? drive is now used as a forestry road. It runs diagonally down a steep north-facing slope on c. 6m wide terrace. This terrace is modern and has been constructed by excavating on the up-slope side and dumping the resulting spoil on the down-slope side. The road has an hard-core surface. To the east of Pont Nant Peiran the track runs on level ground. Here there is no evidence of engineering. No pre-forestry road features survive.

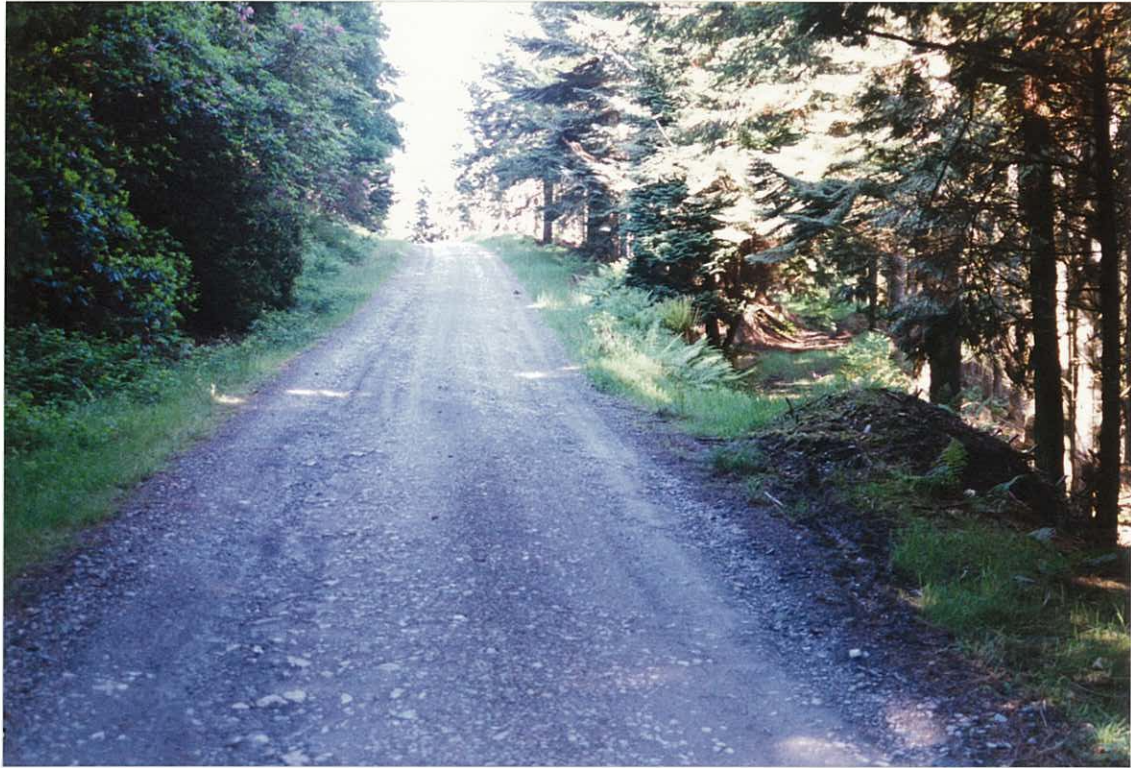
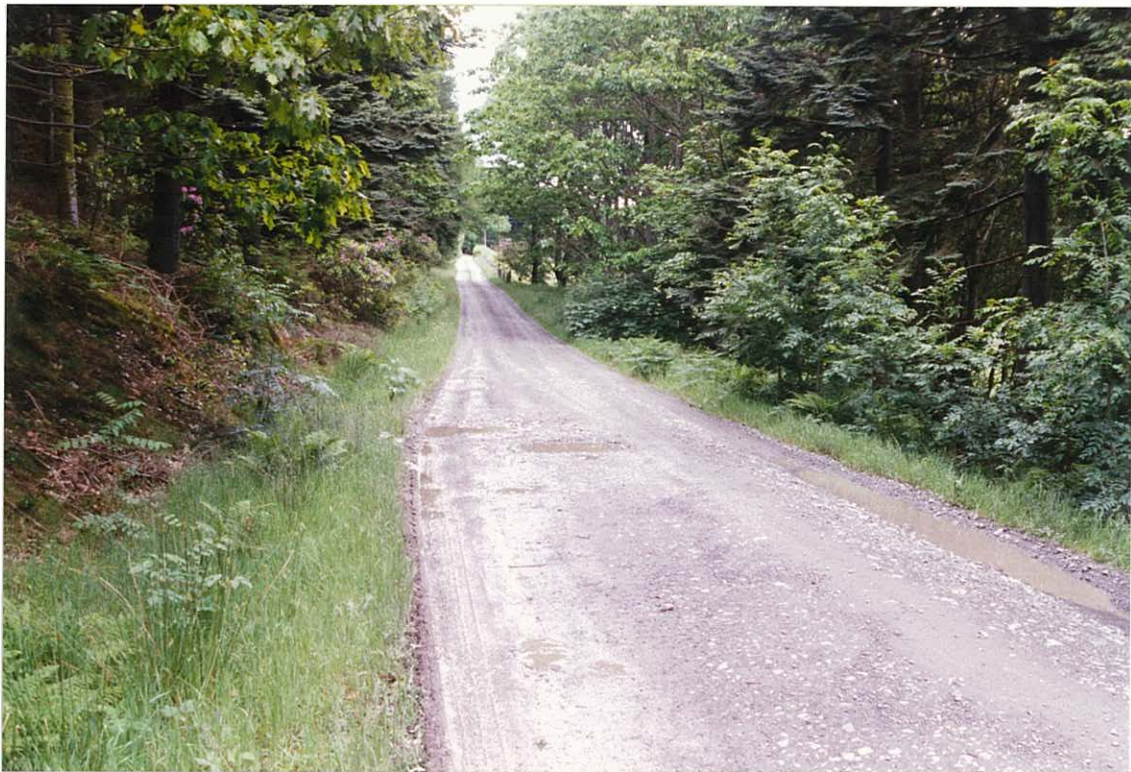
33048 Road (includes elements: bridge 33066, upper lodge 19760, upper lodge gates 33093, culvert 35908, gate post 35421 and viewing point/retaining wall 32960). A current forestry road closely follows the course of one of the first carriage drives on the Hafod estate (established by 1796). The road runs from close to the Mansion site to the Upper Lodge. From the west end the road follows the contours on a steep valley side. After crossing a bridge it climbs gently, still running across the valley side. For most of its course the road has cut into the slope and the resulting spoil deposited on the down-slope side to create a terrace c. 6-m wide. Although much of this terracing was undoubtedly constructed in the late 18th-century, all has been much enlarged and modified for the forestry road. Large turning areas at the junctions of other roads have been provided and pull-ins at intervals. A drain/ditch runs along the north side with culverts beneath the road.

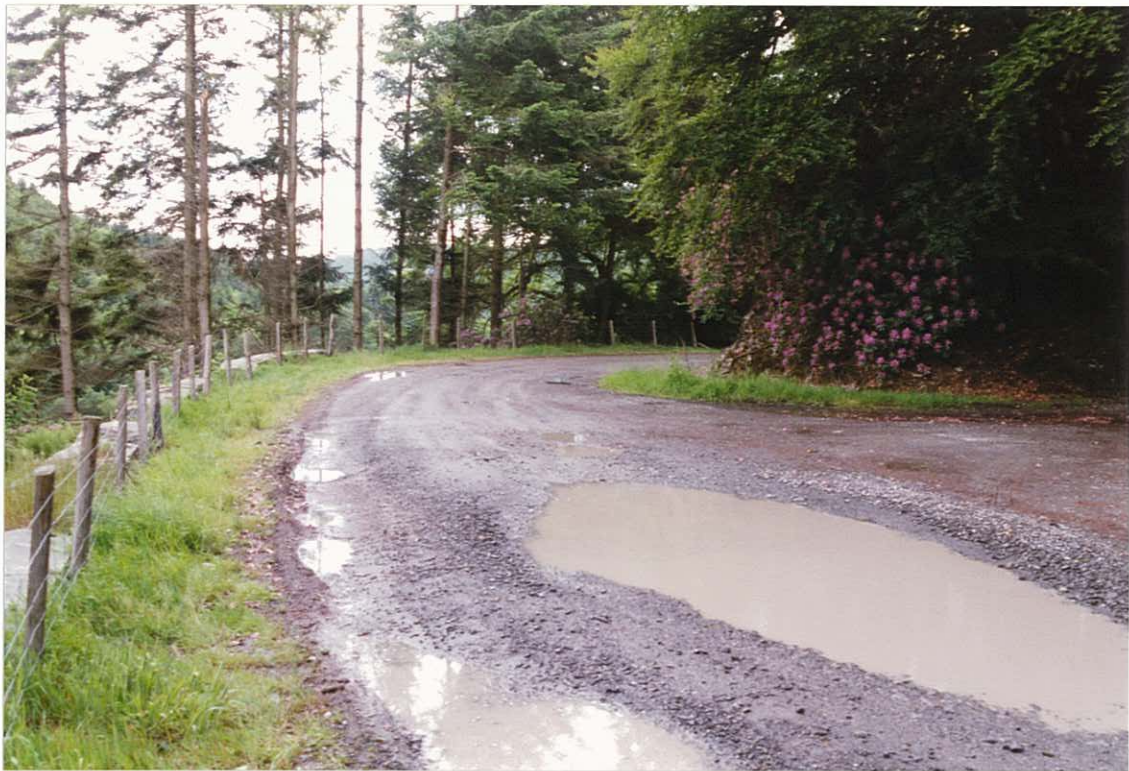
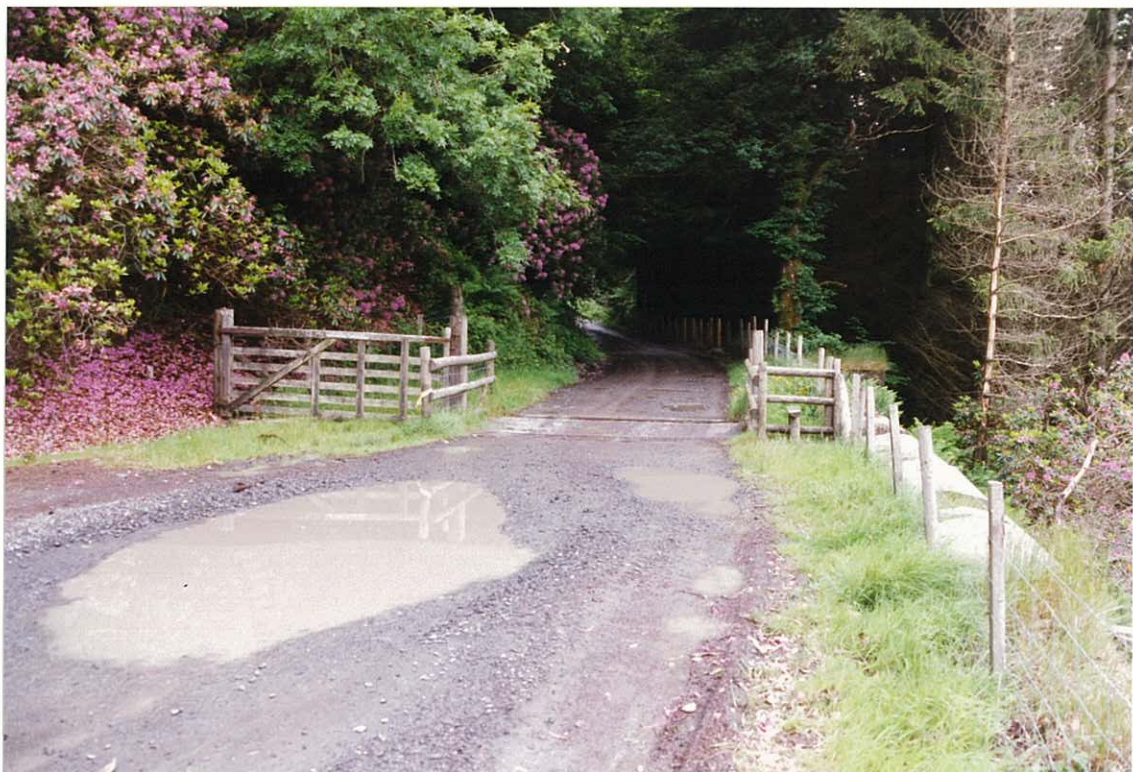
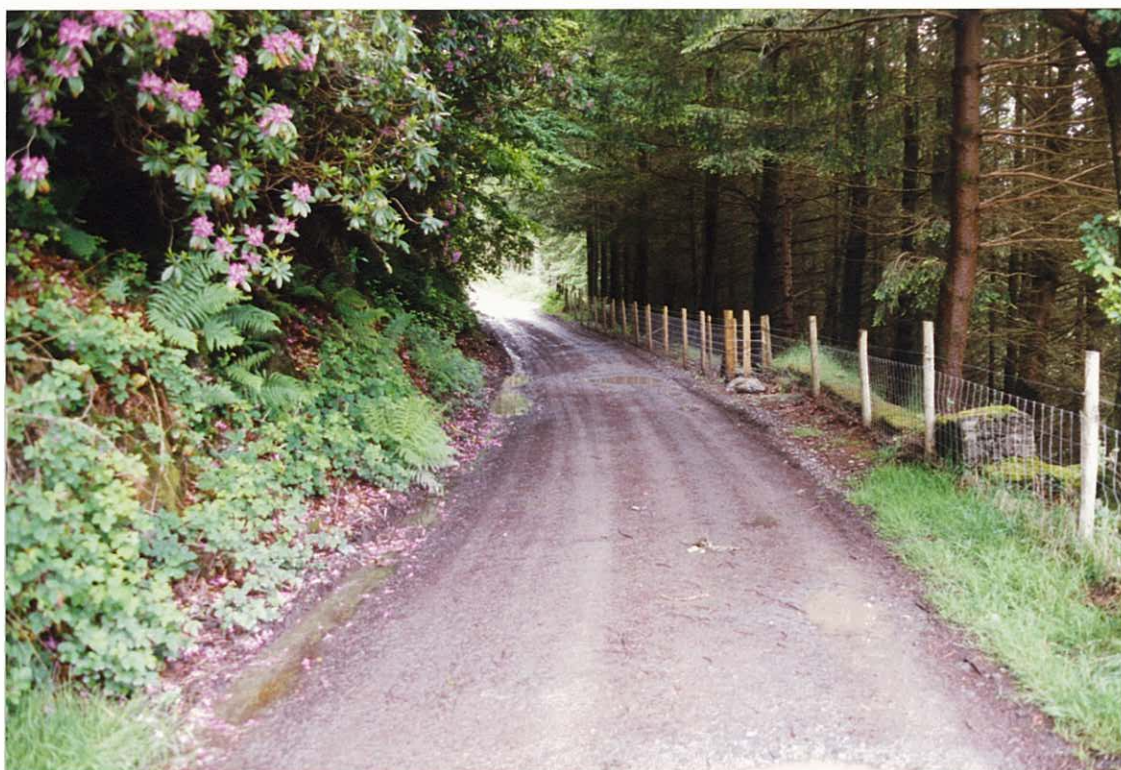
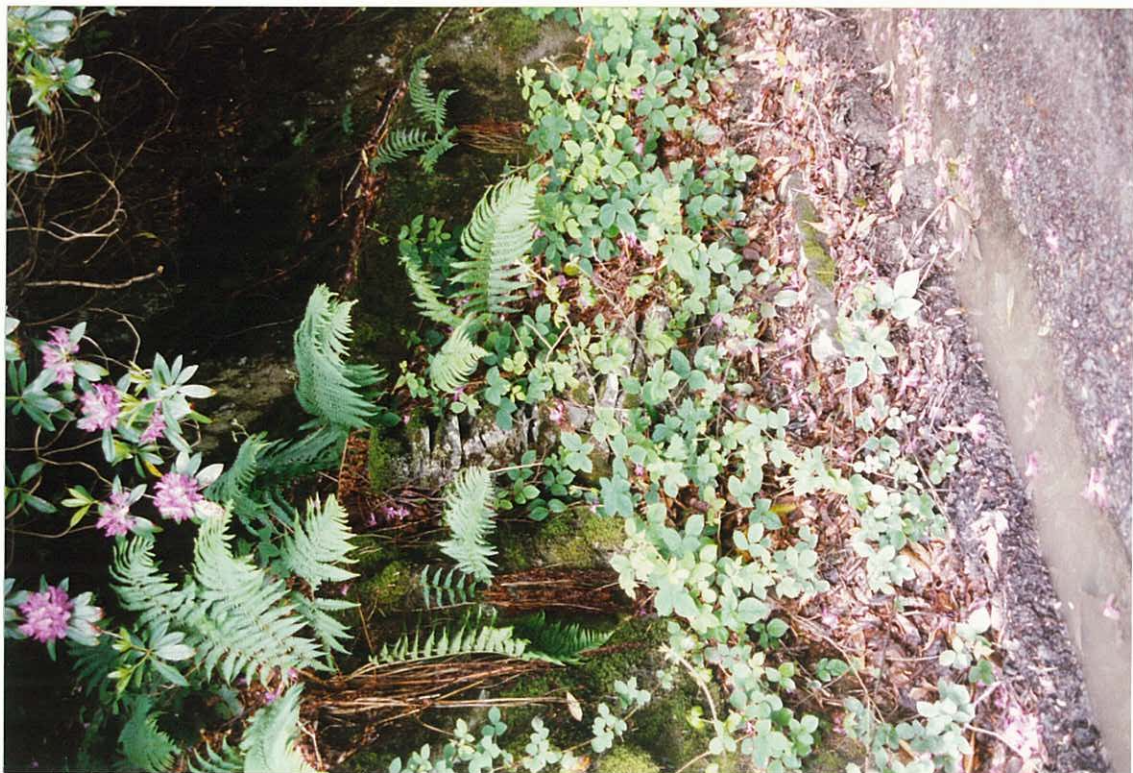
32960 Viewing place/revetment wall and 35421 gate post (on road 33048). The road/carriage drive has here been built on a rock-cut terrace. The down-slope side of this terrace has been reverted with a mortared stone wall. This wall contains two semi-circular viewing platforms (one now almost entirely gone) and is capped with large, dressed slate/shale slabs. These slabs are now almost at the same height as the road surface. Along its eastern length much of this wall has collapsed. Many of the capping stones are missing. At the extreme western end the road terrace is up to 9m wide, with a modern drain on the north side, but it rapidly narrows, with on average a gap of 5m between rock cutting and revetment wall. The foundation stone of a gate post (35421) lies on the north side of the road, hard against the rock cutting, opposite the eastern viewing place. A cattle grid and gate lie to the west of the gate post. It is possible that forestry track is now considerably higher than the original surface of the carriage drive, as one would have expected the capping stones to have been a waist height. This increase in the height of the road may be putting extra pressure on the wall, and is thus a contributory factor in its poor condition. However, the main reason for the wall's poor condition is its proximity to a heavily-used road.

Recommendations: The road should be realigned to run as close to the rock-cut face as possible without damaging the rock cutting or the *in situ* gate post (35421). A machine cut trench dug with archaeological recording against the road-side face of the revetment wall would establish the nature of the road make-up and provide an indication of the original drive surface. It may then be possible to lower the road surface in this area and so relieve pressure on the wall.

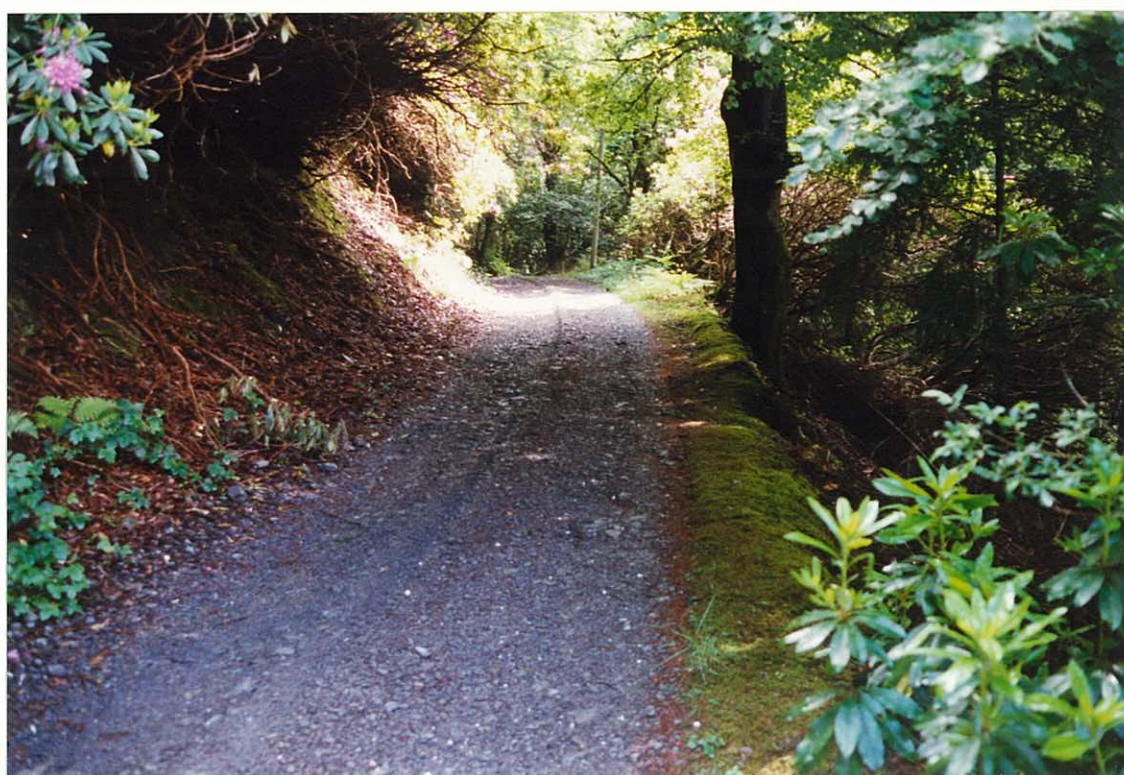
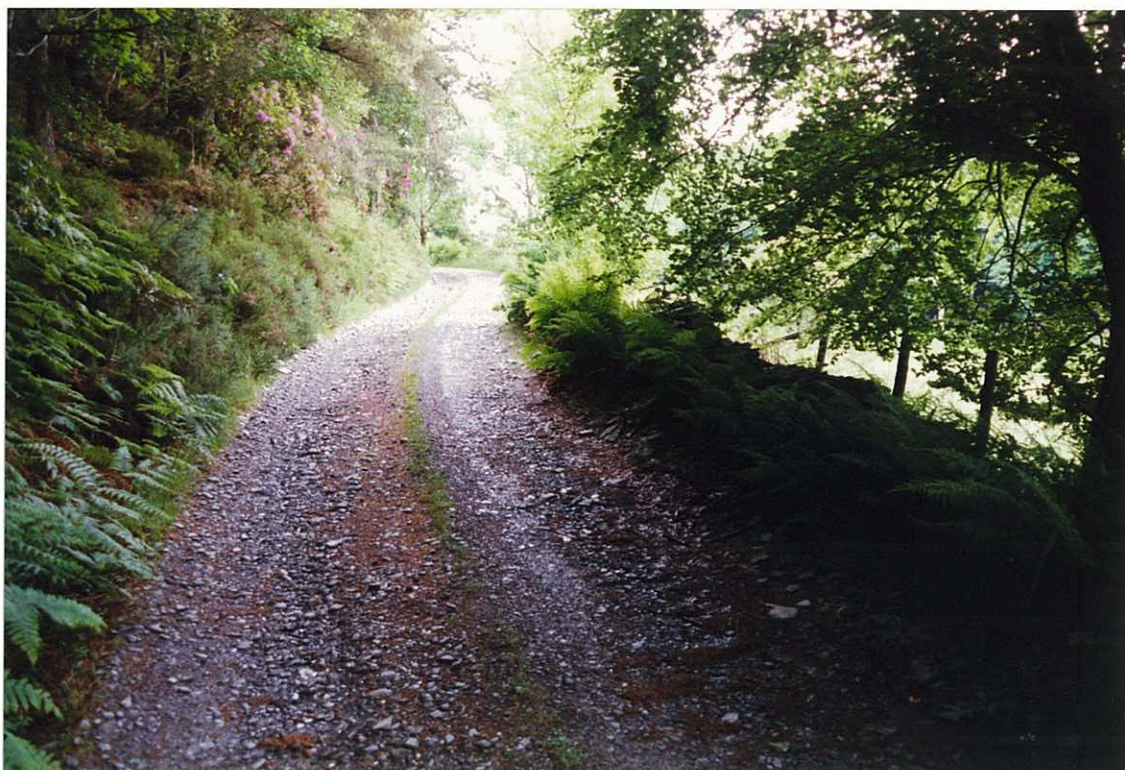
33064 Road (includes elements: bridge 32964, bridge 32968, flanking wall 33613 and site of lodge 35907). The course of this forestry road follows one of the first carriage drives on the Hafod estate (in existence by 1796). Prior to its conversion to a carriage drive it formed part of the public road system - a continuation of road 32980. The road climbs gently at first from west - east across a steep south-facing valley side. At its western end the road has been machine cut into the hillside and the resulting spoil used to form a terrace c. 5m wide. Evidence of recent engineering lessens towards the east. From Pendre Farm to the east the road climbs steeply at the base of the steep south-facing valley side. Road width 3m. Here only light engineering is apparent with no cut terrace and no obvious modern work. A dry-stone wall (33613), now very dilapidated, flanks the road to the south. The road has a hard-core surface. The road is now closed except for access to Pendre Farm.

Recommendations: If this road is to be the subject of upgrading then the section from Pendre Farm to the east should be undertaken in a manner that maintains the scale and character of the original/existing. (see elements listed above for separate recommendations)

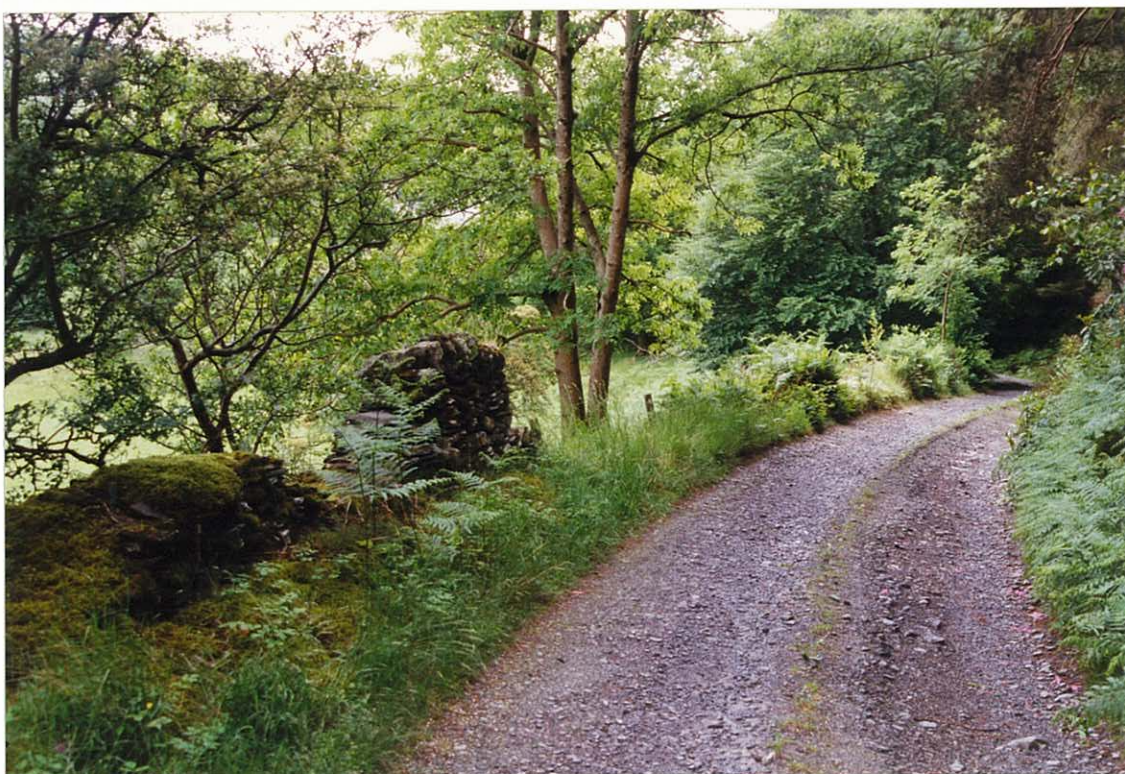
42

33613 Wall (alongside road 33064). This dry-stone wall is in poor condition. Nowhere does it stand to its full height and in long sections it has completely collapsed. It is nevertheless an important element in the Hafod landscape. It forms the southern boundary to road 33064.

Recommendations: This wall should be retained during any proposed road widening/upgrading programme.

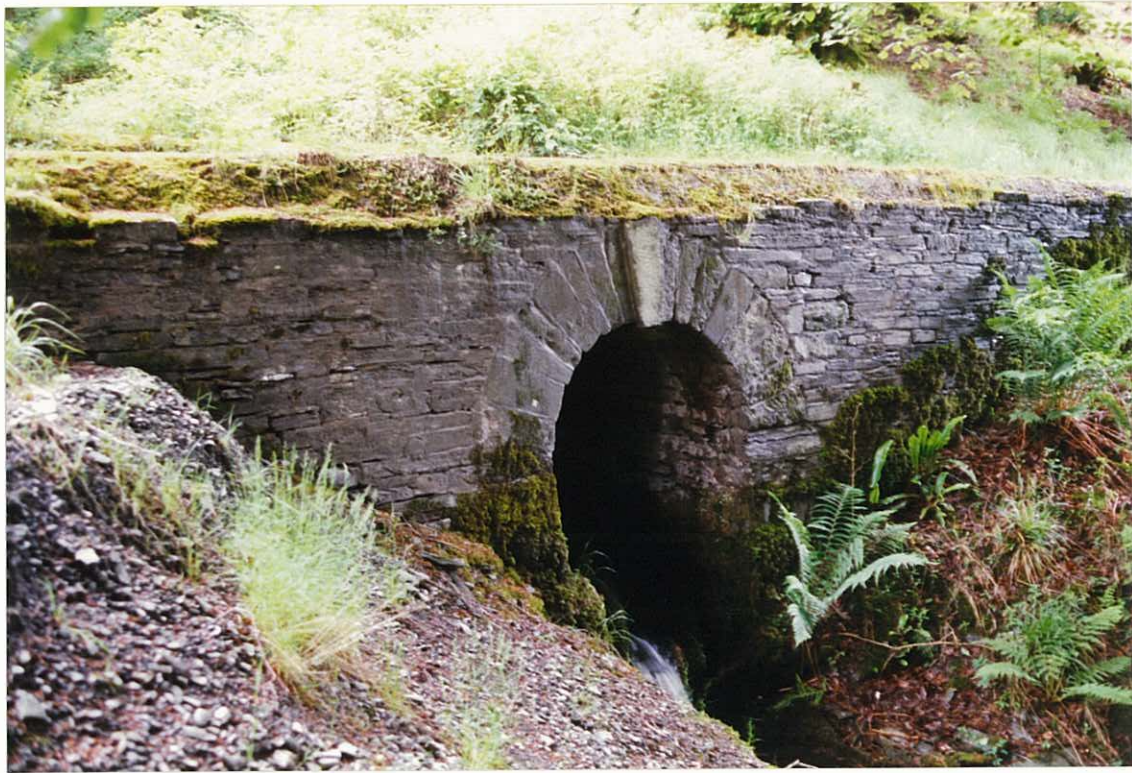
43

33066 Bridge (on road 33048). Single-arched stone built bridge. The voussoirs of the arch on the down-stream, south, side are of dressed stone, those on the up-stream side of rubble. The arch within the culvert is brick-built. The curving parapet on the south side has been replaced by a concrete kerb following its damage c. 10 years ago during road maintenance/improvements (Roger Hallett, pers. comm.). The northern curved

parapet survives to c. 50cm and is now capped with concrete. The road width over the bridge is 4m. The whole structure is in good condition.

Recommendations: This is an important element in the Hafod landscape. Care should be taken to ensure that it is not further damaged during road upgrading.

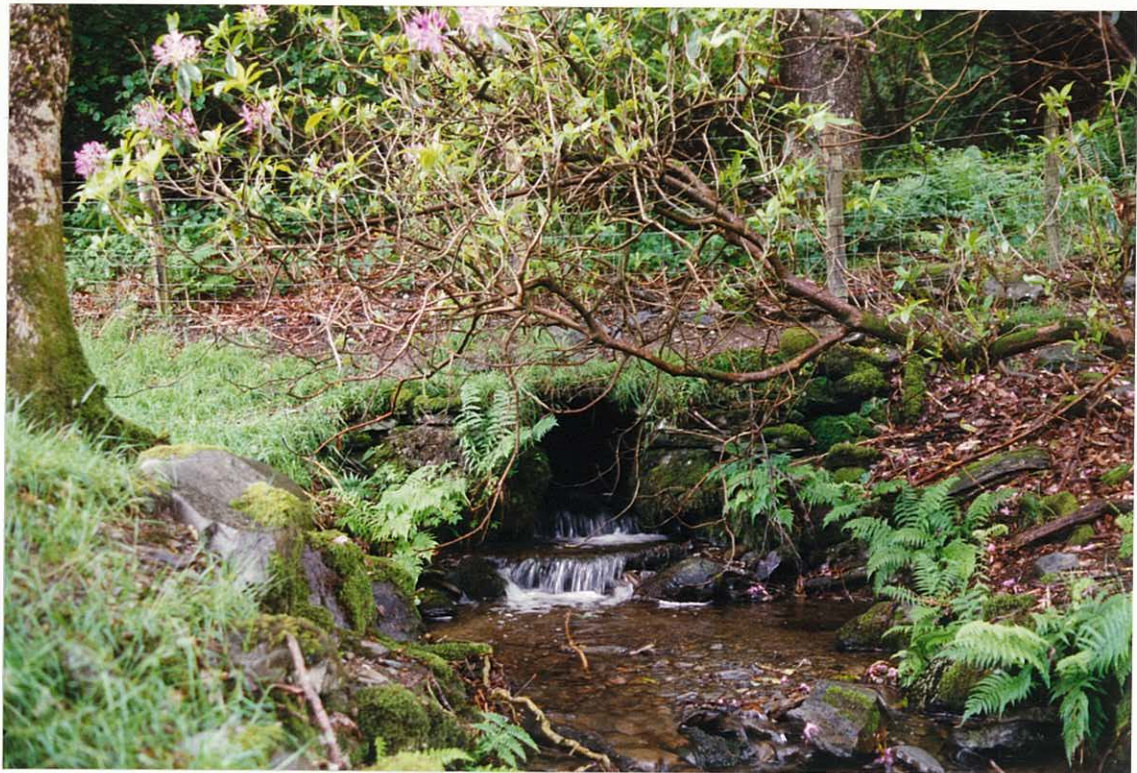
45

35905 Bridge (on road 32980). Small stone-built bridge of late 18th-century to mid 19th-century date. Constructed from mortared local stone with cut slate slabs (only one remaining *in situ*) capping low (0.6m) parapet walls. A block of oolitic limestone has been built into the fabric of the bridge. Parapet walls c. 4m apart. The stream

passed under the bridge in a square-section culvert. The culvert is choked on its upstream, north, side with gravel and rubble diverting flood water across the road. The hard-core road surface is beginning to break up. The whole structure is in poor condition and is urgent need of repair.

Recommendations: The culvert requires immediate cleaning; this could be done with a small mechanical excavator. The whole structure needs repairing/restoration and re-establishment of good road surface. Any repair/restoration should be accompanied by archaeological recording.

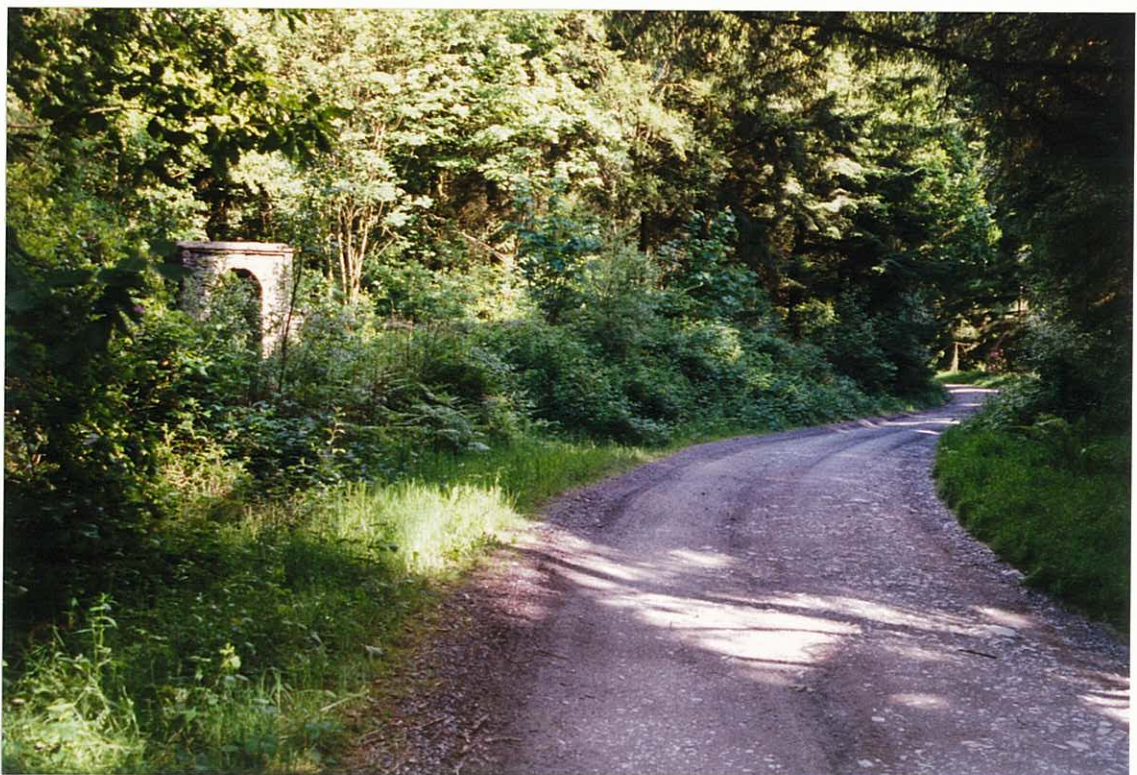
46

35912 Road. Modern forestry road from road 33048 down to the concrete bridge (33091). At its western end this road runs down a steep, south-facing valley side on terrace, 6-7m wide. This terrace has been cut into the slope and the resulting spoil deposited on the down-slope side. This spoil has buried part of the Flower Garden (26521) - an important element of the Hafod estate - and enclosing wall. To the south-east the road runs in a cutting 2-3m deep and c. 6m wide. This cutting has destroyed a swathe of the Flower Garden.

Recommendations: It is essential that no further damage to the Flower Garden occurs. Therefore, the road terrace or cutting should not be widened. Re-surfacing or other works on the road surface on the terrace or within the cutting will not affect the Flower Garden.
