Tir Gofal Farm Visit Report

Trefenty

W/12/1086

ACA Project Record No 36333

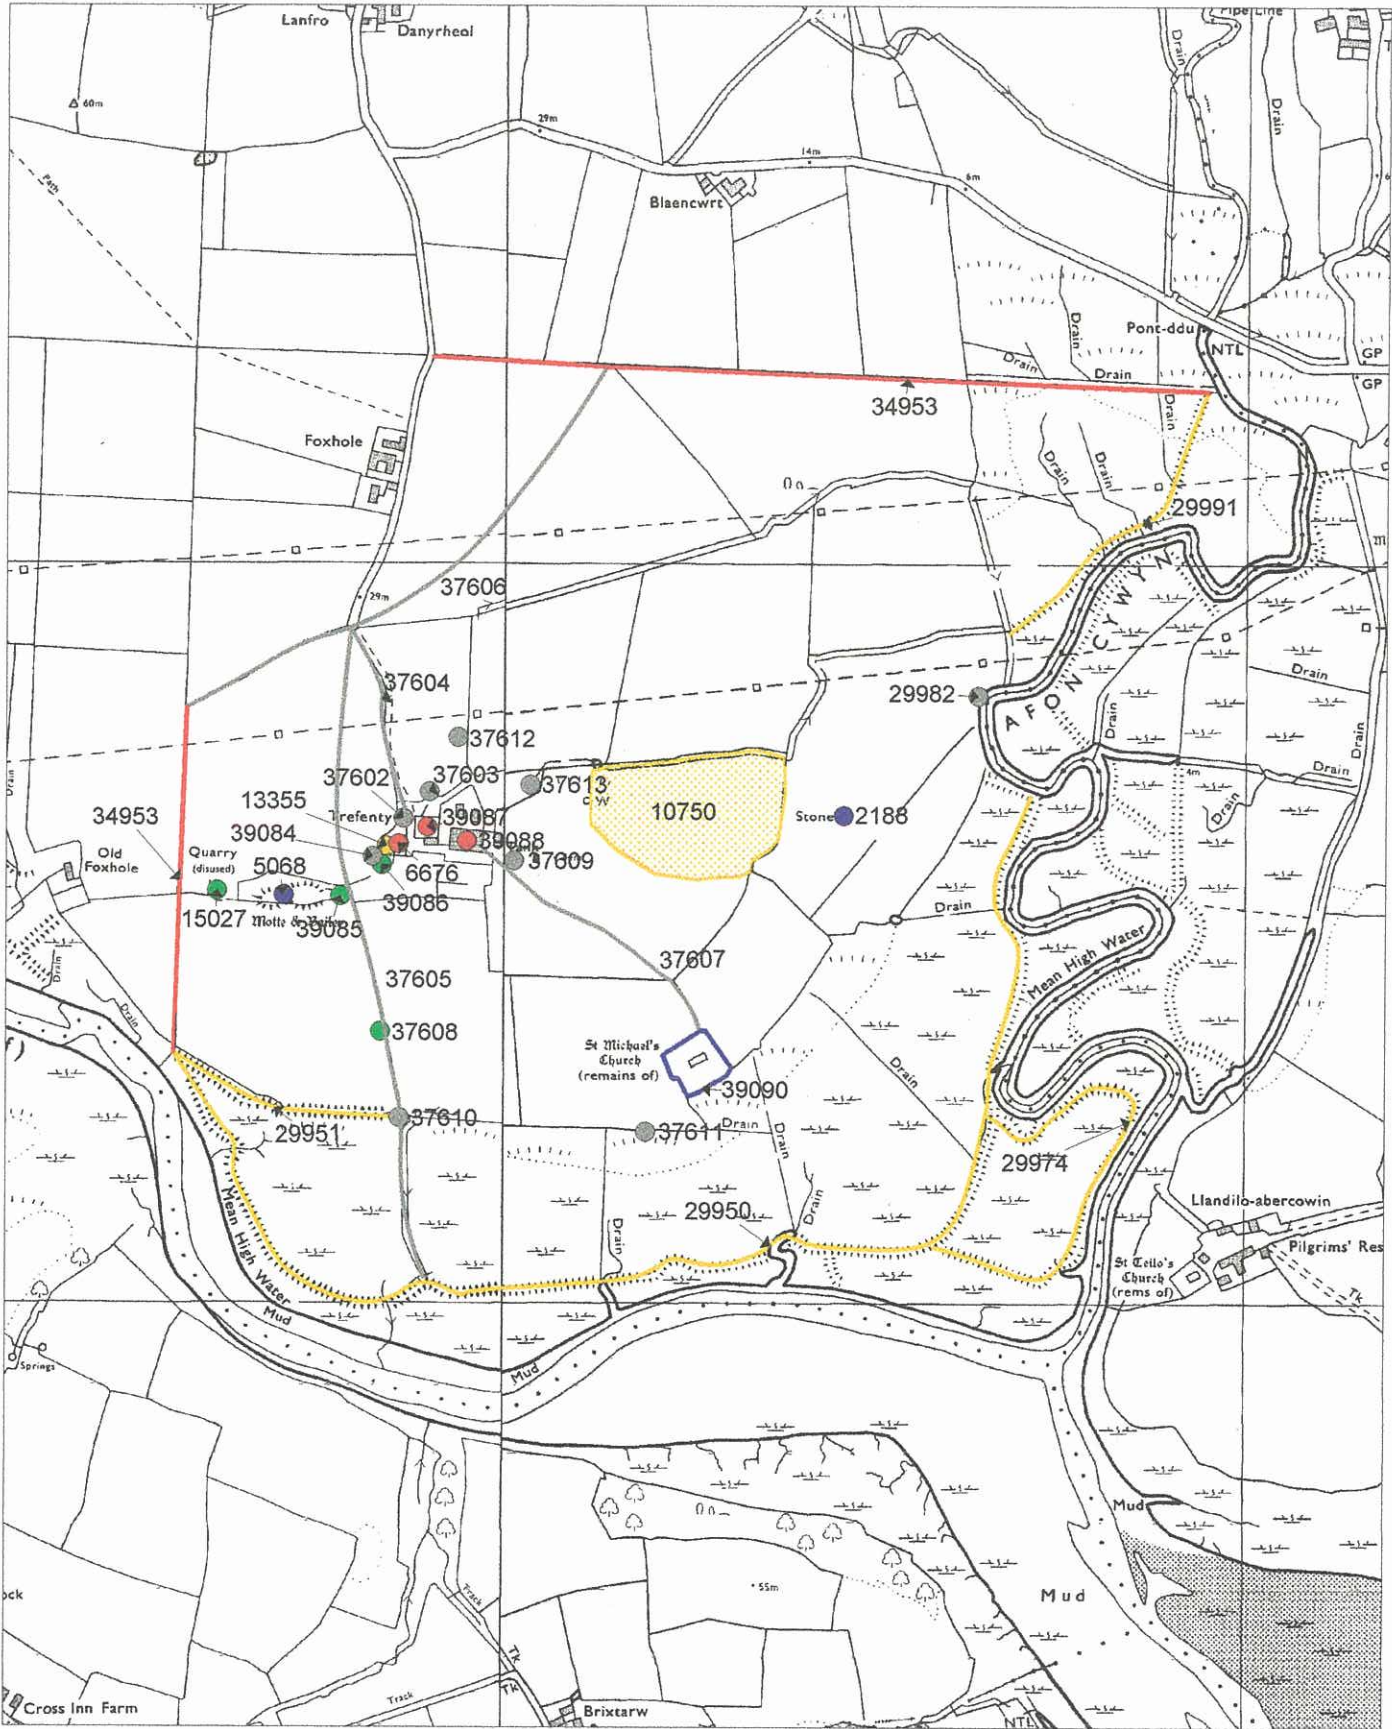
Tir Gofal Farm Visit
Trefenty - ACA Record Number 36333

This is a detailed topographic map of a rural area in Wales, showing the River Taf (Afon Taf) and the River Coran. The map includes numerous place names, elevation points, and a network of roads and tracks. A yellow dashed line highlights a specific path or boundary. A red line is also visible near the top center. The map is oriented with North at the top.
