Tir Gofal Farm Visit Report

Ffosfach Uchaf Farm

ACA Report Number 2001/27

Tir Gofal Application Number W/12/1690

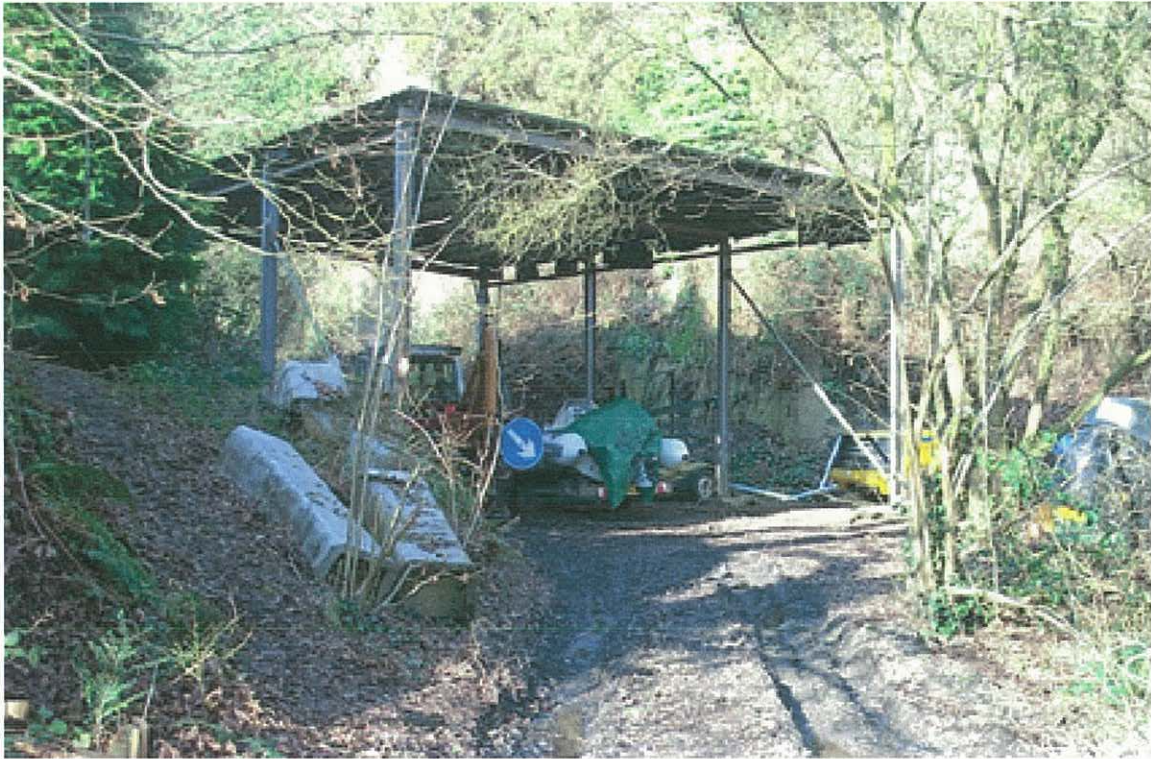
Large quarry (c.0.25ha), situated immediately to the east of Ffosfach Uchaf Farm. It was first recorded on the 1st edition OS map of 1878 although an eighteenth century coal shaft is located on its northern side (PRN 42309) and it is likely that some quarrying occurred here before the late nineteenth century (plate 1). The quarrying may have been associated with the construction of the nearby Llangennech and Llanelly railways in the early nineteenth century. A large pool of water in the southeastern corner could mark the site of a well that was recorded on the 1st edition OS map in 1878.

Plate 1 - large quarry (PRN15960) to the east of the farm showing the modern building and rubbish that was dumped by the previous owner.

The quarry has been used by previous owners for dumping large quantities of rubbish and a substantial (c.9m by 12m) steel girder and breeze block structure has been constructed at its centre for storing heavy plant machinery. The quarry faces are relatively stable and are overgrown. The rubbish should be cleared. The quarry faces should be left undisturbed.

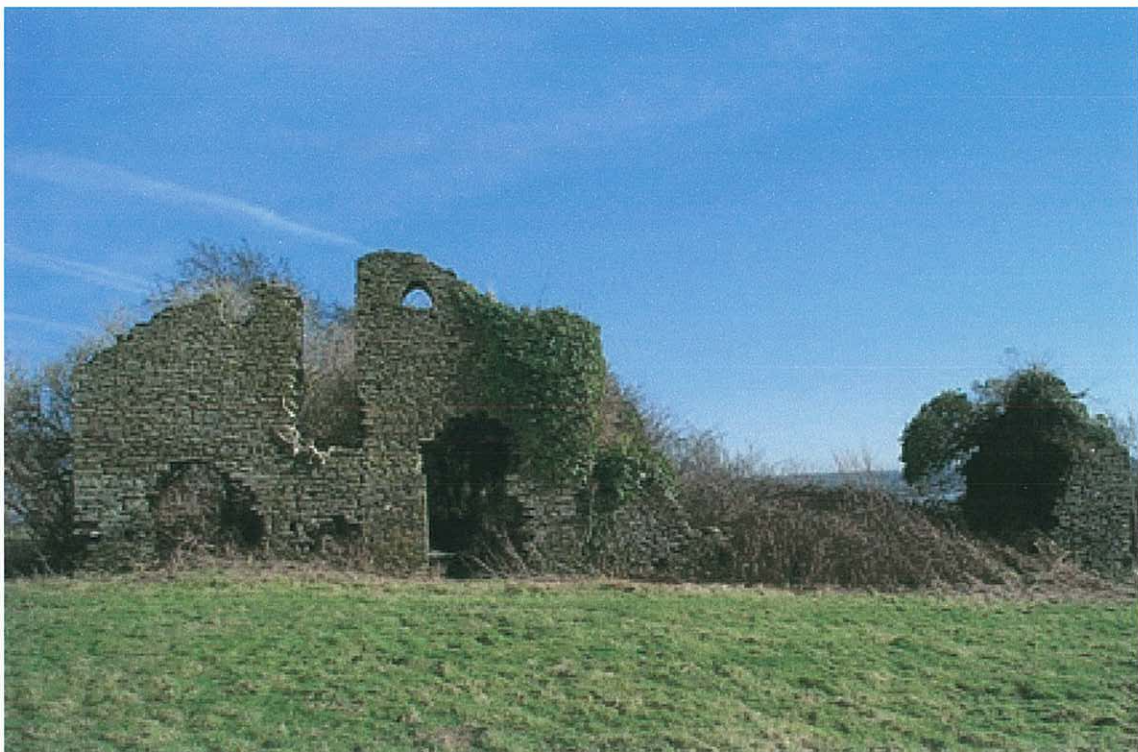
Pencoed lead works, first established at the initiative of Sir Thomas Stepney in 1754-5. It was first recorded on a 'Plan of directions for ships to come in safe to Burry' in 1757. Local coal was used to smelt the lead ore which was shipped up the Lougher Estuary to an adjacent quay. An associated canal was planned by William Fenton in 1770 but was never realised. References suggest that the leadworks were financially unsuccessful and the works closed in the 1770's. The 'Old lead house at Pencoed' was leased to General George Warde in 1802 and the building may have been briefly reused for copper smelting in the early nineteenth century. It was later reused as Ty-coch Farmhouse and was recorded as such on the 1st edition OS map of 1878. The southeastern end of the building was destroyed by the construction of the modern route of the Llanelly railway to the south after 1905. The standing remains include a large rectangular building to the north (orientation east-west) and a lower, abutting structure to the south (orientation north-south) forming an L-shape in plan (plate 2). Both are of rubble and lime construction with dressed stone quoins and gabled roofs. The southern and western walls of the northern part stand to roof height. The footings of the northern wall stand to a height of 0.5m and are overgrown. The western gable wall has two doorways and a tall central window with vertical oval oculi to either side. The interior is overgrown with ivy and young trees and has been used more recently for dipping sheep and dumping farm machinery. The scheduling information (1996) also records the survival of a nineteenth century boiler within this area. The southern gable wall of the building to the south stands to roof height and has a large blocked-in window. The remaining walls are lower (c.0.6m) and the interior is extremely overgrown with bracken. The area around the buildings is uneven and may contain the subsurface remains of watercourses, tracks and spoil tips.

Plate 2 - Pencoed leadworks (PRN30662) showing overgrown ruins.

The lead works is one of the earliest non-ferrous metal smelting sites in Wales with upstanding remains. It has been identified as being of national importance and was designated as a scheduled ancient monument in 1996. The buildings are ruinous and structurally unstable. The walls are overgrown with ivy and several of the dressed stone quoins and lintels have been robbed. Some concrete lintels were inserted by CADW in 1996 to arrest decay, but the condition of the buildings appears to have deteriorated since this date. The ivy should be cut and the walls consolidated to ensure its survival as a standing structure. The interior should be cleared of rubbish and any intrusive vegetation should be controlled to minimise further damage to the structure. The surrounding area should not be disturbed. The association between the leadworks and the counting tower should be investigated further.

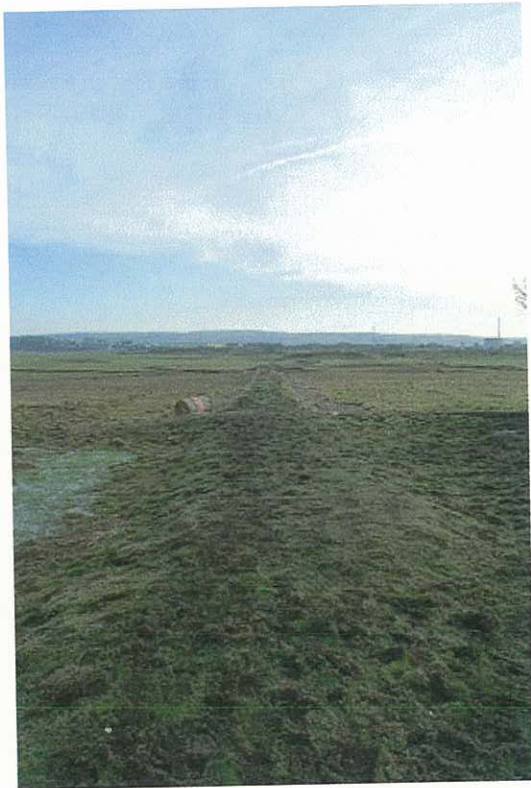
Section of the Llangennech Coal Company's railway which ran from Llangennech Quay to Spitty Bank. The railway was built in 1826/27 to alleviate transportation difficulties between Llangennech Quay (where coal was delivered) and Spitty Bank Copper Works. Its construction restricted local access to the marshes and caused great controversy. Its use was consequently short-lived and it was abandoned in 1829 when the landowners lease was surrendered. Two sections of the former railway lie within the boundaries of Ffosfach Uchaf Farm.

The section which runs across the holding from northeast to southwest to the north of the later Llanelly railway was identified during previous surveys as a possible sea defence (PRN 31607). Most of this section survives as a substantial raised embankment (c.2m high by 5m wide), except at its northeastern end where it is cut into natural rock. A fine stone-built bridge crosses a culvert beneath the railway line midway along its length. This section was reused by the Llanelly Railway and Dock Company for their Llanelli/Llandeilo Railway (PRN 30866) in the late nineteenth century and is now cut by the modern Llanelly railway at either end. The section to the south of the Llanelly railway line runs from north to south across marshland. It was reputedly constructed from copper slag from the Spitty copper works. Access rights to the River Lougher dictated that the railway ran along the high water mark for most of its length. This section of the railway was known locally as the bulwark and following its abandonment acted as a sea defence. It now survives as a low (c.0.7m high by 2.5m wide) embankment.

Plate 3 - remains of the Llangennech Coal Company Railway (PRN30739) as it crosses the marsh to the south of the holding.

The section of the railway to the north of the modern Llanelly Railway line is in good condition and part of it is still used as a footpath/trackway. It is completely grassed over and the sides are overgrown with brambles, reeds and thorn. Some piles of rubble have been left along its sides and the bridge over the culvert has been repaired with concrete. The top of the embankment should be kept clear and the rubble removed from along it. Any further repairs or alterations to the bridge should be carried out using appropriate traditional materials.

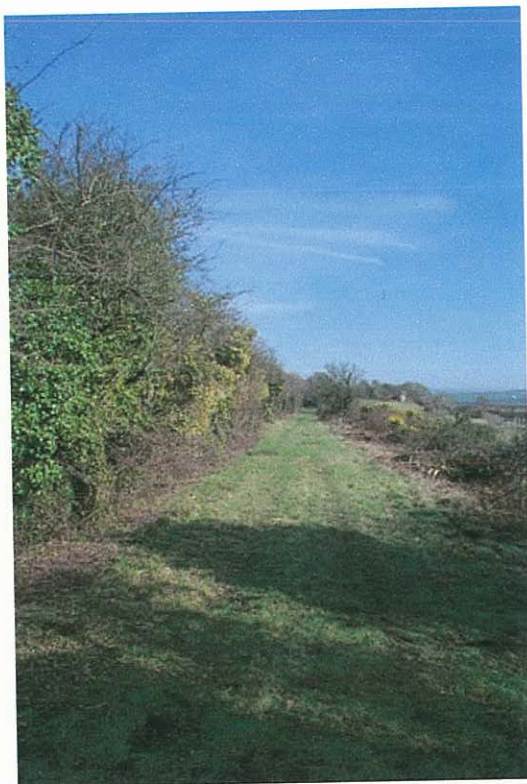
Section of the Llanelly Railway and Dock Company railway, where it runs through the holding of Ffosfach Uchaf. It was built from Llanelli to the Ammanford district between 1828 and 1842 and was subsequently continued to Llandeilo and the Tywi valley. Its original route overlay that of the earlier Llangennech Coal Company railway (PRN 30739) to the north of the current Llanelly railway line and the earlier lead works at Pencoed (PRN 30662). It was recorded in this location on the 1st edition OS map of 1878. Some time after the 2nd edition OS map of 1905, the line was diverted to its current route that cuts across the site of Pencoed lead works (PRN 30662). This bend in the railway was locally renowned as a drop-off point for luxury food goods during wartime rationing and it is reputed that a pig was once slaughtered on the line here.

Plate 4 - disused section of the Llanelli Railway (PRN30866), where it overlies the line of the earlier Llangennech Coal Company Railway.

The railway is still used as a mainline route and the owner is not responsible for its management. No specific management recommendations.

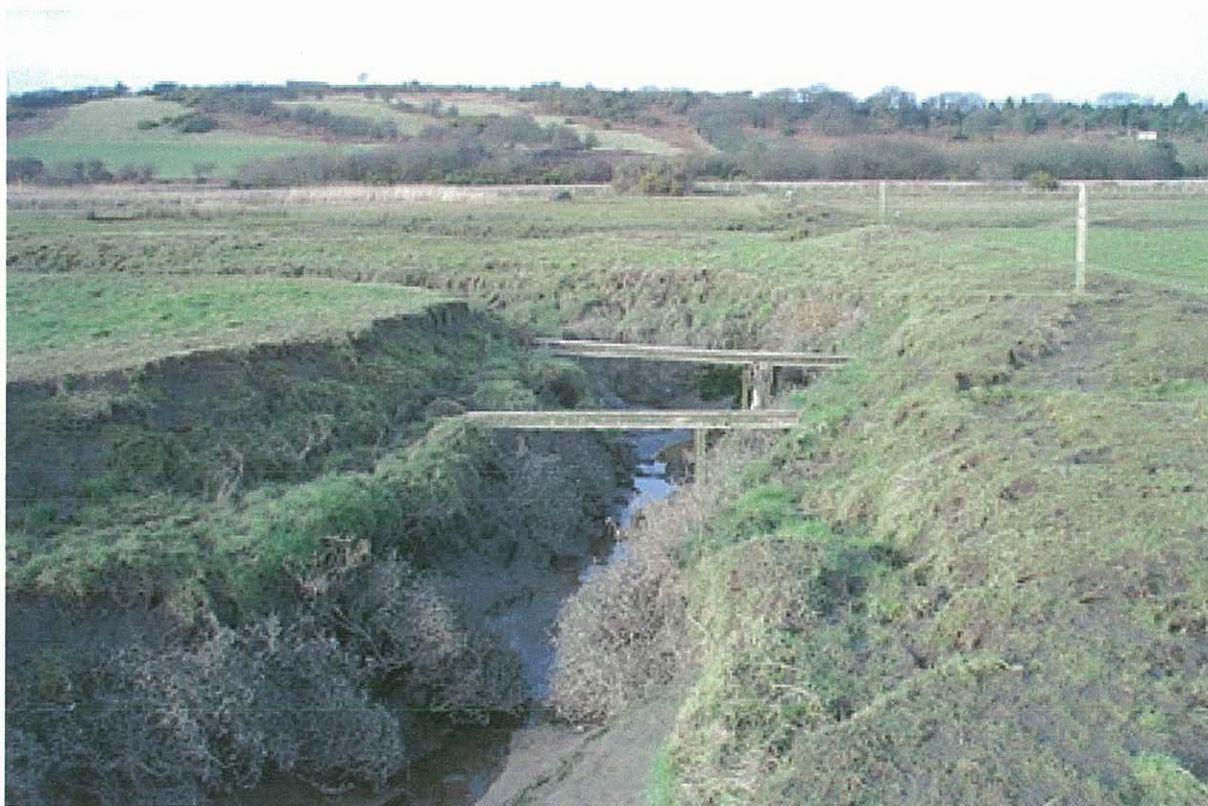
Site of a sluice, first recorded on the 1st edition OS map of 1878. It was more recently recorded during an archaeological assessment of the Llanelli and Lougher wetlands in 1997. Part of an iron and wooden structure survive within the drain at this point and probably represent the remains of this sluice. The underground drain which surfaces here holds a narrow iron pipe like that of the pipeline that runs alongside the Llangennech Coal Company Railway to the east of Ffosfach Uchaf Farm. It is possible that this sluice and drain form part of the extensive pipeline (PRN42307) that linked the reservoirs to the north of the farm to the Spitty copper works and later Bynea steel works on marshland to the south.

Plate 5 - remains of possible sluice (PRN31614) on the salt marsh.

The remains of the sluice and underground drain should be left in-situ.

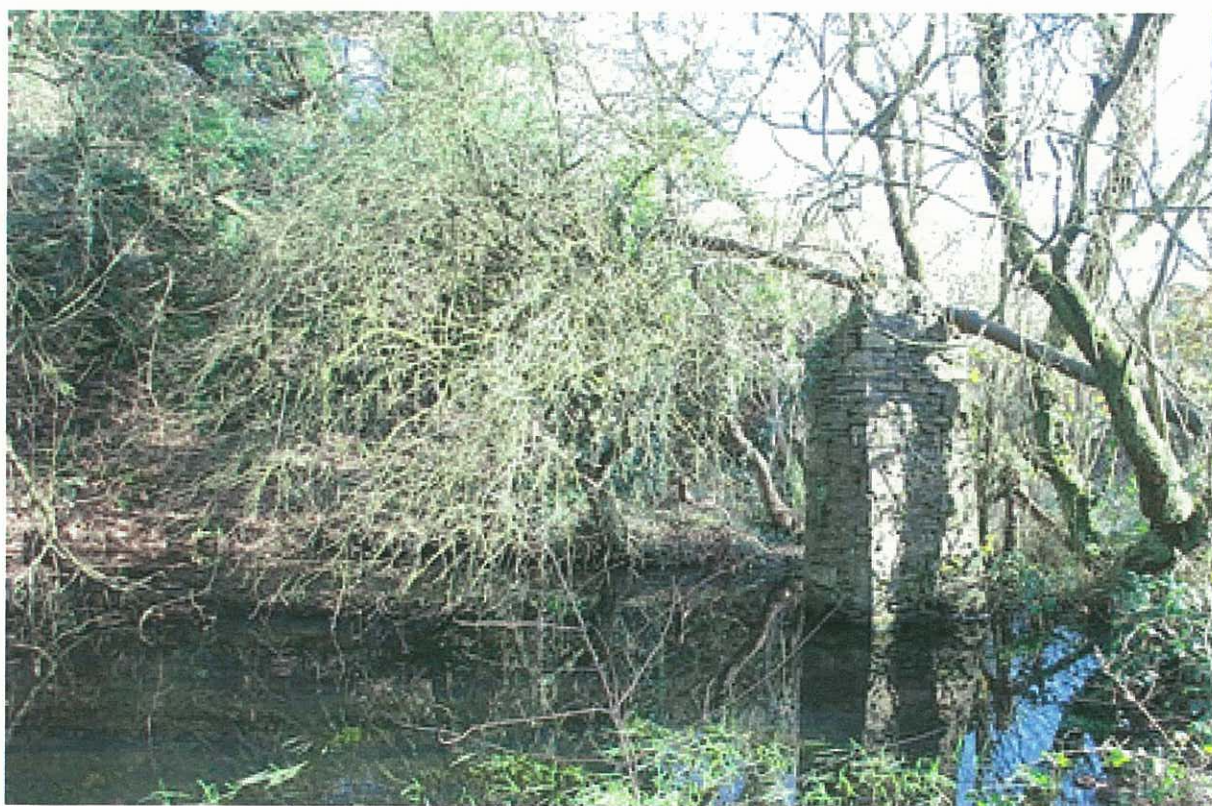
Extensive system of water pipes connecting the reservoirs to the north of Ffosfach Uchaf (PRNs 42310, 42311) to eighteenth and nineteenth century industrial plants on the salt marshes to the south. The section immediately to the southeast of Ffosfach Farm (PRN 15960) runs parallel to the Llangennech Coal Company's Railway on substantial (c. 1.5m by 1.5m by 4m tall) rubble and lime mortar pillars. It crosses the railway line further to the west. The water was carried in a narrow (c.0.3m in diameter) iron pipe. Some of the original pillars that supported the pipe have been replaced with brick versions. The remainder of the system presumably ran underground or has otherwise been removed. A similar pipe runs beneath ground to the sluice (PRN 31614) that drains onto the marshes further to the south. The exact purpose of the pipeline is unclear. However, the owner thinks that it formerly ran to the eighteenth century copperworks at Spitty bank and was later reused to supply water to the Bynea Steel works.

Plate 6 - rubble pillar supporting the pipeline (PRN42307) from the reservoir (PRN42310).

The upstanding section of the pipeline is in poor condition. The stonework on the pillars is crumbling and several are overgrown with ivy. The pipe itself is breached where it crosses the gateway to the quarry (PRN 15960). The ivy should be cut to prevent further damage and the stonework should be consolidated. The system should be retained as an integral part of the eighteenth and nineteenth century industrial history of the area.

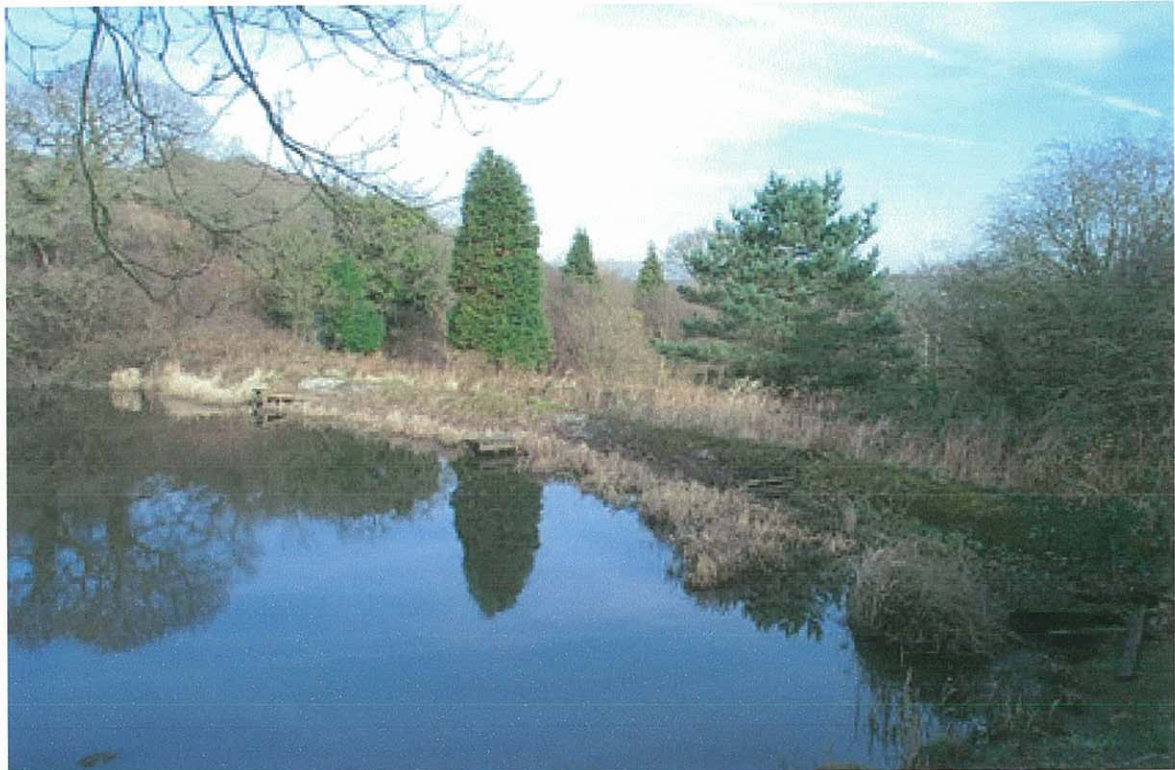
Large reservoir (c.0.6ha in area) situated to the north of Ffosfach Uchaf Farm. It was first recorded on the 1st edition OS map of 1878 although its date of construction may be earlier. According to the owner, it was constructed to provide water to the Bynea Steel works that lay on marshland about 1km to the south. It consists of a sluice at its western end, a reservoir, and a substantial dam and overflow at its eastern end. The site of the sluice is now marked by a pile of rubble in the inlet channel to the west of the reservoir. The dam consists of a substantial (c.5-8m wide) concrete and rubble bank. The overflow channel is situated in the southeastern corner of the reservoir. It is defined by rubble walls at its western end and runs steeply downslope into a channel that feeds an earlier reservoir (PRN 42311) further to the east. An iron pipe runs from the base of the dam and presumable links to the pipeline that runs through Ffosfach Uchaf Farm (PRN 42307). A small jetty and fishing piers are situated along the southern side of the reservoir and presumably relate to its later use. A narrow trackway (c.3m wide) runs along the southern side of the reservoir and may also be later.

Plate 7 - reservoir (PRN42310) feeding the pipeline to Bynea Steelworks, showing the substantial dam at its eastern end.

The reservoir is in good condition and is not affected by current landuse practices. The loose rubble at the site of the former sluice should be left in-situ. The walls of the overflow channel should be maintained in a stable condition. The top of the dam is overgrown and if possible the vegetation in this area should be controlled.

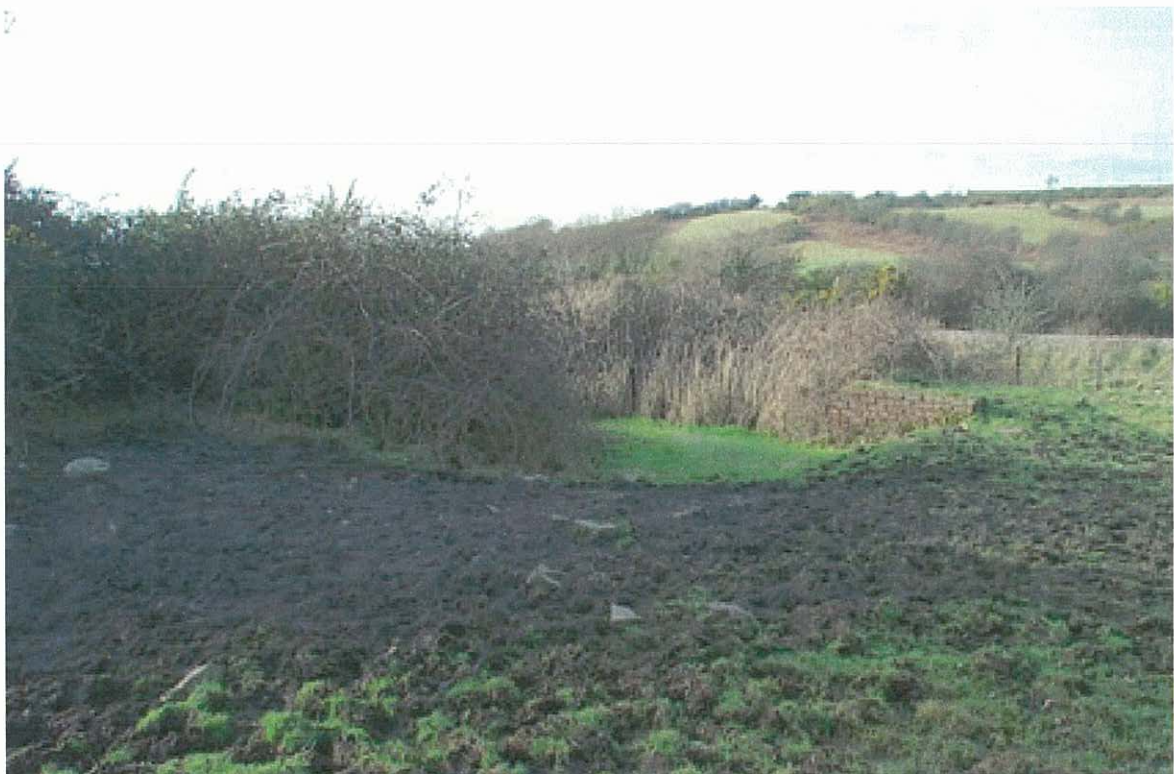
Disused mine shaft on salt marsh to the south of Ffosfach Uchaf Farm. The shaft is one of several sinkings that were made by Thomas Bowen who leased the land between 1748 and 1752. It forms part of an extensive area of small-scale mining round Ffosfach Farm that exploited the 'Marsh Vein' of the Swansea Five Feet Vein (PRN 8767). This particular cluster of shafts are described on a plan of 1772 as 'Pits sunk by Mr Bowen in order to make a new winning but was prevented by water'. The shaft has been covered with a brick and concrete structure. The overgrown footings of a rubble building (c.8m by 10m by 0.5m high) which may relate to the working of the shaft lie immediately to the south of this. A large lump of slag lies a further 10m to the south.

Plate 8 - waterlogged disused mine shaft and building footings (PRN42313) showing erosion caused by grazing and overgrown condition.

The shaft itself is now covered over and in a safe condition. The area to the south of it including the footings of the building is extremely wet and overgrown and the ground here is being eroded by horses. Any rubbish in the area should be removed and intrusive vegetation should be controlled in order to prevent further damage to the building footings. The condition of this site should be monitored.
