**Tir Gofal Farm Visit Report**  
**Bryn (Penygarreg, Nantllwyd)**  
**W/12/1827**

**Report Number 2001/57**

REPORT NO. 2001/57  
PROJECT RECORD NO. 37601

BRYN (PENYGARREG, NANTLLWYD)  
TIR GOFAL FARM VISIT REPORT

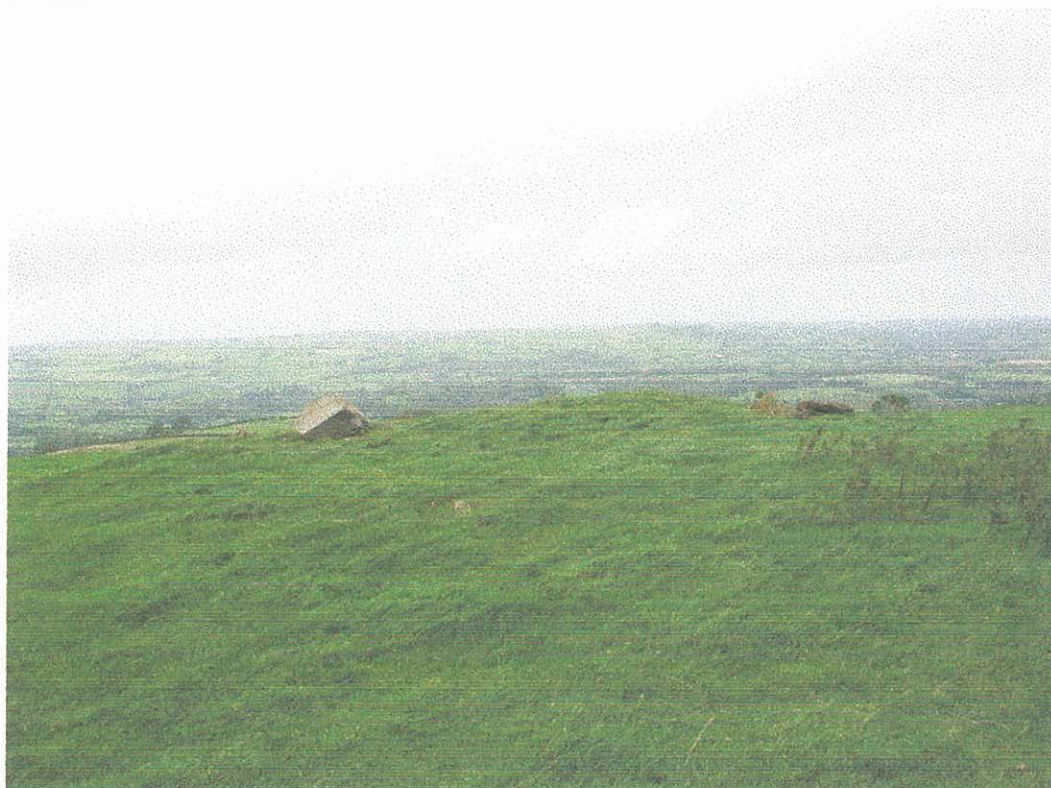
Plate 1 - Pen-Wern round barrow (PRN 753)

A damaged but still visible round barrow (plate 1) sited on the edge of the ridge/high plateau on which associated sites 754 and 7519, intervisible with this cairn, were sited. The well-defined circular cairn survives to a height of c.0.7m with a diameter of 13m and grass covered, with a few loose stones visible on its surface. White quartz stones were also noted on top of the mound, which also has a large thistle growing in its centre. This barrow forms part of a group with a nearby cairn (PRN 7519), c.150m to the southeast and a barrow (PRN 754) c.450 east-southeast.

This round barrow is considered to be of national importance, both in its own right, and as part of a group with cairn PRN 7519 and barrow PRN 754. Placing brash or gorse in the shallow eroded areas close to some of the stones should stop sheep using them as shelters, giving the grass an opportunity to regenerate. This monument and those associated with it would present a good opportunity for increased public access and education. However regular monitoring should be undertaken to assess if this creates a further problem of erosion.

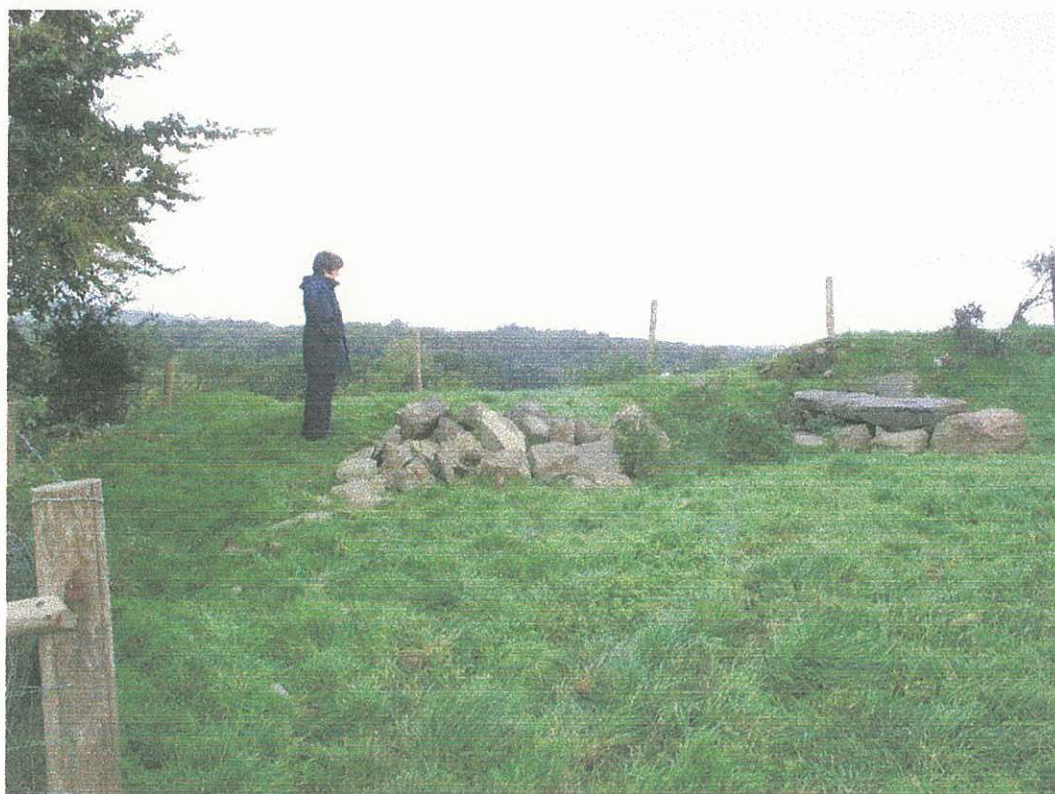
Plate 2 - Bryn Bach, the site of a former cottage (PRN 43574).

The site of a former cottage shown, but not named, on the Llanllwyny tithe map (1841). It was known as Bryn Bach on the Ordnance Survey 1st edition of 1891. The map evidence shows a single, east-west, building, which has since been demolished. Only a short, low section of the north and west wall survives above ground (plate 2), as a grass covered bank, although some of the stones of the north wall are visible. Much of the site has been quarried and the stone removed. Some modern dumping has occurred and the site is now used as a stone dump.

The earthworks should be cleared of all modern rubbish and the stones that have been dumped there should be removed. Once the site is cleared, the surviving walls should be maintained in their present condition.

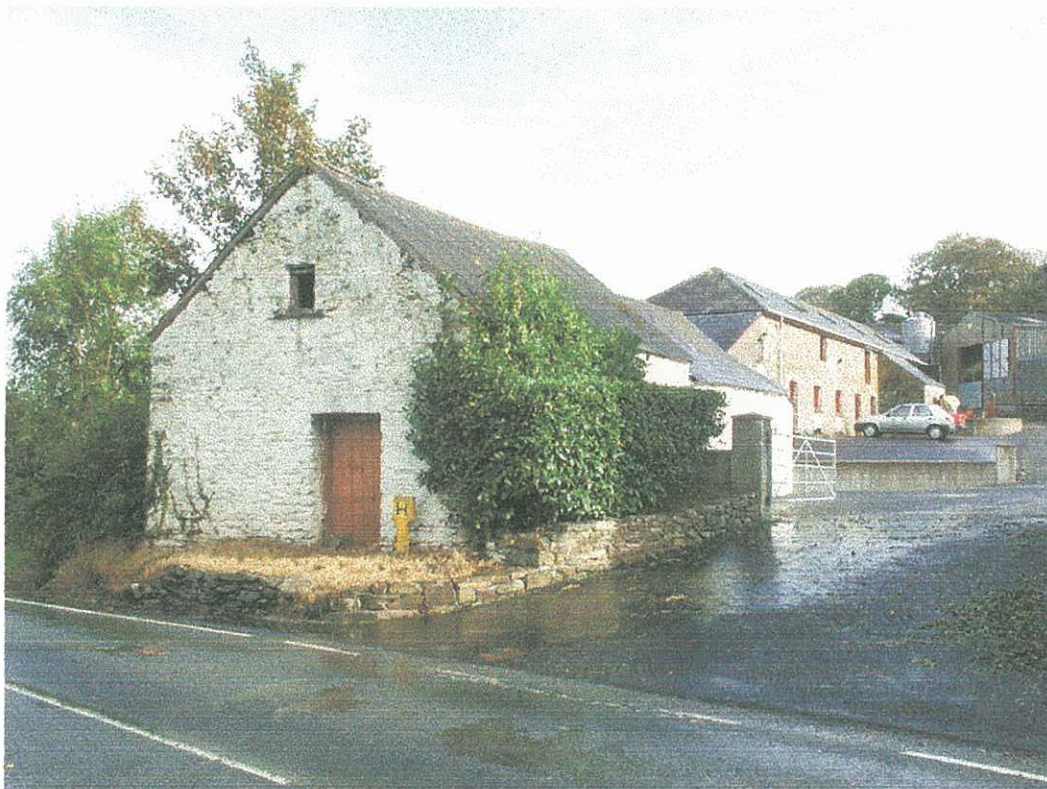
Plate 3 – cow shed north of Bryn Farm (PRN 43575)

A small one-storey cowhouse to the north of the farmhouse, constructed in whitewashed rubble masonry with a pitched roof of corrugated asbestos (plate 3). It is entered from the south side by a low doorway adjacent to a churn stand and by a low doorway in the west end above which is a small window high in the gable. Internally the floor is concrete with a central longitudinal drainage channel. To the east of the cowhouse is a rubble walled extension, slightly lower in height with a pitched slate roof. A blocked doorway is visible in the south elevation. To the north a low calf house runs almost the length of the building with a slated cat slide roof. This is divided into two with doorways at either end. At the west end of the calf house is a small walled enclosure. A further small extension has been added to the east gable end providing access through double doors. The building is currently used as chemical and wood store and the interior was largely inaccessible for inspection. The asbestos roof is in fair condition although some ridge tiles are missing. Some slates are loose and have slipped allowing water ingress. Masonry is generally in sound condition, except the northeast corner where the wall top is collapsing.

The cow shed requires some consolidation where wall tops are collapsing and some loose slates need to be replaced to make the roof watertight.

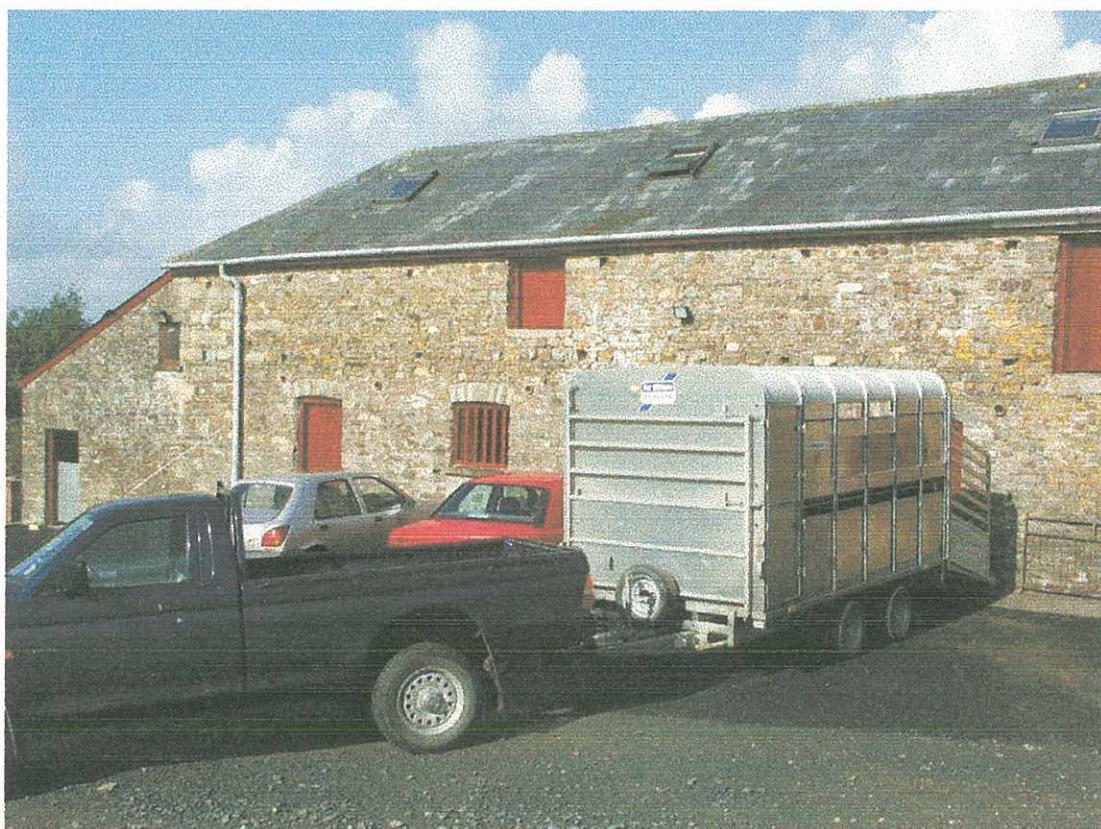
Plate 4 – southwest end of farmbuilding at Bryn Farm (PRN 43576)

A row of farmbuildings to north east of the farmyard, constructed of roughly dressed masonry, built to courses, and with large stone quoins. The roof is a low pitched slate roof, hipped at the west end and half hipped at the east end. The building is two storeys high, and at the west end has cattle stalls beneath and a hayloft and grain store above with two pitching eyes on the south and north facing elevations. The south facing elevation has two existing doorways and two slatted ventilation windows inserted into earlier doorways (plate 4). Internally the cow byre has concrete partitions and floor. The loft floor has been renewed with hardboard and replacement joists, although the beams appear to be original. Attached to the west end is a stable with a single pitch slate roof. A first floor window in the south side and two ventilation windows to the west have concrete lintels and sills. Internally a sloping wooden partition divides the stable into two with hayracks along the cross wall and feeding shoots from the loft above. At the east end two opposing doors indicate the position of a threshing floor (plate 5). The south doorway has a large curved (reused?) timber lintel with a chamfer along its internal edge and the north doorway has a shallow stone arch. The threshold of the north doorway is approximately 1m higher than ground level, allowing access for unloading. A large rubble stone offset is visible above ground level along the north facing elevation. An outshoot at the west end of the north side was inaccessible for inspection. An outshoot on the south side with two low doorways incorporated two pigsties which are currently used as kennels. The building is in good condition and appears to have been recently renovated with a renewed loft floor and modern plastic guttering and skylights added to the roof.

No specific action recommended except general maintenance using traditional materials.

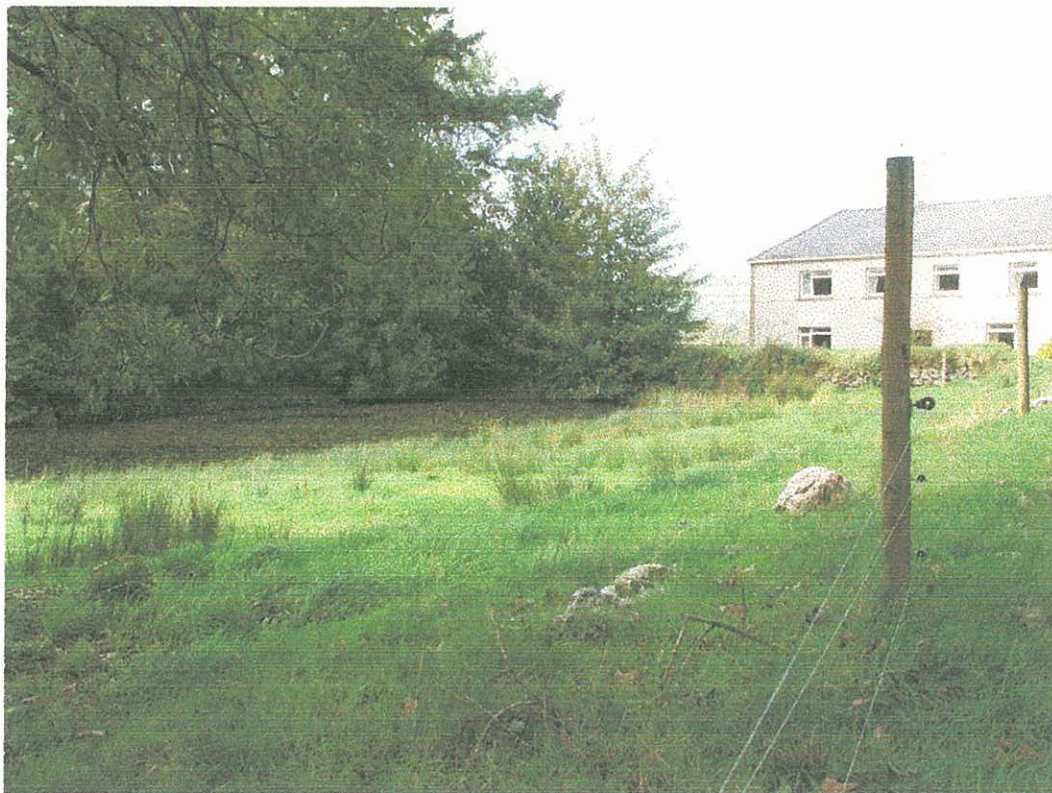
Plate 6 – pond and revetment to the south of Bryn Farmhouse (PRN 43635)

To the south of the farmhouse is a large pond, revetted by a large bank to the north, apparently a remnant of a mill (plate 6). The tithe map of 1841 shows the pond although the schedule makes no reference to a mill. Low banks to the south-east of the pond indicate other structures.

The area to the south of the farmhouse may hold sensitive archaeological deposits which may suffer damage should any clearance of the pond be undertaken. Archaeological advice should be sought if work of this nature is being considered.

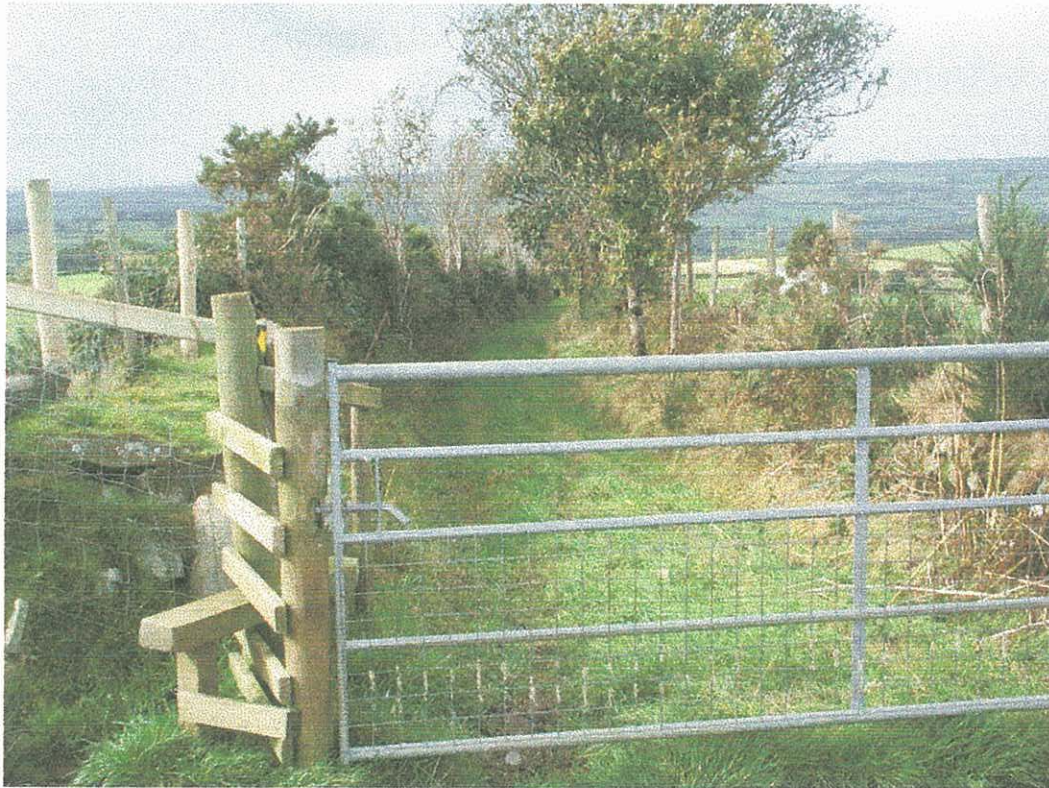
Plate 7 – the trackway leading to Pen-Cil-garn (PRN 43636)

The trackway leads from the public road up the side of Pen Cil-Garn. It is surfaced with stone and has stone faced banks on either side standing to a height of approximately a metre. The banks now have gorse and young trees growing out of it. The tithe map and the 1st and 2nd edition OS maps indicate it continues over the summit and eventually reaches the farms of Blaen-plwuf and Llain-las, although the track currently ends at the boundary to the open hilltop (plate 7).

The trackway is a significant historical feature of the farm and should be maintained in a stable condition.
