Tir Gofal Farm Visit Report

Cwmbach Farm

W/12/2009

ACA Report Number 2001/31

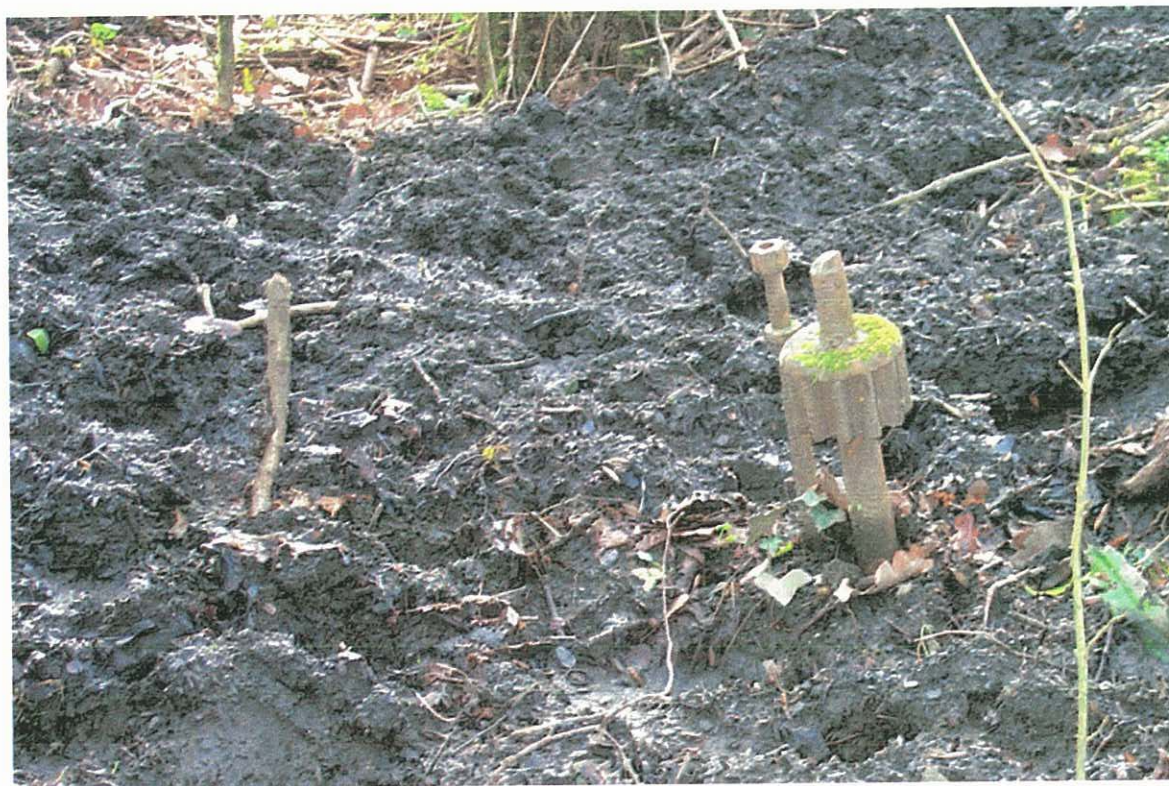
Tramway (c.2m wide) sloping gradually from north to south from the mouth of the main adit (PRN 42318) at Cwmbach Colliery (PRN 30649) before turning sharply uphill to the west and continuing from south to north towards the farmyard at Cwmbach Farm. The section to the south of the adit is dug into the ground to a maximum depth of c.2.5m. The section to the west of this is defined to the west by a substantial earthen bank (c.1.6m high). The section to the north of the earlier road that bisects the workings is cut (c.1.8m deep) into an earlier coal tip (PRN 42326). The cast iron carriage-turn (plate 1) survives at the turning point c. 30m to the south of the entrance to the adit (PRN 42318). All other fittings have been removed. It is not recorded on any historic maps although a level was recorded in roughly the same location on the 1st edition OS map of 1891.

Plate 1 - the remains of the carriage turn on Cwmbach Colliery tramway (PRN42319).

The tramway is in a stable condition and should be maintained in its current state. Wardell Armstrong Mining Consultants have fenced off all sections of the tramway that are cut to a depth of greater than 1.8m. The original carriage turn should be left in-situ.

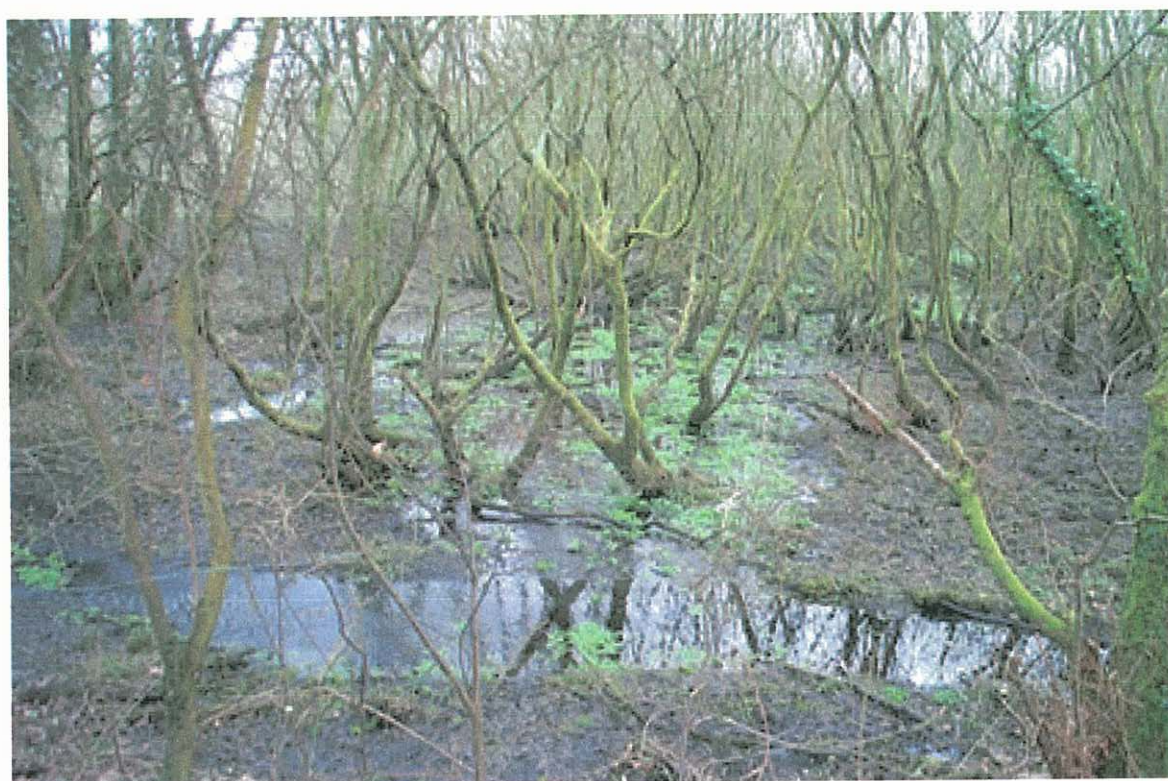
Site of stone culvert that reputedly drained water from the main mine shaft at Cwmbach Colliery (PRN 30649). The culvert surfaces to the south of a large coal tip (PRN 42326) at the centre of Cwmbach Farm. There is no evidence of any stone structure although the owner remembers seeing stonework here some time ago. The area is now extremely wet and overgrown (plate 2).

Plate 2 - a waterlogged area marking the site of the former mine culvert (PRN42321).

The ground in this area should not be disturbed to protect any surviving sub-surface remains.

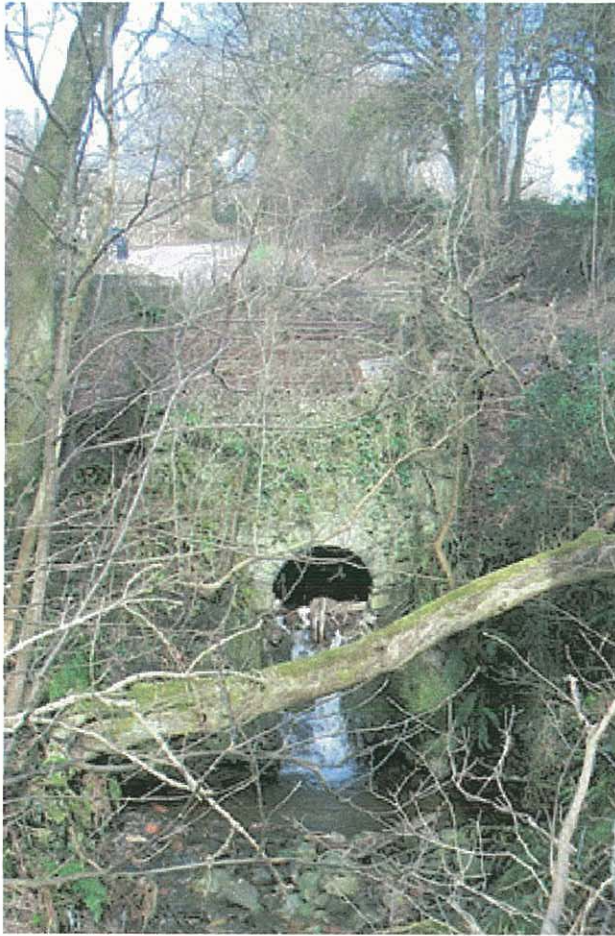
Double-bridge, consisting of an L-shaped tunnel that runs from east to west beneath the road to the west of Cwmbach Farm, then turns and runs from north to south beneath the driveway. The stream emerges from a stone parapet to the south of this through a decorative circular opening with a stone voussoired surround and drops for some distance from here causing a waterfall effect (plate 3). The section alongside the road has been repaired and rebuilt. The tunnel immediately to the south of the driveway has collapsed and is now open.

Plate 3 - the ruined tunnel-bridge to the west of Cwmbach Farmyard (PRN42327).

The bridge is in very poor repair and the entire structure may be unstable. The stonework is loose and overgrown with ivy and much of the original structure has collapsed. The bridge should be consolidated and rebuilt as necessary, using appropriate traditional materials in a way that is sympathetic to its original character. Any intrusive vegetation should be controlled without causing further damage to the existing structure.

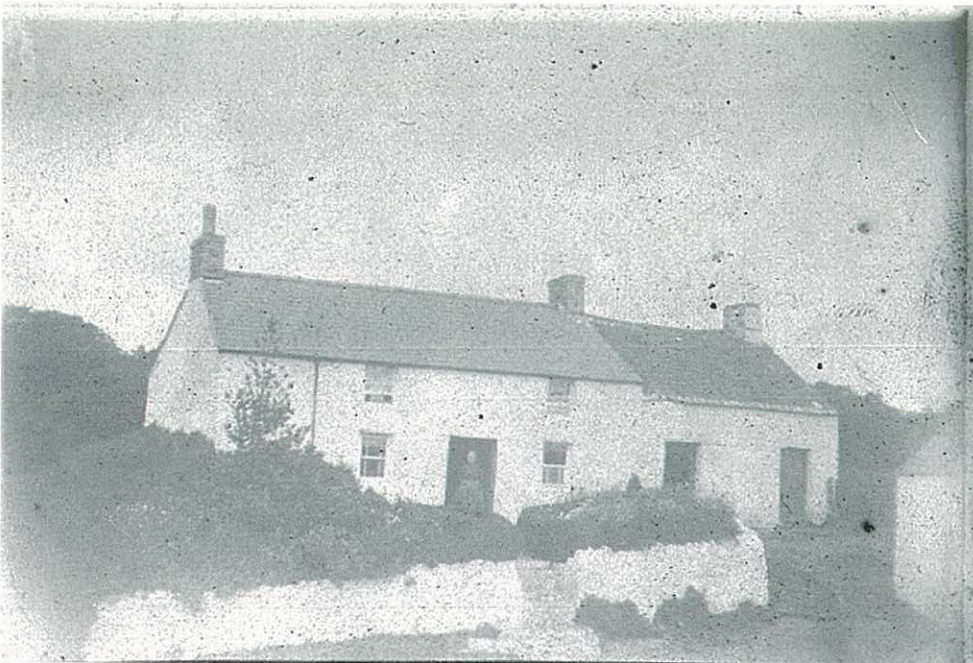
Late eighteenth century farmhouse set on a terraced platform to the north of the farmyard at Cwmbach, orientation east-west. It was first recorded on an undated (probably late eighteenth century) map of the Glyn Abbey Estate. Two storey rubble and soil/lime mortar construction with dressed stone quoins and a gabled slate roof. Until recently the northern and western walls of the house were supported by a substantial stone buttress. The exterior was formerly whitewashed. Asymmetrical elevation with small windows to either side of a central door, set to the east of the frontage. Modern brick stacks stand at either gable end. Many of the original fittings survive. It was approached by stone steps from the south. Although the house was probably originally constructed for farming purposes, it was also used as a mine managers house for some time and a payment hatch for wages survives in an internal door. The house has not been occupied since 1994 when the last occupant died. It has since fallen into a ruinous state. The owner has several late nineteenth century photographs which show it as a fine whitewashed house (plate 4). The platform on which it stood was faced with whitewashed rubble and the area within this was surfaced with stone flags (plate 5).

One and a half storey rubble and lime mortar cowhouse with dressed stone quoins and a gabled slate roof. It stands to the east of the farmhouse (PRN 42333) on the northern side of the farmyard at Cwmbach Farm, orientation east-west. The exterior was formerly whitewashed. It is accessed by two single width doorways in the southern wall and lit by a small window at the western end of the northern wall and a larger window (now blocked in) in the southern wall. The openings are square-headed with timbered lintels. The original fittings for these survive. The interior was converted for use as an animal pen in the mid twentieth century. There is no evidence of a loft floor. A small, square cavity reputedly connects this building to the farmhouse to the west. This was not accessible at the time of the visit. The eastern gable wall collapsed in the mid twentieth century and has been completely rebuilt. Parts of the southern wall have also been repaired /rebuilt with breeze blocks. A late nineteenth century photograph shows that a stack formerly stood on the eastern gable end although no evidence of this survives (plate 4). It is likely that the building has been used both for farming purposes and as a dwelling. It was reputedly a mine workers cottage during the late nineteenth and early twentieth centuries.

Plate 4 - late nineteenth century photograph of the mine manager's house (PRN42333) and mine worker's cottage (PRN42334).

The farmhouse is now in a ruinous state and its survival is under threat. It was considered for listing by CADW in 1988 and has deteriorated considerably in condition since this time. The walls have been deemed by CADW as structurally unstable, the stone buttress that formerly supported the walls has been removed, the rubble surround that skirted the house platform to the south has been demolished and the flagged area within that skirted it is now grassed over. The owner has been unable to find funding to assist with its refurbishment and would now like to demolish the building, sell the stone and erect a new house. The survival of a farmhouse of this date is unusual and ideally it should not be demolished. Further funding sources should be explored and a full archaeological survey should be carried out prior to demolition.

The cow house is now in a ruinous state and its survival is under threat. The roof timbers are in poor condition and the walls have been deemed by CADW as structurally unstable. The owner would like to demolish the building, sell the material and build a modern house on the site. Ideally other funding sources should be explored to assist with its refurbishment and it should not be demolished. A full archaeological survey should be made prior to demolition.

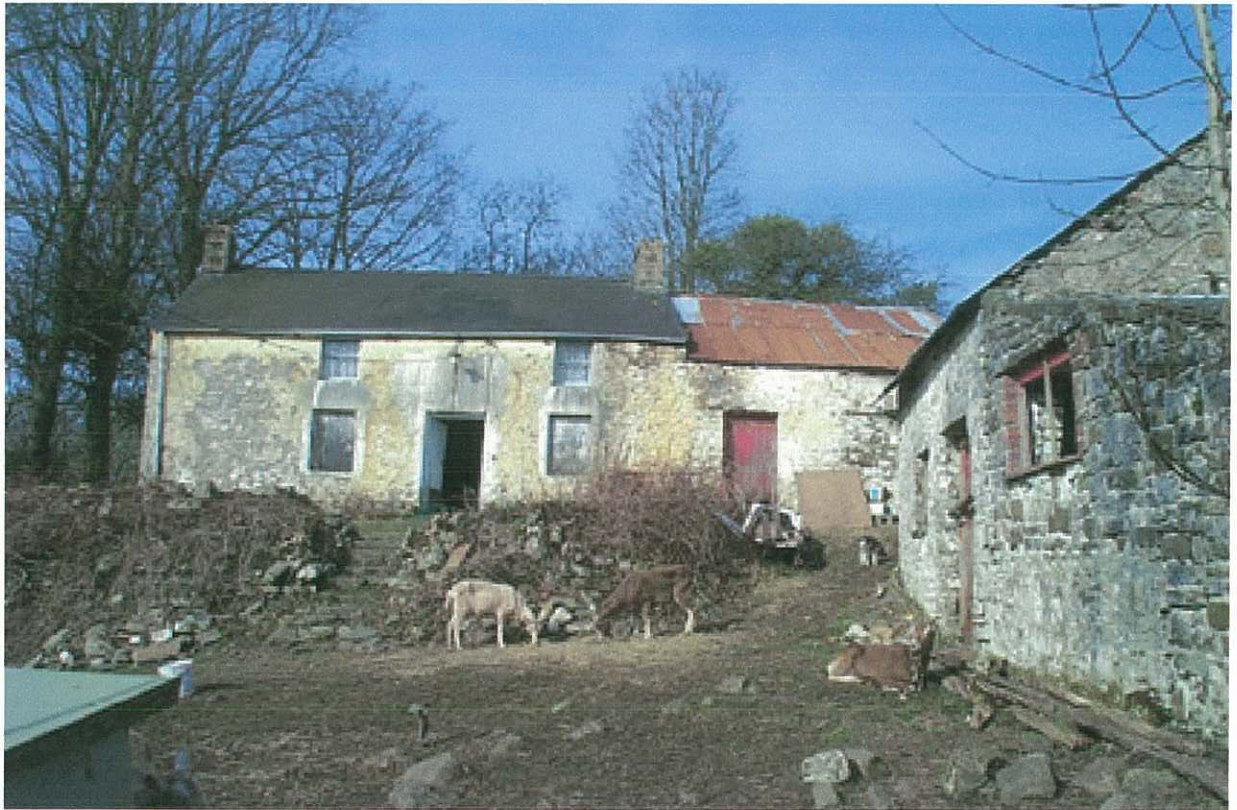
Plate 5 - Cwmbach Farmhouse (PRN42333), showing the ruined state of the farmyard.

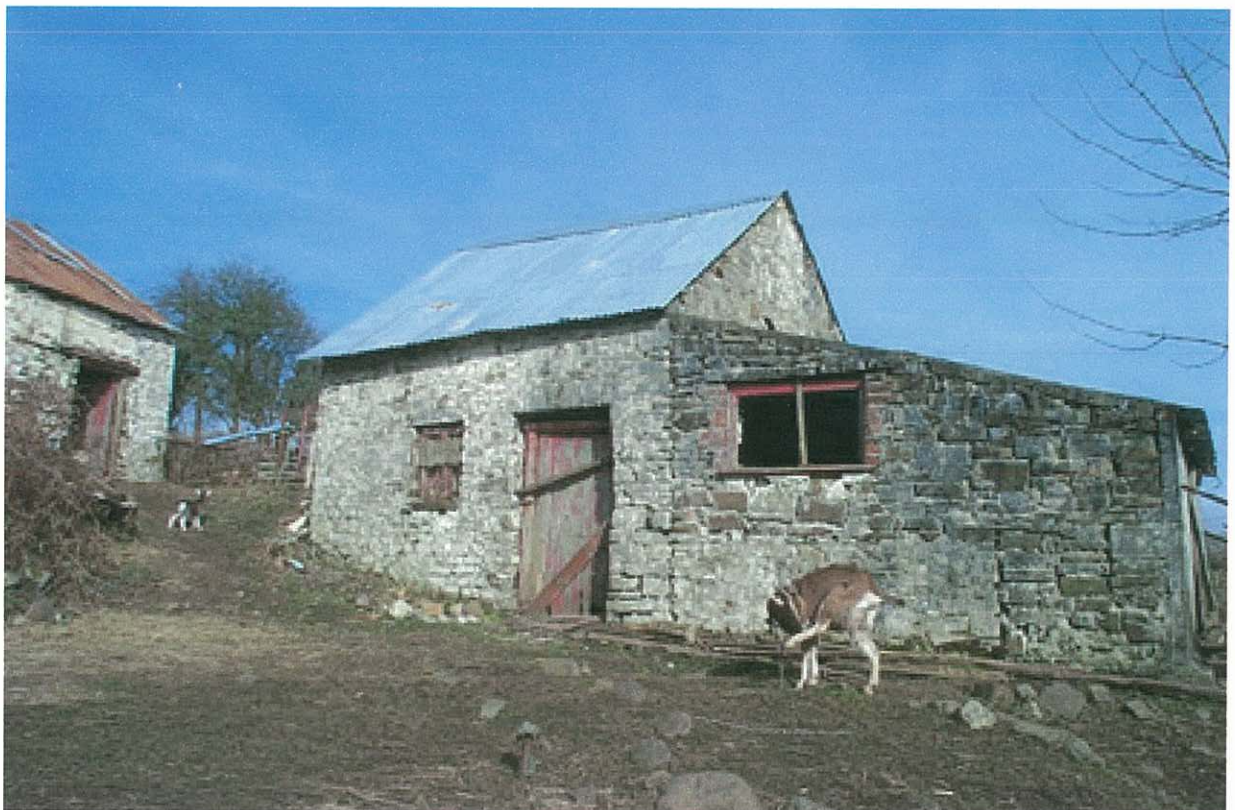
One and a half storey rubble and lime mortar stable with dressed stone quoins and a gabled roof. It is built into the hillside and lies at the northern end of the eastern side of the farmyard at Cwmbach Farm (plate 6). It was first recorded on an undated (probably late eighteenth century) map of the Glyn Abbey Estate. It is accessed at ground floor level by a single width doorway headed with stone voussoirs in the western wall and lit by a small, square window with a stone lintel and sill to the north of this. It is accessed at first floor level from the hillside to the north via stone steps through a half-height loft door headed with a timber lintel. The original fittings for these survive but are in poor condition. The interior is now filled with rubble but the original flagged floor may survive. The loft floor has been removed. The original slate roof has been replaced with tin. The stonework in the southern wall is unstable. The exterior was formerly whitewashed.

Single storey rubble pigsty to the south of the stable on the western side of the farmyard at Cwmbach Farm. Much of the structure has been rebuilt with rubble, breeze block and brick. It is now covered by a sloped tin roof. It is possible that parts of the structure date to the late eighteenth century and belong to a building that was recorded here on an undated (probably late eighteenth century) map of the Glyn Abbey Estate.

Plate 6 - the eighteenth century stable block (PRN42335) and pigsty (PRN42336).

The stable is in reasonable condition although the southern walls is unstable. The owner has started to rebuild this wall but does not intend to continue with the work. He would like to demolish the building. Ideally the building should be retained. It should be reroofed and the repairs to the walls should continue. All repairs should be carried out using appropriate traditional materials in a way that is sympathetic to the character of the original building. The owner could carry out this work as part of his Tir Gofal Agreement.

The pigsty has been considerably modified and its historical interest is uncertain. It should be retained and maintained in its current condition.

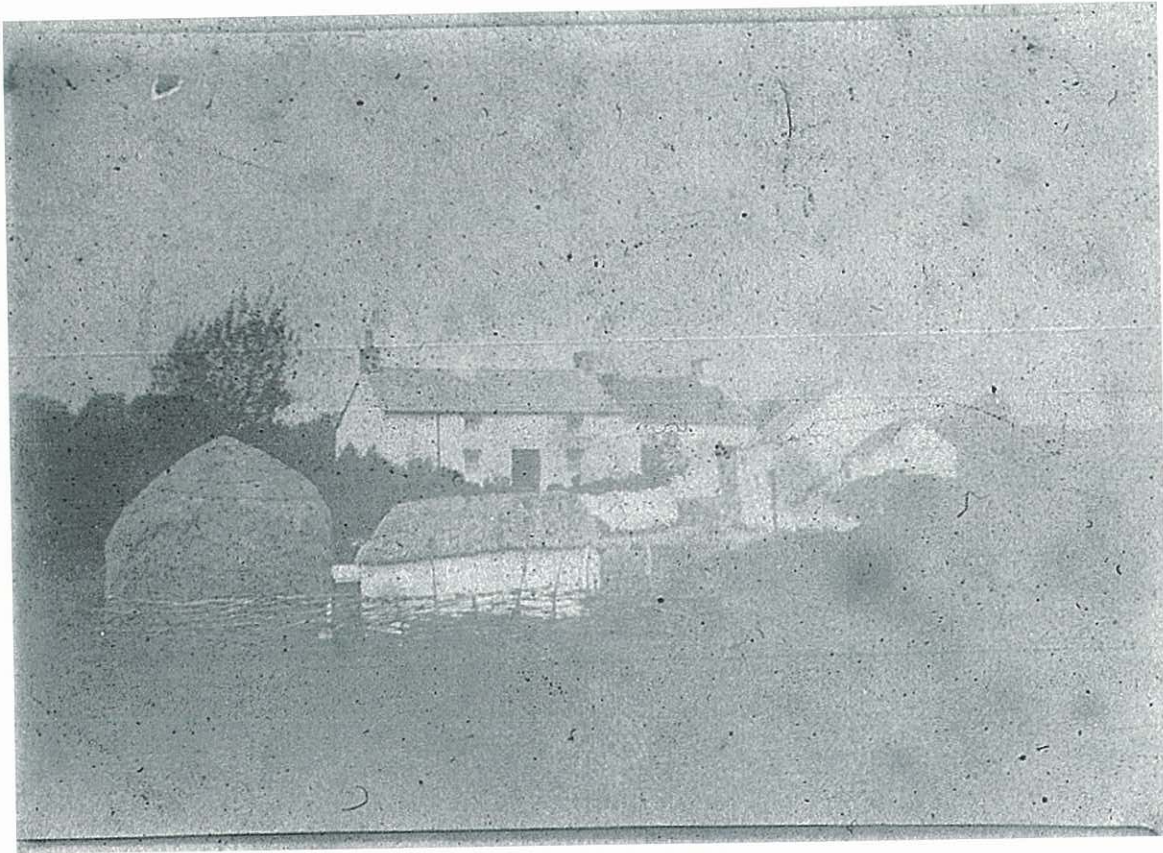
Ruined rubble cart shed with dressed stone quoins situated to the south of the farmyard at Cwmbach Farm, orientation east-west. It was formerly accessed via a full width opening at the eastern end. The walls stand to a maximum height of 1.8m. The northern wall has almost completely collapsed and the remaining walls are unstable and overgrown with ivy. The interior is filled with rubble. A small rubble-built recess (possible kennel) stands against the western gable wall. A late nineteenth century photograph suggests that the building originally had a hipped, thatched roof and was whitewashed (plate 7).

Plate 7 - late nineteenth or early twentieth century photo showing the formerly thatched cartshed to the south of the farmyard.

The remains of the carthouse should be retained and maintained as a stable ruin. It should be kept clear of rubble and any intrusive vegetation should be controlled without causing further damage to the structure.

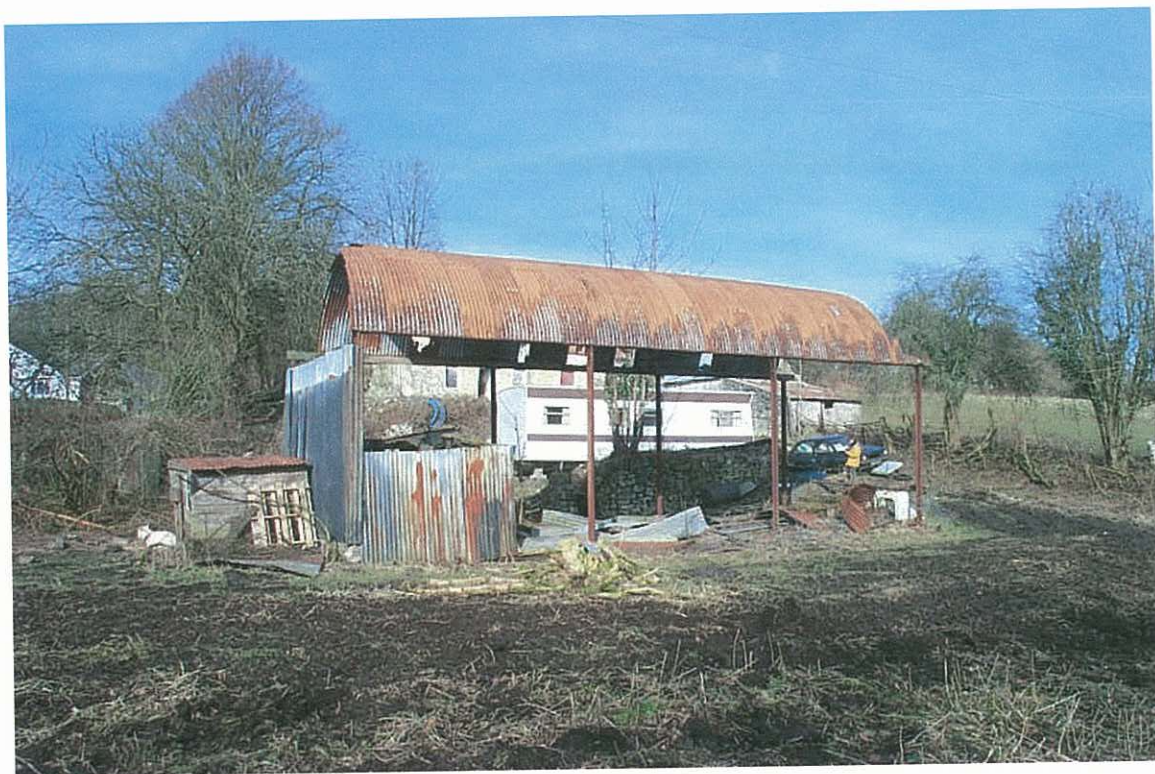
Dutch barn situated to the south of the farmyard at Cwmbach Farm, orientation east-west. Steel girder and tine construction with an internal wooden partition. The roof was reputedly painted red during the Second World War and used as a marker to train RAF pilots (plate 8).

Plate 8 - the Dutch barn, formerly used by the RAF as a marker for training pilots.

The barn is of historical value and the owner is keen to restore it for agricultural use as part of his Tir Gofal Agreement. This would promote the survival of this feature and considerably improve its appearance and usefulness.
