# Deserted Rural Settlements in South-West Wales: 1999-2000 Survey

Report prepared for Cadw

ACA Report No. PRN 37756  
April 2000

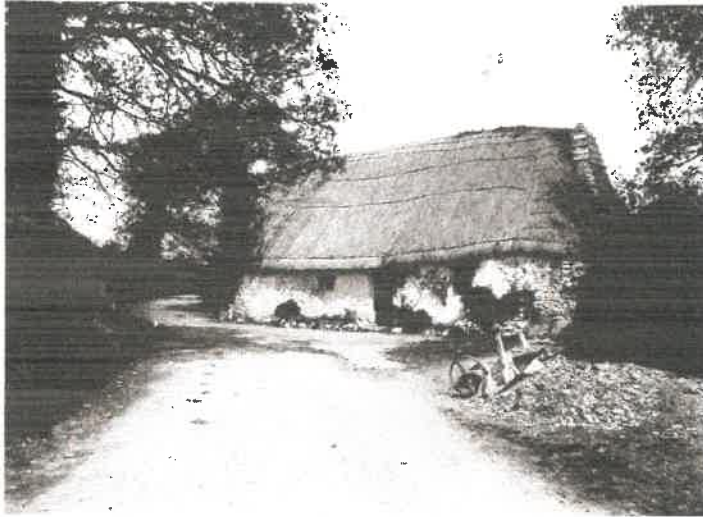
Plate 1: Thatched cottage in the Llandovery area in late 19th century. (from DC Harries Collection, NLW). Note the wooden boxed chimney.

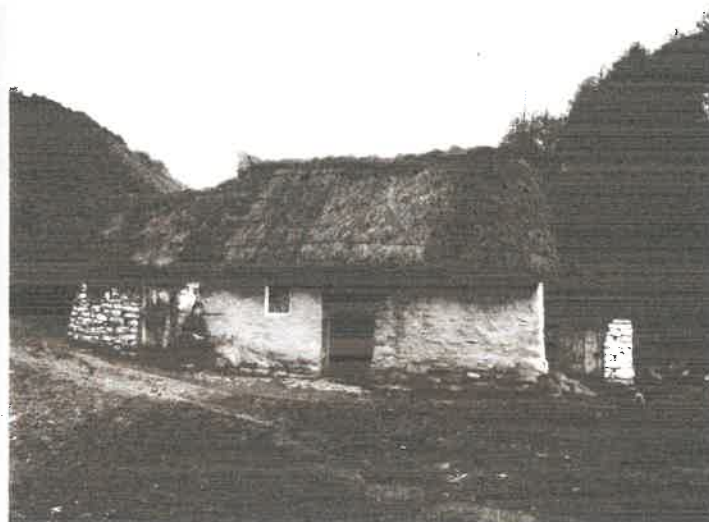
Plate 2: Thatched cottage in the Llandovery area, late 19th century. This demonstrates how small many rural cottages were, and also how they were often extended by the addition of lean-tos. If reduced to wall bases, the plan of a cottage such as this would probably lead an archaeological fieldworker to record the site as a longhut. The additional cells created by the extensions at either end of the dwelling are often seen in longhuts in both upland and lowland contexts.

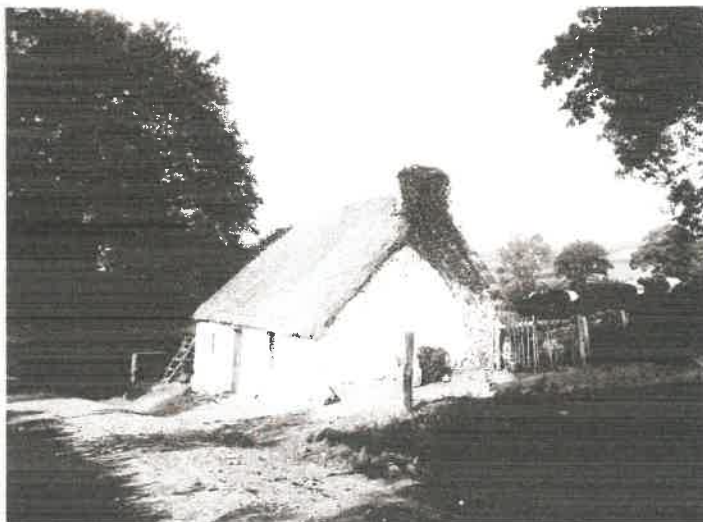
Plate 3: Thatched cottage in the Llandovery area in late 19th century. (from DC Harries Collection, NLW). This building appears to have a stone chimney.

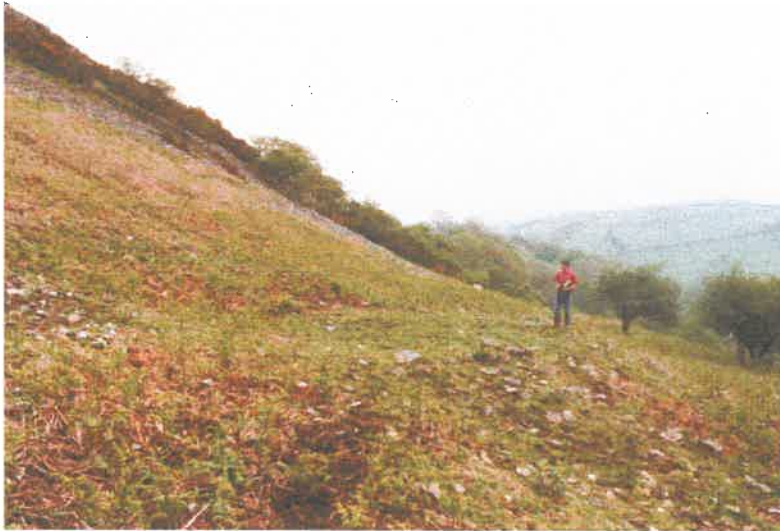
Plate 4: Platform at Tirygraig Farm, Llansadwrn. A small parcel of unimproved pasture near Graig Beynon, formerly part of the Mynydd Llansadwrn common, preserved a collection of archaeological features, including long huts, boundary banks and platforms such as that shown here (PRN 37876). Technically, these features are found in an upland context, however they demonstrate the archaeological potential of unimproved land on otherwise heavily modified land.

Evidence of this was found on the land of Tir y Graig Farm. A small area of unimproved land (a steep and rocky slope) was found to include several features of interest, including a platform, two long huts and evidence of boundary banks. On the improved pasture, two more DRS sites were recorded, which had apparently survived despite the improvement of the land. A third DRS, a complex which cartographic evidence shows to have post-dated the enclosure of the Llansadwrn Mountain common, survived on higher ground on the holding.

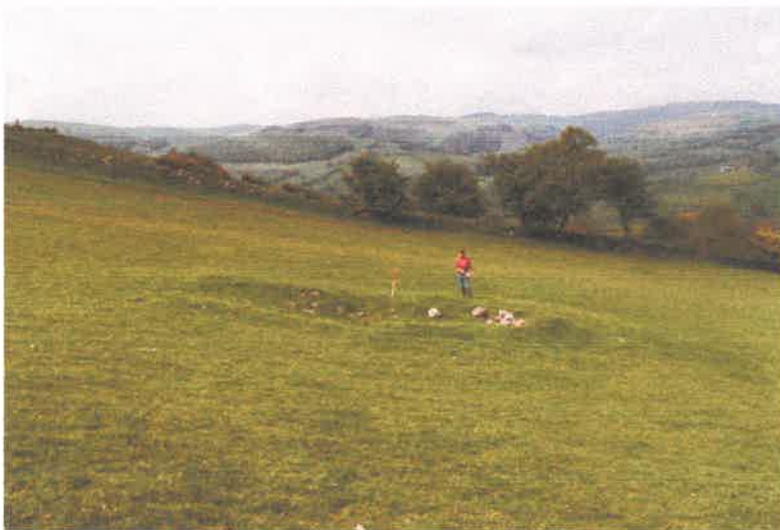
Plate 5: Also at Tirygraig, but here in an improved pasture field carved out of the former Mynydd Llansadwrn common. The foundations of a longhut (PRN 40389) of unknown date, found in a pasture field. It is evident that ploughing has avoided the interior of the longhut and the archaeological potential of the site may well be high. Again, this site is technically in an upland location and it may well be a dwelling which predates the enclosure of the parish commons in 1817.

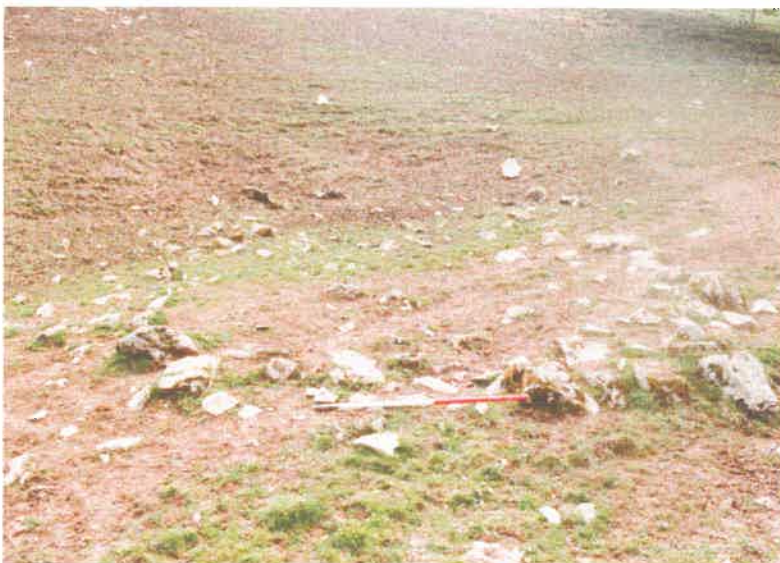
Plate 6: Also at Tirygraig, the stone foundations of a rectilinear structure (PRN 40388) can be seen on this platform cut into a moderate slope. Stone foundations are not commonly found on platforms in the district and therefore this site is particularly interesting. Ploughing and agricultural activity does not appear to have seriously disturbed the site and its archaeological potential remains. Located on semi-improved pasture on the former parish commons.

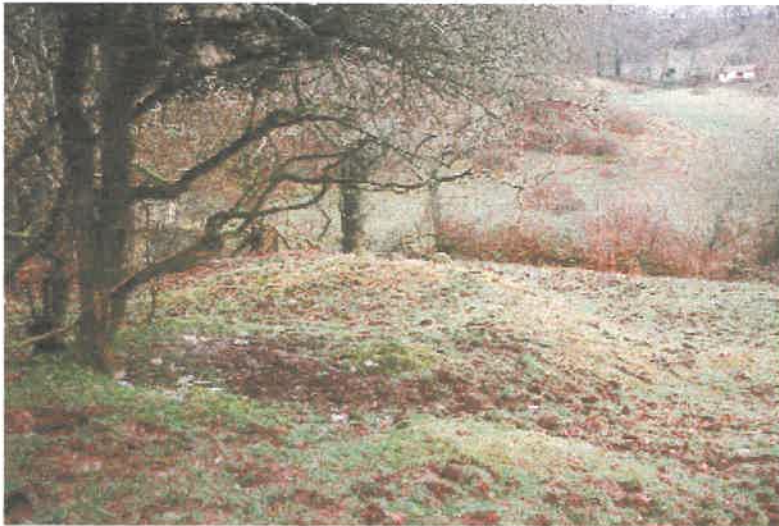
Plate 7: This earthwork 'longhut' has a name and history. 'Persondy' (PRN 37842) was occupied in the mid-19th century and was the parsonage attached to nearby Llangynllo parish church. Its origins are less clear, but the survival of the foundations of the dwelling and the boundaries of the associated garden plots as well as trackways linking the site to other dwellings in the vicinity makes this an interesting site with clear archaeological potential.

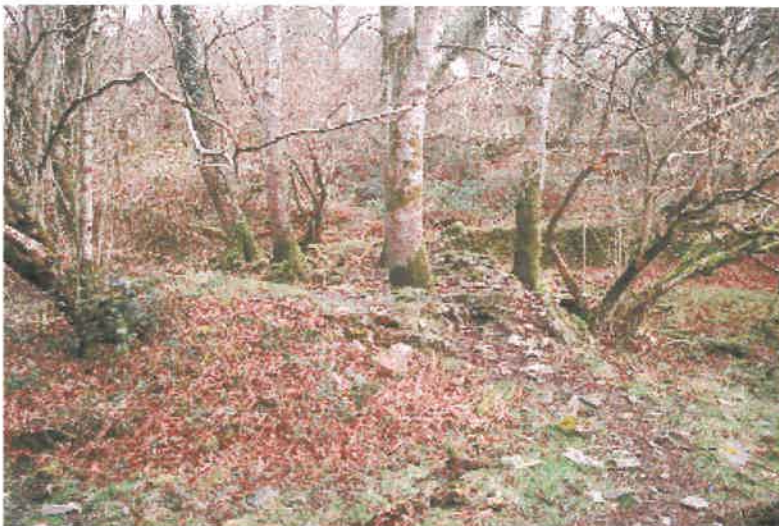
Plate 8: The best preserved of the three cottages which stood at Pentre Cwm Bach, Llangynllo now only survives as a rectilinear earthwork (PRN 37844), over which mature sycamores grow. However, the landowners could testify to this house being occupied until at least the late 19th century and a standing ruin until the 1940's. The process of ruination rapidly turns a recent building into an 'ancient' pile.

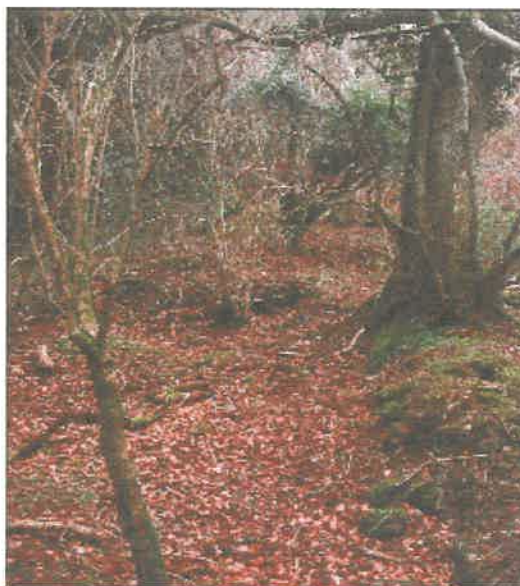
Plate 9: Another of the Pentre Cwm Bach cottages. Oral evidence suggests that this dwelling had been abandoned by the 20th century. Very little surface evidence survives for its presence, other than a small fragment of drystone reventment in the slope and a rectilinear depression. This is the condition in which the majority of the settlements viewed during 1999-2000 now survive. The archaeological potential of such 'lost' buildings is unknown.

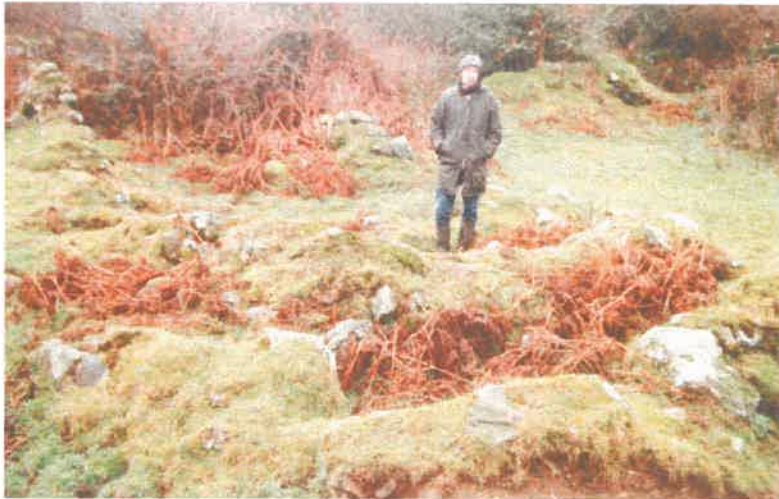
Plate 10: The ruined dwelling of Llwynpiod, a deserted farmstead PRN 23170, on the land of Plas Dwbwl, Mynachlogddu. The Preseli portion of the PCNP includes a significant number of deserted settlements of this quality on the marginal and less intensively farmed land. Llwynpiod was in use into the early 20th century. The survival in plan of the house and farmyard complex make this a site worth considering for statutory protection.

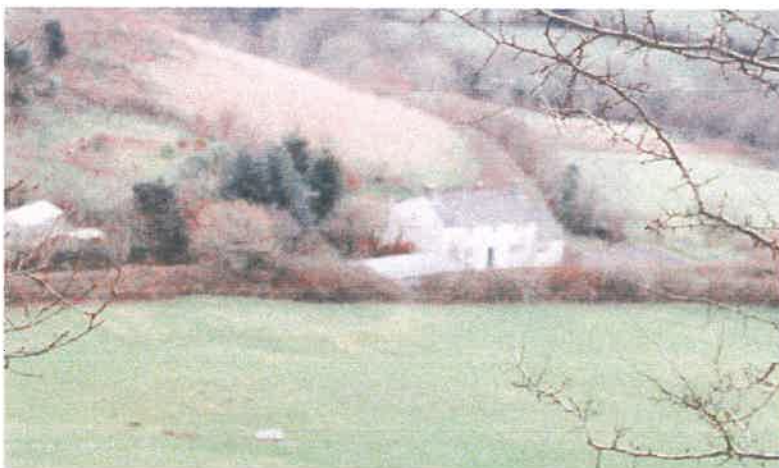
Plate 11: The standing cottage of Lôn, is one of three cottages that are shown at this location on the Llangynllo parish tithe map. A yellow parch mark to the left, in the field in front of the house, is the only physical evidence to show the location of PRN 37846, one of the two other settlements here. The second 'lost' cottage, PRN 37847, would have stood where a parking area now exists to the right of the house.

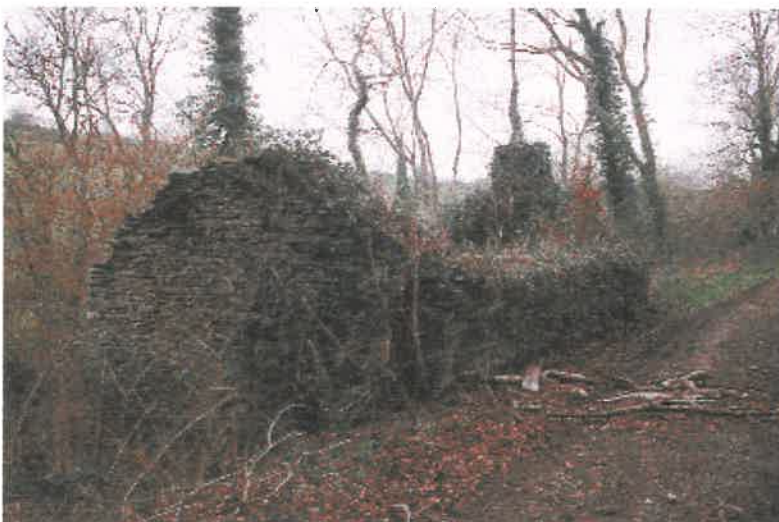
Plate 12: Cwrt-y-gamil (PRN 37858) is an example of what would, in the experience of the 1999-2000 DRS project, qualify as a relatively well preserved cottage. Although roofless, ivy-covered and decaying, the structure still stand to original gable and wallplate height and features such as fireplaces, entrances and windows can be identified. Vegetation obscures the surrounding area, but it is apparent that a garden plot also exists.

Only three cottages shown on the parish tithe map (Penygraig Cottage PRN 37835); Unknown PRN 37848; Cwrt y Gamil PRN 37858) survive in a condition which could be described as being anything like reasonably intact. Penygraig Cottage has been restored and reoccupied, leaving only two roofless, ruined cottages which survive to gable height and have most of their stone built features (door and window openings, hearths) still identifiable.

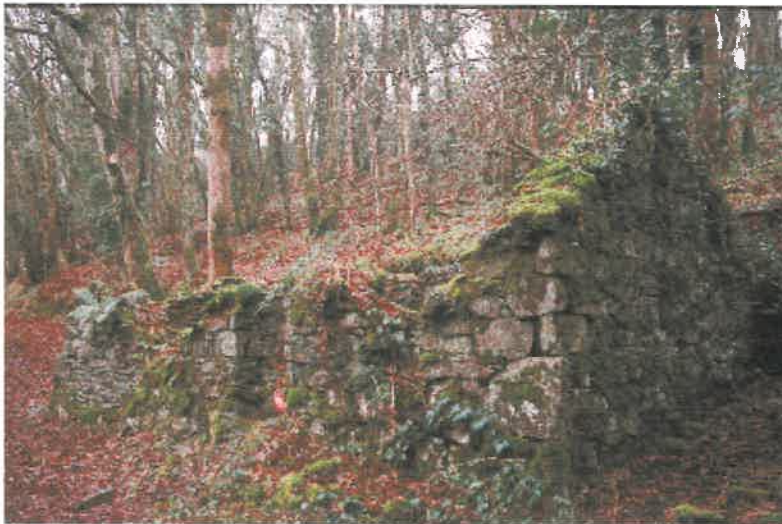
Plate 13: Another 'relatively' well preserved structure (PRN 37848) was described as being associated with a 'grinding mill' on the parish tithe map. The nature of this mill was not established, but the surviving building appears to have been a simple cottage with a central doorway, two windows in the front lateral wall and a small extension built on to the furthest gable wall. The use of fairly large stone blocks in the wall fabric is not typical of the cottage sites visited in the area.

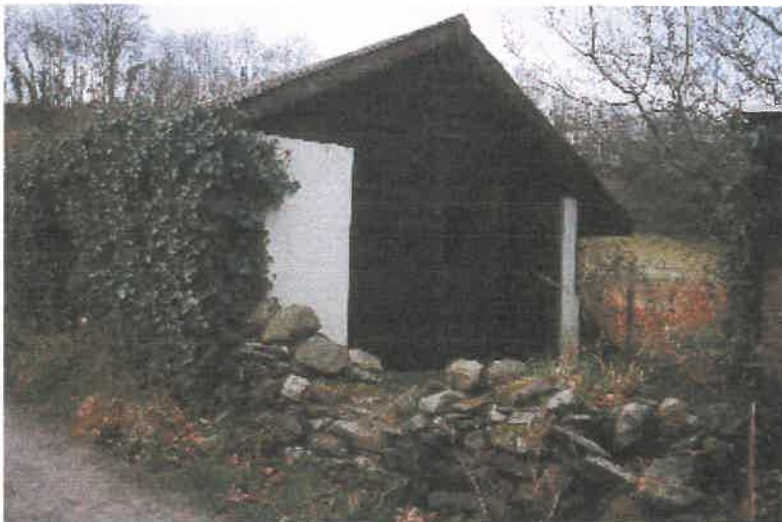
Plate 14: PRN 37809, Penybanc Bach, is an example of a 19th century cottage which has been, in part, salvaged for an alternative use. Half of the building has been incorporated into a modern shed; the other half probably robbed of some stone and therefore now only defined by low wall bases.

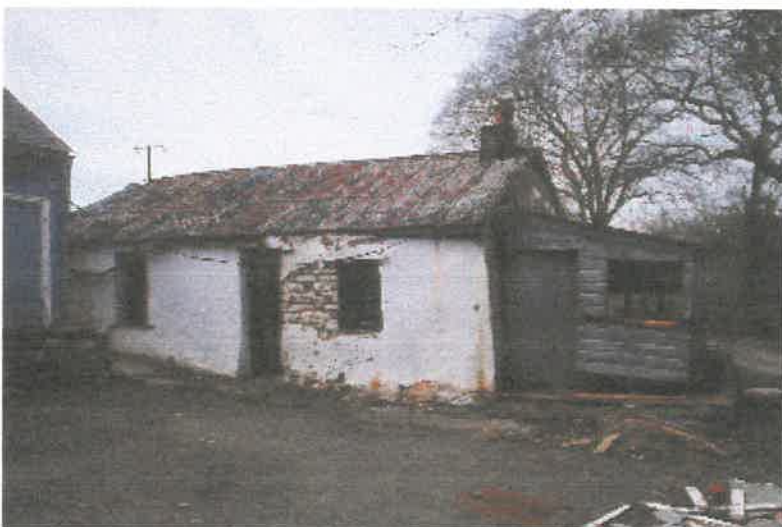
Plate 15: This cottage in southern Ceredigion will remain anonymous in this report as it is subject to a planning application which will involve demolishing the building to make way for a new dwelling. It is part clom-built and the need to record and/or preserve the diminishing examples of this type of structure is becoming increasingly important as their number dwindles.

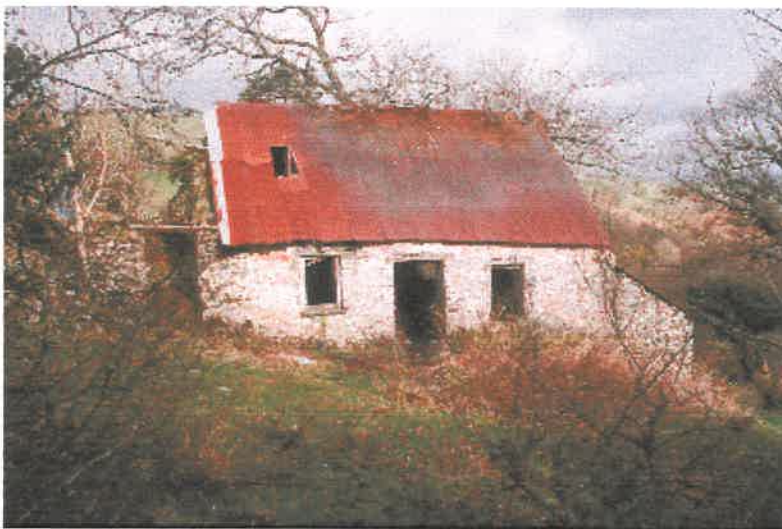
Plate 17: A well preserved cottage at Bryn Pribwll, Llansadwrn. Although outwardly in apparently good condition, this stone built structure's earth bonded fabric is beginning to collapse at the rear and it is unlikely that the structure will survive many more winters unless major repairs are undertaken. The likelihood of that happening in the case of a great number of rural cottages of this type is of course very small.

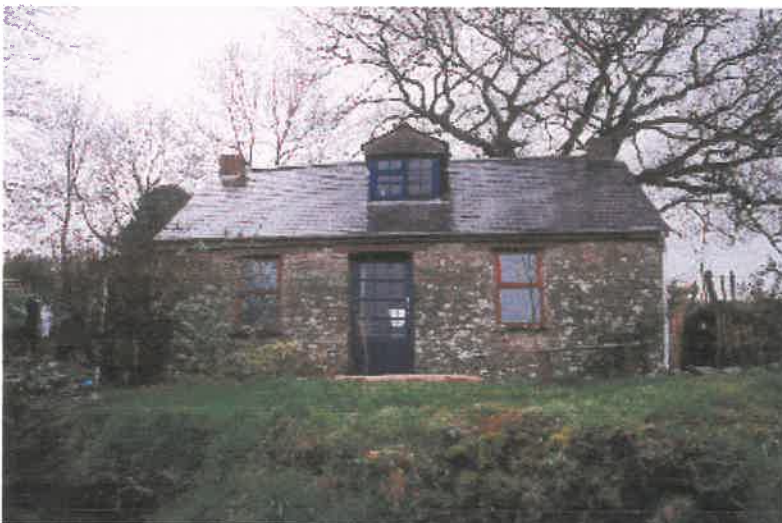
Plate 18: An interesting example of a deserted rural settlement site which has been restored to something approaching its former character. Penygaig Cottage, Llangynllo. The house was abandoned in the 1920s when a falling tree smashed the roof. The original stone was used to restore the building during the 1990s and an effort made to keep its essential character. Penygaig Cottage demonstrates that deserted and ruined cottages can be reclaimed and reused.
