# Tir Gofal Farm Visit Report

## Kilgetty Farm

### W/13/1249

ACA Project Record No 38906

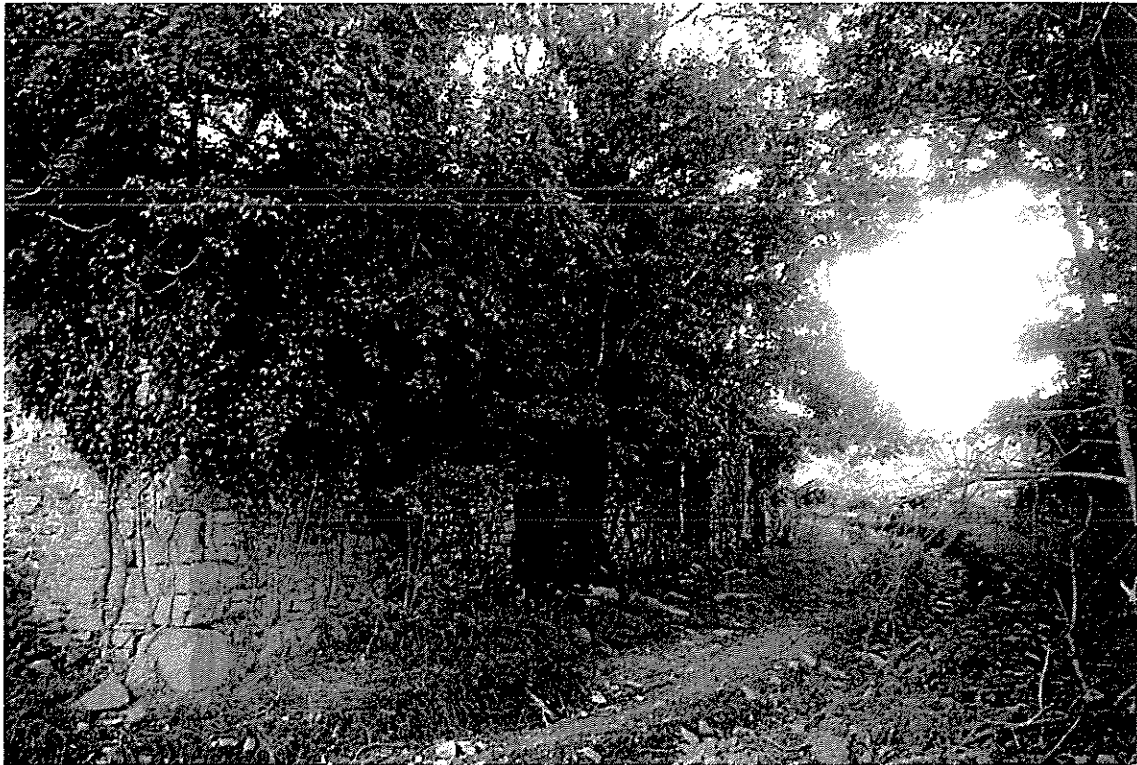
*Fig. 1; Penycwm Slack farmstead viewed from west. Note farm track/4 x 4 off road course passing before building.*

The preservation and consolidation of the standing structure as an example of a small 19th century farmstead would be desirable. Damage to surviving walls by passing vehicles using trackway in front of the main building should be avoided.

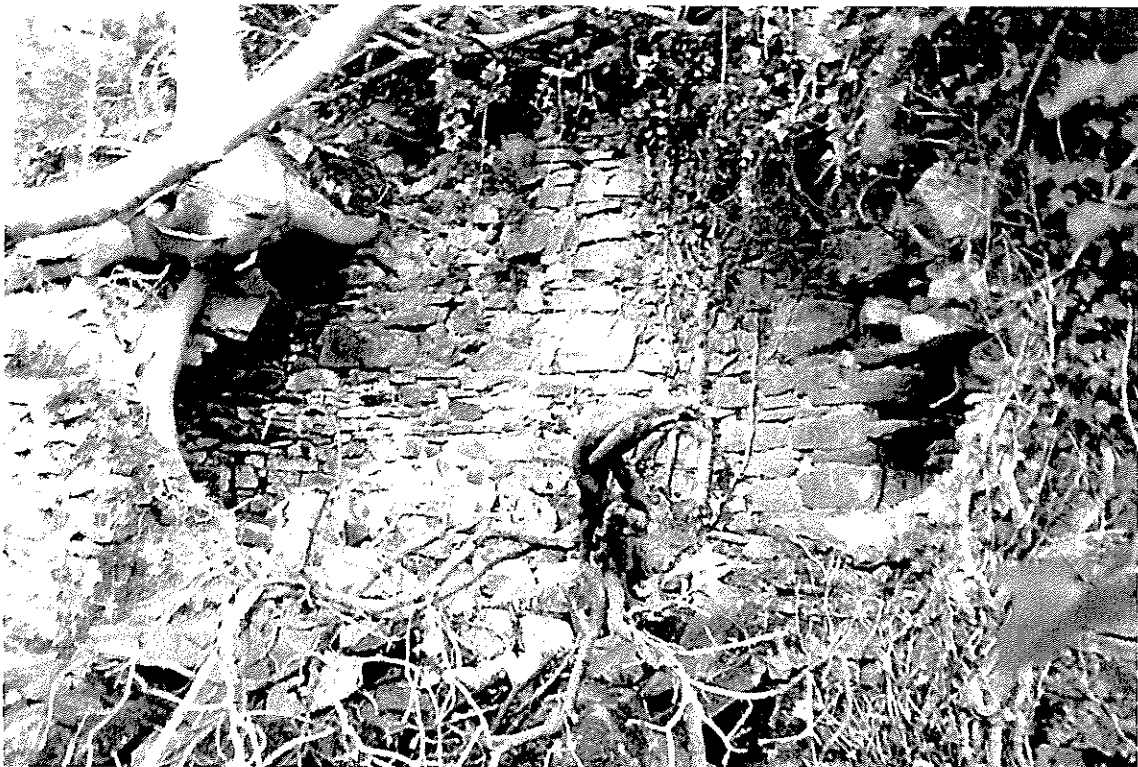
*Fig. 2; "Double oven" in eastern wall of westernmost room at Penycwm Slack farm. The oven recesses appear to have been either side of an inglenook fireplace, which has now collapsed and is only represented by the rubble heap in the foreground.*

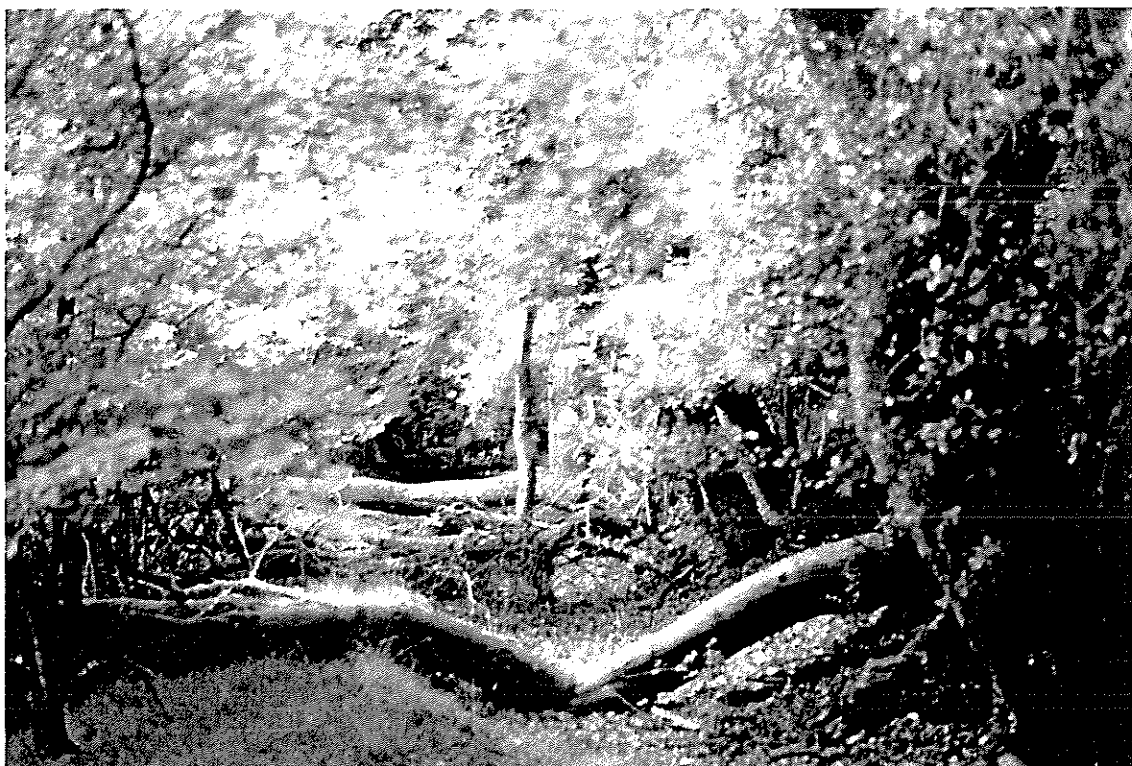
Well preserved leat which probably carried water to the ironworks or coal mines around Stepside during the 19th century. Importance increased by postulated relationship to the ironworks, which is a Scheduled Ancient Monument.

*Fig.3; Section of leat PRN 21367 showing the gradual obscuring and infilling of the leat course by tree debris. At this point the leat is c.1m deep x 3m wide but other sections are deeper and wider.*

The integrity of the leat course should be maintained. Tree growth and debris which currently interrupts the leat should be removed and managed. Further damage by off-road vehicles should be avoided.

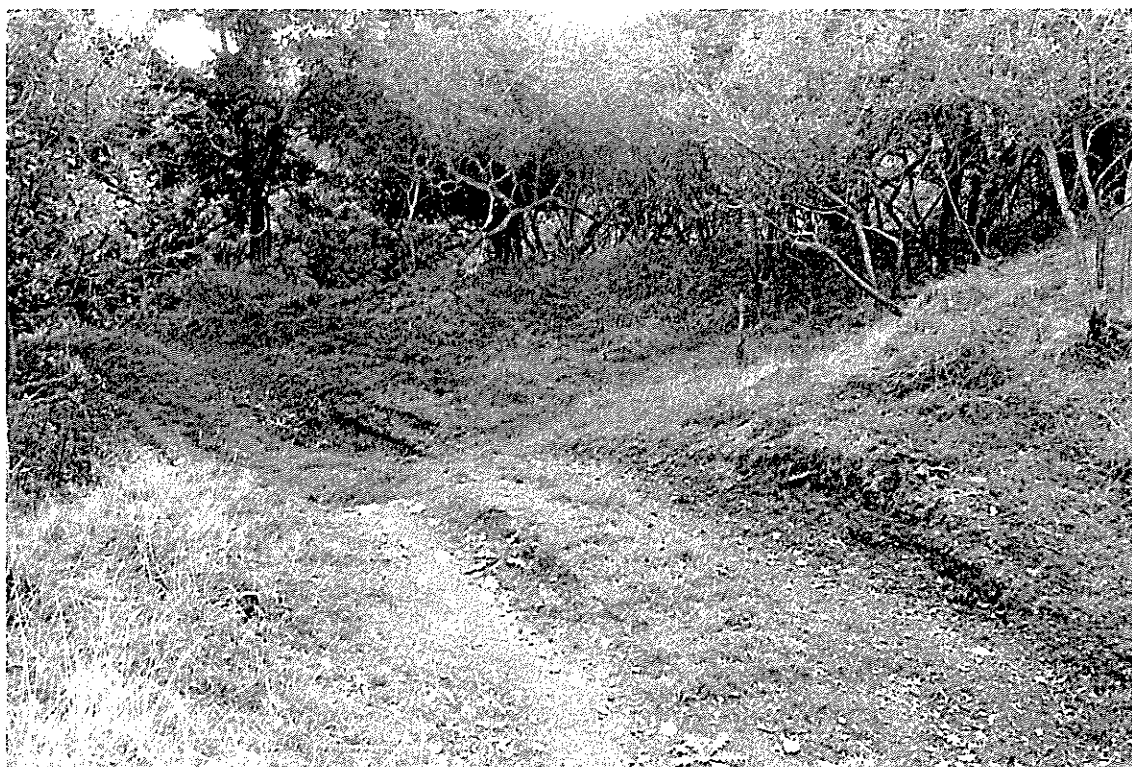
*Fig.4; Site of coal shaft and spoil tip PRN 38936 showing damage caused by 4 x 4 off-road vehicles to the spoil mound south of the old shaft.*

A certain amount of damage to archaeological and historic features has already been caused by the development of the off-road course. It would be desirable that vehicles using the network keep to the existing course and that steps are taken to prevent further damage to features adjacent to it.

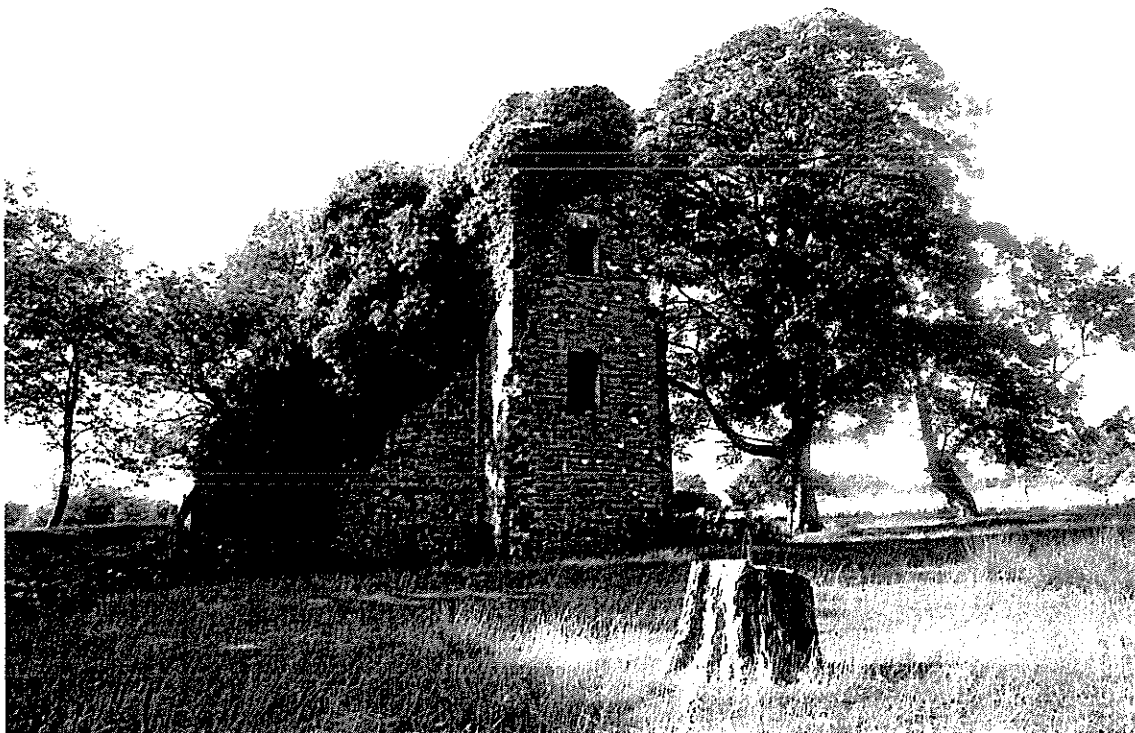
Ruined summer house or belvedere which formed part of the formal gardens associated with the mansion of Kilgetty House.

*Fig.5; The Belvedere PRN 3649 viewed from south-east.*

Preserve structure. Consolidation of the masonry would be desirable to prevent further decay.

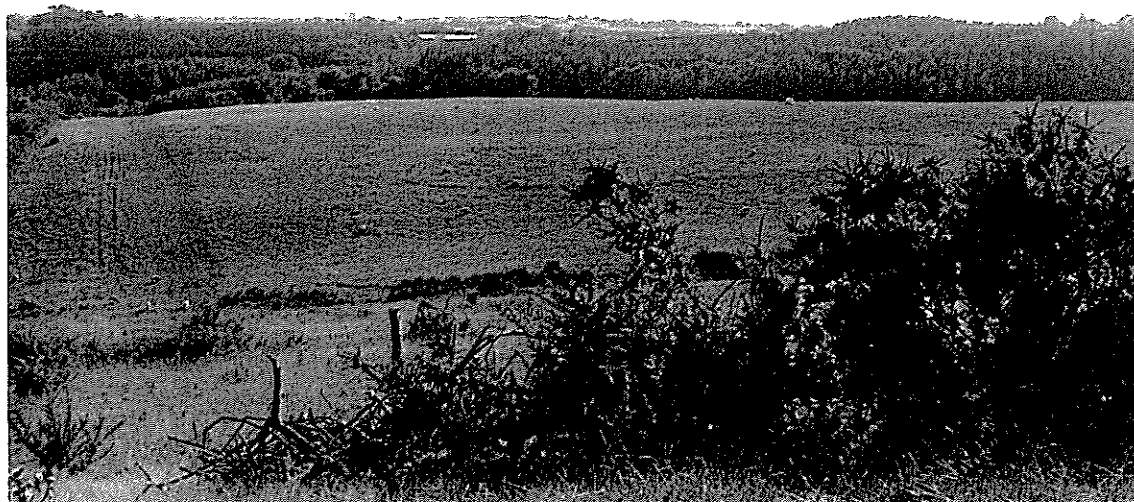
Probable hillfort site situated on a promontory overlooking a deep valley which lies to the south and east. Slight earthworks were noted on promontory and are visible from the vicinity of the Beleverde to the north.

*Fig.6; Looking south from The Belvedere across the open landscape of the Deer Park. Hints of the suspected hillfort PRN38927 can be seen in the profile and sides of the prominent ridge which occupies the centre of the Deer Park.*

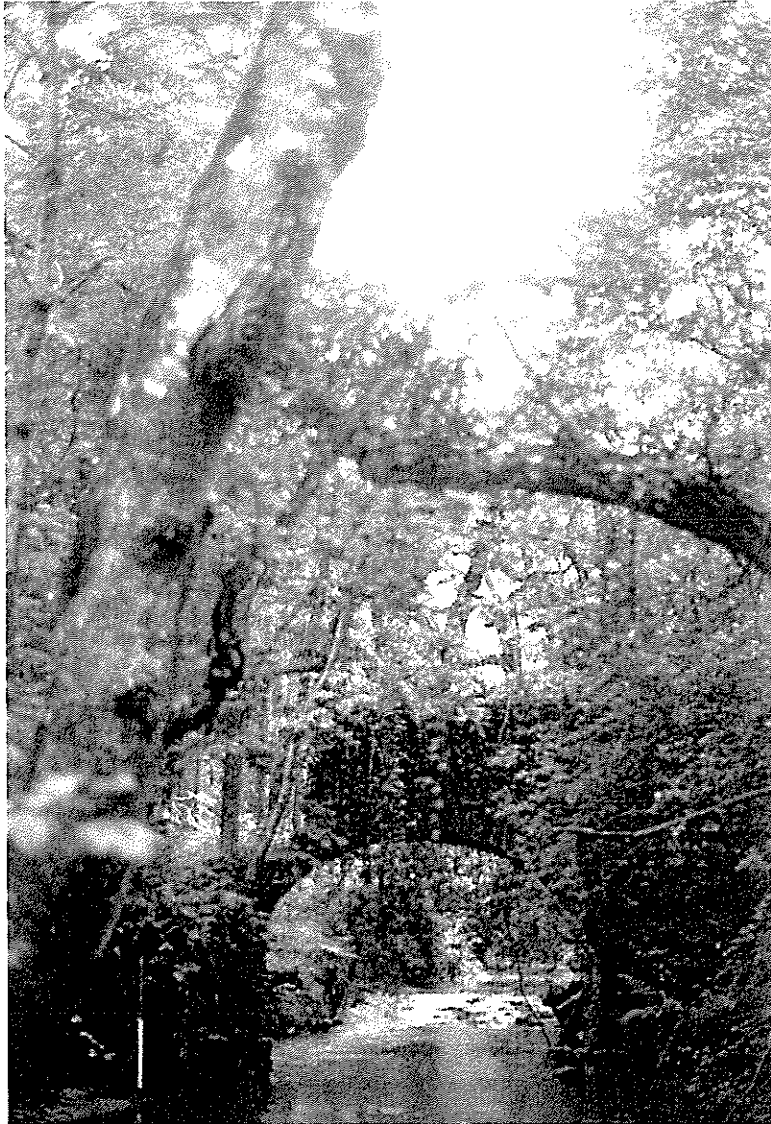
*Fig.7; The arch PRN 38930 which carries the Deer Park wall across the Ford Lake stream*
