# **Tir Gofal Farm Visit Report**

## **South Studdock Farm**

### **W/13/387**

ACA Project Record No 38907

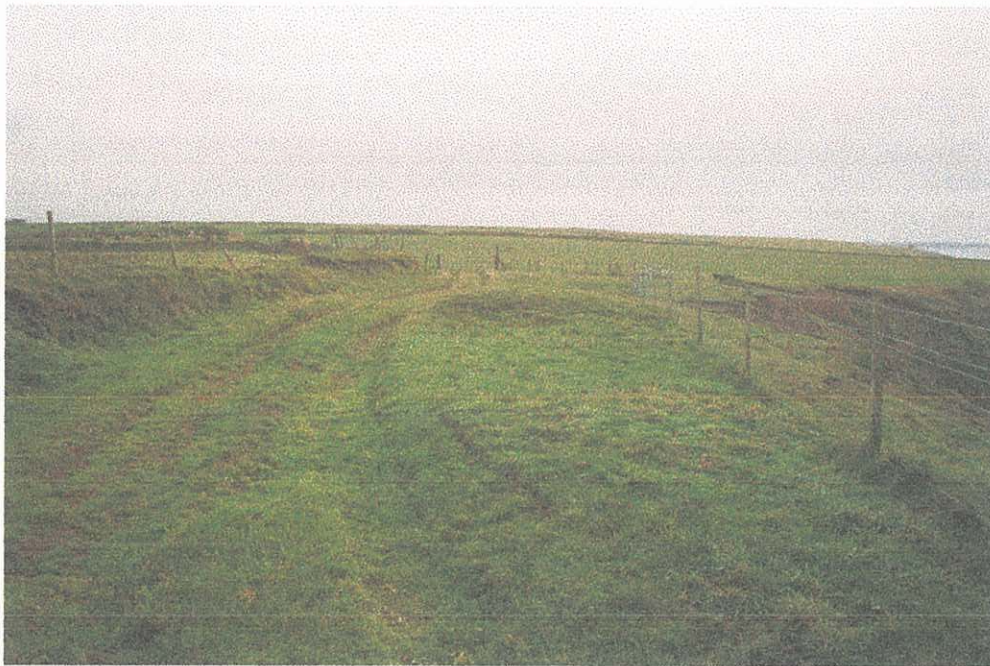
A grass covered mound c.3m x 2m x 0.6m high located just N of the coastal path. The mound seems unusual in this area and does not fit with the surrounding topography. The N end of the mound has been slightly truncated by vehicle tracks. The function of the mound is unknown it could be connected to the WWII activity which was widespread along the cliff top or it could be associated with the small-scale quarrying that occurred in the area or it could be the remains of a small burial mound.

Plate 1: Low earth mound (PRN 39077) alongside the coastal path.

Avoid further damage to its N end and maintain in present condition.

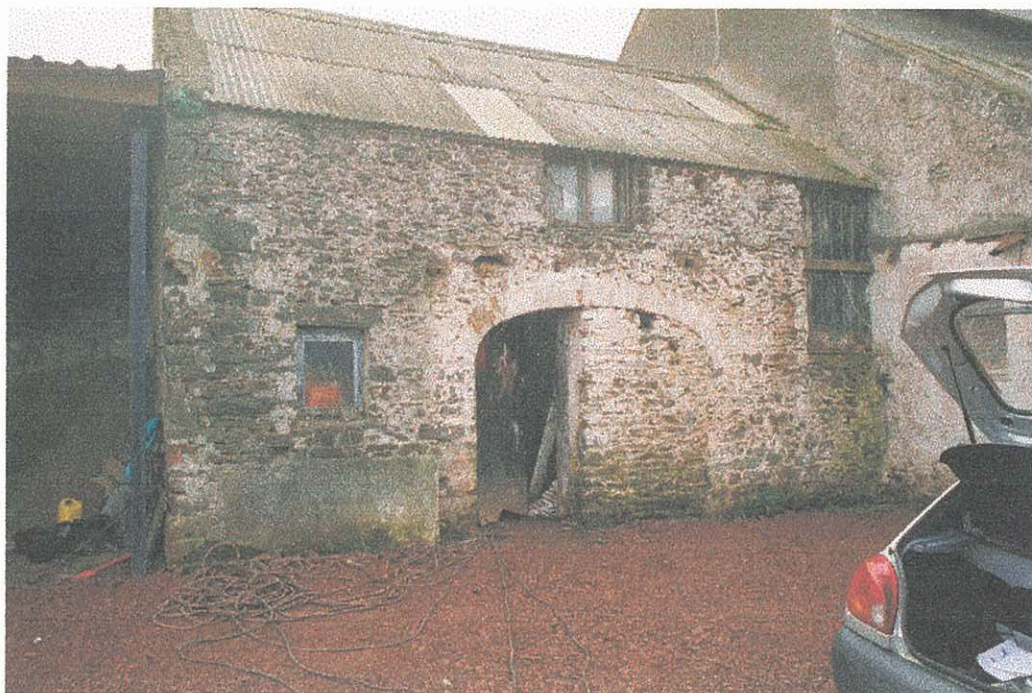
Small two-storey coach house and store of random rubble construction with a corrugated tin roof built against the E end of the house PRN 39619. There are four openings in the front, N, wall two on the ground floor and two in the upper storey. Ground floor entry is via a brick arched opening now partially blocked while the upper storey was entered through a wooden door which is 1.5m above ground level and presumably reached in the past by wooden steps. There is a small square-headed window towards the E end of the ground floor and a slightly larger window placed centrally just below the eaves in the upper storey. Internally the floor for the upper storey has been removed but the joist holes are still visible in the walls. The building is currently used as a workshop. A stone-built wall runs E from the SW corner of the building to form the S side of the yard.

Plate 2: Coach house (Prn 39081). Note the partially blocked archway and the 1st floor entry.

Maintain in present condition.

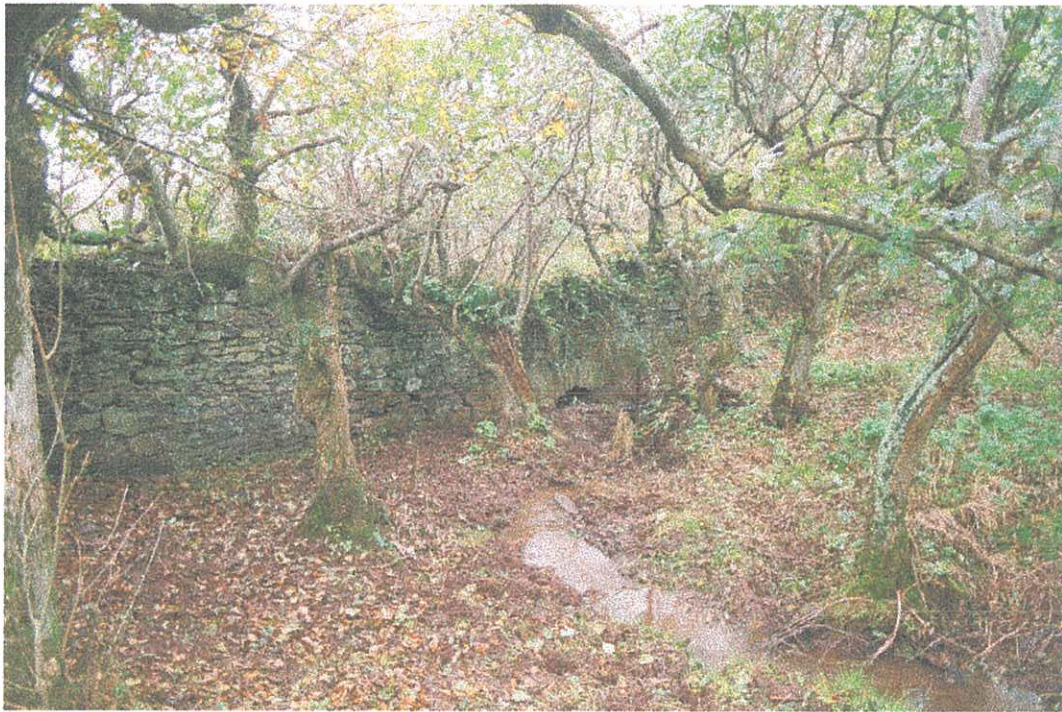
A stone-built bridge over a small stream. The bridge is of dry-stone construction 2-3m wide and stands in places to c.1.75m high. Both the bridge sides continue field boundary lines to create a funnel shaped entrance to another field on the opposite side of the stream. The bridge was not shown on the tithe map (1842) but it was on the OS 2nd edition 6" map published in 1909. The bridge is now overgrown with blackthorn and some cracks are evident in the bridge sides. The track over the bridge is very muddy so it is not known whether it was originally just a dirt track or whether it was metalled or paved.

Plate 3: Stone bridge PRN 39083.

Clear the vegetation from the bridge itself and consolidate the structure.

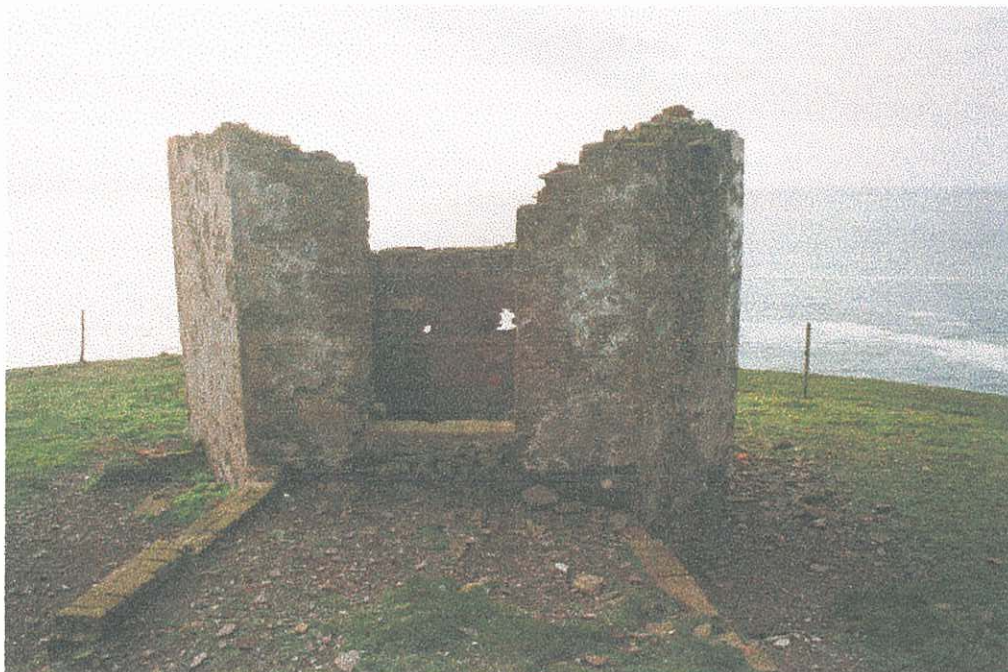
Hexagonal stone built observation post with some brick additions. Now roofless and disused. B Allen 1996. A lookout house was shown in this position on the OS 2nd edition 6" map (1909) and it probably dates from the mid 19th century.

Plate 4: 18<sup>th</sup> century lookout post (PRN33437).

Maintain in present condition.
