# **Tir Gofal Farm Visit Report**

## **Bwlch Cefn Sarth**

### **W/12/380**

ACA Project Record No 39100

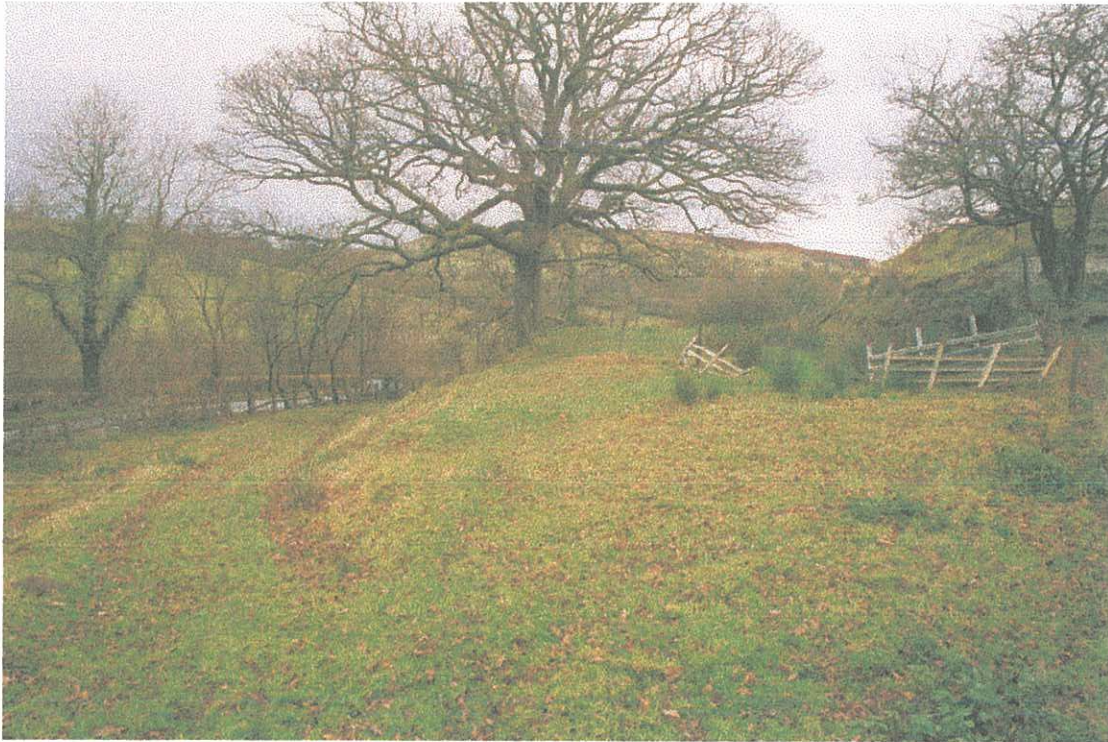
Two linear terraces cut into the N facing slope just S of the present A482 Llanwrda - Lampeter road. The terraces are on two levels, the upper terrace is c.6m wide and the lower terrace is slightly narrower, c.4-5m wide. The lower terrace is up to 2m lower than the upper terrace in some places. The terraces probably represent the line of the former 18th century pre-turnpike road and possibly the line of the Roman road from Llandovery to Pumpsaint.

Plate 1: PRN 39103, terraces of the former 18<sup>th</sup> century pre-turnpike and the possible line of the Roman road from Llandovery to Pumpsaint.

The terraces are substantial and important landscape features and they should be maintained in their present condition. Driving vehicles across, or along the terraces should be avoided where possible, as should any form of potentially destructive activity.

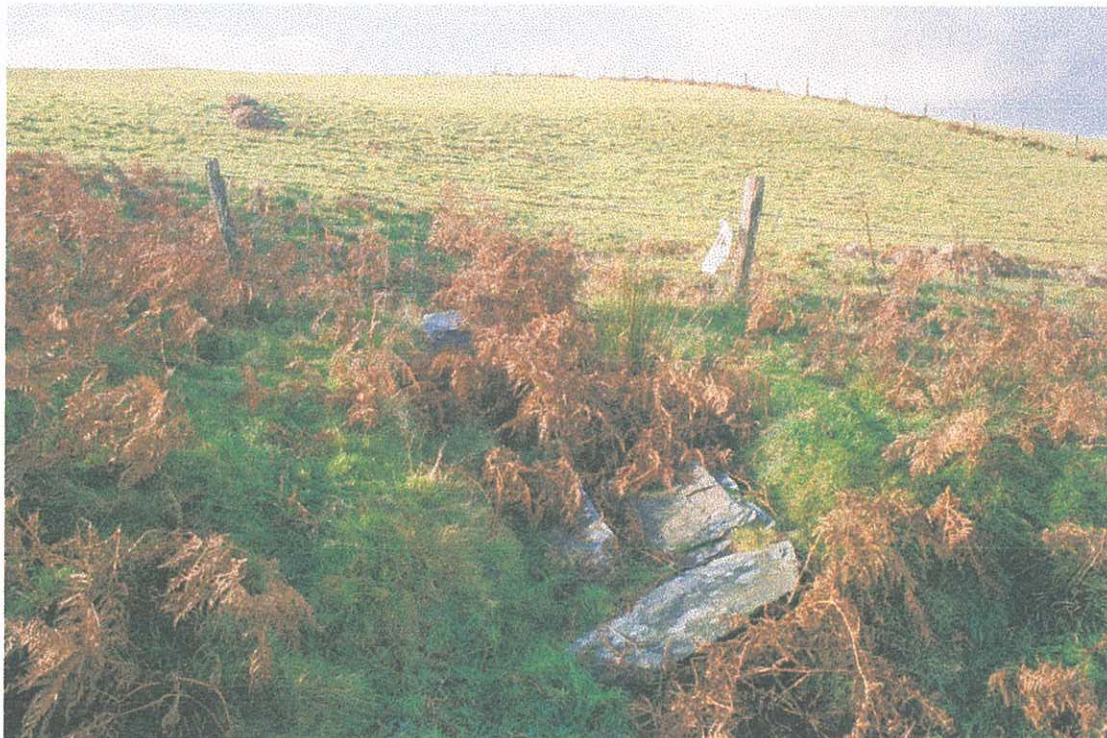
Low mound with large flat laid stones. The stones form a line through the centre of the mound and cap what appears to be a linear void. Some of the stones have slumped into the void at the E end. One large capstone survives in situ at the W end. The mound survives to the S and the N of the stones to c.0.2m high. This feature cuts across a trackway that is supposed to be the line of a Roman road (PRN 39109). There was no indication of the former function of the feature.

Plate 2: PRN 39104, the capped-stone feature. Note the stones in the foreground slumping into the void.

This feature lies on the line of a footpath, although, so far at least, it does not appear to be suffering from erosion damage. The feature lies under a fence and is partially in two different fields. The feature should be maintained in its present condition and excluded from any destructive processes such as ploughing.

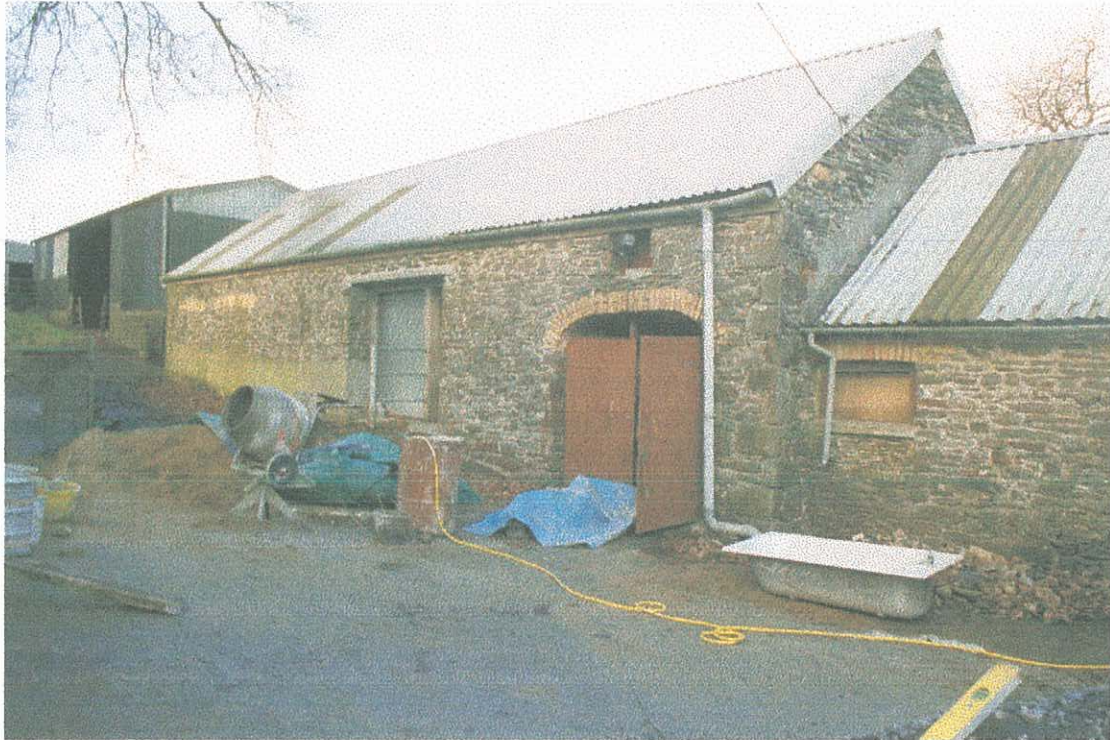
Small rectangular single-storey stone-built structure with a corrugated asbestos roof. This building sits parallel to the road at the N end of the yard. A building is shown in this position on the OS 1st edition 6" map published in 1891, and there is a building shown in a similar position on the OS Old Series map of 1831. A small square stone-built extension, a dairy, was constructed on the S elevation sometime during the very late 19th century or early 20th century. The extension has red-brick quoins around the window reveals and doorway. The original building had three square headed, yellow brick doorways in the S elevation facing the yard. The W door has been blocked and a window inserted. Internally there has been some modern alterations.

Rectangular two-storey stone-built structure with a corrugated asbestos roof. This building sits parallel to the road at the N end of the yard and butts onto the W end of PRN 39106. A building is shown in this position on the OS 1st edition 6" map published in 1891 and there is a building shown in a similar position on the OS Old Series map of 1831. The E end of the building is a cartshed with a depressed semi-circular headed opening in yellow brick. A small square window is positioned under the eaves and centrally above the cartshed door. There are two other yellow brick headed openings at the W end that have been blocked and partially rendered. A large square opening with a concrete lintel has been inserted into the middle of the S wall. The building has also had some modern alterations to its interior.

Plate 3: PRN 39107 and part of PRN 39106 at the right of the photograph.

If this building is to be converted to commercial use, it should be carried out in a manner that will retain the historic character of the buildings. If this building is not to be included in the redevelopment plans it should be maintained in its present condition.

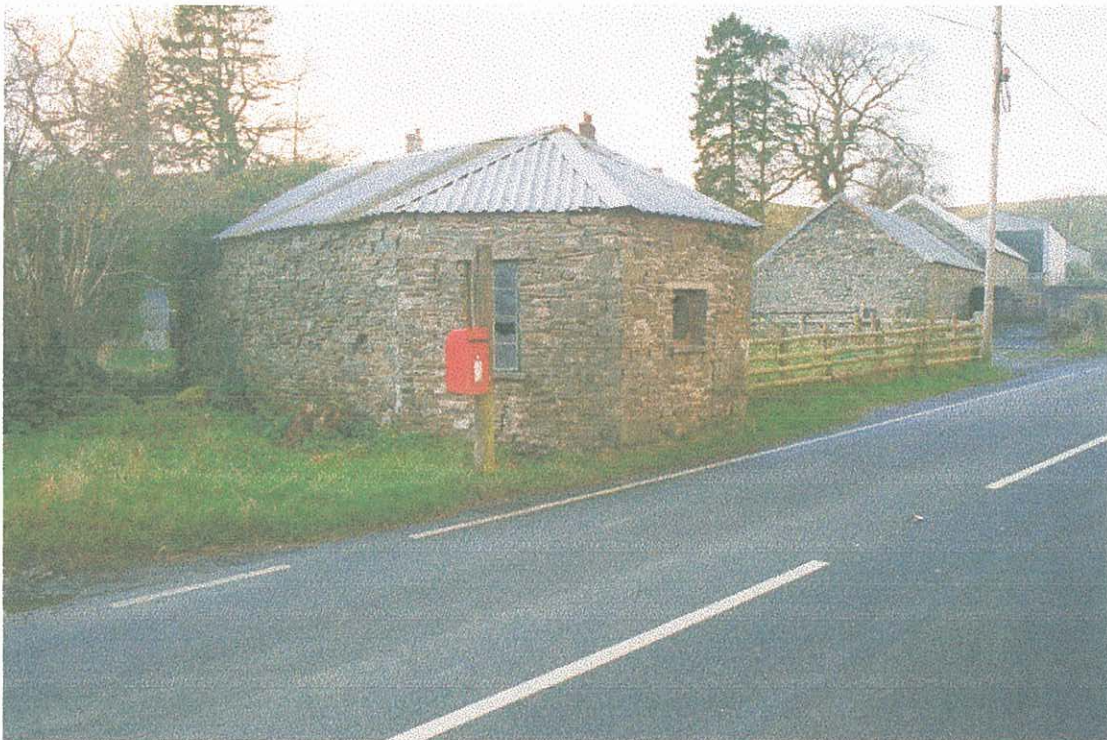
Probable remains of Toll Gate House standing adjacent to A482 Llanwrda to Lampeter road. Building is uninhabited, but appears to be largely intact. E. Morgan, 03:04:1990. The building is a low, single storey stone-built structure with a modern tin sheeting roof. It is aligned NE-SW, it measures c.6m x 4m and is semi-octagonal apsidal ended at its NEE end. Internally it is divided into two rooms. The NEE, or front, room is c.2m x 3.5m and is entered from the N side. The original door was in the NEE wall, although it has now been blocked and a window inserted. There is a another window in the ~~ONE~~ wall, which has replaced an earlier opening, one of the reveals of the earlier opening is visible in the exterior face of the wall. The front room has a fireplace and chimney breast built into the internal dividing wall. The rear room measures c.2m x 3.5m. Traces of the stone floor survives and it has a blocked window in the rear, SW, wall. There is an inbuilt cupboard in the NW wall. The fabric of the building is in fairly good condition although the original roof has been lost and replaced by a modern tin roof.

Plate 4: PRN 24750 the tollgate house .

Toll Houses are becoming increasingly rare in the landscape as modern transport requirements demand changes to the existing road network. The fabric of the walls of this building are in good condition and it would be worthwhile to survey the standing remains to assess whether the building meets any of the criteria for Listed Building status. The building is of significant local interest and has a value beyond being part of the farm property. The building should be preserved in-situ and consolidated to allow proper management of the building in the future.
