# **Tir Gofal Farm Visit Report**

## **Mwche Farm**

### **W/12/726**

ACA Project Record No 39110

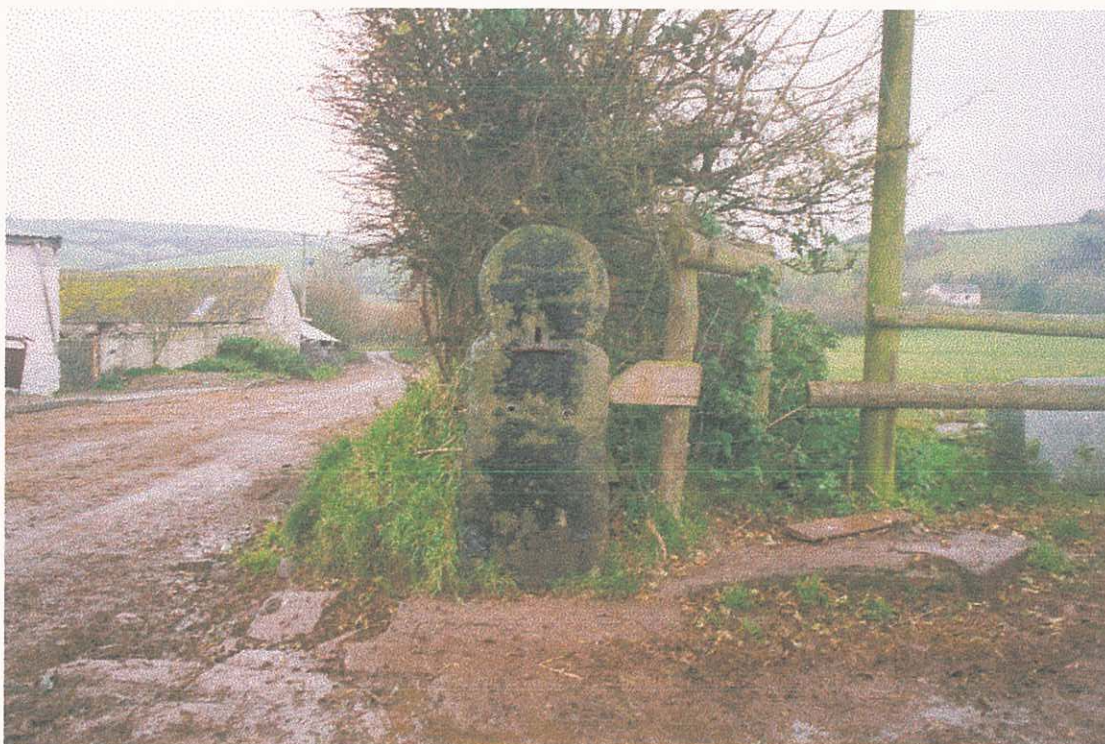
A carved stone now used as a gate pillar, c.1.2m high x 0.4m wide. The stone is a flat slab body with rounded shoulders topped by a circular head. The stone had been covered with tar in the past, but this is now beginning to erode. Some inscribed decoration is beginning to show through the tar in places. The head has a band around the outer edge of its face. The band is filled with a sunburst decoration. There may be three horizontal lines in the centre of the face, although this is not certain. The stone has a socket just below the shoulder on its E edge. The back of the stone has been roughly cleaned, but not smoothed or carved. Whilst the stone is still covered with tar it is not possible to say anything about its date or function, although it is unlikely that it was originally intended to be a gate post. There are two small square holes in the front of the body of the stone that appear to have lead inserts that may have been related to a former use.

Plate 1: PRN 39307 - Inscribed stone gate post.

The stone should be professionally cleaned to uncover any decoration and to allow some analysis of the possibly date and former functions of the stone. Once cleaned it will be possible to make recommendations regarding the future management of the stone.

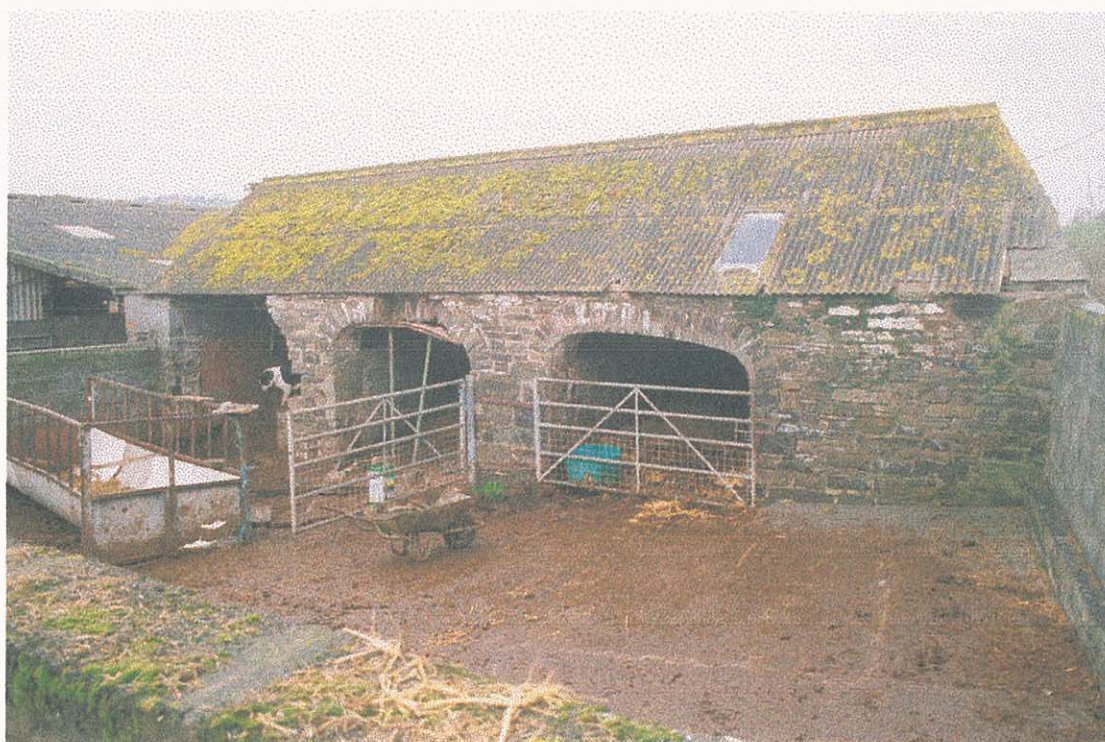
Single storey, four-bay stone built structure with a corrugated asbestos roof. The building is aligned E-W and stands at the NE corner of the yard. The three W bays contained depressed semi-circular headed openings, although only two now survive, the westernmost opening has collapsed. The centre arch is also in danger of collapse, it is currently supported by timber props. Internally the bays have been divided by modern block and brick walls. A modern block-built pen has been constructed in front of the building. This building is probably the last of the historic farm buildings left at Mwche.

Plate 2: PRN 39308 - cart shed, this is one of the last historic buildings within the yard complex.

This building should be consolidated and made safe. It may be possible to reconstruct the broken arch and restore the building to its original appearance.

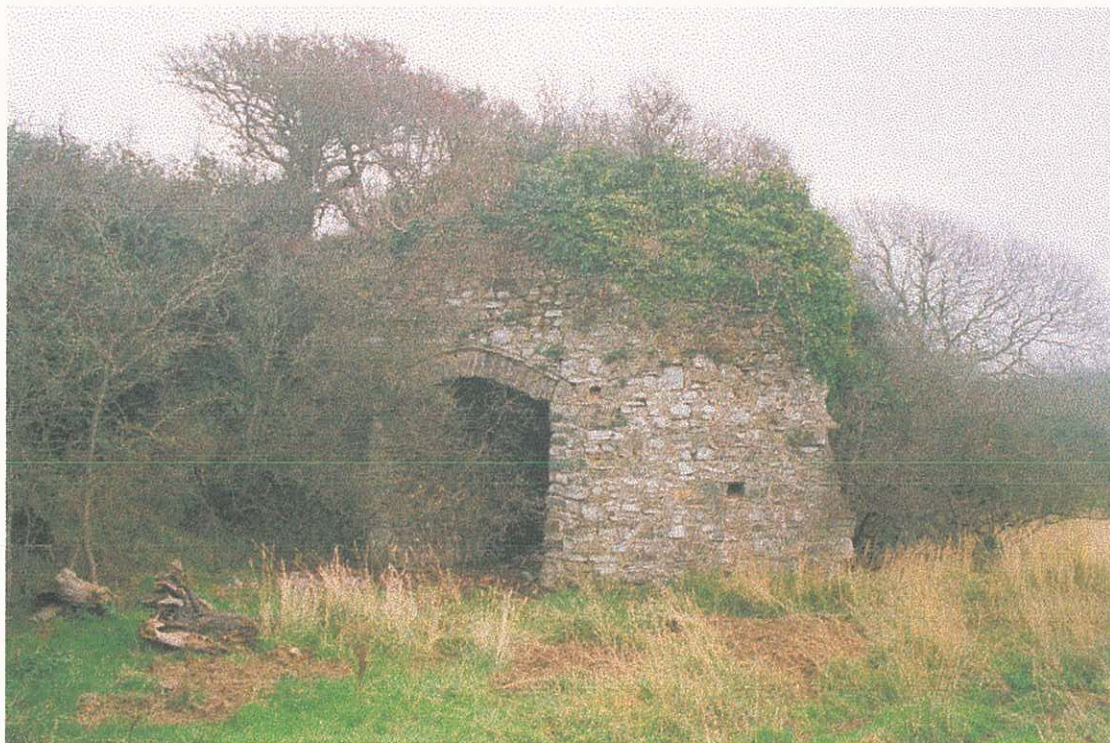
Stone-built half round kiln with 2 drawing arches. There may have been a third arch, now collapsed. The structure is now overgrown, there are some fairly large and mature trees growing on it which are beginning to affect the fabric of the kiln. Large cracks are visible in the W face above the draw arch.

Plate 3: PRN 15736 - the drawing arch of the limekiln at Black Scar.

The larger trees growing on the structure are damaging the standing remains and they should be removed to relieve the pressure on the cracks in the fabric.

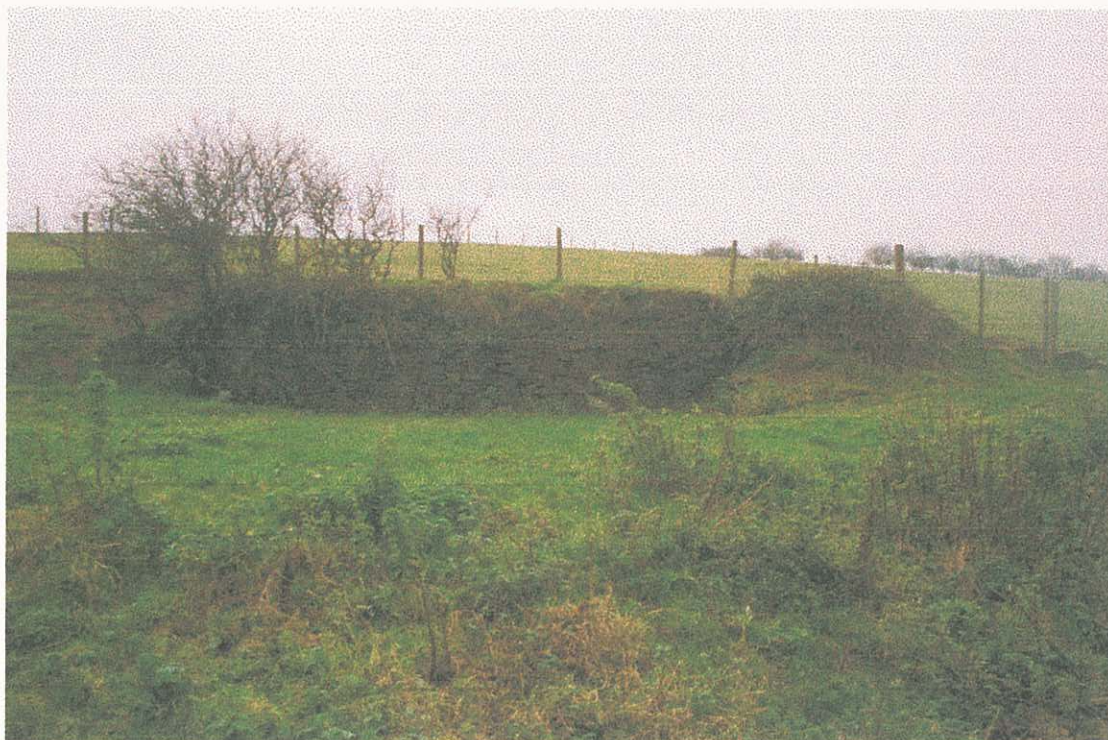
The site of a 19th century cottage. All that remains today is part of the rear, S, wall and the terrace of the cottage platform and a small terrace to the E which may have been the garden. There is a pile of rubble a short distance to the W that may have been a former outbuilding.

Plate 4: PRN 23580 - the rear wall and house platform of Ffynnon fach cottage.

The site is located in the corner of a field and could therefore be excluded from any destructive processes such as ploughing. It should be possible to, maintain the sit in its present condition without affecting the overall management and uses of the field.
