# **Tir Gofal Farm Visit Report**

## **Norchard Farm**

### **W/13/337**

ACA Project Record No 39133

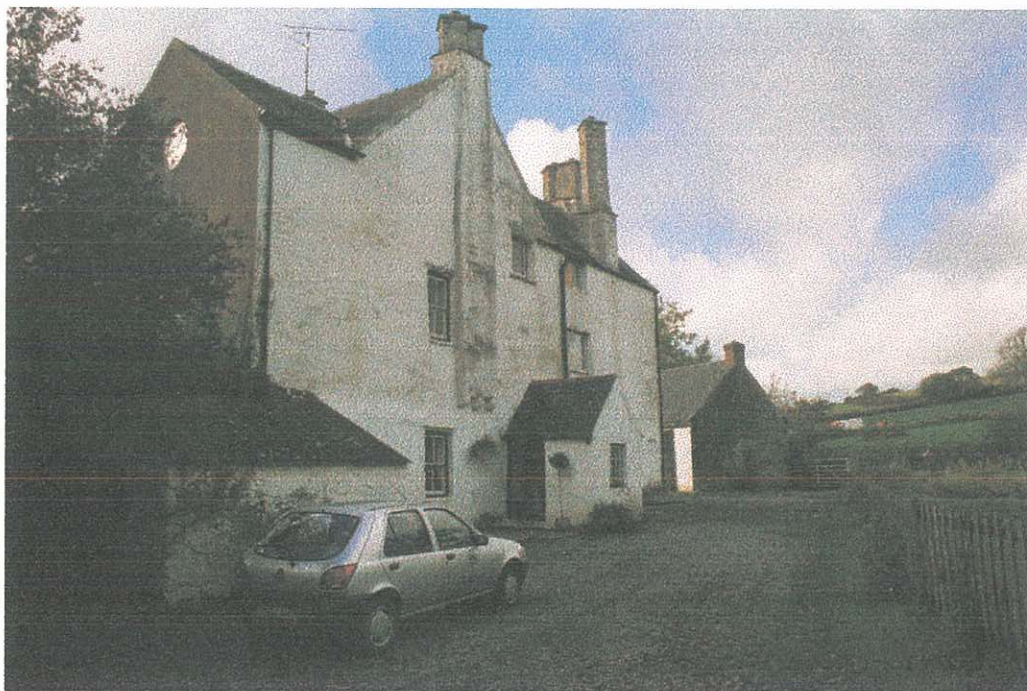
The earliest surviving elements in the house are 15th century vaults at the W and E ends of the main range. The W end has twin vaults running E-W, the E end has a single N-S vault. These are probably the remains of a hall house. During a rebuild of the 17th century a new centre section was constructed between the vaulted wings. The main range of the house is south facing with symmetrical gabled wings projecting forward. The W projection may be false to balance the E projection. A stone staircase from the main range gives access to the upper floor of the E wing. A garderobe is present in the N end of the E wing. There has been some internal modernisation by the previous and the present owners, but the main structural components and the character of the house have been maintained.

Plate 1: East elevation of east range of the house (PRN 7283). Some of this range dates from the 14<sup>th</sup> century.

The quality and character of the house is recognised in its designation as a Listed Building therefore works on the house are subject to Listed Building Consent. Care should be taken to avoid unsympathetic modernisation and development.

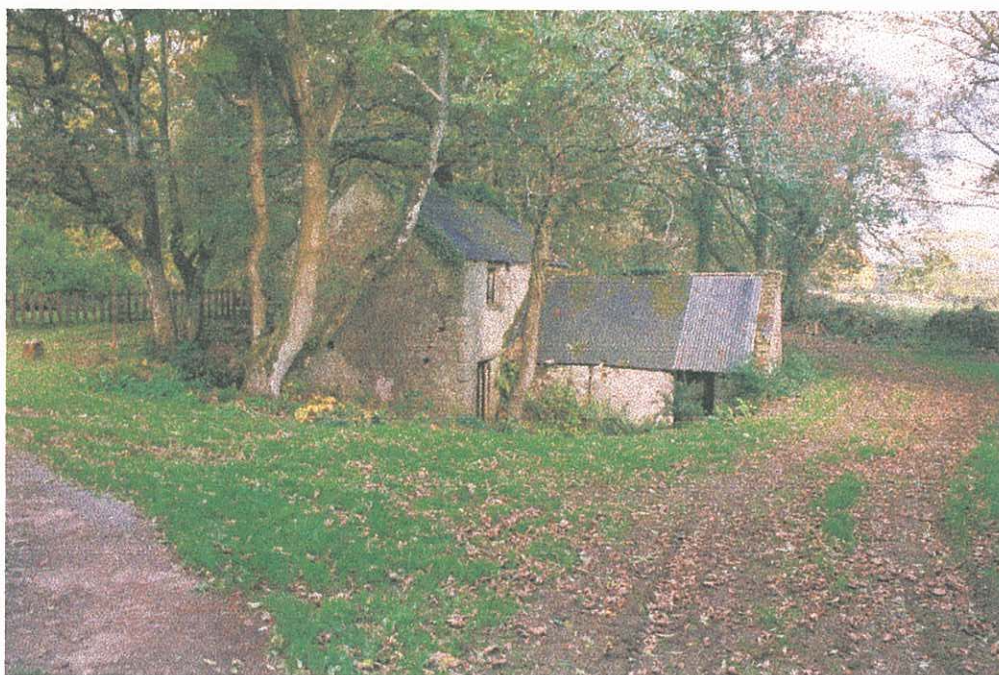
Grist Mill to east of Norchard Farm farmstead. A two storey corn mill fed by mill pond, PRN 37641. The mill is built into the SW edge of the pond and fed via a sluice in a dam. The upper floor of the mill is reached from the dam. The mill consists of two ranges an E-W range that formerly housed the gearing and a smaller, single storey extension on the S side that has a wooden pulley surviving on its N wall. Both ranges are of random-rubble construction with slate roofs. The wheel was mounted on the E wall of the main range, the wooden axle survives but the rest of the wheel is missing. Some of the wooden internal gearing remains, but only the fly wheel is in-situ. The tailrace runs beneath the SE corner of the S extension and under the track PRN 37646 and into a field to the S of the farm. Internally the wooden floor for the upper storey in the main range is unsafe. Tree roots from several adjacent trees are beginning to encroach into the building and these are having an impact on the fabric of the structure. There is some cracking to the external walls.

Plate 2: Corn mill (PRN 37642).

Remove the trees closest to the building. Repair the internal wooden flooring for the upper storey and consolidate the cracks in the walls. This building has statutory protection as a Listed Building and all works are subject to Listed Building Consent.

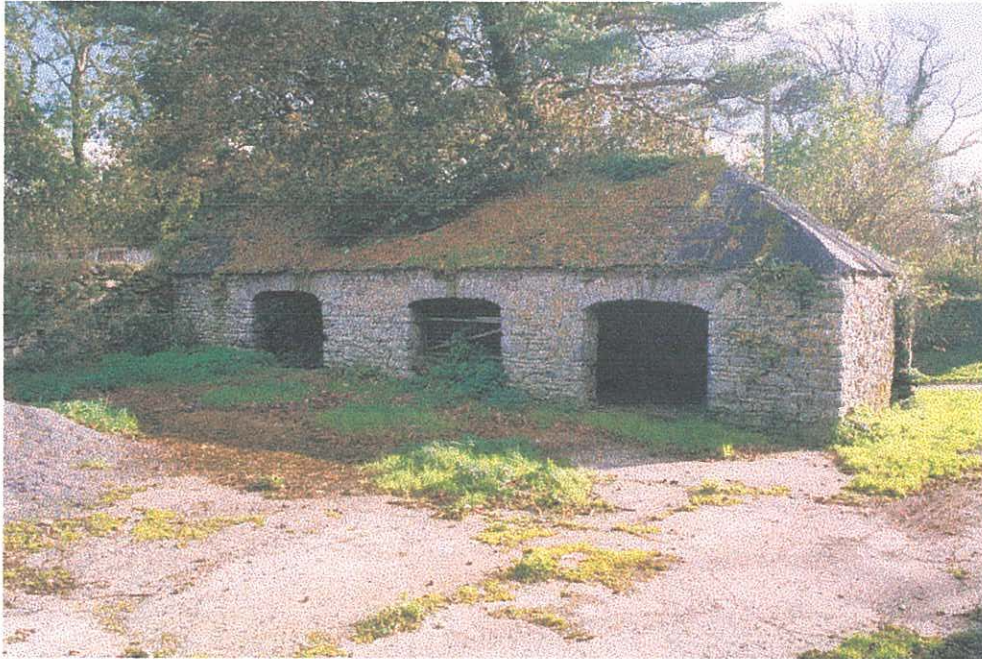
Rectangular cart shed, c.15m x 6m, constructed from local random-rubble, with three open arches in the N wall. The E end of the shed is built against the outer face of the W wall of the kitchen garden, PRN 39075. This building was not shown on an estate plan of 1772, nor on the tithe map of c.1842. There is some damage to the W end of the roof, and the E end of the rear wall is cracked internally, but otherwise the building is in relatively good condition. The roof timbers are fastened with wooden pegs.

Plate 3: Cartshed (PRN 39606) showing the three arched openings in the north elevation.

Repair damage to roof and consolidate the walls.

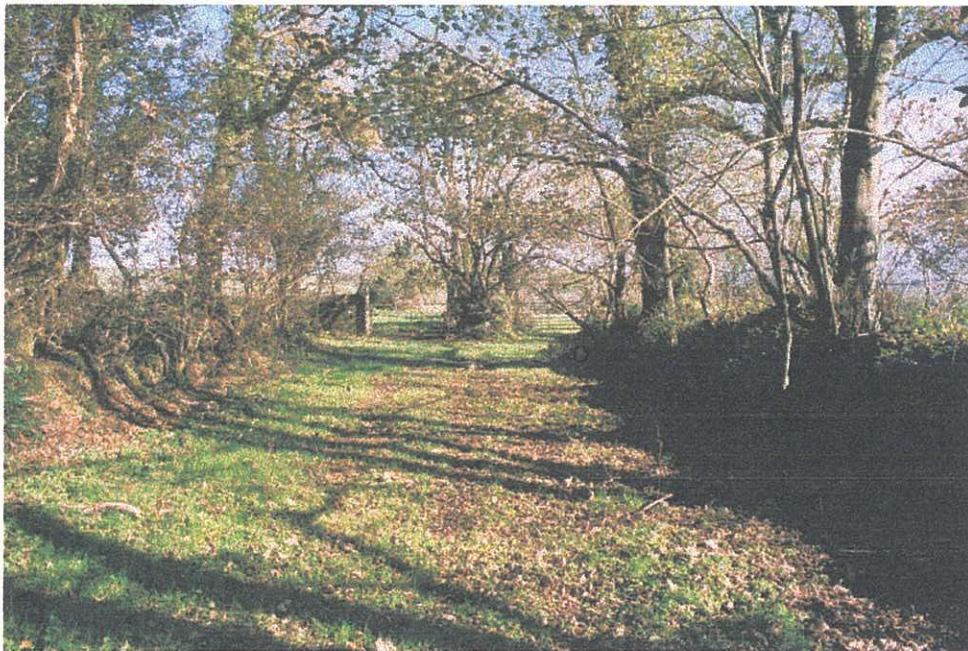
A metalled trackway c.7m wide flanked on either side by earth and stone boundary banks (up to 1.2m high x 1-1.5m wide). The bank on the N side is the boundary for wood PRN 37640. This track may formerly have extended to Lydstep. At its E end the track now terminates at entrances into two pasture fields. The entrances had curved stone walls on both sides, a typical Pembrokeshire feature, but only the northernmost wall survived intact.

Plate 4: The gravelled trackway (PRN 37646) leading towards Lydstep. The wood (PRN 37640) is on the left of the picture.

Maintain in present condition.
