Tir Gofal Farm Visit Report

Maesllyn

W/11/1294

ACA Project Record No 39315

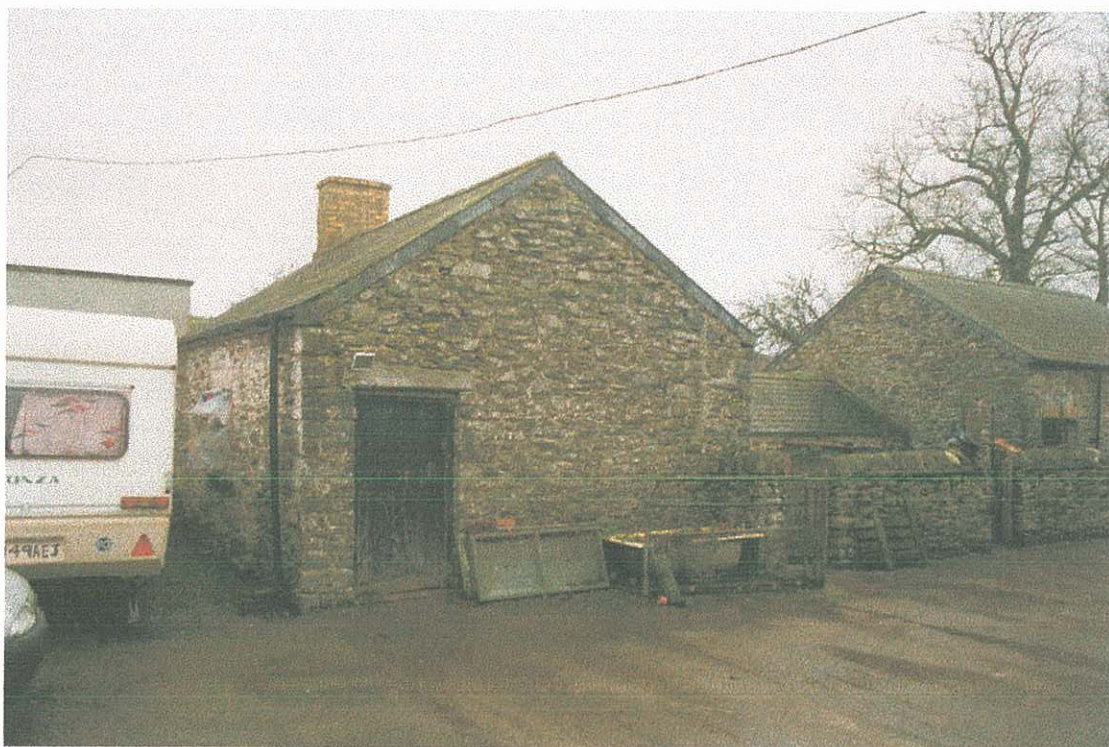
Small rectangular stone-built structure with a slate gabled roof, with a rectangular chimney on the E gable. There is a door in the W gable wall and a square window in the N wall, both openings have segmental brick heads in yellow bricks. The S wall of the building forms the N wall of the pigsties. Its location next to the pigsties is typical of a brewhouse, but its incorporation into the pigsty structure is unusual. A brewhouse was used for a variety of purposes such as boiling clothes, baking and brewing, but the fact that these buildings are often known as 'y gegin foch' (the pigs' kitchen) shows perhaps its most important role on the farm, that of preparing food for the pigs. This type of building generally dates from the mid- to late-19th century.

Plate 1: PRN39311 - the brewhouse. The pigsties (PRN39312) and the stable (PRN 39313) are to the right of the brewhouse.

This building is an interesting and slightly unusual survival and its association with the pigsties makes it of particular value. This building should be maintained in its present condition.

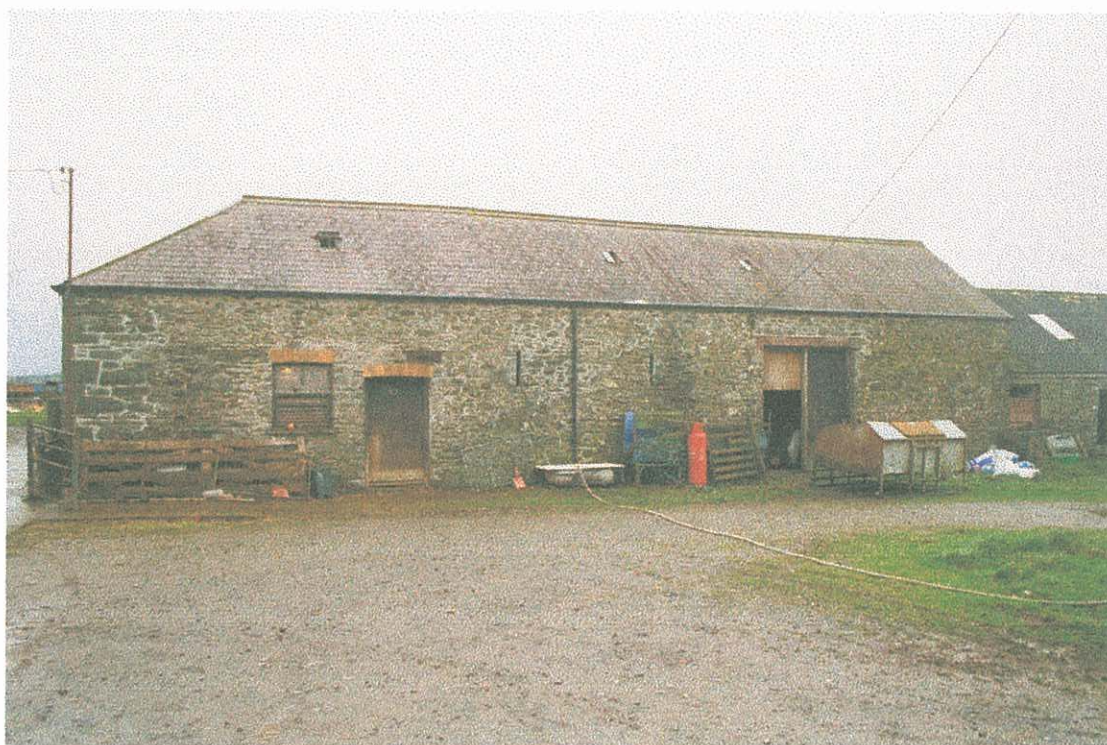
Two-storey L-shaped stone built stable with a slate roof. The stable occupies the N-S wing; the E-W wing is used for storage. There is a storage area above the stable area which is entered via a 1st floor door in the S gable wall reached by a flight of stone steps. The steps are now in a ruinous condition. The openings in the front, N, elevation are a mix of segmental heads in red brick and square headed openings with either a timber or concrete lintel. The segmental-arched openings consisted of a door and a window into the stable area of the building; the square headed openings were a large, almost full height, doorway and a smaller blocked door at the W end. Internally the stable area appears to be largely in its original state. The building was re-roofed during the 1930s following a fire.

Plate 2: PRN 39309 - the stable.

This building, along with the other surviving farm buildings forms part of an interesting farm complex which has had little modern development and retains its historic character. The building is in daily use and should be maintained in its present condition.

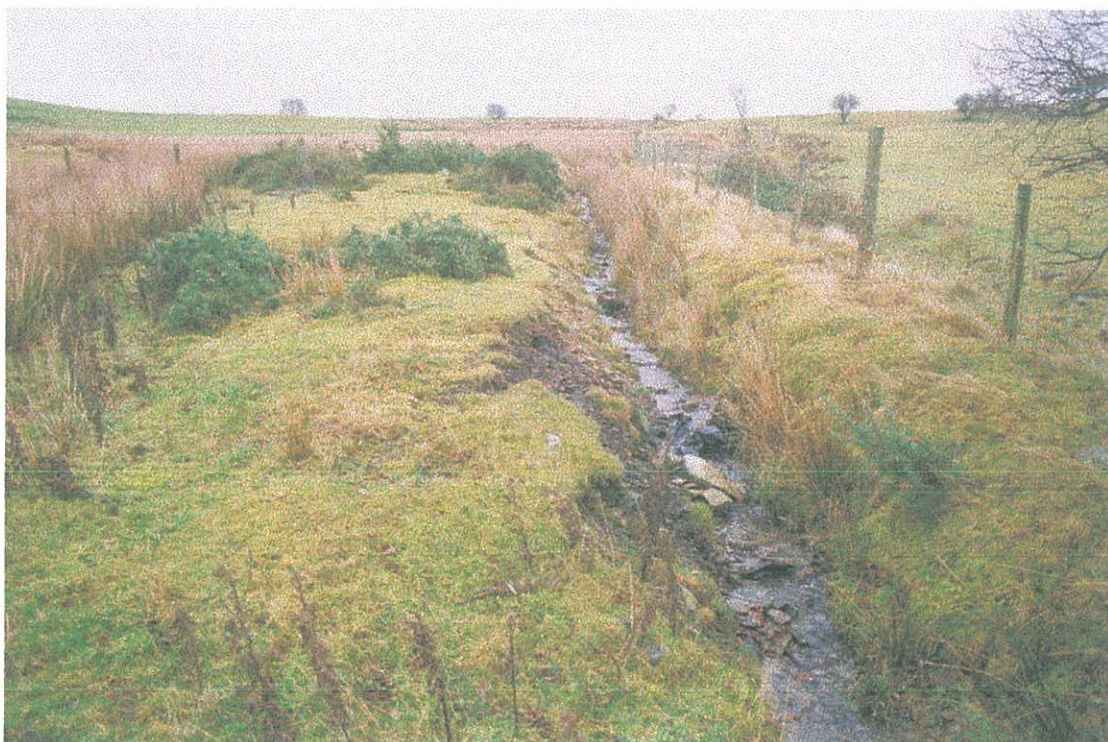
A small spread of burnt and fire-cracked stones alongside a small stream. The mound is being eroded on its S side by stream action.

Plate 3: PRN 39317 - burnt mound. Burnt mounds are normally of Bronze Age date and they are made up from the remains of stones that were heated and dropped into water to heat it, probably for cooking.

The area around the mound has been ploughed in the past by the current owner but it should be excluded from further ploughing.

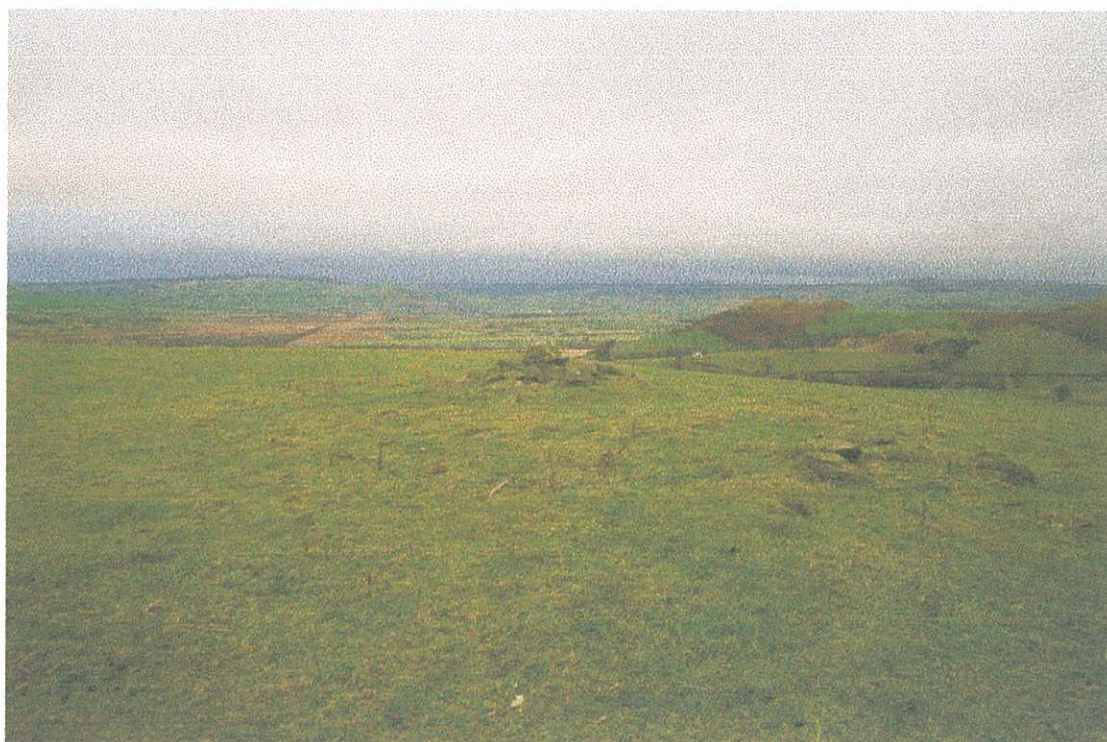
Small mound of stones. There is no evidence of any structure to the mound and the stones appear to have been dumped randomly. The most likely explanation of the stones is that they form a clearance cairn. The area has been ploughed in the past and the current farmer has himself created similar if larger clearance cairns to facilitate modern ploughing. The area of the stones is raised slightly above the surrounding ground which is probably the result of ploughing up to and around the stones. Clearance cairns are common features of upland areas and can date anywhere from the Bronze Age to the modern period.

Plate 4: PRN 39316 - clearance cairn on Pen Llanerch.

The mound is a clear feature and should be maintained in its present condition. If this area is to be ploughed again the mound should be excluded.
