Archaeoleg Cambria Archaeology
Tir Gofal Farm Visit Report
Gilfach y Bettws
W/12/629

ACA Project Record 39331

Tir Gofal Application Number W/12/629

Address Gilfach y Bettws
Penybont, Carmarthen

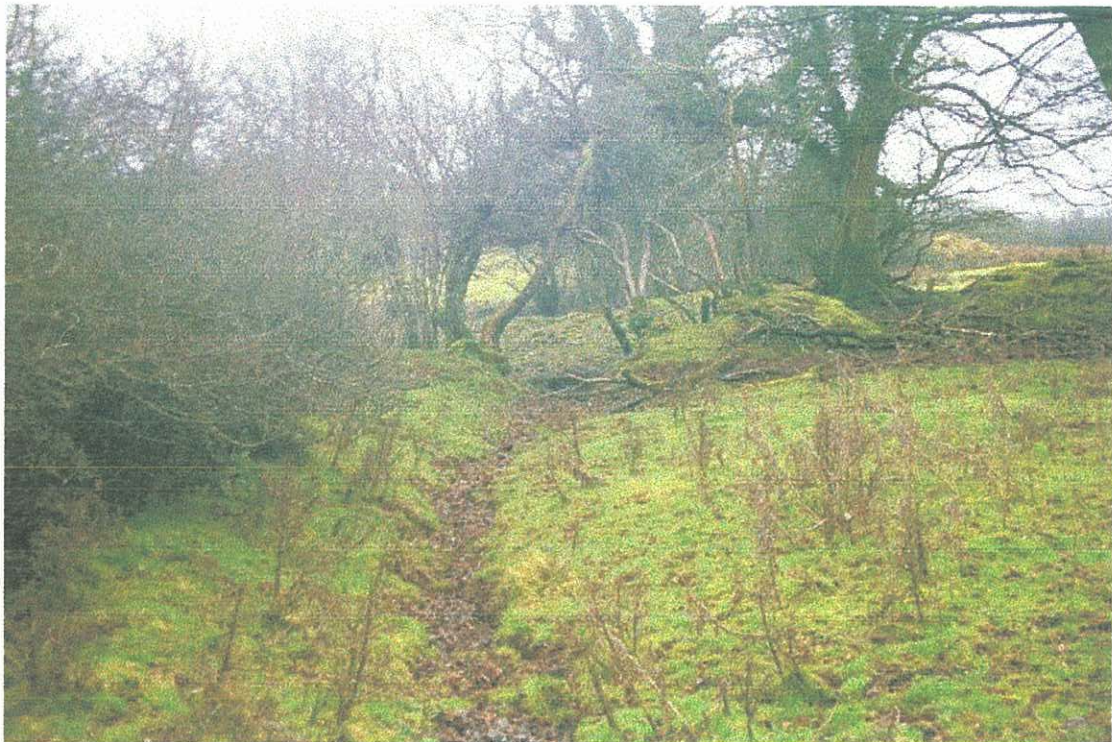
Well defined ditch, up to 2m wide x 0.3-0.5m deep, cut along a north facing slope leading from a pond (PRN39335) to the farm yard. Spoil from the leat was deposited on the north, downslope, side of the leat to form a bank which survives up to 2m wide in places. A small spur was run off this leat to run through the outside toilet to act as a flushing system. On OS maps of the 1960s the leat is shown running into the building at the N of the yard, where it presumably powered a waterwheel and some form of machinery.

Plate 1: PRN 39334 - view east along the leat where it passes through a field boundary

The leat survives in good condition for much of its length and it should be maintained in its present condition.

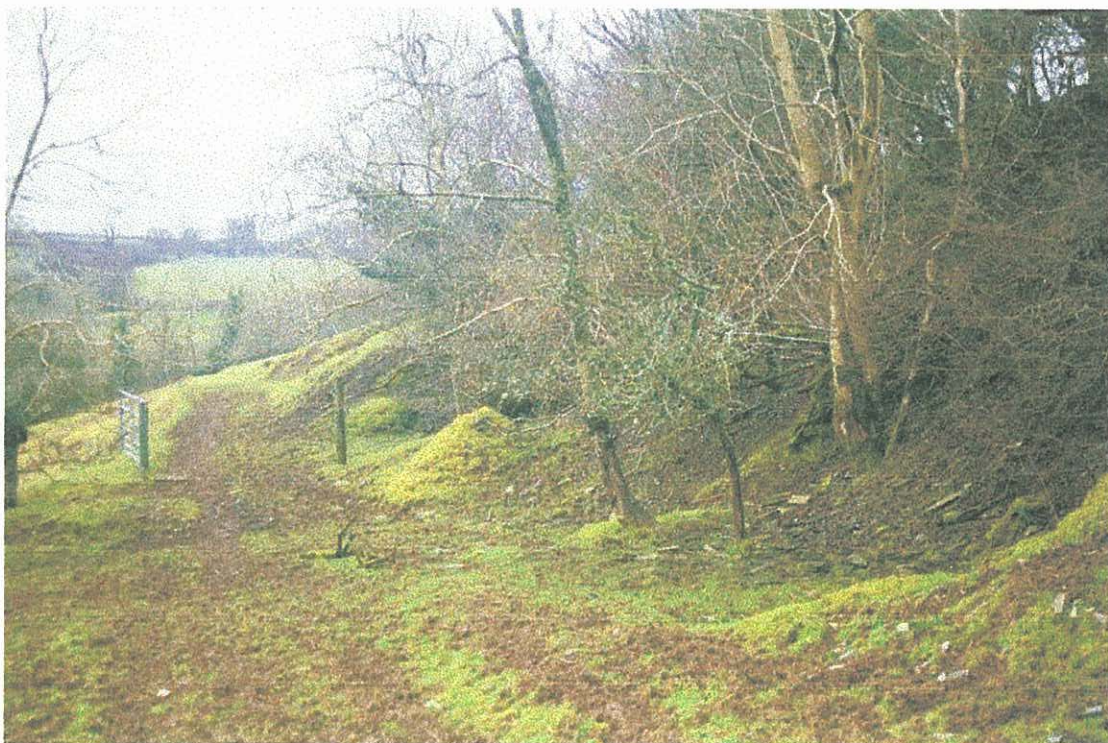
A track terraced into the north facing slope of the steep valley to the N of the farm. The track is part of a much longer track that originally ran for several kilometres along the valley and linked a number of farms. The track survives as a c.4m wide, grass-covered terrace. Where it passes immediately to the N of the farm the terrace is reveted by a pitched stone wall. The track runs past two small quarried cut in to the slope just NE of the farm.

Two small quarries cut into the north facing slope of the steep valley to the N of the farm. The quarries are located alongside the track (PRN39340) and their small size suggests that they were used to supply stone for the farm only and not as part of a commercial operation. The quarries are today overgrown with trees and shrubs.

Plate 2: PRNs 39340 & 39341 - the two small quarries alongside the track, looking east

The track is in good condition and it still provides access for some areas of the farmland it should be maintained in its present condition.

The quarries are clear of modern rubbish and the vegetation growing in them will not cause them significant damage. They should be maintained in their present condition.

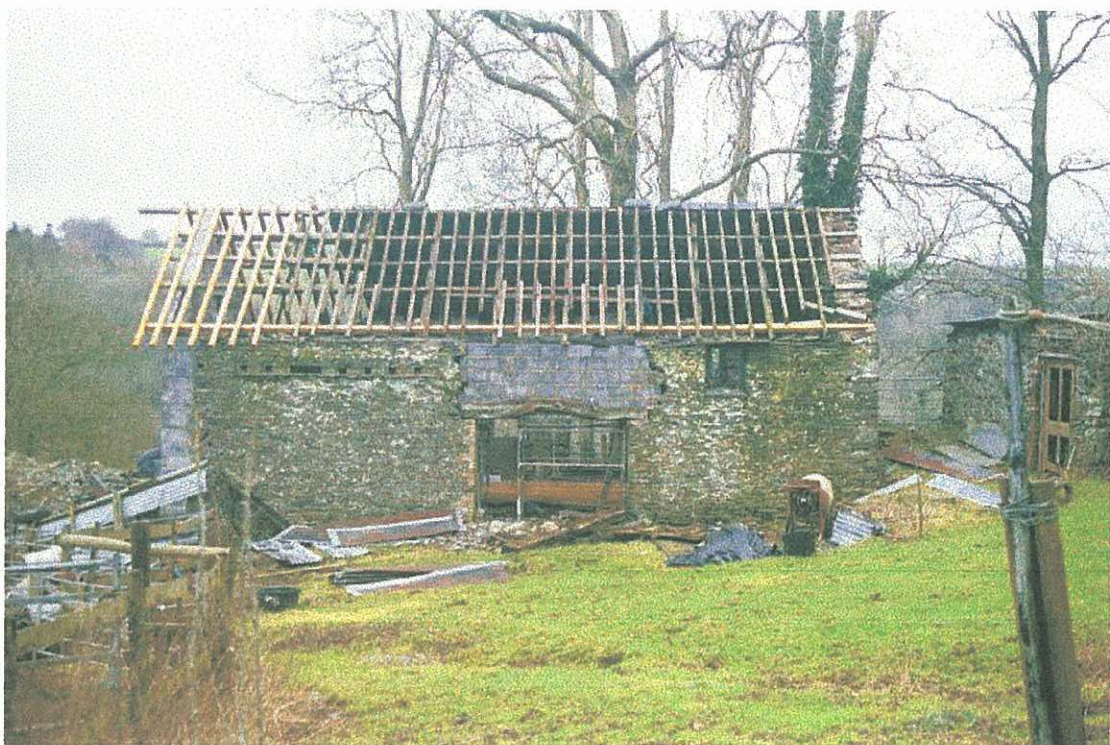
The house and most of the farm buildings are in daily use and are in good condition. The cartshed on the NE side of the yard is currently being substantially rebuilt for holiday accommodation. Where possible the original yard buildings should be retained, and if rebuilding or renovation works are required they should retain the character of the original buildings. There are no current plans to remove any of the existing boundaries on the farm. Most of the boundaries appear to date to at least the 18th century and those alongside the entrance track are almost certainly medieval in origin. Where possible all boundaries should be retained and maintained in their present condition.

Plate 4: barn/cartshed undergoing extensive rebuilding
