# **Tir Gofal Farm Visit Report**

## **Brynteg**

## **W/12/678**

ACA Project Record No 39418

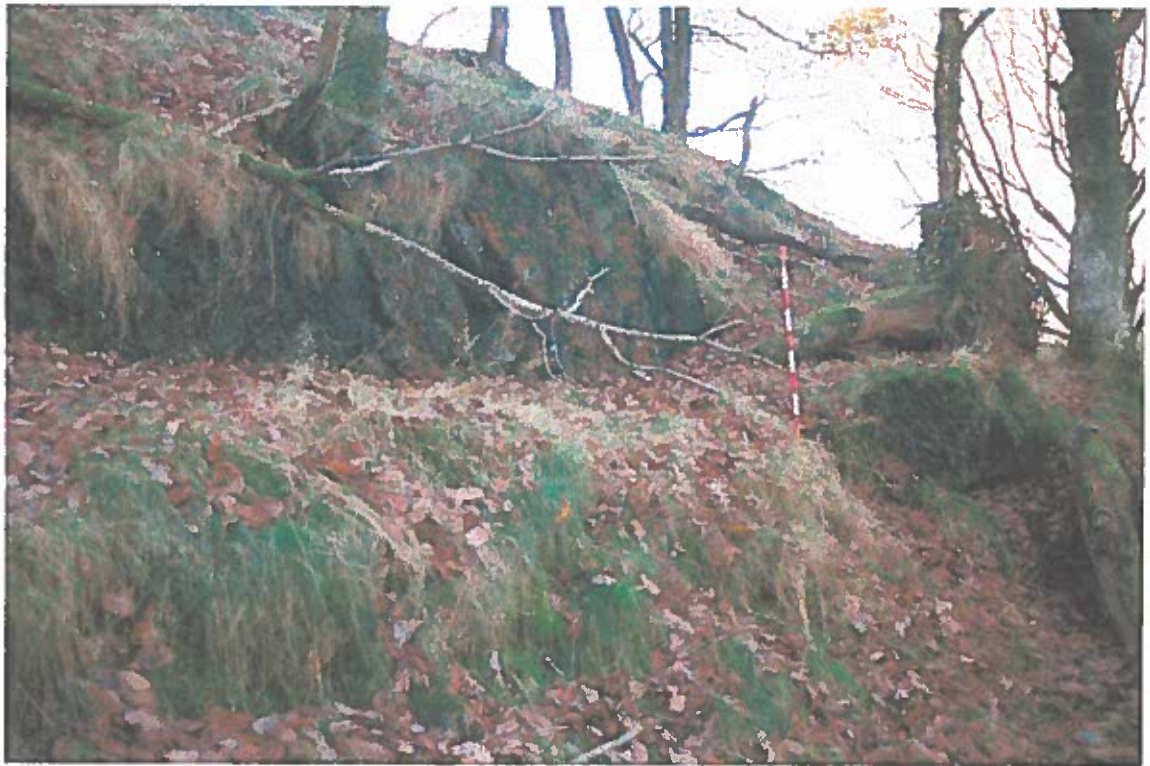
**PRN 1947 - Cothi Leat**

The Cothi leat is partly scheduled as Carm 200. The leat is, in general, clearly visible as a break in slope which in places is up to 2m wide and in part has been used as a trackway. In places the leat is rock cut.

*A rock cut section of the leat passing through broadleaf woodland.*

The leat passes through an area of relatively mature conifer plantation in the west and then through an area recently planted with mixed broadleaf as part of a bracken challenge scheme. Further east are mature broadleaf trees. Along the eastern part of the leat a number of trees have fallen across its line with windblow uprooting trees and causing some damage. Clearance of fallen trees and timber, and management of the trees along the line of the leat reducing such damage occurring in the future is recommended. The method of harvesting the conifer plantation will need to endure the protection of the leat from damage by machinery.

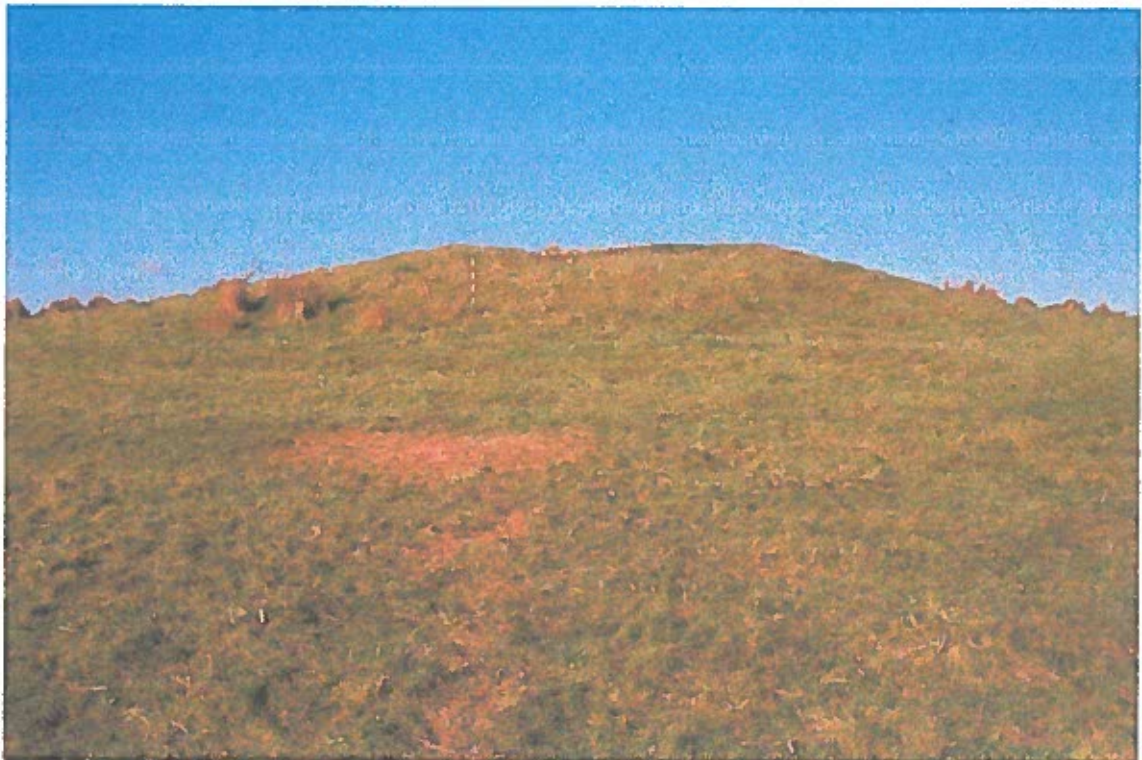
**PRN 1962 Banc Maes-yr-haidd**

This barrow comprises a grass covered earth and stone bowl shaped mound with traces of a possible stone kerb. It measures c. 20m in diameter and stands to a height of c. 1.8m. Some erosion by stock is evident on the south side of the mound.

*Grass covered mound with on-going erosion as a result of a sheep scrape adjacent to the horizontal scale*

Good grass cover over the mound should be promoted to prevent any increase in levels of erosion. Stocking levels should be kept low to encourage the present scar to grass over. Feeding points for stock should be kept away from the mounds.

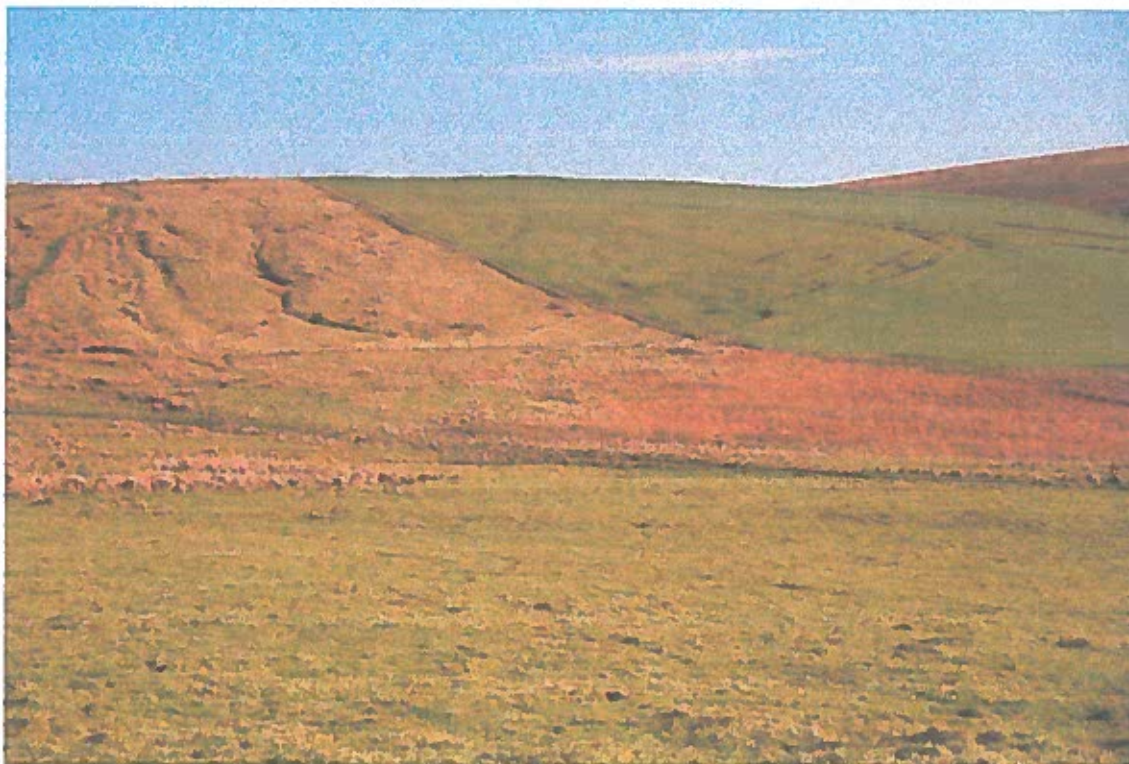
**PRN 39415 & PRN 8883**

SAM Carm 211. This feature was originally considered to be the line of a Roman aqueduct taking water from the River Annell to the Dolaucothi gold mines. Recent survey and research has recognised that a channel running a considerable distance across unenclosed land supplied water to the scheduled section of the feature and it could not have been fed from the Annell. The multiple channels have been explained as a result of the severe change of gradient needed to bring water around this route. Either the channel had to be rebuilt a number of times or the flow was split between channels. Recent investigation suggests that one or more of the channels may have been cart tracks. It has been postulated that the upper channel might be an ancient excavation along the back of a mineral load, the leat could then have supplied water for hushing. The leat may have followed the contours of Cefn-y-Bryn north and east almost to Rhiw Garegog, before dumping its load in a tributary of the Cothi just below this point. A maximum of four channels are visible within the Scheduled section of the feature.

This west facing hill slope has a number of what appear to be roughly parallel water worn gullies giving an appearance of irregular ridge and furrow running down the hillside. These appear to be cut through by the Anell Leat. It is possible that these features are the result of intentional prospecting for mineral bearing rock. By using collected water, possibly using a system of small tanks or dams and washing away the soil and or mineral within gullies down the hillside.

*Swinging down round the hillside are the four channels of the Gwenlais/Annell Leat, these cut across what appear to be roughly parallel water worn gullies, in the left part of the photograph, which are interpreted as hushes.*

The four channels all continue across into the project area, although not as visible as in the neighbouring field, and survive well under rough pasture. Water collects within the channels above a later boundary bank which cuts across the channels. Maintenance of a good grass cover will help to protect the features. Feeders should not be placed near to these features in this part of the field.

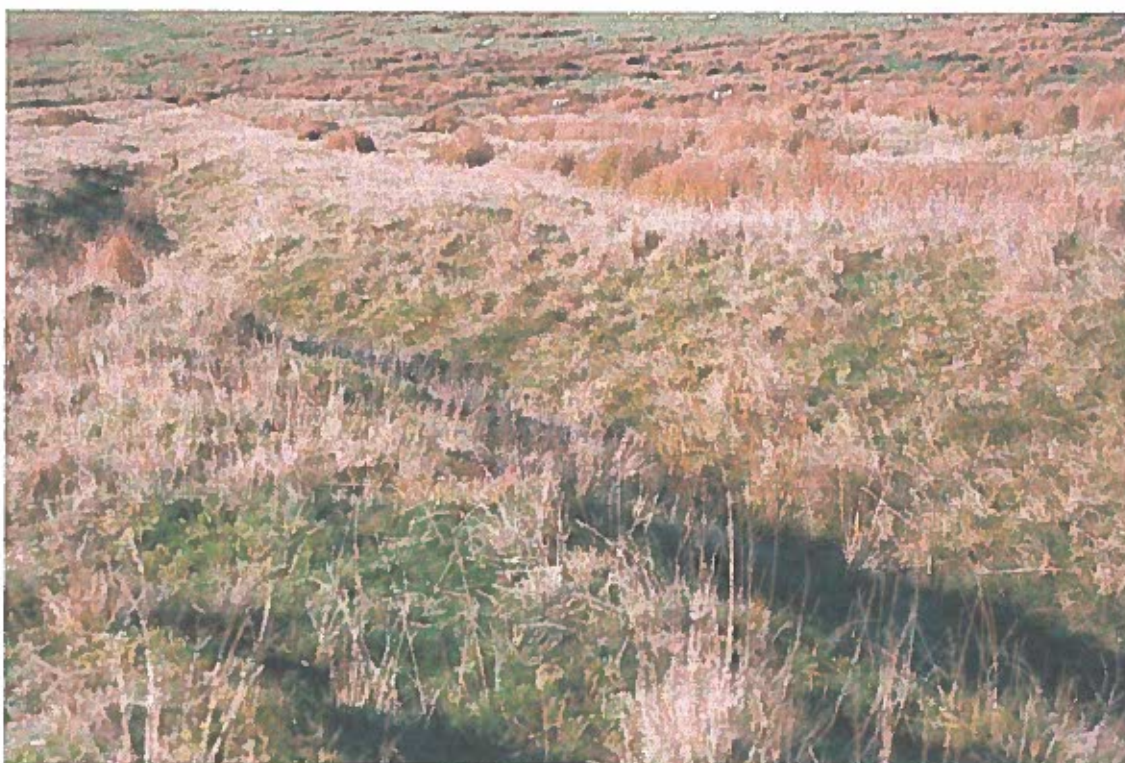
**PRN 39415**

*A closer view of the form of the gullies of the hushes and surviving ridges between them.*

If the remains are of early Roman or pre-Roman date they are undoubtedly of national importance and should be considered for scheduling, forming an important part of the Dolaucothi early mining complex. Good grass cover should be maintained on the site.

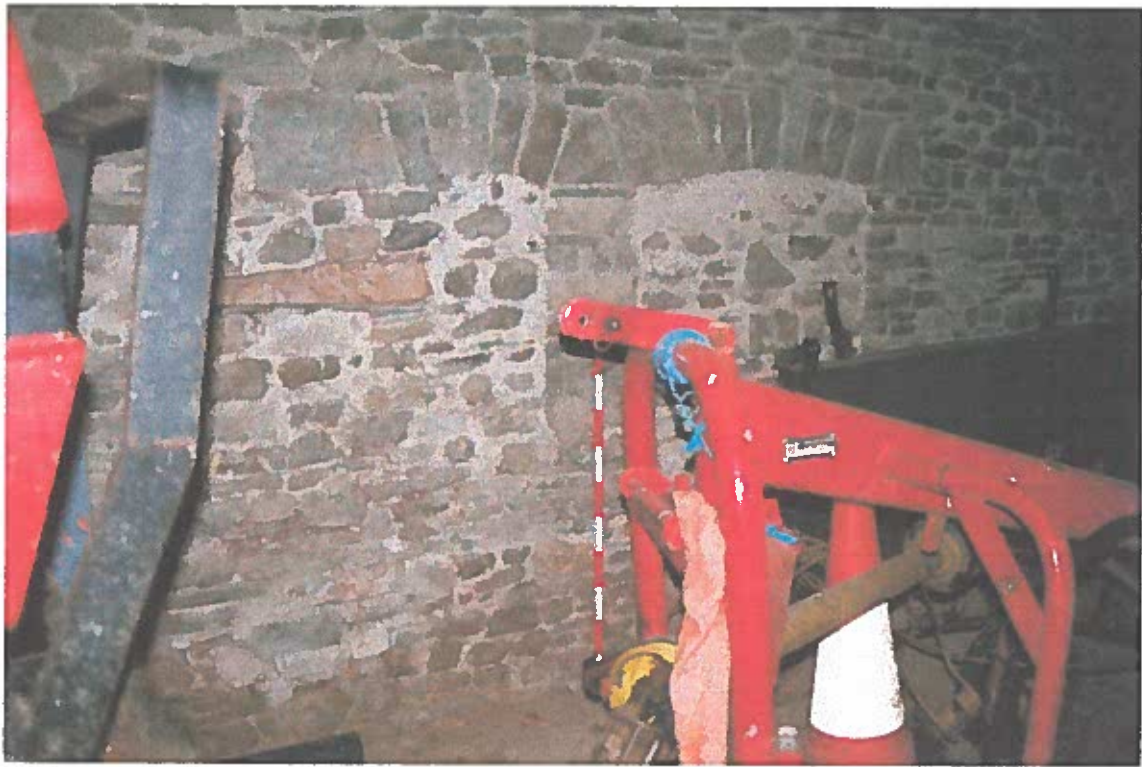
**PRN 18895 Eastern Range of Farm Buildings at Brynteg**

Described in the Cadw listing description as a barn range the building also incorporated a water powered mill. The building comprises a mid 19th century barn range contemporary with the farmhouse which is dated to 1843. It includes a rubble built high-door barn range with square quoins, a slate roof and slated barges. The barn door is at the southern end of the yard facing wall while there are two cart arches in the northern part. At the north end of the building is a flight of stone steps up to a loft door. A water wheel survived on the east wall of the building until c.1950, this drove agricultural machinery (pers. com. Mr Mercer). Two infilled arched openings are still visible in the east wall associated with the mill.

*The rear wall of the barn range/mill building showing blocked openings associated with the mill wheel.*

The building appears to be in reasonable condition. It is important that the roof is kept water tight to ensure its long term preservation.

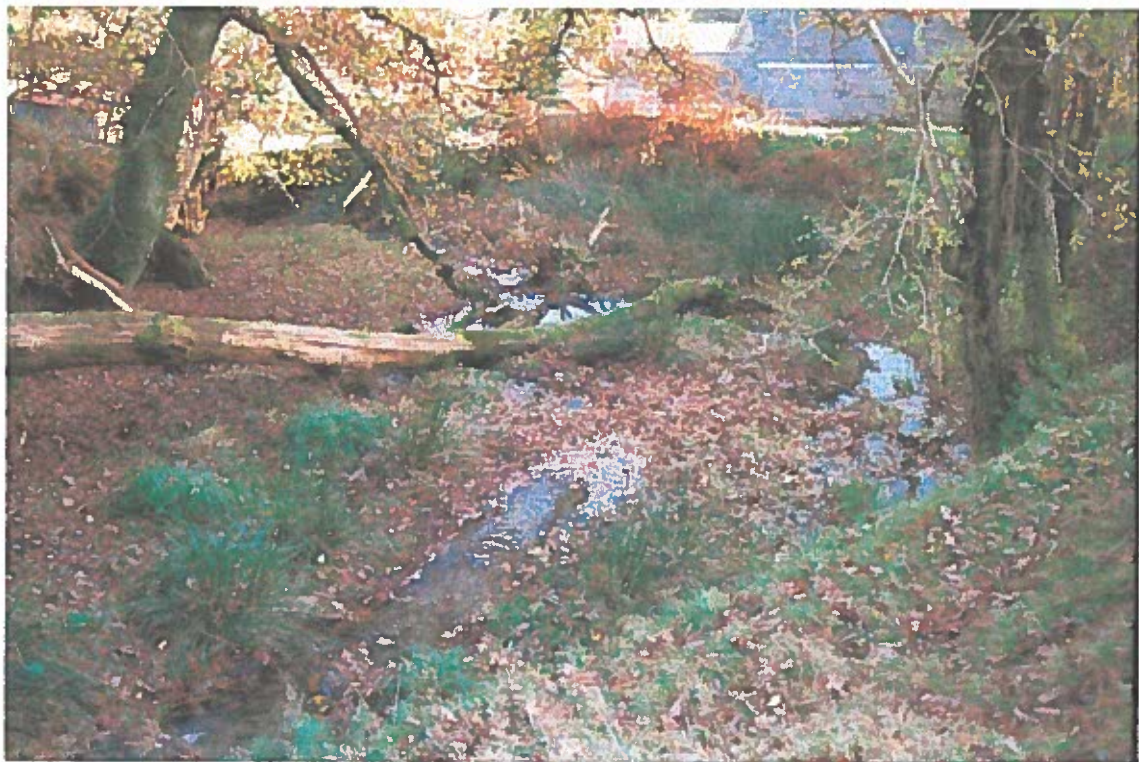
**PRN 39410 - Mill Pond**

Situated directly to the rear (north) of Brynteg Farm the, pond has been created by the construction of a dam which stands 2.5m high on the downslope side and 5-6m wide. A sluice system at the eastern end of the dam controlled the water flow down to the mill wheel at the rear of the range of outbuildings to the south.

*Silted pond with Brynteg Farm in the background*

The pond is currently silted up with vegetation growing within it. Clearance of the vegetation and some of the silts combined with repair of the sluice system would enable the pond to hold water again and would be a positive enhancement of the site. Any clearance would need to respect the original profile of the pond and dam.
