TIR GOFAL MANAGEMENT PLAN: HERITAGE MANAGEMENT INFORMATION (HE2)

**Prepared for:
Bryn Farm**

**Tir Gofal Reference No
W/13/1247**

**ACA Report No. 2005/135
Project Record No. 39420**

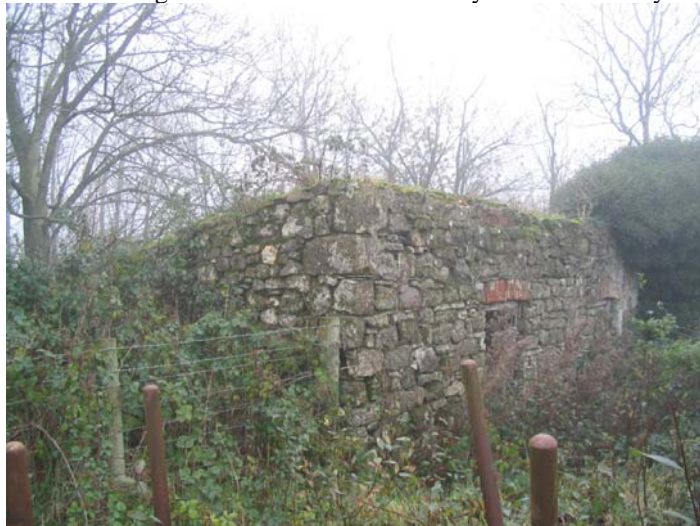
The remnants of the traditional farmstead complex at Bryn Farm. The ruins of the main dwelling are still visible, along with a pigsty to the north, described in section ii. Tumbled stone lies on a platform on the east side of the ruins, in an area covered with mature trees. Map sources indicate the barn ranges lay to the west of the main dwelling, these have now been replaced with modern structures and a modern dwelling. Farmsteads are archaeologically sensitive areas and may have seen continued occupation over a long period of time. Francis Jones (1996) first records Bryn in 1692, when it was the home to Philip Mathias. By the late 18th and throughout much of the 19th century it was owned by the Twyning family. *Visited 22/11/2005 (PP)*

SE facing shot of the front of the ruined traditional farmhouse building.

The aim of the management for this site should be the preservation and maintenance of remaining features of the traditional farmstead complex. The pigsty is still roofed and management recommendations are provided in section ii. The main dwelling has walls standing to single storey height, although much of the rear wall has collapsed. Trees grow close to the walls and on top of some tumbled stone. Root action and branches are putting pressure on upstanding masonry in places and causing damage. A section of flat roofing survives at the southern end of the building, collapsing at the edges. There is also a heavy growth of ivy on the southwest corner, this could be causing structural damage and masking further problems.

- Trees growing close to upstanding walls and causing damage should be cut back to prevent further damage.
- Heavy ivy growth should be cut back to reveal the extent of damage. If it is possible to remove it without causing further damage then this should be done.
- Areas of loose masonry may require consolidation to maintain the structural integrity of the walls. Walls may also have to be capped to prevent further deterioration.
- Partly fallen sections of roofing should be removed to relieve pressure on remaining sections.

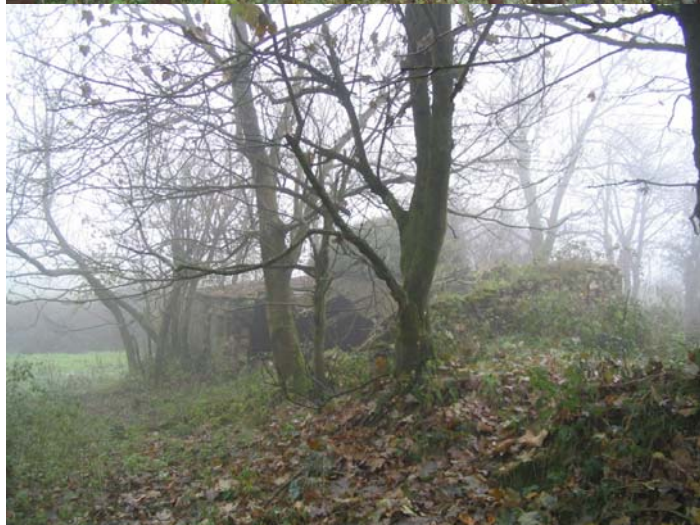
SW facing shot of the tumbled rear of the traditional farmhouse building.

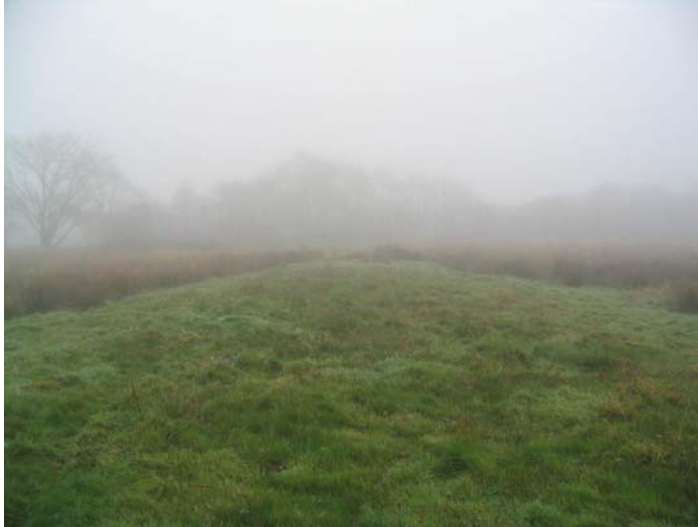
A c200m length of well preserved Roman Road, designated a Scheduled Ancient Monument. The feature is visible as a prominent grass-covered agger, c10m wide and up to 0.5m high, running through a boggy field. This section was first identified by Richard Fenton in the early 19th century, subsequently picked up on aerial photographs. The site was proved by trial excavation in 1993/4, which revealed a 2-phase road. The line of the road has been traced further west through aerial photography but is not clearly visible on the ground (PRNs 28112 & 28113). This section is in good condition, vegetation cover has returned over the area of excavation. The field is occasionally grazed but there is no evidence of erosion on the monument, and this area has not been ploughed within living memory of the owners. *Visited 22/11/2005 (PP)*

Looking ESE down the grass-covered remains of the Roman Road.

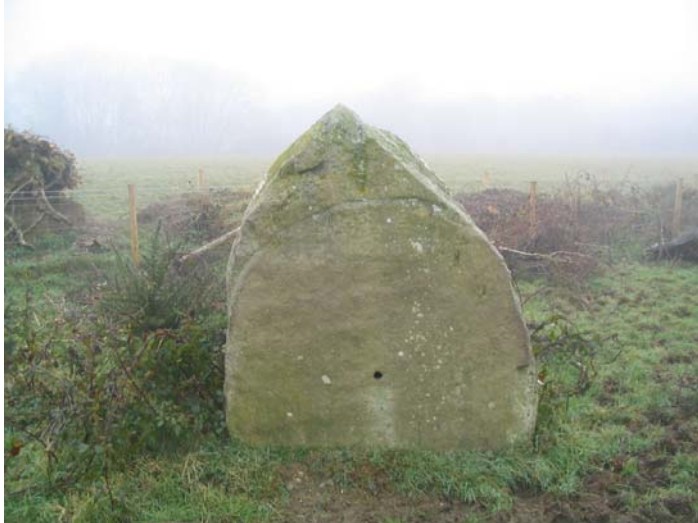
A large stone deliberately placed upright near the field boundary. The stone measures at most c1.6m across and stands 1.5m high, tapering towards the top. It is a fairly flat stone, with a circular groove carved into its eastern face. with a small (4cm in diameter) hole in the centre. The stone lies c5m from the field boundary.

below the summit of a low hill, and aligned north-south at an angle to the field boundary. The stone is marked on the 1st edition Ordnance Survey map of 1890 and the field name is recorded as 'Parc Carreg' in the tithe apportionments of 1840. The flatness of the stone and the marking on the eastern face suggest an attempt was made to make the stone into a large quern stone, possibly breaking or deemed unsuitable soon into this process. The date of the stone is unclear, although the Post Medieval mill of Felin Bryn lies c900m to the north. *Visited 22/11/2005 (PP)*

The eastern face of the stone, with the curved groove and central hole visible.

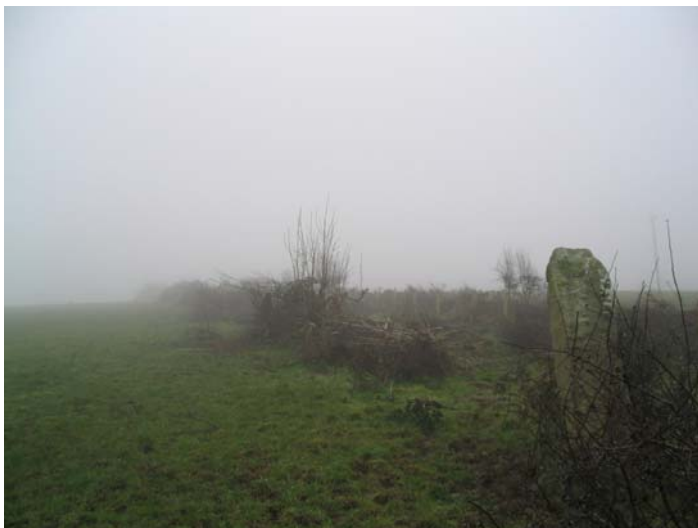
South facing shot showing the location of the stone in relation to the field boundary and hill summit.

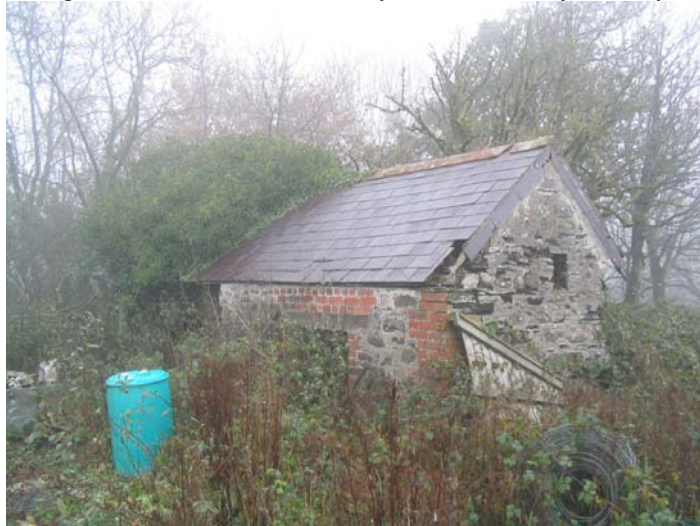
The remnants of the traditional farmstead complex at Bryn Farm. The ruins of the main dwelling are still visible, along with a pigsty to the north. The dwelling consists of a mortared stone rubble built structure. The walls survive up to single-storey level, much of the rear walls has gone. The windows and doors have brick lintels, and there is a mixture of stone and brick quoins. Part of a flat roof survives at the southern end, no internal features survive. The surviving stonework shows different phases of building and repair, map evidence indicates the structure once extended further east. The pigsty is a mortared stone rubble built structure, with patches of brickwork and a slate roof. Tumbled stone lies on a platform on the east side of the ruins, in an area covered with mature trees. Map sources indicate the barn ranges lay to the west of the main dwelling, these have now been replaced with modern structures and a modern dwelling. Farmsteads are archaeologically sensitive areas and may have seen continued occupation over a long period of time. Francis Jones (1996) first records Bryn in 1692, when it was the home to Philip Mathias. By the late 18th and throughout much of the 19th century it was owned by the Twyning family. *Visited 22/11/2005 (PP)*

SE facing shot of the pigsty building.

The pigsty is the only remaining roofed traditional building to survive, the aim of the management for this site should be to ensure the survival of the last elements of the traditional farmstead here by maintaining this building. The walls of this building appear to be in a reasonable condition although many of the corner stones have fallen away threatening the integrity of the structure and damaging the roof. There is a heavy growth of ivy on the north-eastern corner of the building, causing structural damage to the wall, putting pressure on the entranceway to the building and loosening roof tiles.

- The ivy should be cut and removed where this will not causing further damage to the structure.
- The corners of the building need to be consolidated, with loose masonry re-bedded. Once this is done the corner of the roof structure above could be repaired and fallen slates replaced.
- Ivy and vegetation should be cleared from around the entranceway to the building to assess the extent of damage, which will then require consolidation to prevent collapse.
