# **Tir Gofal Farm Visit Report**

## **Brownslate Farm**

### **W/13/332**

ACA Project Record Nø9421

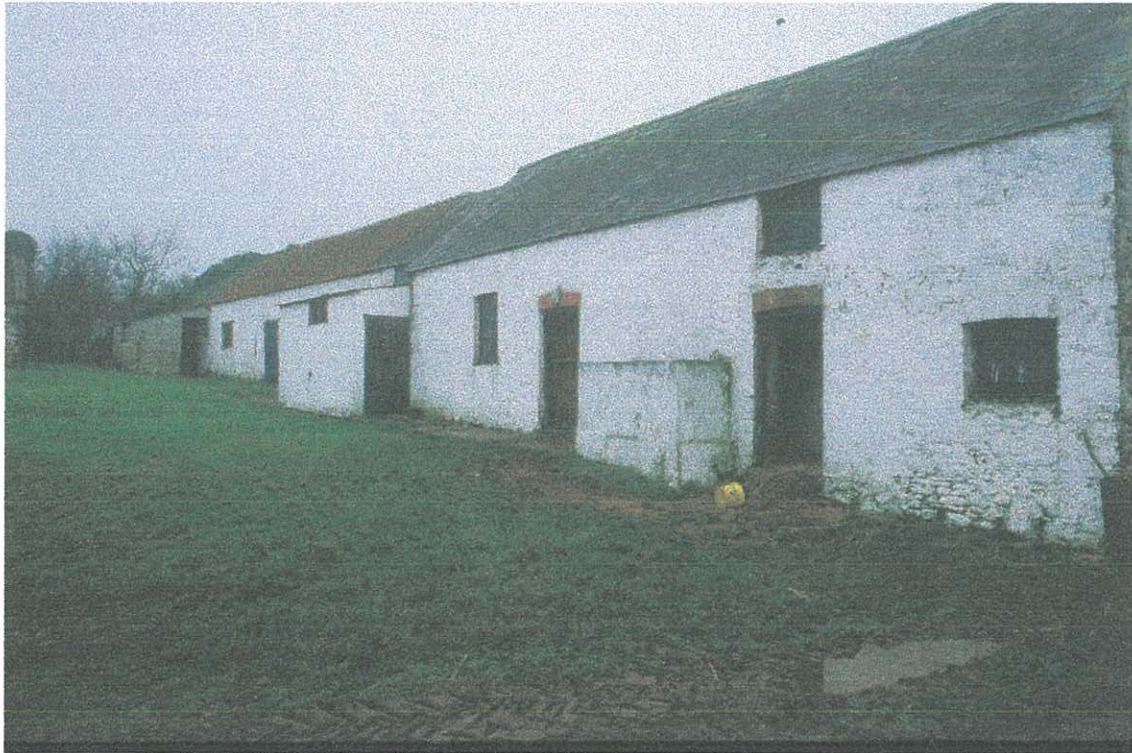
Rectangular range of buildings forming the west side of the yard. The range consists of two buildings, a cow house forms the southern end and a stable with first floor storage occupies the north end. Both buildings are stone-built with slate gable roofs and both are whitewashed externally. The openings in the cow house are square headed with timber lintels, whilst those in the stable have segmental arches in red brick. The cow house also has two trapezoid ventilation slits. A modern extension on the south end of the east wall of the cow house may have been a small dairy. On the tithe map of 1839 this building is shown as only half its present size, but that may just be the way it was drawn rather than being a true reflection of its size. The tithe map only showed this building and part of building PRN 39354 and the area was called the Homestead, which suggests that the house was originally part of this range, or at least on the same site.

Plate 1: PRN 39356 - cowhouse and stables at Goldborough

This range of buildings is still in daily use and in good condition. At least part of the range may date from the 18th or early 19th century, a survey of the building may help to resolve questions regarding its construction date and development history. The building should be maintained in its present condition.

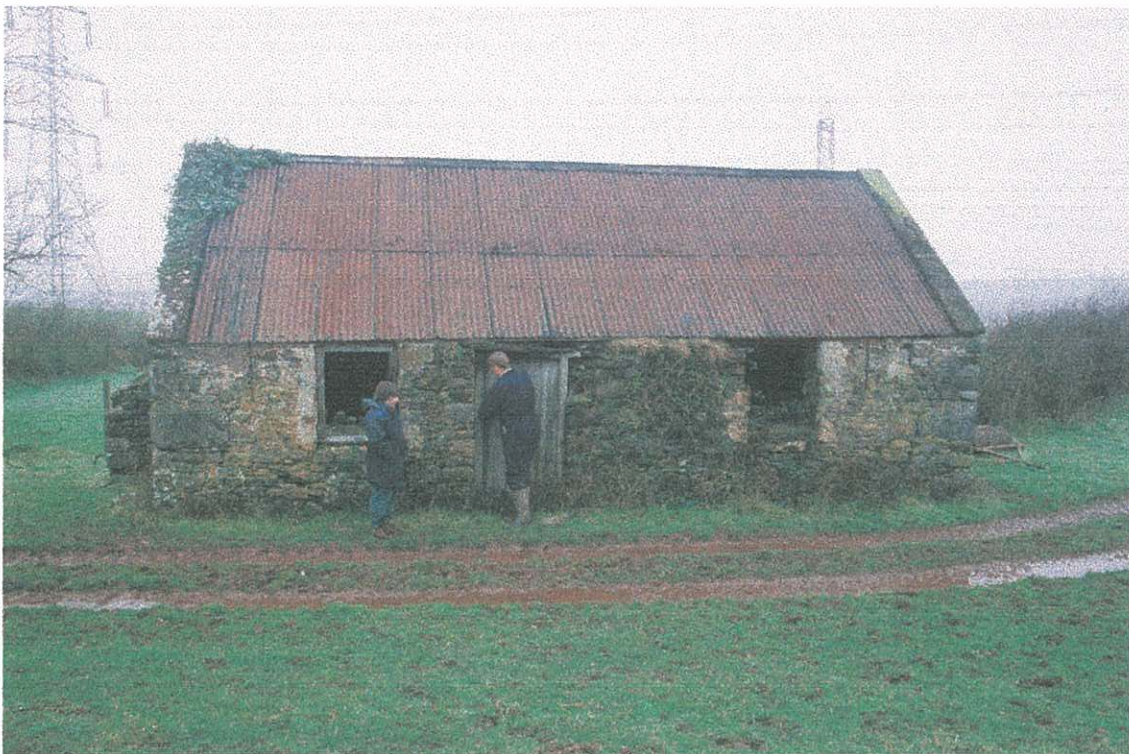
A single storey stone-built cottage with a corrugated zinc gabled roof. The walls are of random rubble construction with some very large boulders used for quoins on the end of the front (south) wall. Entry is via a central door in the south wall, the door is flanked on either side by small square windows. Internally it is divided into two rooms of equal size arranged either side of a central passage. Both rooms have a fireplace in the gable wall, that in the west room appears to be a later addition and contains a small oven. The cottage was shown, but not named, on the tithe map of 1839 as part of the Brownslate holding. It also showed that there was a smaller outbuilding (now gone) to the north of the cottage. Brownslate Cottage was last occupied during the first half of the 20th century and in recent times it has been used as an animal shelter.

Plate 2: PRN 39358 - Brownslate Cottage

The cottage is currently in reasonable condition, but it is deteriorating quickly and ultimately it will become totally derelict. The cottage is a typical worker's cottage of the late 18th or early 19th century and whilst they are not uncommon they are an important part of the history of the region and a significant landscape feature. This type of cottage was the norm for the vast majority of the rural population, but today they are disappearing often through abandonment and neglect or through alteration during rebuilding and refurbishment. The cottage does not have an active role in the present agricultural regime of the farm, it is not likely to be re-occupied in the future and it is not in a location where it could be easily visited by walkers using the nearby Coast Path so consolidation and restoration is unlikely. However, it is recommended that the surviving structure is maintained in its present condition and any major defects likely to affect the future stability of the structure are rectified.

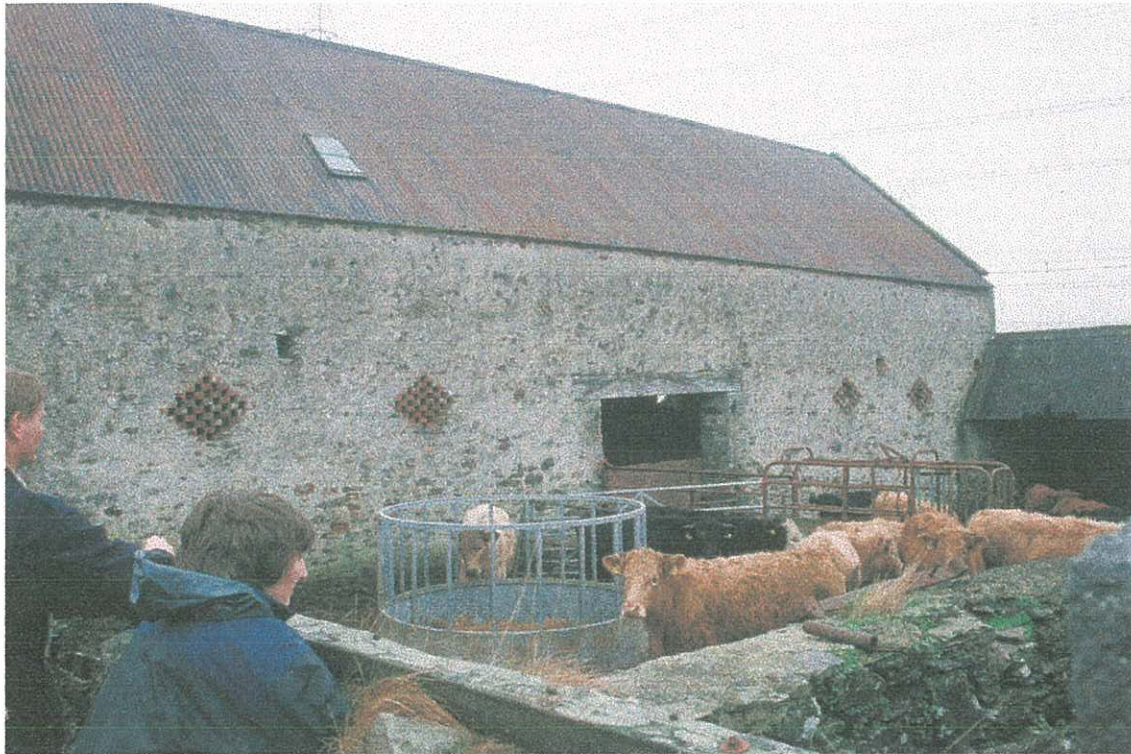
Large random rubble built barn with corrugated iron gable roof. The barn is located at the west end of the yard area and it has opposing double doors in its long sides for cart entry and exit and to provide a through draft for winnowing. The doors in the west wall are full height with a cambered brick arch. The opposing doors in the east wall are half height and square headed with a timber lintel. The difference in door heights is probably to allow a laden cart in through the west doors and the empty cart out through the east doors. The east and the west walls have lozenge shaped pierced brick ventilation holes. Geometric shapes for brick ventilation holes is regarded as an early 19th century innovation (Peters 1981, 16). Internally the building has a half loft over the south end. The central threshing floor has stone flags and the south end is brick paved. A stone-built, corrugated iron roofed lean-to engine shed was constructed against the south end of the west wall during the mid-19th century.

Plate 3: PRN 39364 - large barn at Brownslate Farm. Note the geometric pierced brick ventilation holes.

The barn is a Grade II Listed Building and it is therefore protected from deliberate damage and major alterations. It is currently in a good state of repair and it should be maintained in its present condition.

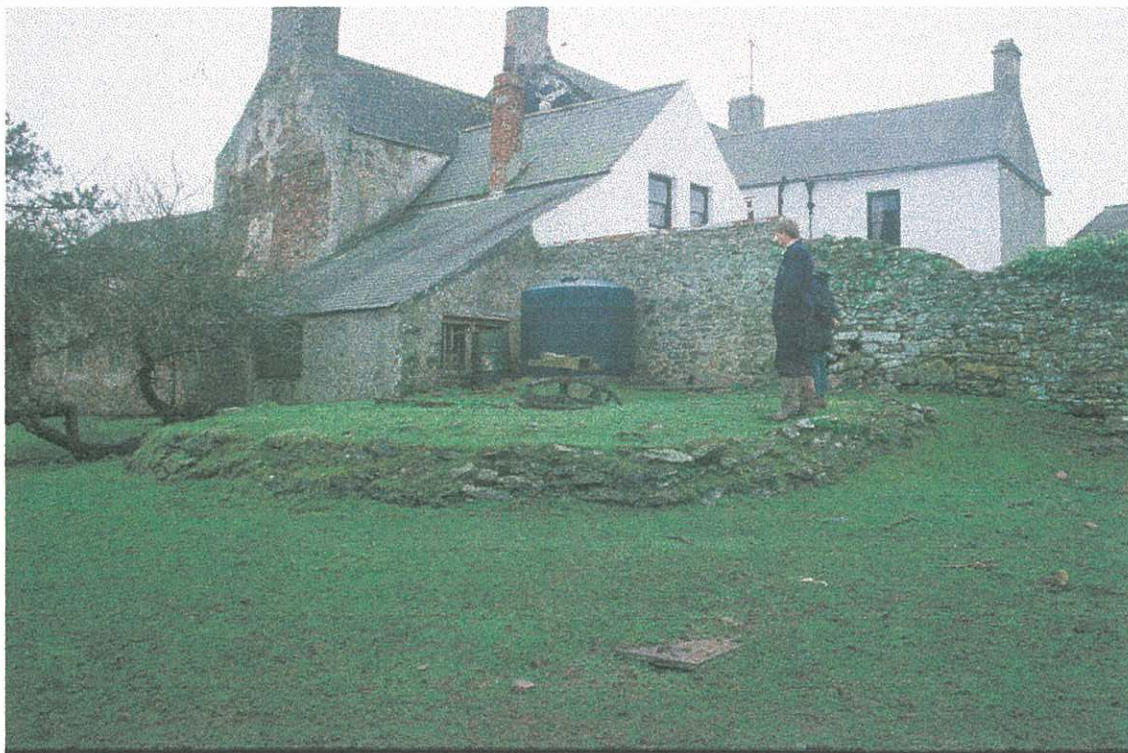
Plate 4: PRN 39366 - raised track and surviving steel gin of the mid- to late-19th century horse engine

This is an unusual survival, the raised mounds of the track were often flattened when the horse engine was replaced by mechanical engines. The mound should be maintained in its present condition.

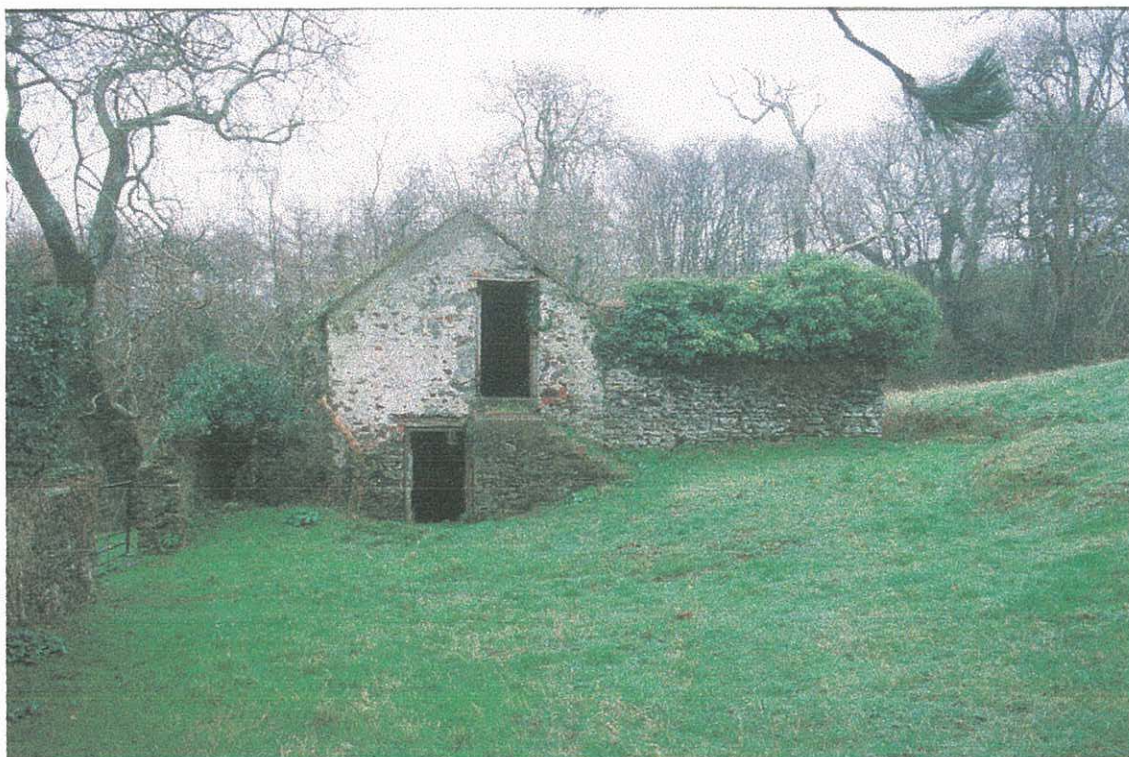
Small random rubble lofted building with asbestos slate gable roof. The lower floor is vaulted with stone in a late medieval style. The vault is single span and measures c.2m wide x 2.2m high x 4m long. Entry to the lower floor is through a door in the west end. External steps to the right of the door lead to the door of the loft. Both doors are square headed with timber lintels. The loft has six rows of pigeon holes arranged around a brick-framed window in the east gable. There are three rows of pigeon holes in the north wall, and a ruinous stone built enclosure against the south wall. The vaulted lower floor appears to date from the late medieval period, whilst the loft apparently dates from the 19th century. A building is shown in this location on the Monkton parish tithe map (1839), although, its size and shape are different to that shown on the OS 1st edition map (1881). Therefore, it seems likely that the loft was constructed during the third quarter of the 19th century when the building underwent some conversion as part of a general remodelling of the yard area.

Plate 5: PRN 39360 - west gable of late medieval vaulted outbuilding.

This building is in reasonable condition, but general neglect is beginning to have an affect on the structure. As a Grade II Listed Building it already has some protection from unsympathetic alterations or deliberate damage, but this offers no protection against the general deterioration expected in an old and unused building. Therefore, it is recommended that the building be surveyed and recorded to provide baseline information regarding its current condition and its structural development. The information gained during the survey will inform the future management strategy for this important building.

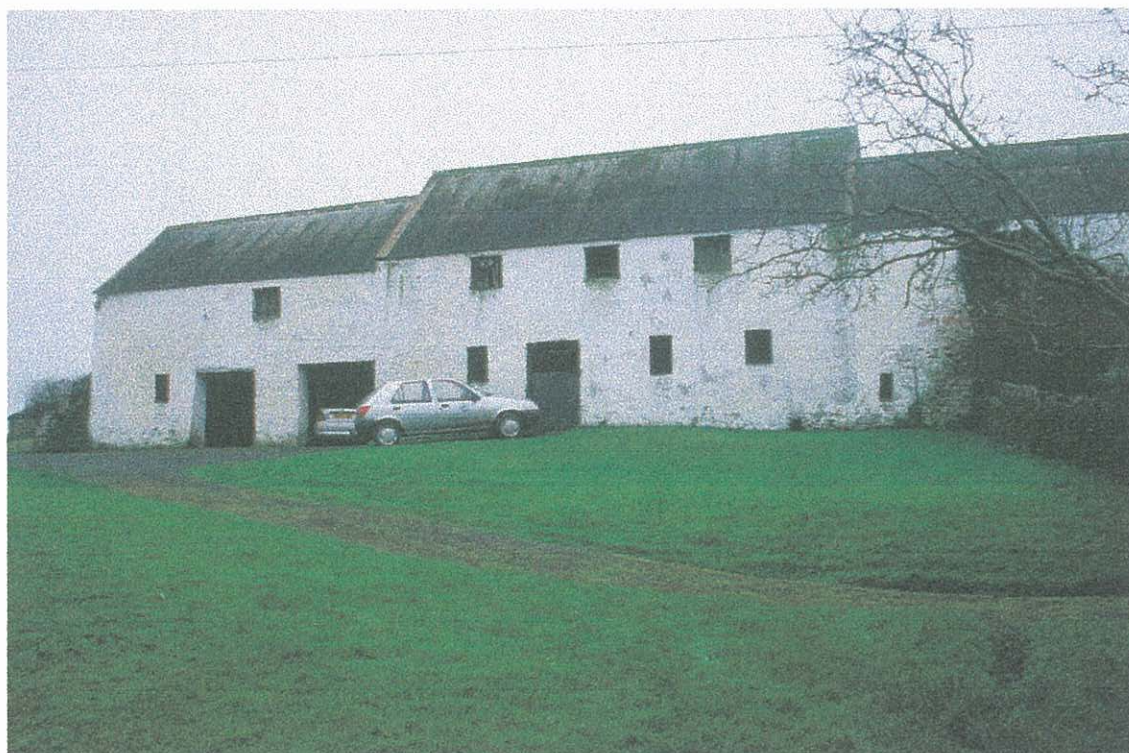
18th or early 19th century, east-west rectangular range of buildings in whitewashed random rubble with asbestos slate gable roofs. The range consists of four parts, the two easternmost parts are probably the earliest with the other two parts added. The front of the range faces north into the yard at the east of the house. Two square headed cart entries occupy most of the wall of the eastern building, a small window to the east of the entries and a loft window are the only other openings. The second and largest building has a large square headed door and three small windows on the ground floor with three small loft windows. A straight joint between the second and third buildings suggests that the third building was added to the second. The third building has two small loft windows, whilst the fourth building has three circular red brick openings and row of red brick pigeon holes. It also has a blocked square brick headed doorway to the east end of the ground floor. The first three buildings have interconnecting lofts. Entry to the loft in the easternmost building is via external steps, with dog recess below, on the east gable.

Plate 6: PRN 39361 - east end of the long range of outbuildings at Brownslate.

This range of buildings is in good condition and parts of it are still in use. The entire range is a Grade II Listed Building and therefore protected from unsympathetic development or deliberate damage. The range, along with the other buildings which make up the yard area at Brownslate, should be surveyed to provide baseline information on their current condition and structural development.
