**TIR GOFAL MANAGEMENT PLAN:  
HERITAGE MANAGEMENT INFORMATION  
(HE2)  
YEAR 5 REVIEW**

**Prepared for:  
Clyngwyn**

Tir Gofal Reference No  
**W/12/0097**

Report No. **2006/9**  
Project No. **39436**

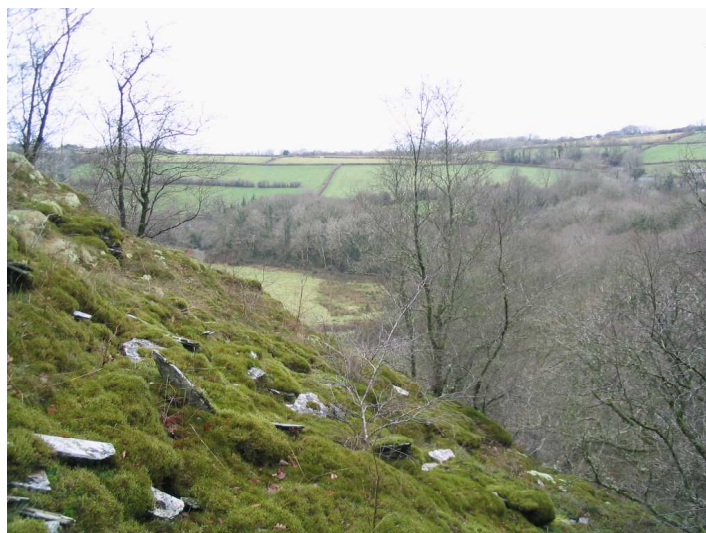
Spoil-tips below Clyngwyn quarry.

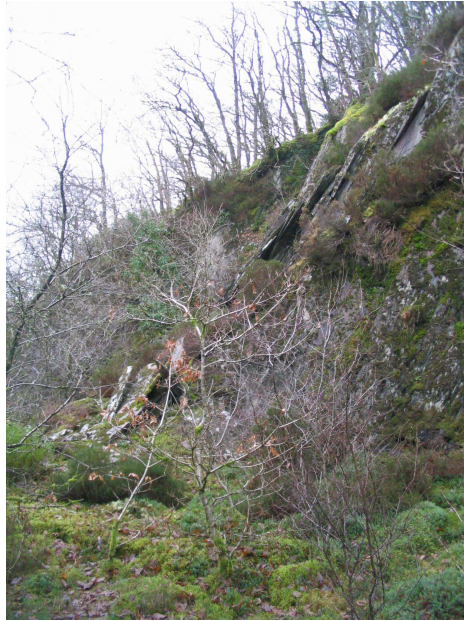
<b>2</b>	<b>CLYNGWYN</b> <a href="#">(55479)</a>	<b>Post Med quarry</b>	<b>SN1243025970</b>	<b>B</b>	<b>Specific</b>
	<p>Disused slate quarry worked on a moderate scale during the mid nineteenth century and reopened in 1928 by the Wheeler family, finally closing in 1938. Incorporates three extraction sites on two levels linked by an incline, and with extensive spoil tips below. Remains include dressing sheds (PRNs 55480, 55481), a tramway incline (PRN 55483) and an explosive store (PRN 55482), together making this an interesting industrial complex. (based on Richards 1998). Part of larger group PRN 19770.</p> <p>Fair condition. The site is overgrown, in regeneration woodland, but is otherwise clear of dumping or interference (WWS February 2006).</p>

The upper, possibly later, extraction site at Clyngwyn.

It has been agreed that a display panel will be provided as part of the Tir Gofal agreement. The purpose of the panel is to provide information to the public about the former quarrying industry at Clyngwyn and its significance.

The current proposed location is to one side of the Lansker Borderlands Trail at SN1243726006 in view of the explosives store (PRN 55482) and below the quarry tips. This site lies within a Site of Special Scientific Interest (S.S.S.I.) as defined under the Wildlife and Countryside Act 1981.

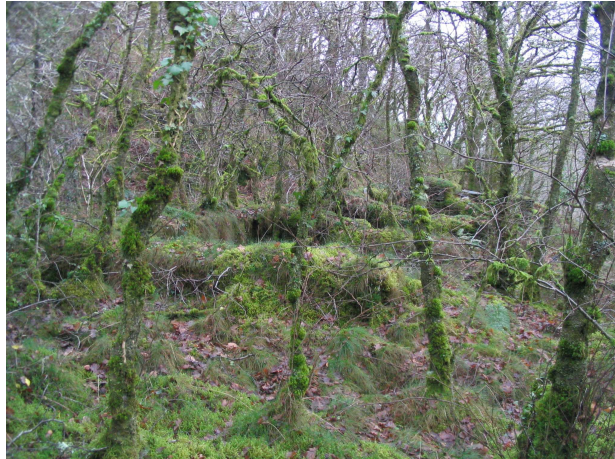
A line of three open fronted dressing sheds on the upper extraction site at Clyngwyn quarry. Simple slate slab construction, measuring approximately 15m long by 5m wide, and with only the low stub walls now remaining. Noted by Richards (1998) as formerly housing two treadle powered Greaves pattern dressing machines, the third apparently having been smashed in transit.

In an area of soft vegetation in regeneration woodland (WWS February 2006).

The remains of a line of three dressing sheds on the upper extraction site.

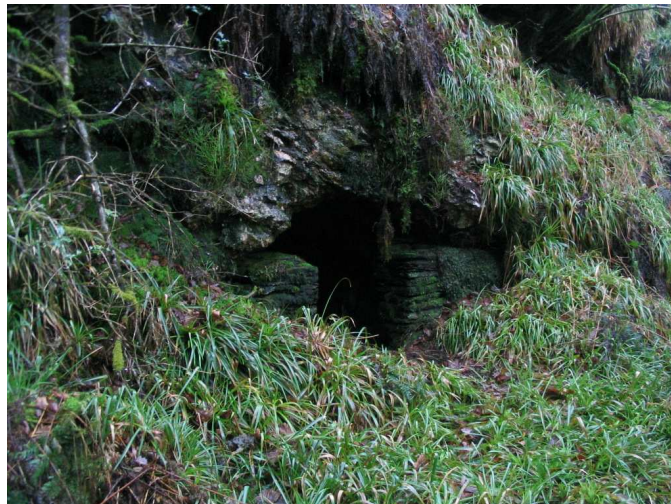
A powder store situated at the break of slope below Clyngwyn quarries. The store is, in essence a rock cut cave, closed off by a slate slab wall and iron door and with a slate flag floor lining. It remains basically intact, though the door has been removed. In an area of regeneration woodland above river (WWS February 2006).

The opening of the rock-cut explosives store as seen from the north.

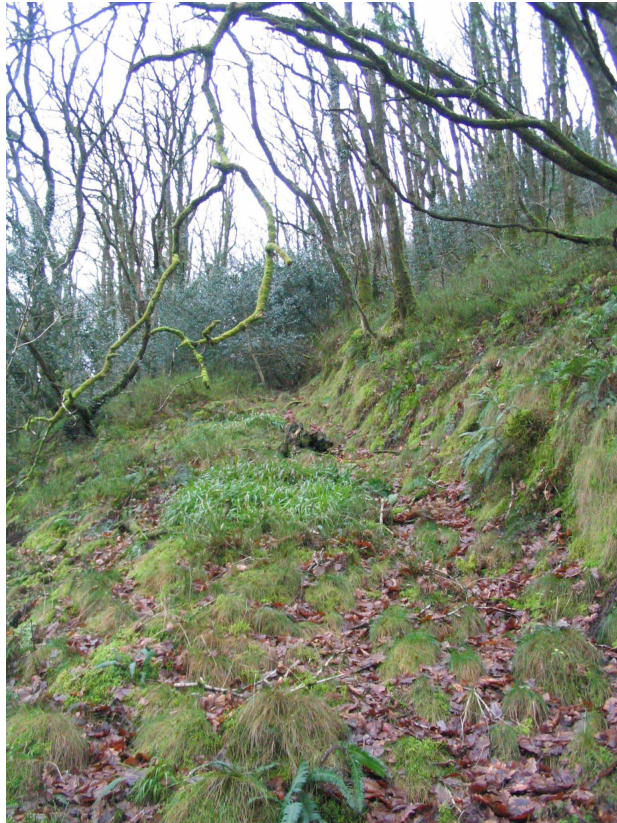
A quarry tramway extending upwards in a straight line from the lower extraction site at Clyngwyn to the break of slope. The tramway fell out of use long ago but it is said by the owner that wagons were propelled by a static engine in the field above. The inclined plane of the trackbed remains, the track and associated apparatus having since been dismantled.

In an area of regeneration woodland (WWS February 2006).

Looking south-east along the line of the quarry tramway.

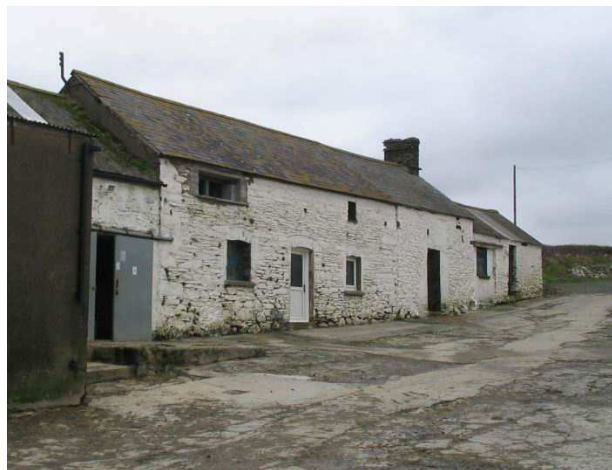
A working nineteenth century farmstead with modern sheds situated behind the historic core. The farmhouse and buildings are arranged around three sides of a rectangular yard with symmetrical aspects to the layout; the house is at the head of the yard, and the garden behind.

The farm buildings are of whitewashed stone, with cut stone heads and drip courses to door and window openings marking a stylistic theme, and slate roofs still present in part. They include, a cart house/granary, cow shed range with carved inscription 1836 and also a ty'r odyn, and lofted stable amongst other buildings, their function now difficult to discern. A wheel pit and leat shown situated behind on historic maps (OS 1889, 1907), where belts drove barn machinery, are now gone.

Changing agricultural practices have seen a number of alterations including the addition or widening of door and window openings and removal of internal fittings. Clyngwyn is nevertheless a relatively intact farmstead of the nineteenth century with a number of original features remaining. Surviving buildings are generally in good order, though corrugated asbestos and tin have been used as a substitute for slate in parts.

Buildings on the north side of the yard at Clyngwyn farmstead.

Clyngwyn is a relatively intact farmstead of the nineteenth century with a number of original features remaining. Surviving buildings are generally in good order, though corrugated asbestos and tin have been used as a substitute for slate in parts.

- The priority is to maintain the farmstead complex as a whole, ensuring that all buildings are maintained in a weatherproof and structurally sound condition.
- Consider how capital works money can be best directed to enhancing the overall appearance of the farmstead. eg. replacing corrugated asbestos and tin with traditional slate. If re-roofing both pitches of a building proves too expensive, slate can be reserved for more prominent slopes only. Welsh or Spanish slate can be used.
- As a general rule, original features should be repaired rather than replaced otherwise replacement features should be in the original style of the building. eg. it is intended that the unsafe stable/ granary floor will be replaced. New materials should match existing ones; pine floor boards of similar size and thickness should be used.
- Please contact Cambria Archaeology if further advice is required.
