Archaeoleg Cambria Archaeology
Tir Gofal Farm Visit Report
Danllan
W/12/71

ACA Project Record 39437

Tir Gofal Application Number W/12/71

Address Danllan
Llanwinio, Gellywen, Carmarthenshire

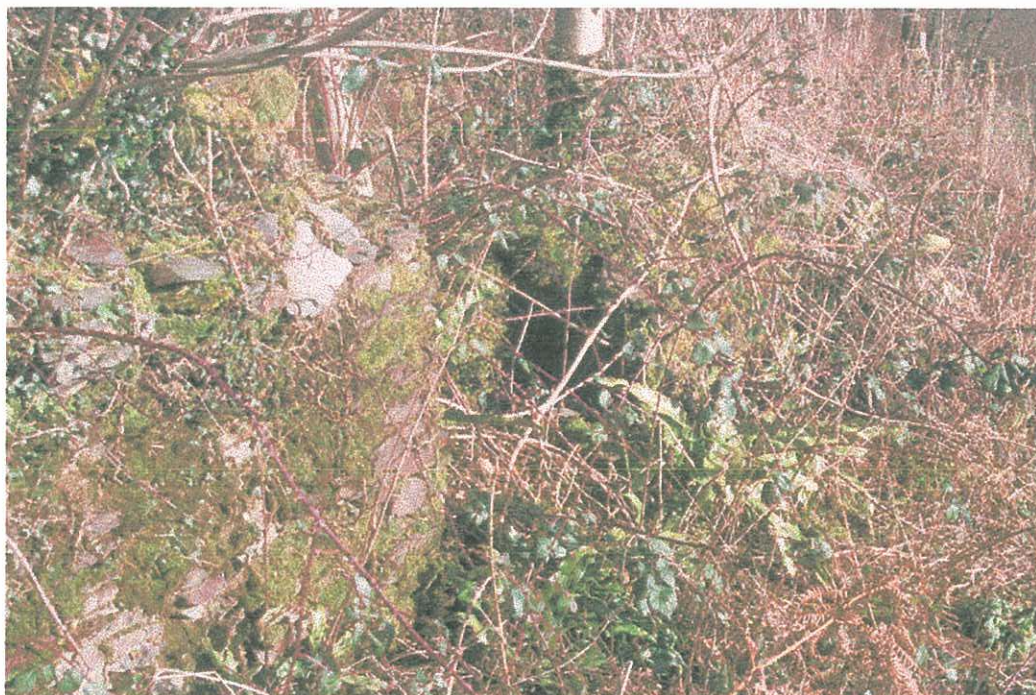
Pen Rhiw was a late 19th century cottage, possibly constructed on the site of an earlier dwelling. It was not shown on the tithe map of 1844, but the area it later occupied was called Clyn Hendre Cottage. This suggests that there may have been a cottage on the site prior to the tithe survey. By 1907 Pen Rhiw consisted of a rectangular dwelling at the north end of a small garden. It was shown as unroofed on OS maps of the mid 1960s, which means that it was only occupied for a relatively short time. A low section of the north gable wall survives alongside track PRN 39346. The wall was stone built and has a fireplace in its interior face. The rest of the site has been recently levelled, but some below ground remains may survive.

Plate 1: PRN 22860 - the overgrown north gable wall and internal fireplace of Penrhiw Cottage

The surviving remains of the cottage are in an area that is outside normal farm processes and is therefore secure from damage from daily farm activities. The possibility of surviving below ground remains and associated features must be considered and the area adjacent to the surviving structure should be excluded from further damaging activities. Whilst this site is not considered to be of significant archaeological value it is recommended that the site continues to be excluded from farming activities which could cause direct damage.

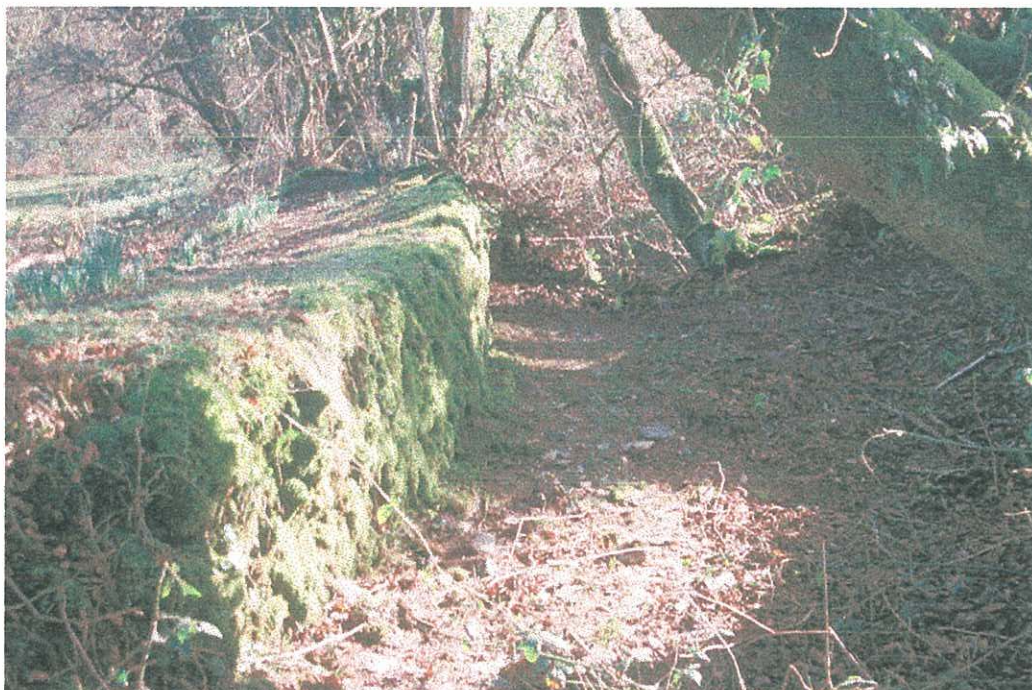
Parc-Bras was shown on the tithe map of 1844 as owning several of the fields in the northeast corner of the present Danllan holding. At that time Parc-Bras, called Parkybras on the tithe map, appeared to consist of a single building set in an irregular enclosure. A second building was shown on the OS 2nd edition map of 1907, and both buildings are still shown, although now roofless, on modern maps. Exactly when the site was abandoned is unknown, but it was sometime during the first half of the 20th century following the sale of its holdings to Danllan in 1923 (information from deeds and sale details held by the owners). Parc-Bras was built on a levelled platform on a north sloping spur above the Afon Cynin. The main dwelling is now very overgrown and it is not certain how much of the structure survives. A small outbuilding to the west survives as a low stone wall and a mound of fallen stones. The property was formerly reached via a short sunken entrance track leading off of track PRN 39346. The sides of the entrance track were stone-lined and the stonework survives in good condition. There are several possible terraces and features to the north and west which may be the remains of a garden and some overgrown and neglected garden plants survive. The amount of work that went into the construction of the stone-lined entrance and the apparent garden features suggests that the owners of Parc-Bras had time and resources to devote to the appearance of their property. There are two rows of abandoned coppiced hazels running northwest from the site which would have provided withies for use around Parc-Bras.

Plate 2: PRN 39344 - stone lined entrance way to Parc-Bras

This site is currently excluded from farming activities and this should continue. The vegetation on the site will over time have an effect on the surviving above and below ground remains, but unless there are plans to improve access to the site for interested groups, schools for example, there is little point in clearing the site. A topographical survey of the site may help to identify the layout of the buildings and gardens.

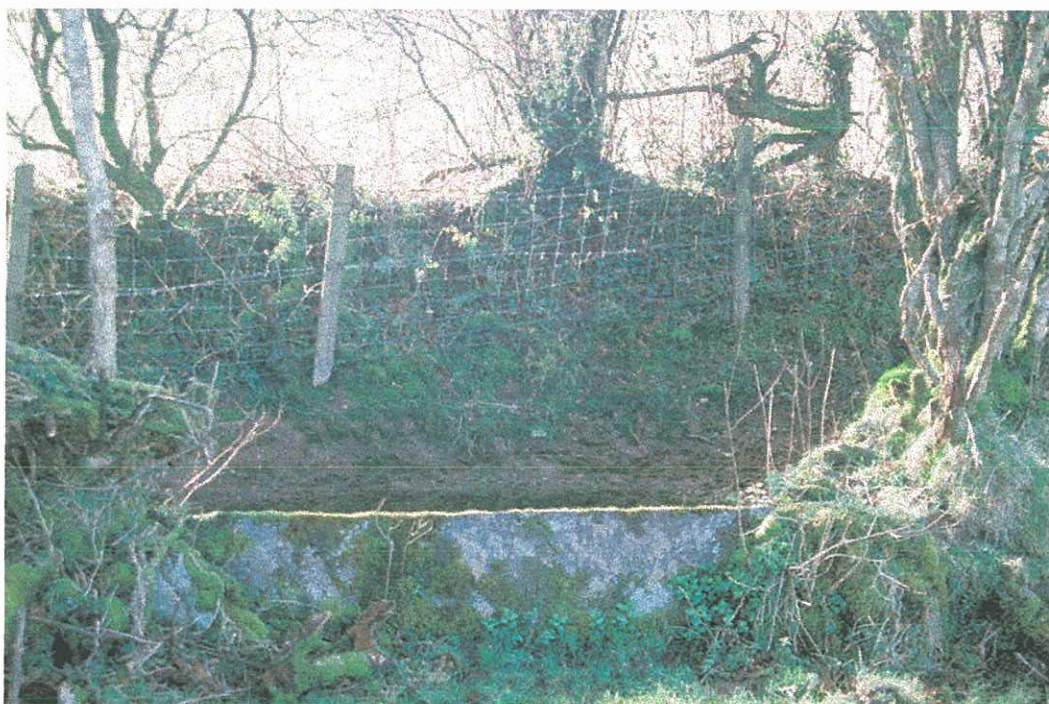
A small stone-built drinking trough built against the southern side of an earth bank field boundary. The sides of the trough are constructed from pitched stones and the front, south side, is formed from a single flat slab set on edge. The trough is c.0.3m high and is now partially grass covered and there are some hazel trees growing on the sides. Water was fed to the trough via a pipe from the south. This trough and one of very similar construction (PRN 39348) elsewhere on the farm are an innovative method of using the excess water on the farm, which would otherwise simply be drained away to the Afon Cynin, to provide drinking water in the fields.

Plate 3: PRN 39347 - stone-built trough constructed against a boundary bank

This feature is interesting and in good condition. The trees should be removed from the sides of the structure and any stones that have fallen should be replaced.

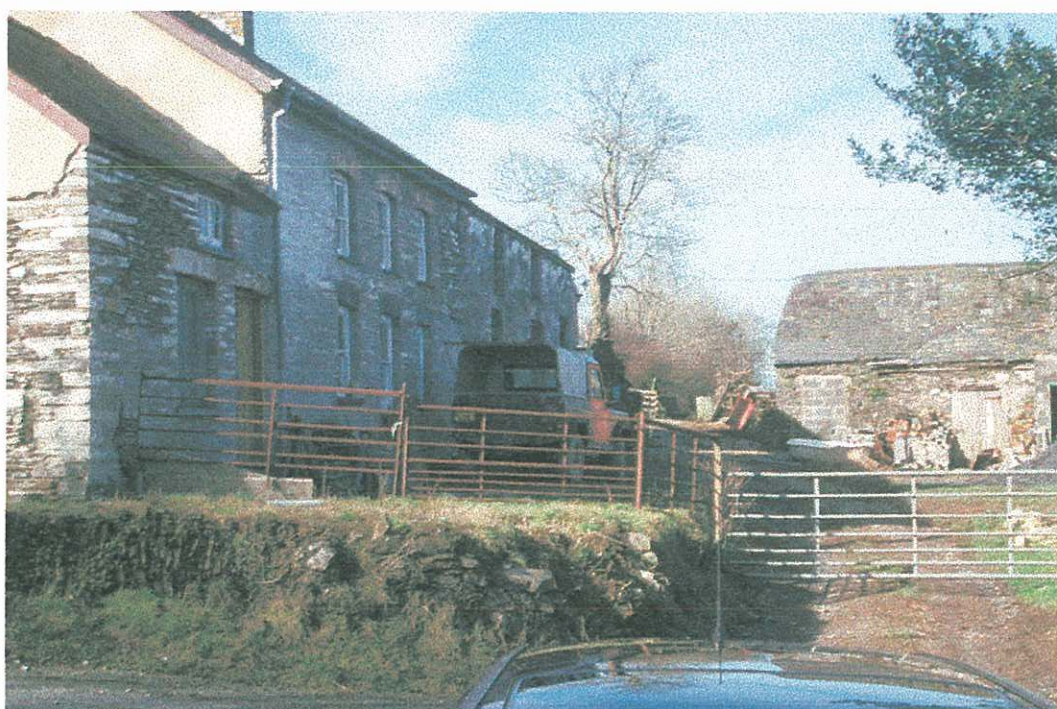
Danllan occupies c.57 acres (23 ha) on a north facing slope between approximately 183m and 107m above Ordnance Datum. The northern boundary of the farm is marked by the Afon Cynin. The name Danllan (Below the Church) describes its position in the landscape: the farm sits c.350m to the northeast and slightly downslope of the church. The present holding developed during the later 19th and early 20th century by acquiring land from three different farms, Pant y deri; Parc-Bras (PRN 39344), now abandoned; and Llanwinio Farm. During the 1840s when the Llanwinio tithe map was surveyed and published Danllan was not mentioned by name as a separate holding, it was part of Pantyderry (modern Pant-y-deri) lands and it consisted only of a cottage and garden (PRN 39345). The cottage was situated to the southeast of the present house and yard in the area just south of a small corrugated tin garage which has been built in the old cottage garden. The shift to the current site had occurred by the time the 2nd edition Ordnance Survey maps were published in 1907. The new site, which was on the opposite side of the track (PRN 39346) leading from the church to the ford beyond Parc-Bras, consisted of two long ranges of buildings aligned northeast-southwest along the southwest edge of the yard and a separate building in the northeast corner. The two long ranges were staggered and apparently the southeast half of the northwesternmost range was connected to the southwest face of the northwest end of the southeastern range. The original cottage was shown as still roofed and it may still have been occupied at this time. The cottage (PRN 39345) was abandoned sometime during the first half of the 20th century and the site cleared. The northwest range of buildings has been replaced by modern buildings, but the other original late 19th century buildings remain. The surviving long range of buildings includes the house, and it is currently being extensively renovated. Comparisons between the tithe map (1844) and modern maps of the farm show that the field system was well established by the mid 19th century and that, with the exception of one or two field boundaries which have been removed, no significant changes have occurred since. The boundaries are a mix of stone walls, earth banks, earth banks with a pitched stone core and modern fences. Many of the boundaries are flanked by ditches which carry water from numerous springs and streams across the farm. Controlling the movement of water across the farm has been an important consideration in the past and a complex system of drains and ditches has been established to achieve it. In places small stone-built pools (PRNs 39347; 39348) were built into the drains to provide drinking water for animals. The track (PRN 39346) that leads from the church past Danllan and eventually to the ford over the Afon Cynin is likely to have early origins. The original church is an early medieval foundation, and it is possible that the church itself was constructed in a prehistoric enclosure. A house called Dan-y-gaer (Below the Fort) built opposite the church during the 19th century recalls the tradition of the church site being a prehistoric enclosure. It is probable that the track was contemporary with the early church, if not the earlier enclosure. Once it crosses the Afon Cynin the track links several farms and an Iron Age hillfort, Castell Mawr, located on the hill opposite Danllan on the north side of the river.

Plate 4: PRN 39343 - general view of the linear range of buildings that includes the house.

Currently the farm is undergoing renovation, the farm buildings are being modernised and refurbished and many of the overgrown boundaries are being cleared and repaired. Most of the individual features identified are in areas that can be reasonably excluded from day-to-day farm activities and are therefore fairly well protected. Others, like the stone drinking pools (PRNs 39347; 39348) are, with a little renovation, still operational and would be useful features of a working farm. In general the present management of the farm is sympathetic to the identified archaeological sites and features and should be maintained.
