Tir Gofal Farm Visit Report

Broniwan

W/11/807

ACA Project Record Nø9457

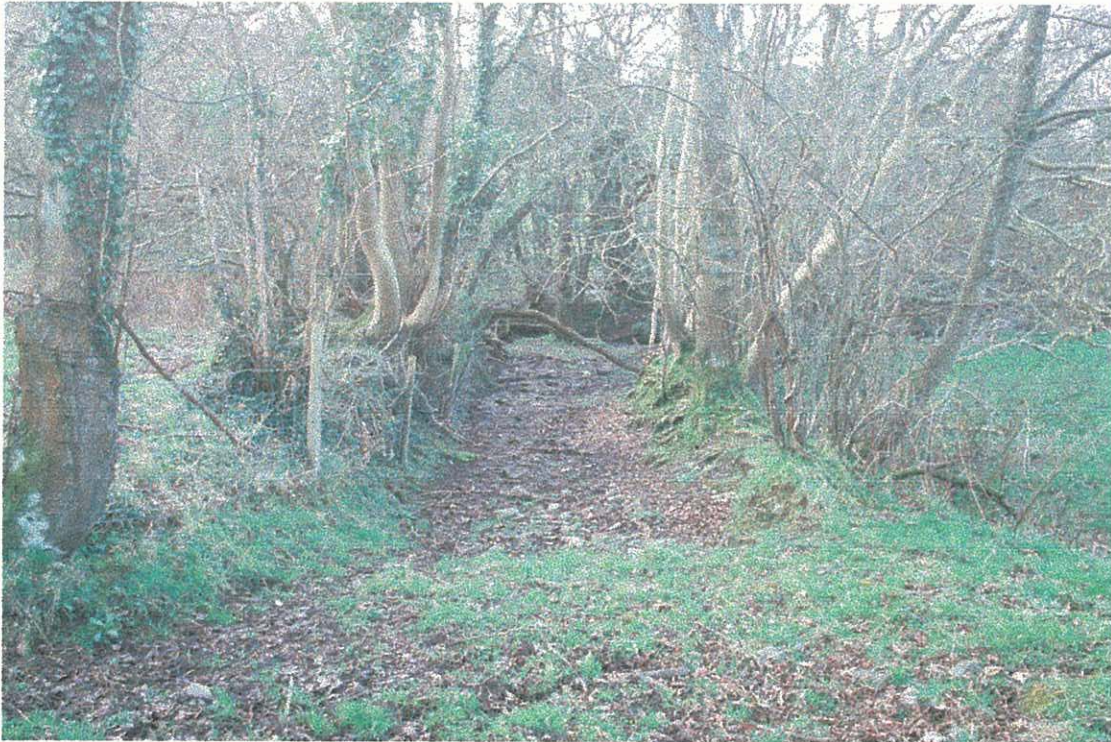
A small farmstead, first recorded in 1787, consisting of a single building and several fields. The building was almost certainly of the long-hut type with animals and people housed in the same building. The farmstead survived into the mid 19th century, it was called Cribben on the tithe map of 1834, but it had disappeared by the 1870s when the surveys for the 1st edition OS maps were undertaken. Aerial photographs taken in the 1950s show that the site of the building had been levelled and ploughed and there are no surviving above ground remains of the house. A short length of track flanked by stone-faced banks leads south from the house site.

Plate 1: PRN 39371 - part of the lane leading to the site of the former farmstead Cribin Clottas

There is no surviving above ground structure, but the possibility of below ground remains must be considered. Therefore, it is recommended that an area around the site be defined and excluded from further ploughing

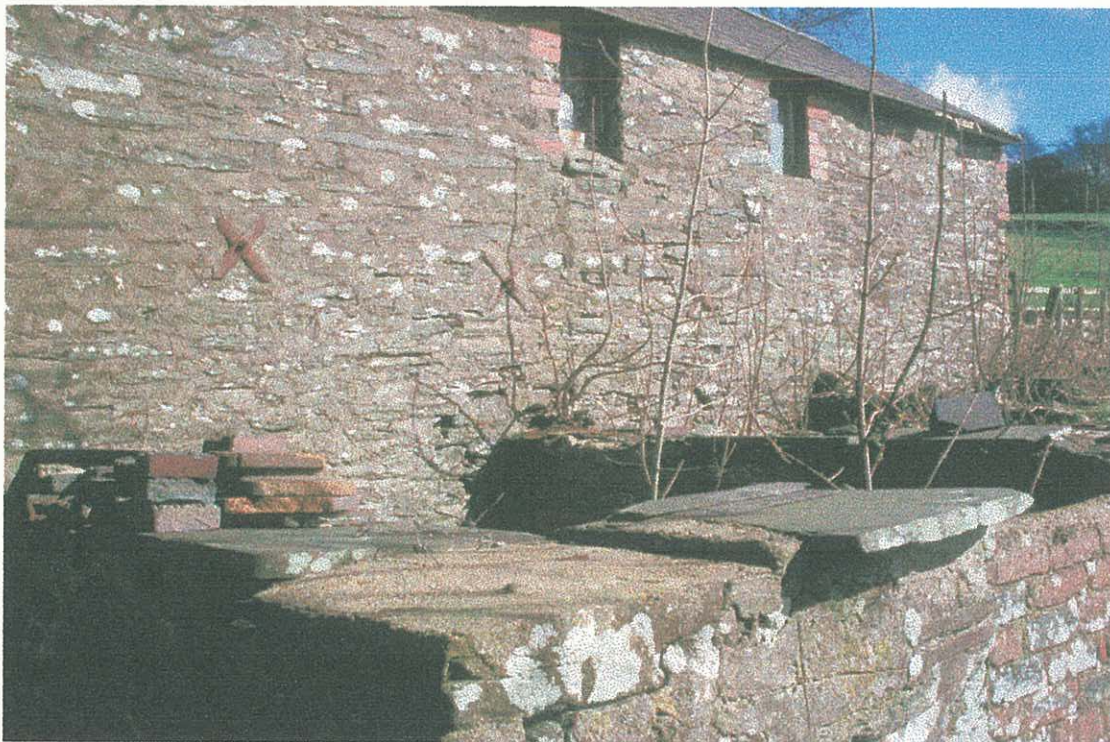
Two-storey pigsty with 1st floor hen-house. The structure is stone-built with brick quoins on the corners and around the openings and a slate gable roof. It contains three 'in-and-out' sties, each consisting of a sleeping section, c.2m x 2m, and a yard of similar dimensions. A passage along the rear of the sleeping sections is reached via a door in the northwest gable wall. The rear of the sleeping sections are made up of large upright slabs of slate held in place by a wooden rail. Slate slabs were also used to cap the walls of the yards. Entry to the hen-house was through a door in the northeast wall, two small hen entries were also present in this wall. This building was constructed sometime between 1891 and 1906, it appeared on the 2nd edition OS map, but not on the 1st edition published in 1891.

Plate 2: PRN 39376 - pigsty with hen house above

The combination of pigsty with a 1st floor hen-house is unusual, but not rare, and this example is in reasonable condition, despite the southeast gable wall having been rebuilt in modern blocks. The building should be maintained in its present condition, and if there are any future plans to renovate it a survey of the existing structure should be carried out prior to the works beginning.

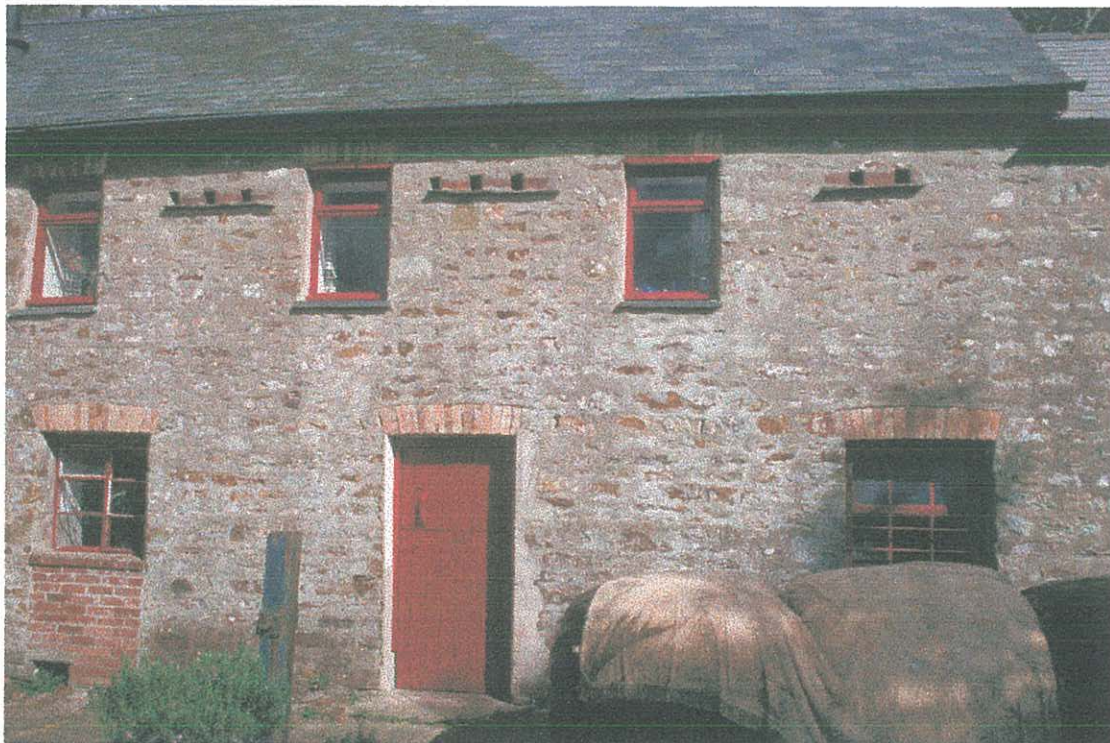
Stone-built two-storey cowhouse with 1st floor storage area terraced into the sloping hillside. The ground floor cowhouse is entered from the southwest and contains five double stalls arranged along the back wall. The storage area is entered from the north. A date stone above the entry to the cowhouse has an inscription T E 1774. This building appears to have been extended sometime between publication of the Troed yr Aur parish tithe map and the OS 1st edition map of 1891. The openings in the southwest wall consist of two doorways, one blocked, and a window on the ground floor and three windows on the first floor. All the openings have segmental arch heads in yellow brick, which suggests a date consistent with the extension of the building during the third quarter of the 19th century. There is a line of pigeon roost holes near the top of the southwest wall, the holes are separated by red bricks.

Plate 3: PRN 39374 - cowhouse, 18th century with later windows added

This building is undergoing long-term restoration and so far the work has been sympathetic to the historic character of the building.
