Tir Gofal Farm Visit Report

Merryborough

W/13/262

ACA Project Record 39460

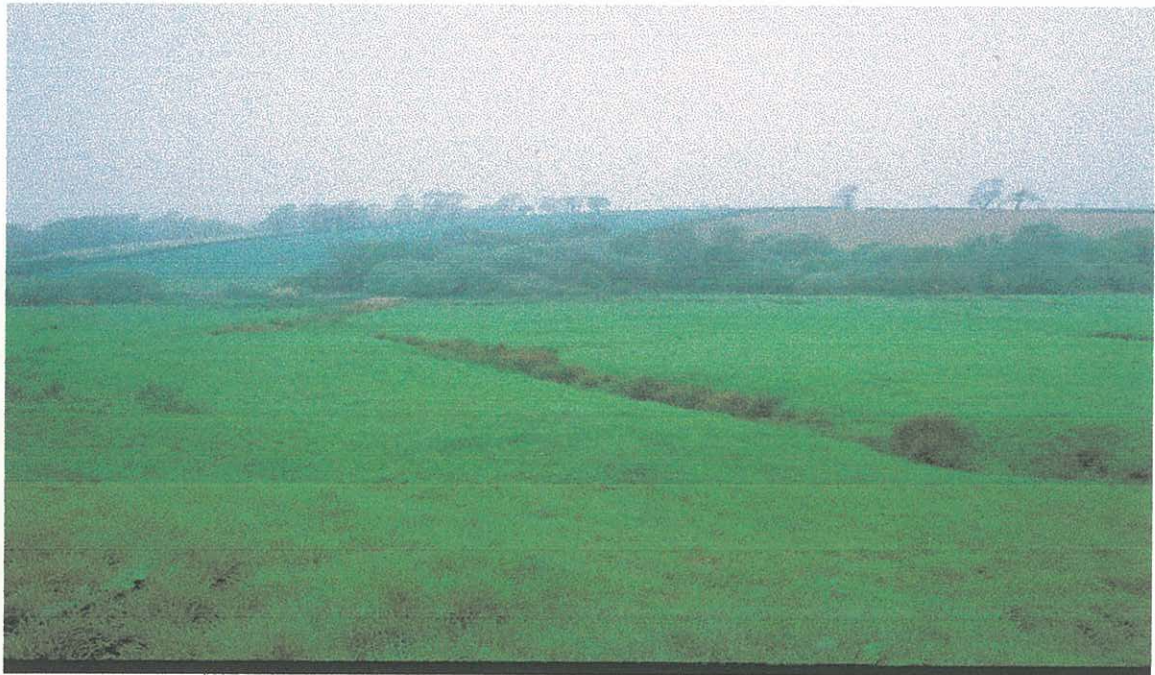
Moated platform in broad valley bottom. It is 37m square with a centre ditch on average 3.5m wide. There are outer and inner banks to the ditch measuring between 2.5-3.5m wide and standing up to 1m high. CADW 1994. A small stream that ran into the ditch at the southwest corner has been re-routed away from the monument and the erosion scars caused by the stream have grassed over.

Plate 1: PRN 10389 - view north across the medieval moated enclosure

The enclosure is a Scheduled Ancient Monument and is therefore protected from deliberate damage. It is in a pasture field and the stocking levels are sufficiently low to avoid significant damage, although cattle should be excluded from the monument during very wet periods.

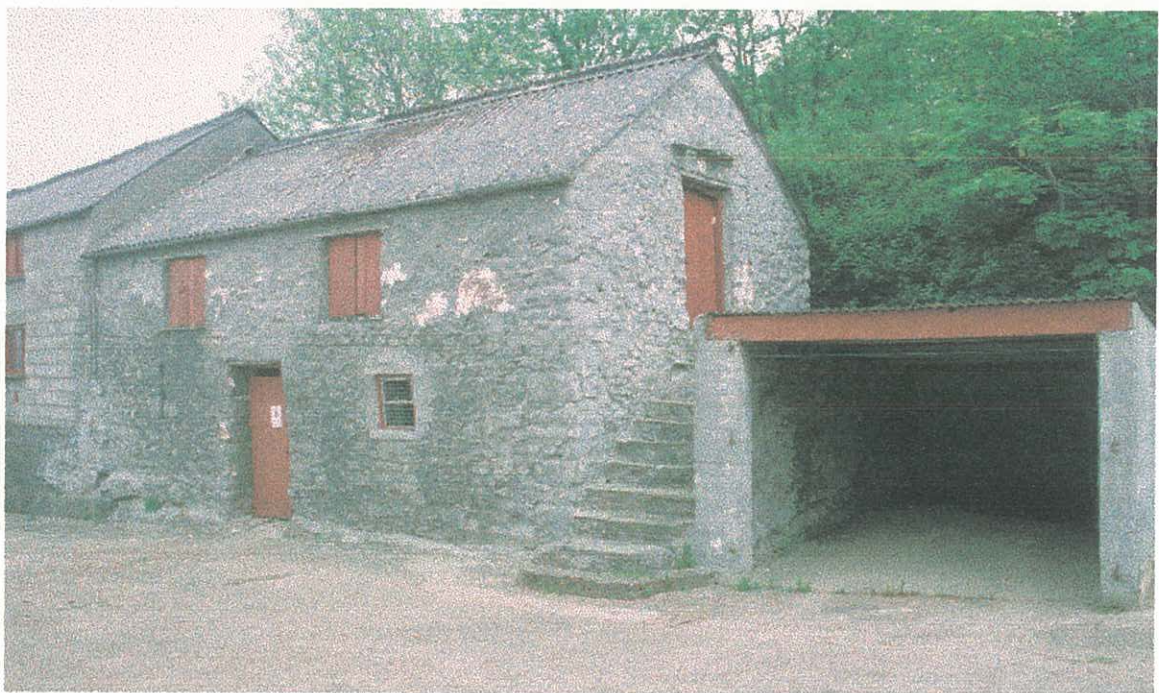
Two-storey cowshed with loft over constructed from uncoursed random rubble with a corrugated asbestos gable roof. This is the surviving south end of a longer building first shown on the tithe map of 1843: the rest of the building was rebuilt in the 1950s. The west front elevation has a central door with a narrow vent loop to the north and a small square window to the south. The window was adapted from a vent loop that matched the surviving one. The loft has two square pitching eyes these are matched in the rear east wall. All the openings are square headed. Possibly originally used as a calf shed the ground floor now houses grain grinding machinery including a belt driven mill.

Plate 2: PRN 40646 - Surviving cowhouse with loft.

The surviving section is in a good state of repair and it should be maintained in its present condition.
