**Tir Gofal Farm Visit Report**

**Edwinsford Farmhouse**

**W/12/0783**

**ACA Report Number 2001/9**

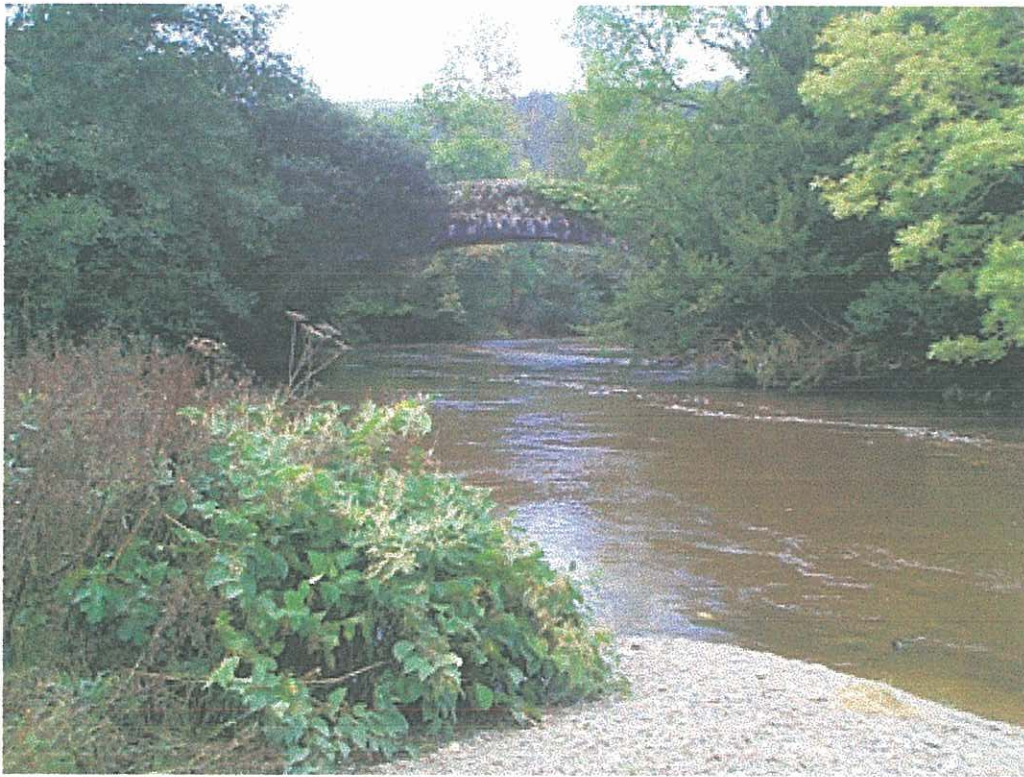
Plate 1 - Cothi bridge (PRN 5109).

An elegant, single span stone bridge, built by the Edward's brothers whose father was the architect of the famous Pontypridd bridge (plate 1). Dressed, coursed stone construction with a slate built arch and stone parapets. An inscription stone on the bridge dates it to 1773 and claims it to be "the sole property of the family of Edwinsford". A carved and moulded stone at the southern end of the parapet has obviously been reused. It has been suggested that it was originally the pedestal on which the c.1710 sundial stood.

The bridge is in a stable condition and is designated as a Grade II Listed building. It is therefore protected from significant damage or modification. It should be maintained in its current condition.

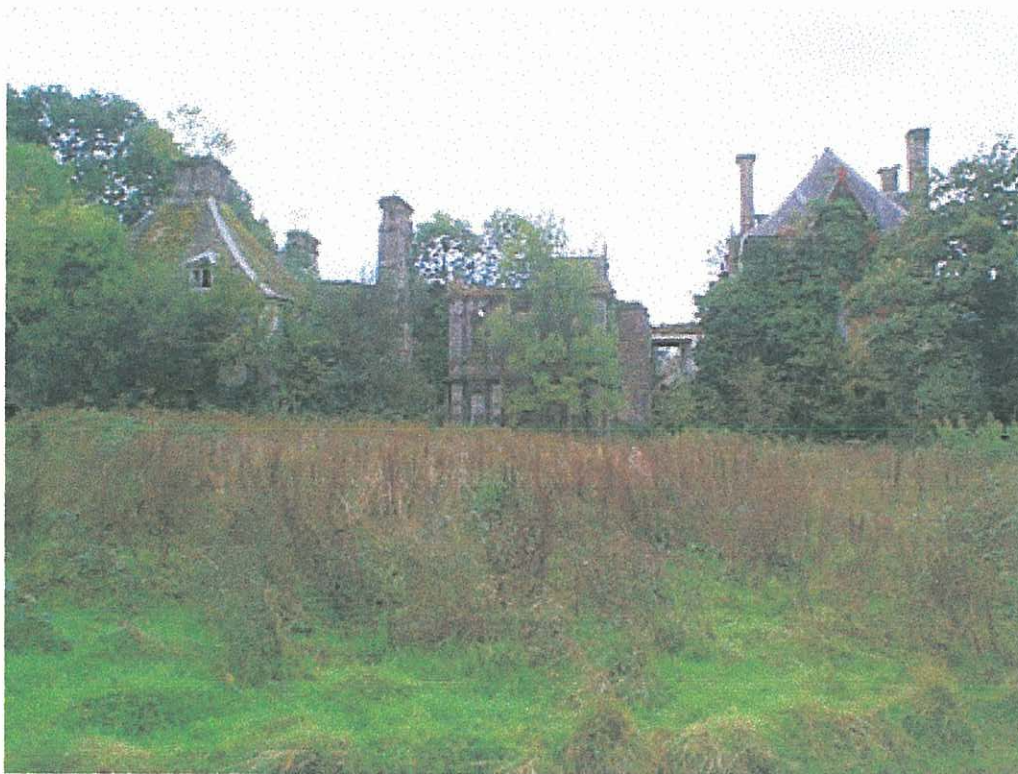
Plate 2 - Edwinsford mansion house (PRN 6943).

The ruin of Edwinsford mansion house is situated to the south of a bend in the Afon Cothi (plate 2). It has a rambling appearance and a complex history of construction. The oldest part of the house was built c.1635 and was known at this time as Edwinsford Uchaf. It is square in plan with a huge central chimney and a high, pyramidal stone clad roof. The central portion of the current house was built about thirty years later and was apparently remodeled during the eighteenth century. The centrally positioned porch was remodeled c. 1842 and a large drawing room was added to the east of the house in 1863 on the site of an earlier chapel. The grounds that surround the mansion are now completely overgrown but a late nineteenth century photograph shows that an ornamental stone stairway once led down to the riverside. This apparently survives beneath the undergrowth although it was not visible at the time of the farm visit.

The mansion is in a ruinous and unstable condition and has been deemed to be beyond repair for some years. It should be left to decay and kept clear of dumping and rubbish. The owner would like to use the stone roofing tiles to re-roof the cowhouse on the home farm. This is a productive use of what is otherwise a crumbling ruin and has apparently been approved by CADW. The area alongside the river should be cleared of undergrowth to establish whether any garden features survive here.

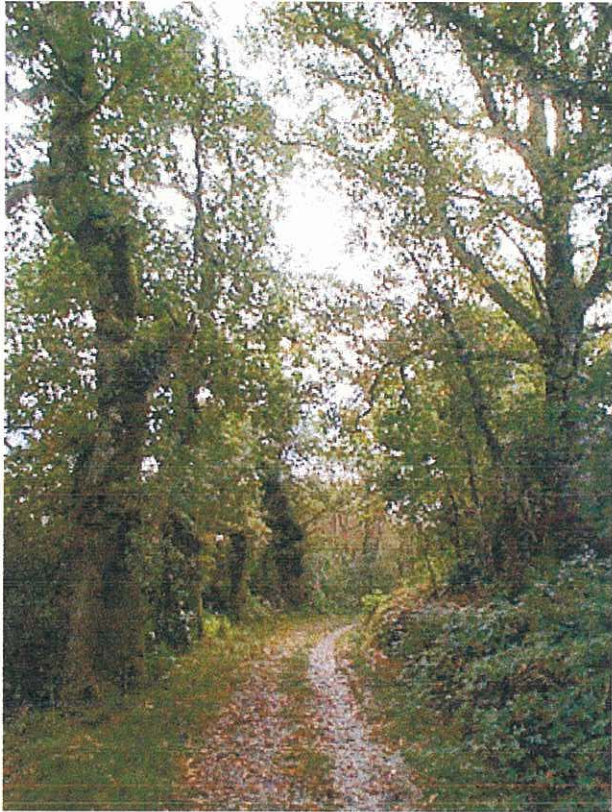
Plate 3 - the beech-lined carriage drive (PRN 41456).

A terraced, c.4m wide carriage drive runs southwards from Edwinsford mansion house through an area of planted woodland (plate 3). It formerly continued in a circuit around Moelfre hill (to the south) and returned towards the mansion from the east. The surface of the drive is roughly gravelled in places but is now overgrown with reeds and extremely wet. Its route is lined with mature English and ornamental oaks and the woodland alongside it (PRN 42090) was designated as an area of parkland on the 2nd Edition OS map of 1906. More recent trackways have been cut through this woodland and somewhat detract from the original driveway. The drive itself has also now been blocked and re-routed at its southern end where it formerly left the woodland and circuited the hillside. Historic maps suggest that the drive was lined with an avenue of oaks for its entire length although it was not possible to walk the complete circuit in the course of the farm visit.

The carriage drive is an important surviving element of Edwinsford Park and should be protected. It should be cleared of reeds and young trees and drained to prevent further erosion. Whilst the section of it to the south of the mansion house is the best preserved, the maintenance and reinstatement of the entire length of the carriage drive around Moelfre Hill should be considered as a longer-term strategy.

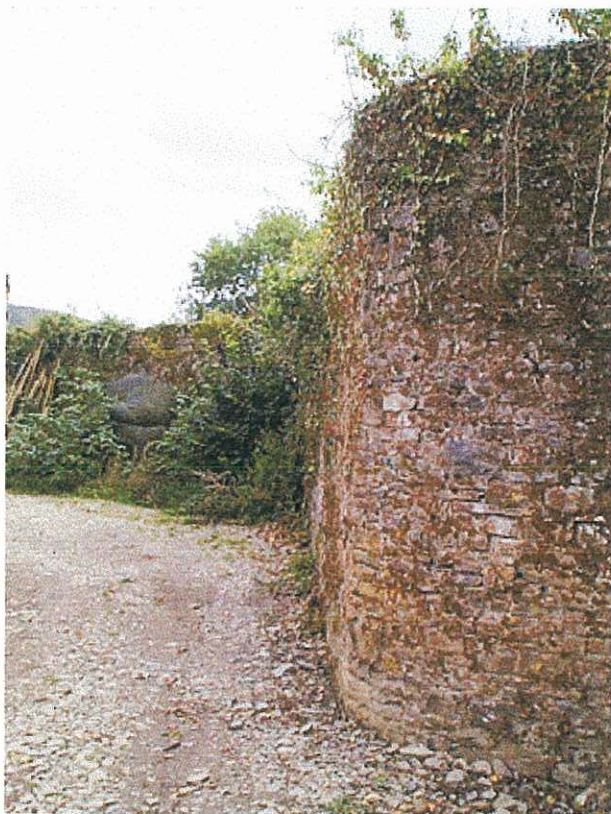
Plate 4 - the walled garden (PRN 41458).

Walled garden to the north of the Home Farm on the Edwinsford Estate. It is attached to a 'Garden Cottage' on its southern side and was presumably built at about the same time (c.1811-12). It is surrounded by c.3m high random rubble walls which enclose an area of c.2.2ha. The main gateway to the southwest is adorned with tall piers of dressed rubble with raised table and coping, which are rebated to accommodate the gates. The gates themselves do not survive. A further entrance is located to the rear of Garden Cottage through a low, timber planked and studded door which is similarly flanked with tall piers of dressed rubble with stone ball finials and is headed with stone voussoirs. The area within the garden has been extensively cleared in recent years and part of it is now used for rearing pheasants. The remainder is still overgrown and littered with piles of rubble. Remnants of the formal box-hedging and orchard survive on the eastern side of the garden. A derelict single storey rubble building that at one time stood in the northeast corner of the garden was overgrown and completely inaccessible at the time of the visit.

The wall is in a reasonable condition alongside the Garden Cottage (plate 4), but elsewhere is overgrown with ivy and has apparently deteriorated considerably in condition since the Listed Buildings description was made. Only one of the stone piers that flank the main gateway now survives and the wall is breached on its southern side to the east of Garden Cottage. The walls should be cleared of ivy and consolidated to prevent their further deterioration. The internal area should be cleared of vegetation, taking care to retain the plantations from the original garden in the area to the east. The site of the former garden building should be cleared of vegetation so that its condition can be determined.

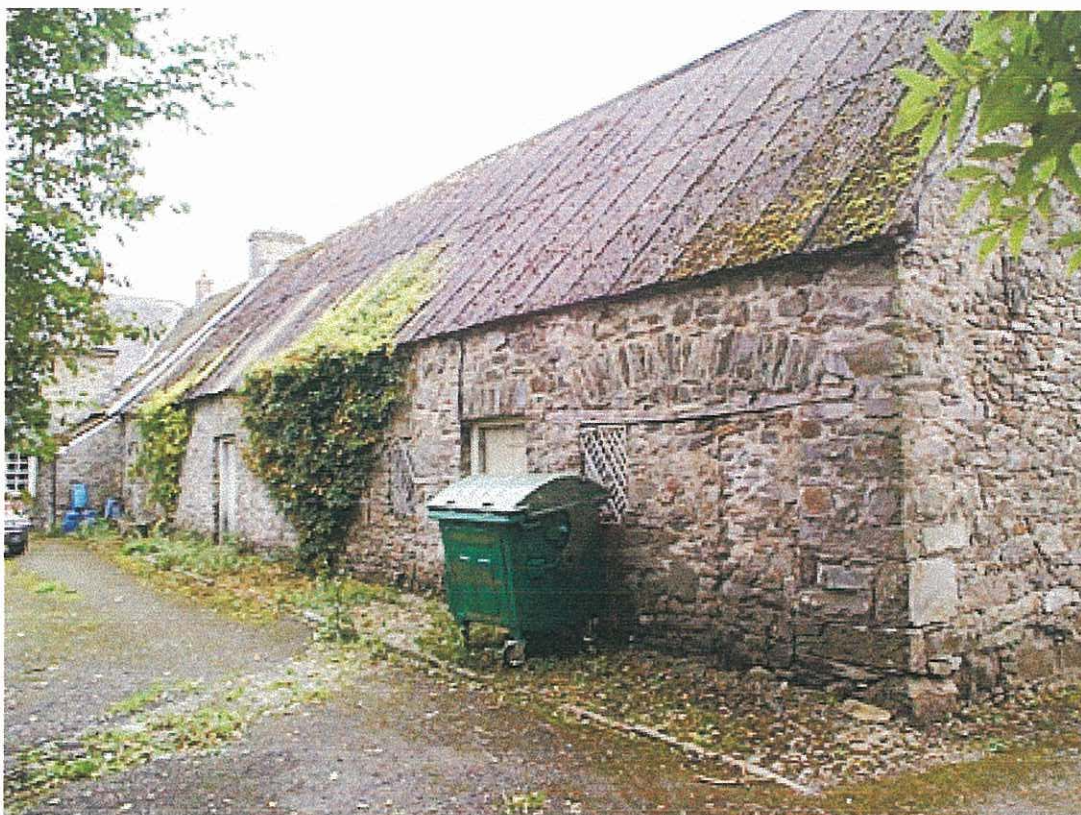
Plate 5 - the cow house from the rear (PRN 41460).

It is a one and a half storey, random rubble construction with a stone tiled roof (replaced with asbestos to the north) which is hipped to the angle between it and the two storey farmhouse to the east. Accessed via eight equally spaced openings in the south-facing wall, three planked doorways headed with stone voussoirs and an arched cart entry in the north-facing wall, and a single-width planked doorway in the western gable wall. The openings to the south and north are headed with cambered stone voussoirs. That on the gable end is headed with brick voussoirs and has a single loop overhead. The three openings at the eastern end of the southern wall were modified and incorporated into the farmhouse that was built onto its eastern end in 1822. Two hipped dormer windows with slated sides were added above the converted part of the cowhouse at this time. The easternmost doorway in the northern wall has also been incorporated into the later farmhouse and is now accessed via a twentieth century porch.

The cowhouse is protected from significant alteration or damage by its status as a Grade II Listed Building. However, the stonework along its northern wall is unstable in places and is overgrown with ivy. The owner would like to re-roof the northern side of the cowhouse roof with stone tiles. He has received permission from CADW to use fallen tiles from the ruined mansion house for this purpose and would like to carry out this work as part of his Tir Gofal agreement. This would improve both the appearance and condition of the building. The ivy should be cleared and the walls consolidated to prevent their further deterioration.

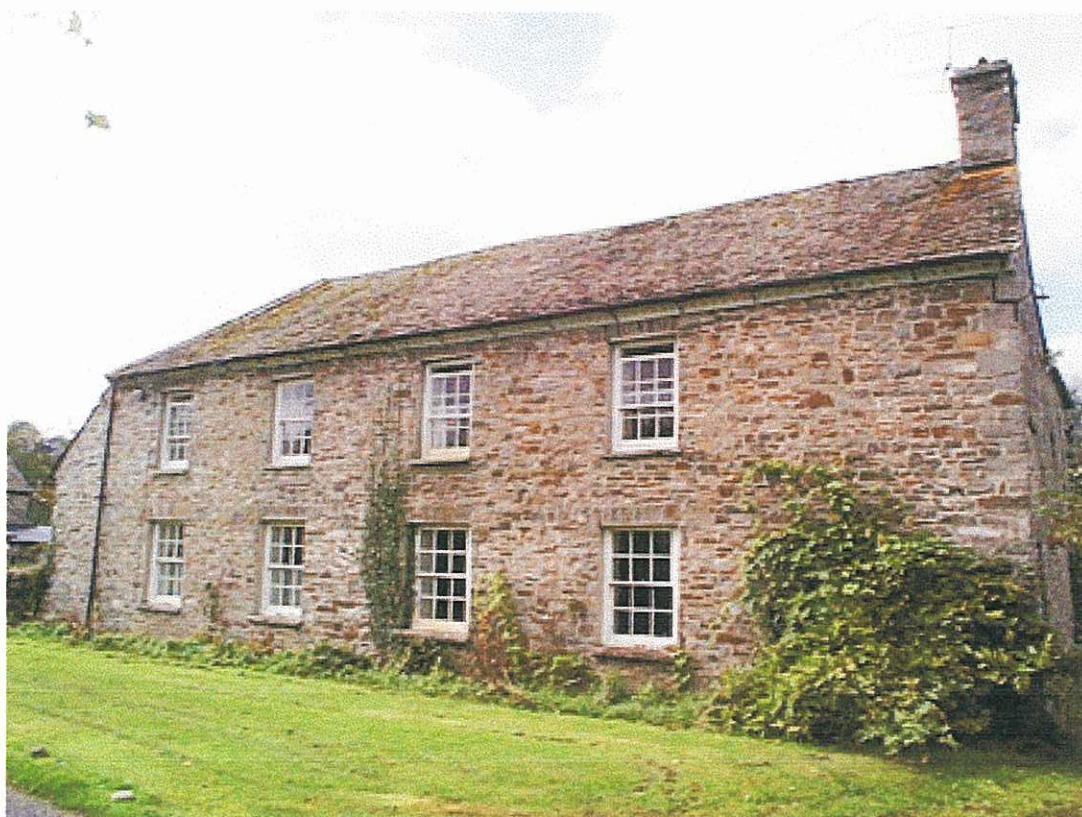
Plate 6 - the farmhouse (PRN 41461).

A two-storey farmhouse (orientation north-south) forms the eastern side of the farmyard at Edwinsford Home Farm (plate 6). It was built in 1822 as an extension to the one and a half story cowhouse (PRN 41460) to the west to form an L-shaped plan. The cowhouse was remodelled at the same time and its eastern end was incorporated into the farmhouse. The farmhouse is of random rubble construction with a gabled stone-tiled roof which is hipped up to the angle with the cowhouse at its southern end. It is accessed by an open rubble porch at the inner corner with the cowhouse. A further entrance is provided to the south via a twentieth century door through one of the original entrances to the cowhouse. The stack at the northern gable end is of rubble construction with stone tabling. The original openings have cambered stone voussoired heads and stone sills. Most of the original fittings have been replaced. The interior was not inspected.

The farmhouse is in an excellent condition and is currently occupied by the owners. It is protected from significant damage or alteration by its status as a Grade II Listed Building. No specific management recommendations.

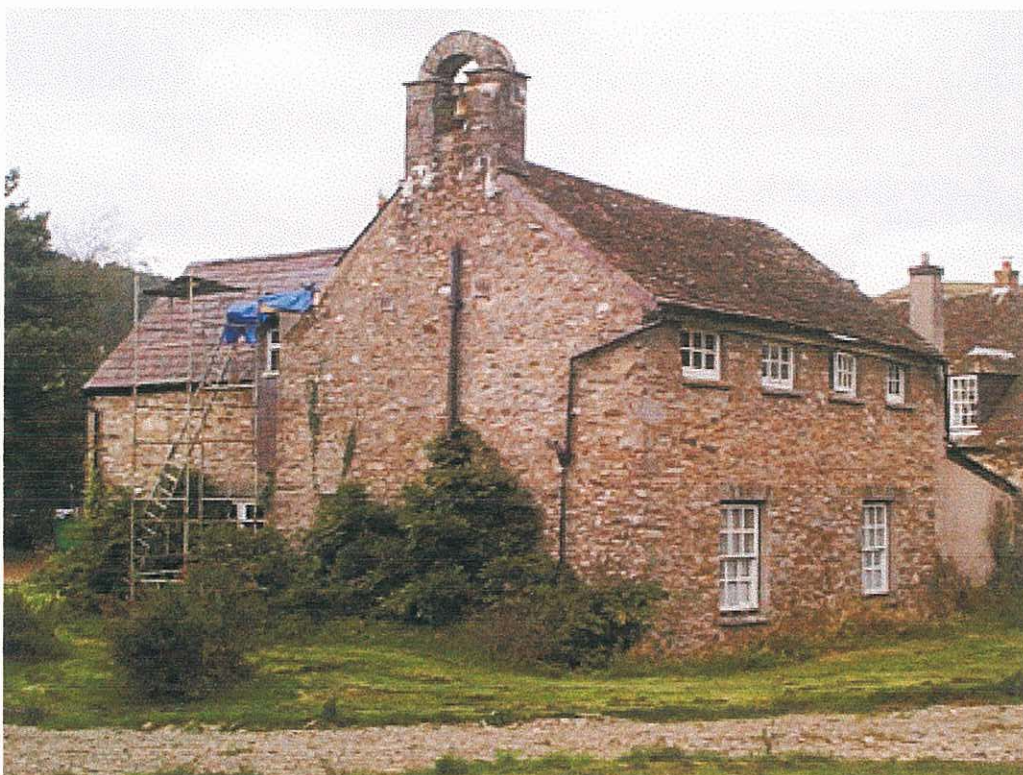
Plate 7- the dairy (PRN 41462).

The dairy house was one of two original buildings at Edwinsford Home Farm that were recorded on an engraving in c.1776 (plate 7). It was probably constructed in the early eighteenth century and was modified and repaired in 1822 when the farmhouse was built to the north of it. It comprises of a N-S oriented main section to the front and a rear wing which projects to the west. It is a two storey building of whitewashed random rubble construction with a stone tiled roof. A dressed stone bell-cote with a rounded head stands on the southern gable roof and contains a bell dated to 1743. This reputedly originates from the chapel that once stood to the north of the mansion house. A rubble stack is located to the south of the rear wing. It is accessed from the north through a stone voussoired opening which is hidden by a more recent porch. The openings vary in style and date, but are mainly headed with stone voussoirs and have stone sills.

The dairy is now a residence and is in excellent condition. It is protected from major damage or alteration by its status as a Grade II Listed Building. No specific management recommendations.

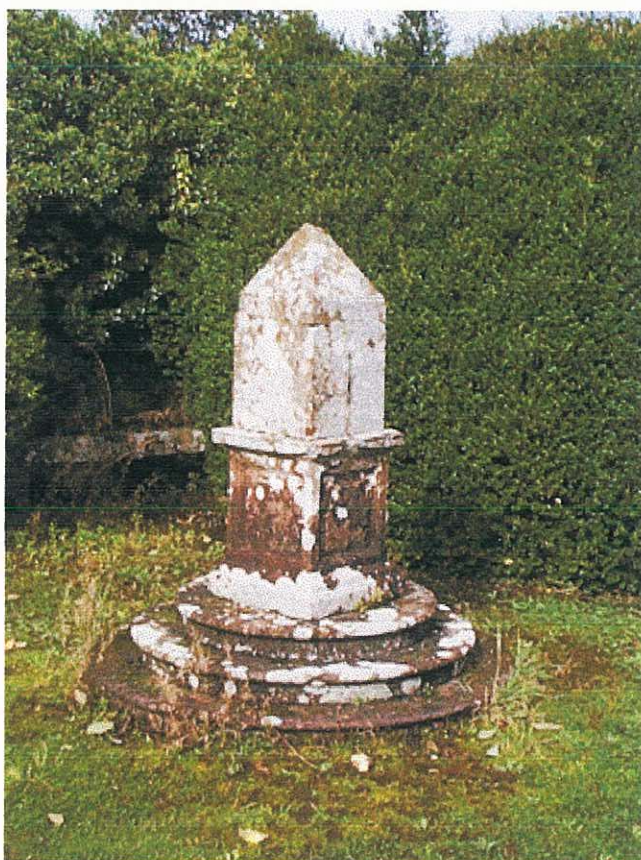
Plate 8 - the sundial (PRN 41465).

A sundial stands immediately to the east of the Home Farm at Edwinsford (plate 8). It was erected in 1899 for Sir James and Lady Madeline Williams Drummond of Edwinsford mansion and formerly stood in the front garden of the mansion to the south of the river. It is an upright stone sundial with a triple stepped circular base and a moulded square pedestal, upon which is mounted a four-sided stone sundial with an obelisk head. The panelled sides to the pedestal are carved and inscribed with raised lettering includes its date of construction and heraldic shields.

The sundial is protected from major damage or alteration by its status as a Grade II Listed Monument. It should be maintained in its current condition.
