Tir Gofal Farm Visit Report

Derlwyn

ACA Report Number 2001/11

Tir Gofal Application Number W/12/0577

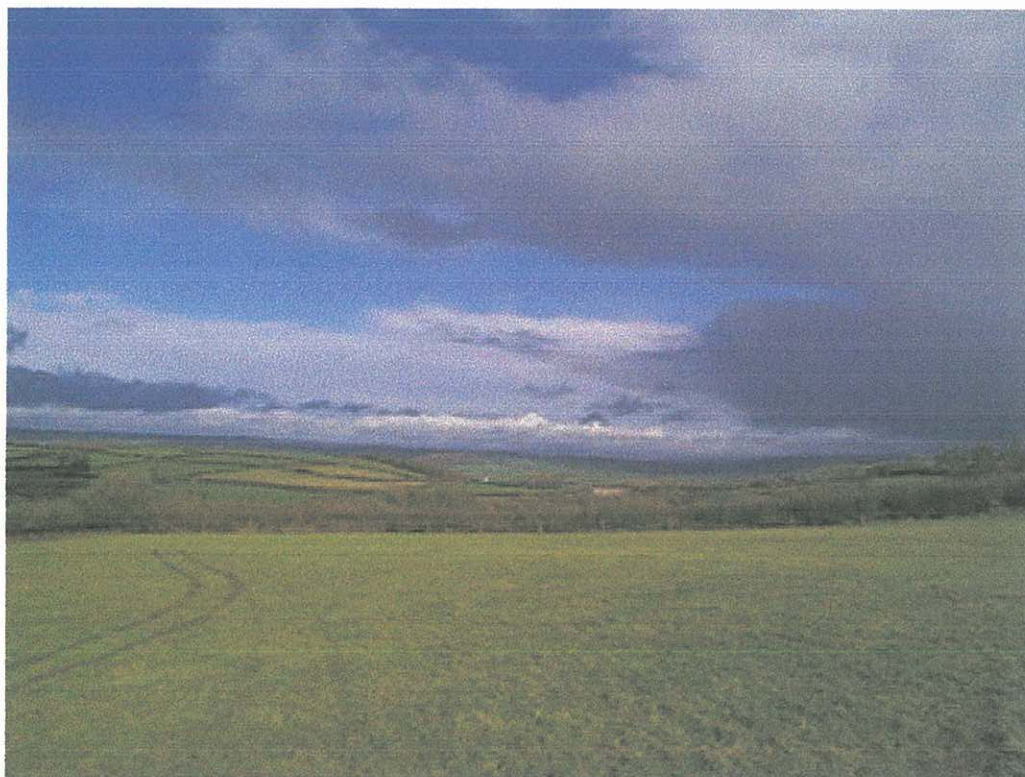
Plate 1 - hilltop enclosure on Derlwyn Farm (PRN 789).

Later prehistoric earthwork enclosure situated on the western slopes of Mynydd Pencarreg on the northern side of Derlwyn Farm commanding extensive views to the north and south (plate 1). Defined by a single, substantial earthen bank which is sub-rectangular in plan and encloses an area of c.50m by 40m. This has been considerably damaged by ploughing but survives as a substantial earthwork c.12m wide by 0.6m high to the south and east and as a barely perceptible change of slope to the north and west. There is no surface evidence of settlement within this area.

The substantial bank that once defined the hilltop enclosure has been fairly intensively ploughed and its survival is threatened under the current land-use regime. The farmer has been using this field for hay and has therefore ploughed the field regularly to improve the land. Ideally, the field should not be ploughed to ensure the continued survival of this unusual prehistoric settlement as an upstanding earthwork.

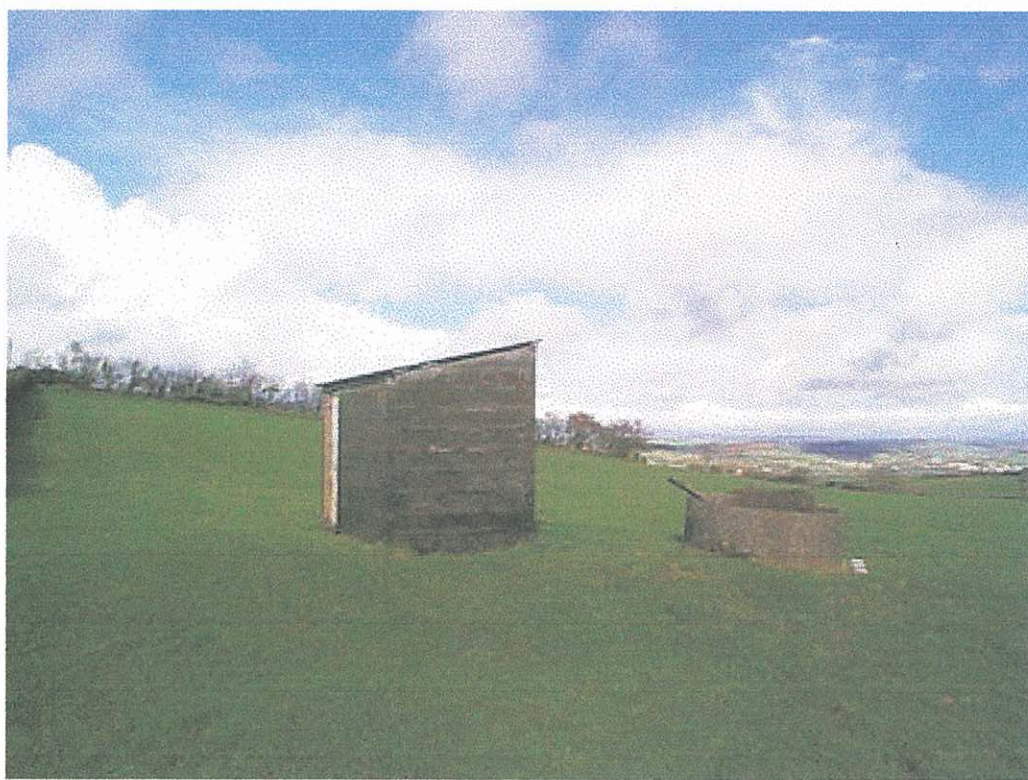
Plate 2 - site of possible barrow (PRN 13006) on Derlwyn Farm.

Possible barrow first identified during a rapid field survey in 1986 as one of a series of barrows that line the ridge that runs from northwest to southeast towards Mynydd Pencarreg. Consists of a broad (c.10m in diameter and 0.6m high) earthen mound upon which a breeze block pumping station has been erected (plate 2). The mound is one of a series of earthworks in this area including a curvilinear bank and other amorphous mounds that the owner claims were created at the time that the pumping station was erected. The true origin of the mound is difficult to establish but its form and situation support the idea that the earthwork was associated with the erection of the pumping station.

No specific management recommendations.

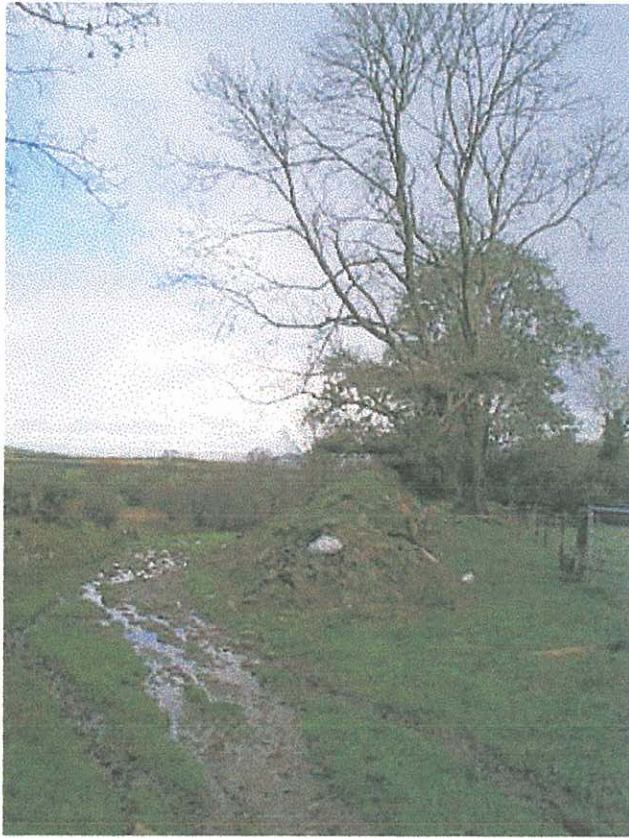
Plate 3 - site of hafod on Derlwyn Farm (PRN 17172).

Site of nineteenth century cottage or hafod associated with Castell Farm. First recorded on the Pencarreg title survey of 1841. The farmer has cleared the ruins of the building into a substantial pile (c.8m by 3m by 2.5m high) at the corner of the field in which it once stood (plate 3). The enclosure that once surrounded it has been completely flattened to the south and east. However, the track that approached the cottage from Castell and the hedges that immediately surrounded it to the west survive and preserve an element of the domestic nature of this site. Several box trees grow amongst the rubble and the hedges that enclosed the site to the west are planted with holly.

The rubble pile that remains of the cottage is in a stable condition and should be left in its current state. Any loose stones should be left in-situ and the distinctive hedges that defined part of the enclosure around the cottage should be maintained in their current state. The box bush that now grows through the remains should not be removed.

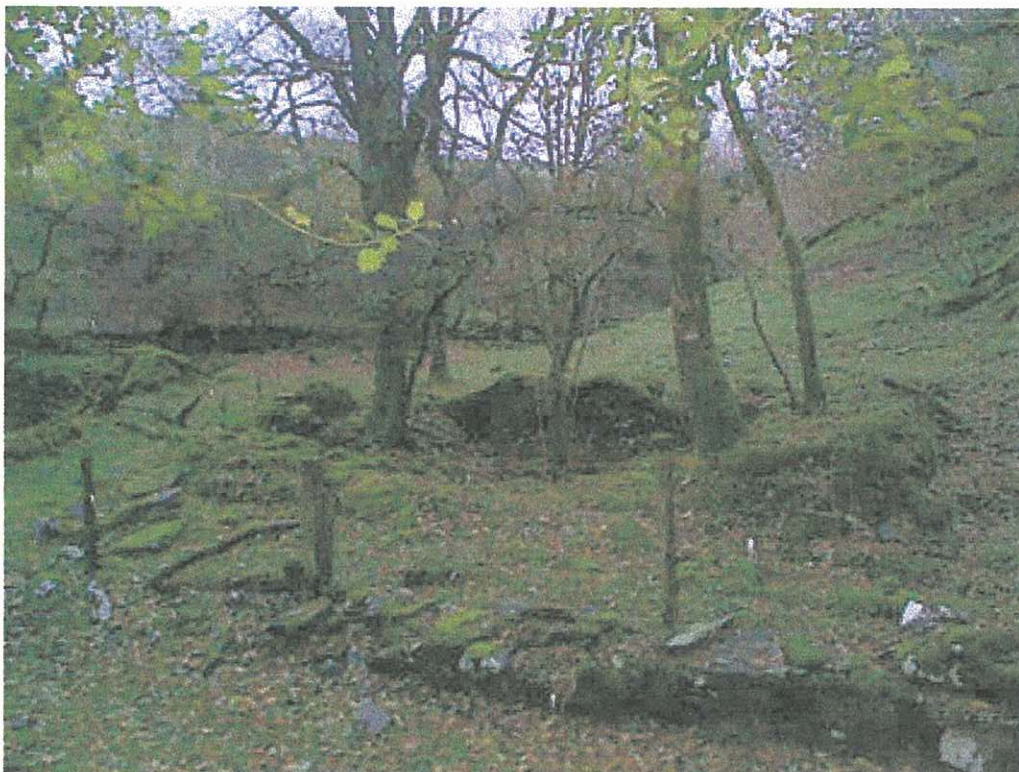
Plate 4 - deserted cottage of Twr-gwyn (PRN 21888).

Ruined cottage of Twr-gwyn set in the valley bottom to the south of the Nant Geredig on the northwest facing slopes of Mynydd Llanybyther (plate 4). Consists of a single-roomed rubble dwelling (c.7m by 3m) and an adjoining outbuilding (c.4m by 4m), both with drystone walls. Orientation north-south. A narrow walled corridor and circular stone-lined well lie to the south of the dwelling. The buildings are set within a small enclosure defined by the river to the north, a steep cliff-face to the southeast and a low wall to the west. Approached from the southwest by a narrow trackway that connected several contemporary farms to the west. The footings of the dwelling stand to a height of c.1.2m and are covered with moss. The interior is filled with rubble and overgrown with young trees. The footings of the outbuilding stand to a height of c.0.6m and are also covered with moss.

The upstanding walls of the cottage are unstable and overgrown with moss and occasional young trees. The area in which it stands is not accessible to livestock and the owner does not plan to use this area for farming purposes. The cottage should be maintained as a stable ruin.

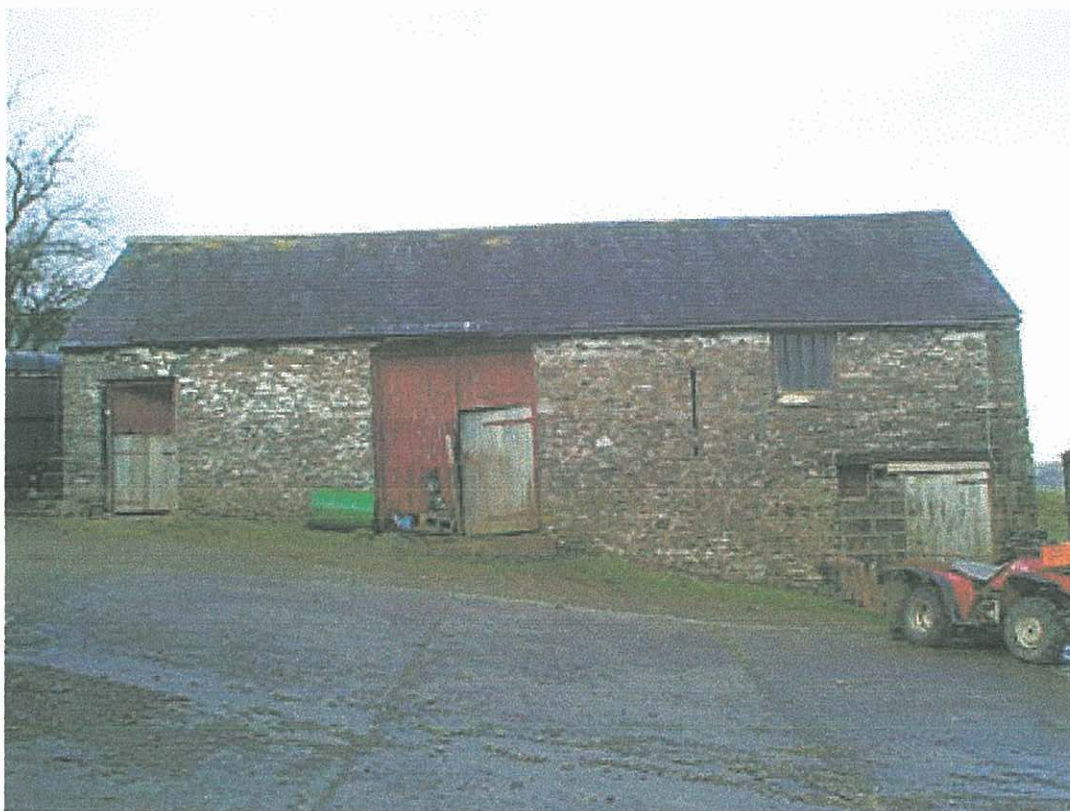
Plate 5 - farm building at Derlwyn Farm (PRN 42094).

Two-storey rubble farm building with a gabled slate roof to the north west of the farmyard at Derlwyn Farm. Consists of a stable (PRN 42095), barn (PRN 42096) and carthouse (PRN 42097). The original openings are headed with stone voussoirs. Recorded on the 1st edition OS map of 1891 although it may be earlier, but obscured on the damaged tithe map of 1841. Orientation east-west. See individual part descriptions for more details.

The building is generally in good working condition and should be maintained in its current state. Any alterations and repairs should be carried out using materials that are sympathetic to the original character of the building. See individual site recommendations for more details.

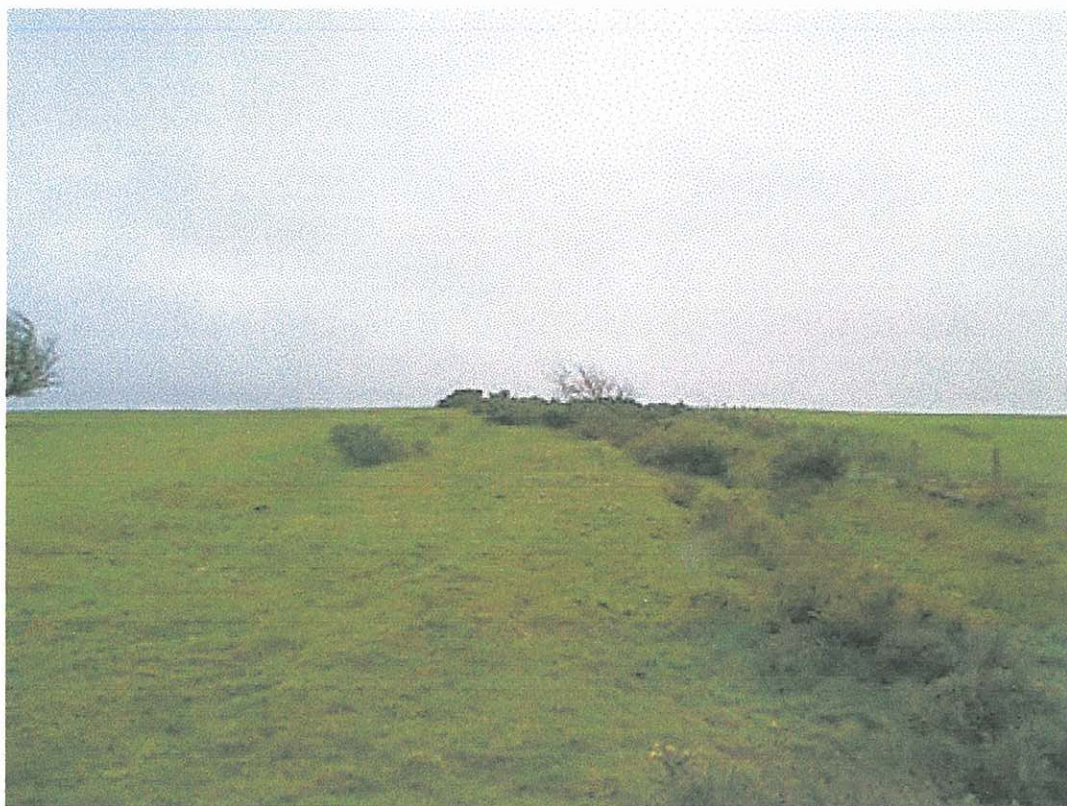
Plate 6 - possible drovers road on Blaen-plwyf Farm (PRN 42099).

Broad trackway (c.6m wide) running from northwest to southeast to the south west of Blaen Plwyf Farm (plate 6). Defined by a substantial ditch (c.1m wide) on its southwestern side and a low earthen bank (c.0.5m high) on its northeastern side. First recorded on the tithe survey of 1841 on which it appears to connect with a longer distance droveway over Mynydd Llanybyther. The route is now grassed over and overgrown with gorse. Clearance stones have been placed along its edge.

The banks that define the trackway are in a reasonable condition and should be retained and maintained in their current condition. The area within these banks is overgrown with gorse and should ideally be cleared. It is no longer used as a routeway but should be retained and preserved.

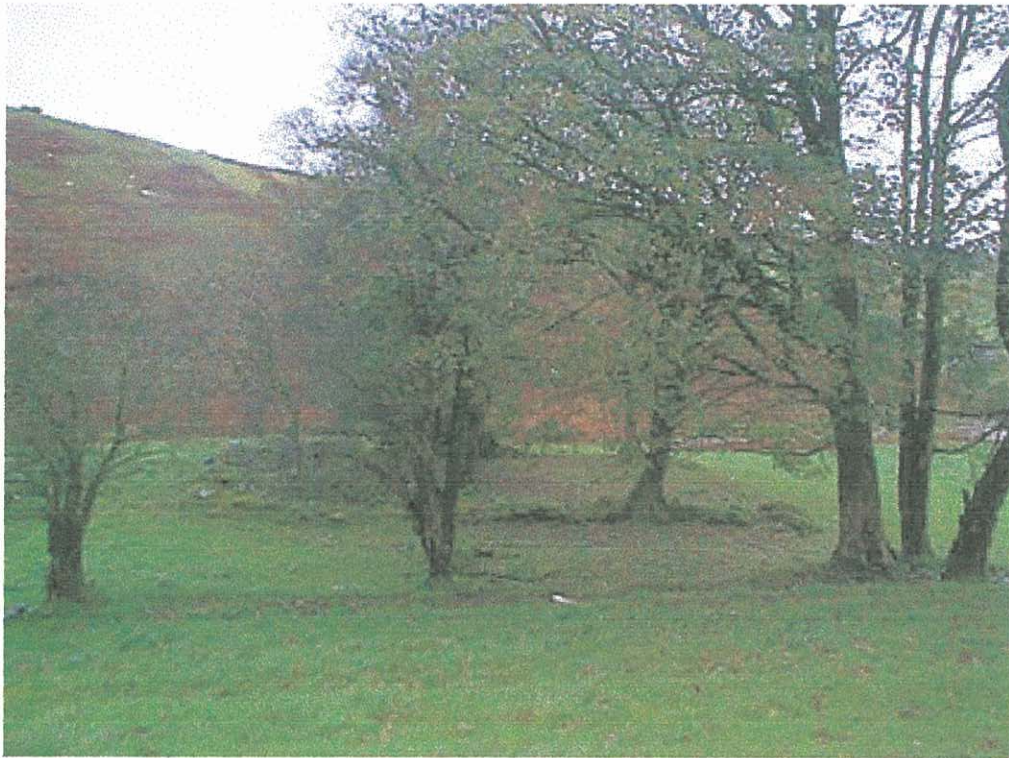
Plate 8 - deserted cottage of Croes Ceiliog (PRN 42101).

Ruined farmstead of Croes-ciellog, set in a valley bottom on the north west facing slopes of Mynydd Llanybyther (plate 7). First recorded on the tithe survey of 1841. Consists of a three-roomed building (orientation northeast-southwest), set to the south of a pair of small enclosures from which it is separated by a narrow trackway (c.2m wide) that runs from west to east towards Nant Ceiliog. The footings of the building stand to a height of 0.8m and are grassed over, damaged by young trees and infilled with rubble. The enclosures are defined by low earth and stone banks and planted with deciduous trees. The trackway is defined by stone and earth banks (c.0.8m high) and is overgrown and littered with loose stones.

The footings of the house and its associated outbuildings and enclosure are grassed over and in a stable condition. They should be maintained as stable ruins. Any loose stones should be left in-situ. The field is used for grazing sheep and cattle and the condition of the site should be monitored to assess the extent of any erosion that this might be causing.

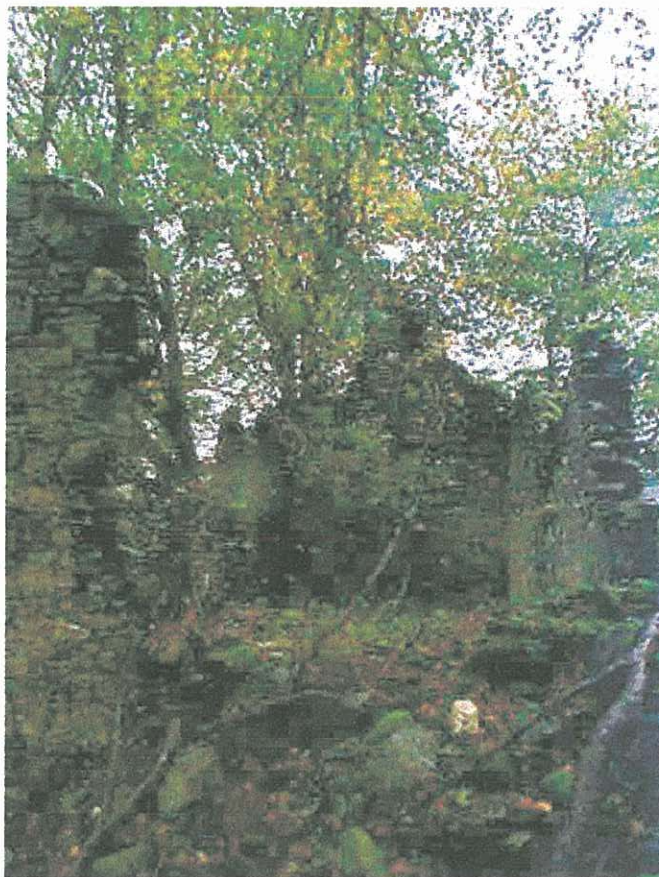
Plate 8 - ruined farmhouse of Blaen-waun-henfod (PRN 9474).

Ruined farmstead of Blaen-waun-henfod, on the northwest facing slopes of Mynydd Llanybyther to the north of the Nant Cynhenfod. The site lies in a series of stone and earth banked enclosures with laid stone faces and beech hedges. It was first recorded on the tithe survey of 1841. Consists of a farmhouse (PRN 42102), pigsty (PRN 42103), three outbuildings (PRN 42104-6) and a waterwheel (PRN 42107). See individual site descriptions for more details.

The farm was obviously once a fairly substantial nineteenth century holding and its history and context within the nineteenth century landscape deserve further investigation. It was formerly owned by the nearby High Mead Estate. Its survival and maintenance should be prioritised over the other deserted farmsteads on the holding. The enclosure that surrounds it should be maintained in its current condition as should the internal dividing walls. The area is now used for herding and collecting cattle and sheep and contains a series of pens and barriers. The condition of the ruins should be monitored to assess any adverse effects that this may be having on their survival. (See individual sites for more specific management recommendations.)
