Tir Gofal Farm Visit Report

Penyrallt Home Farm

ACA Report Number 2001/10

TIR GOFAL FARM VISIT REPORT

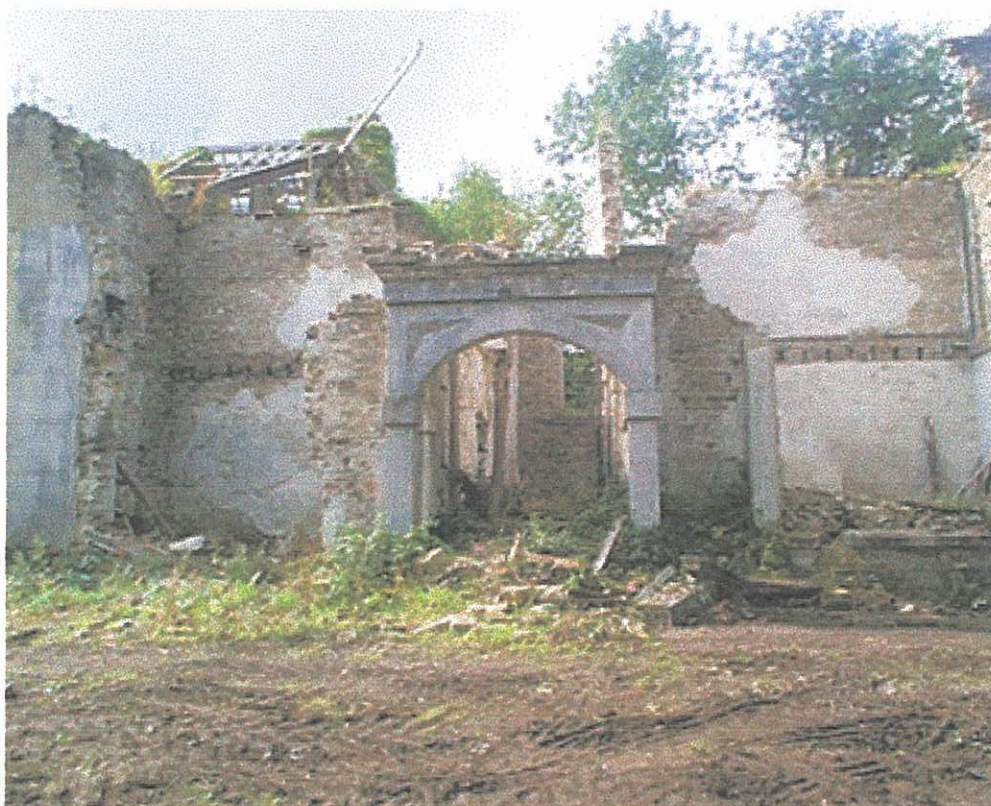
Plate 1 - Penyrallt mansion house from the east (PRN¹⁵~~5~~1869).

Substantial, sub-classical ruined mansion house set in landscaped grounds (PRN41414) to the north of Penyrallt Home Farm (plate 1). Rubble construction with dressed sandstone facing. No roofing material survives. Accessed via a fine arched portico in the eastern wall. The mansion was reputedly built between 1869-71 and was first recorded on the 1st edition OS map of 1891. The original structure was L-shaped in plan, facing east. A rubble extension was later built to the rear. The walls stand to roof height but are rapidly deteriorating in condition. The building was neglected during the latter years of its occupation and until recently the grounds were littered with substantial rubbish dumps which the owner has now cleared. Since the death of the last owner some thirty years ago, much of the fine dressed sandstone from which it was constructed has been robbed for local building use.

The building is structurally unstable and its renovation would require considerable investment. Given sufficient funding, the owners would like to restore the original part of the house and demolish the later extension which blocks a large window in the western wall of the original structure. Remedial action should be taken to prevent further deterioration of the existing structure. Archaeological and architectural advice should be sought prior to the renovation of the house.

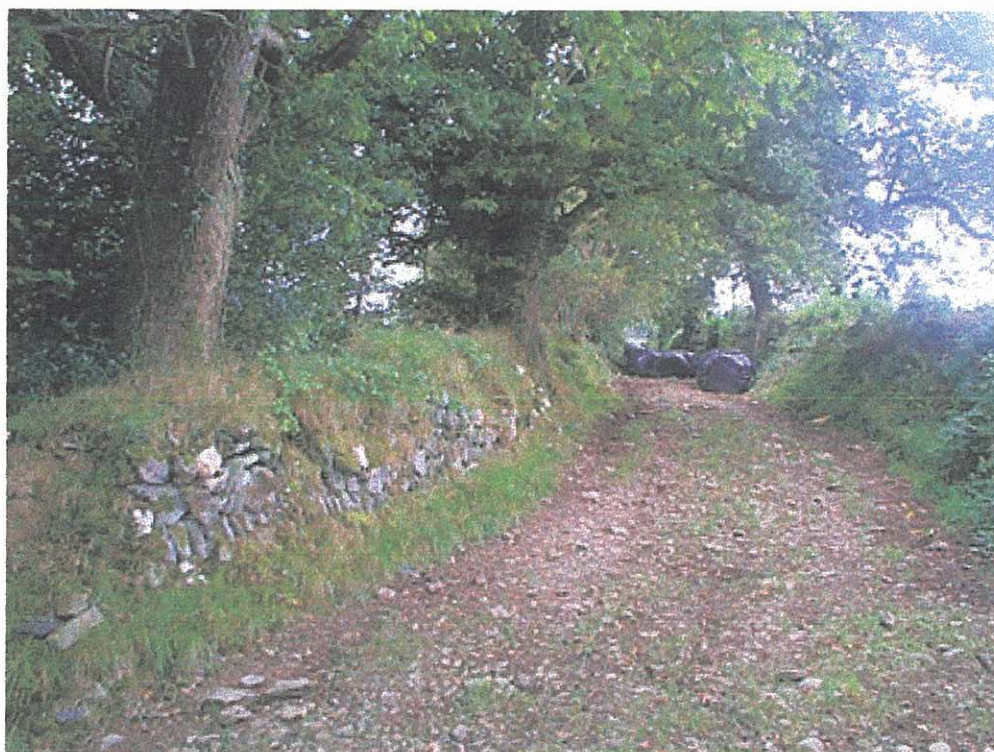
Plate 2 - trackway leading westwards from Penyrallt Home Farm (PRN 41398).

Substantial trackway (c.5m wide) running westwards from the farmyard at Penyrallt (plate 2). Defined by hedged, stone-faced earthen banks (c.1.2m high) to either side and roughly surfaced with gravel. First recorded on the tithe survey of 1839. Although the trackway now ends in fields to the west of the farm, at one time it continued westwards towards the farm at Ty-newedd via a small stone bridge which has since been demolished.

The trackway is well maintained and still used to provide access to the fields on the western side of the farm. The hedges are overgrown but the owners plan to lay them which would considerably improve their condition and appearance. The banks that define the trackway are in good condition. They should be maintained in a stable condition and kept clear of intrusive vegetation.

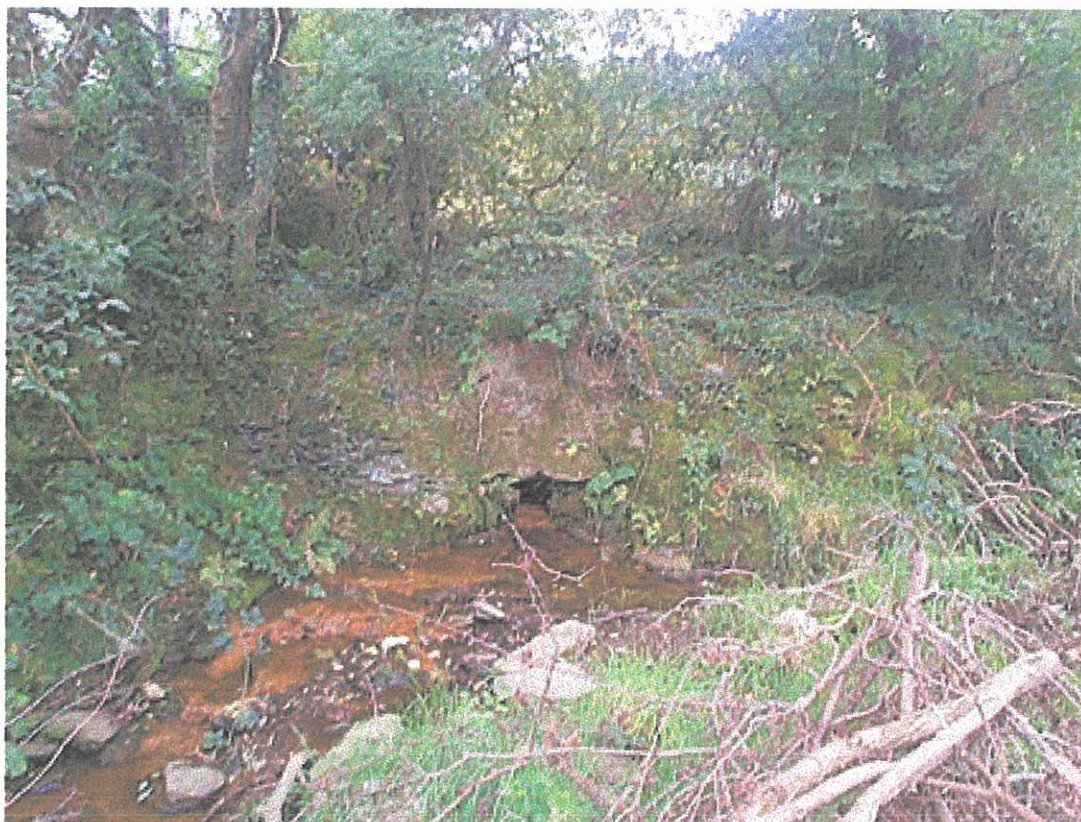
Plate 3 - millpond to the west of Penyrallt Home Farm (PRN 41400).

Fine sub-circular millpond (c.5m in diameter) with a laid stone surround, situated in a bend in a trackway (PRN 41398) to the west of Penyrallt farmyard (plate 3). The pond is now silted up and very overgrown, but the surrounding walling is in good condition and stands to a height of c.0.8m. The original iron sluice gate survives at the mouth of the pond and has not been disturbed since it was last cleared. A stone lined leat (c.0.5m wide) runs eastwards from the pond towards the farmyard along the southern side of the trackway. The leat formerly crossed the trackway and continued along its northern side to a raised platform just to the south of the farmyard where it fed an overshot wheel on the southern wall of the barn (PRN 42289).

The owners plan to clear the pond and the surrounding wall of vegetation which would considerably improve its condition and appearance. If possible, the iron sluice should be retained in-situ and the stone surround should be consolidated. The remaining section of the leat should be retained and kept clear of intrusive vegetation.

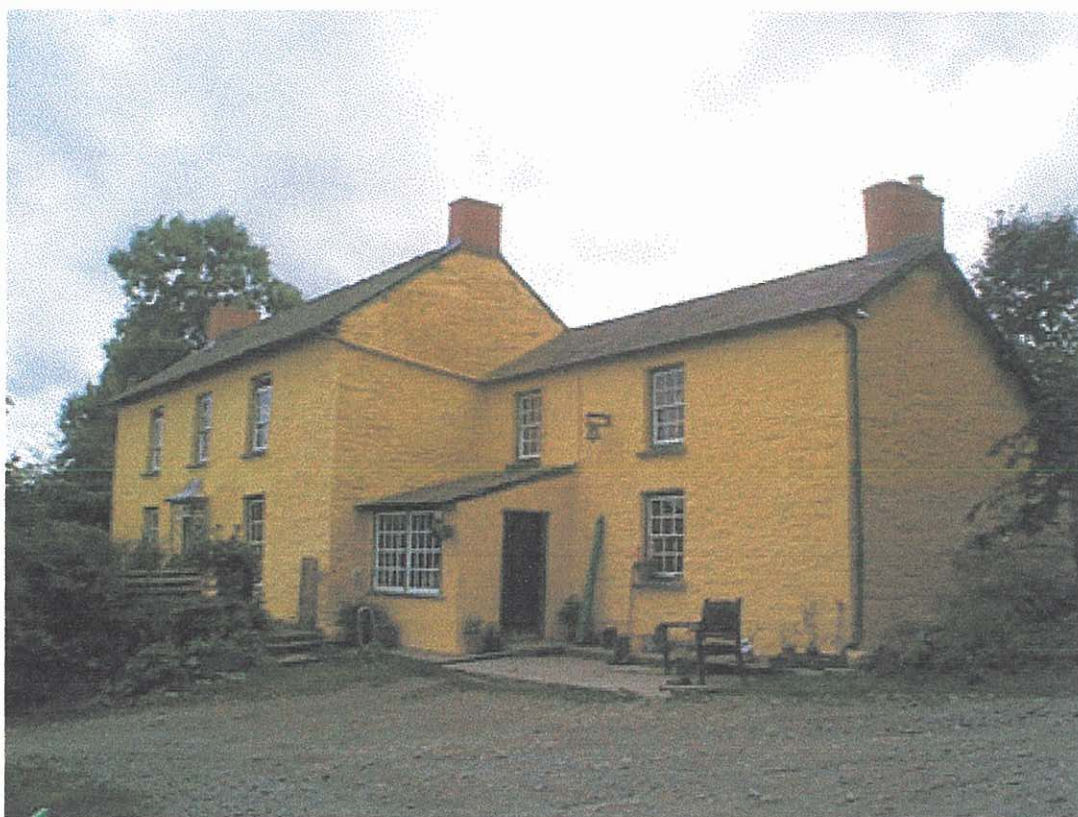
Plate 4 - Penyrallt farmhouse (PRN 41402).

Two-storey farmhouse occupying the western side of the farmyard at Penyrallt Home Farm (plate 4). It is clearly the earliest surviving building in the farmyard. It was mapped on a 1" Ordnance Survey map of 1831, but records of its occupation date back to the late seventeenth century. The house has a complex history of construction which deserves further investigation. The main building is of soil and rubble construction to first floor level and rubble and mortar construction above this level. Many features of historical interest survive within the house, including a clay floor beneath the current slate flagged floor, an inglenook fireplace and a substantial stone vousoired archway which may relate to the earlier use of the building for agricultural purposes.

The farmhouse is in excellent condition and is of considerable historic interest. It has been maintained with great attention to the original fabric of the building. Its history of construction and occupation could be clarified with further survey work.

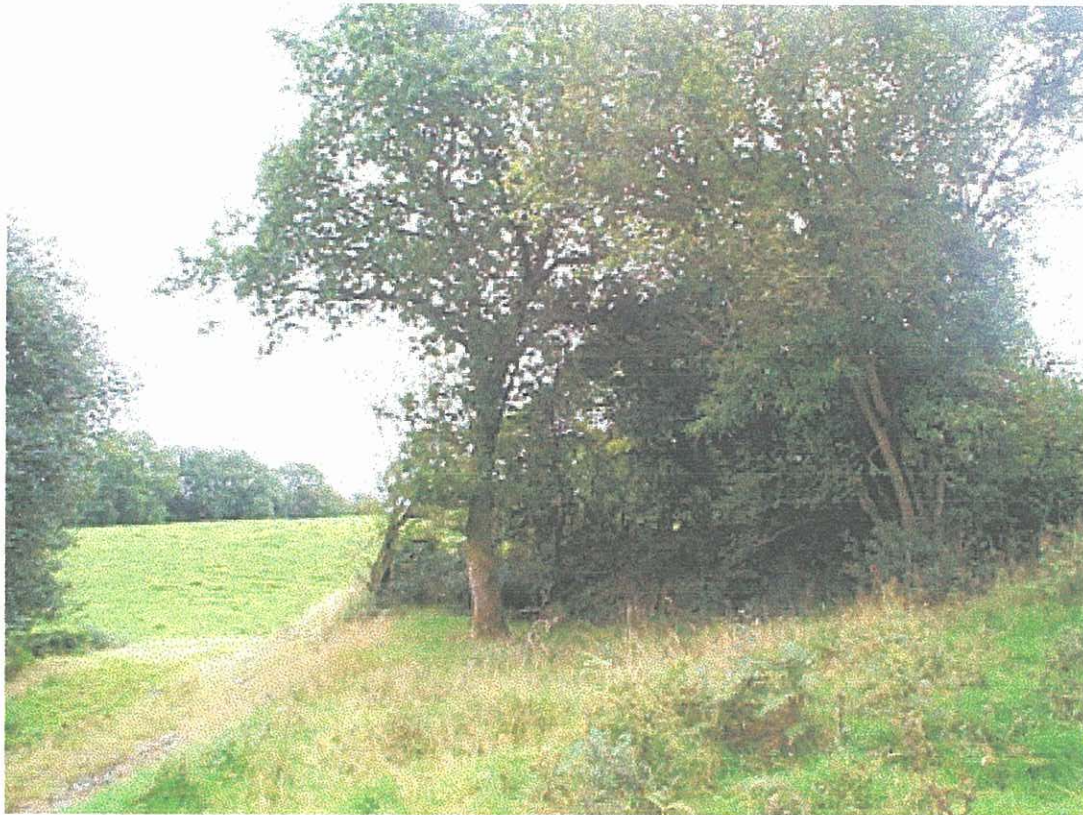
Plate 5 - site of Tir Fach cottage (PRN 41406).

Ruined remains of Tir Fach cottage on the northeast-facing slopes of the Seidi valley, to the northeast of Penyrallt Home Farm. Very little remains of the building itself, although the terraced platform (c.3m by 5m) on which it stood survives (plate 5). A small, square garden lies to the northeast of the cottage in which a ring of holly trees stands. The garden is defined by a low (c.0.4m) high bank. A twentieth century diversion of the track that originally led to the cottage now bisects the cottage and its garden.

The site of the cottage should be maintained in its current condition and kept clear of intrusive vegetation and rubbish. The site of the garden should be retained and its banks maintained in a stable condition. The recent landscaping of this area to form a pond and divert the trackway has caused some damage to the setting and remains of the cottage but the owners now plan to leave this area undisturbed.

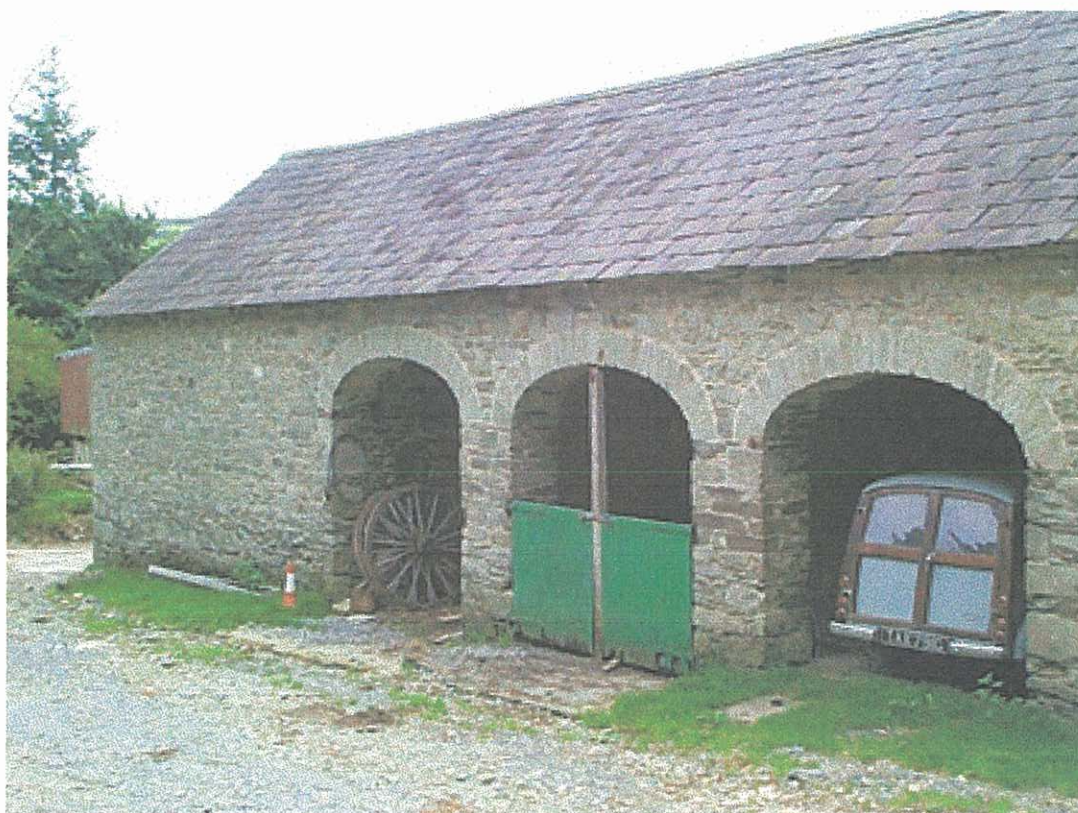
Plate 6 - coach house at Penyrallt Home Farm (PRN42291).

One and a half storey coach house, occupying the northern side of the central portion of the building that forms the northern side of Penyrallt farmyard (PRN 41401). It is open to roof height and accessed via three, symmetrically arranged, stone voussoired arches along its northern wall (plate 6). The internal slate flagged floor survives.

The building is in very good working condition and should be maintained in its current state. The original flagged floor should be retained. Any alterations and repairs should be carried out in a way that is sympathetic to the character of the original building.
