Carters Green Farm W/13/1673

Tir Gofal Farm Visit Historic Environment Report

Report No. 2002/45

Carters Green
Tir Gofal Farm Visit Historic Environment Report

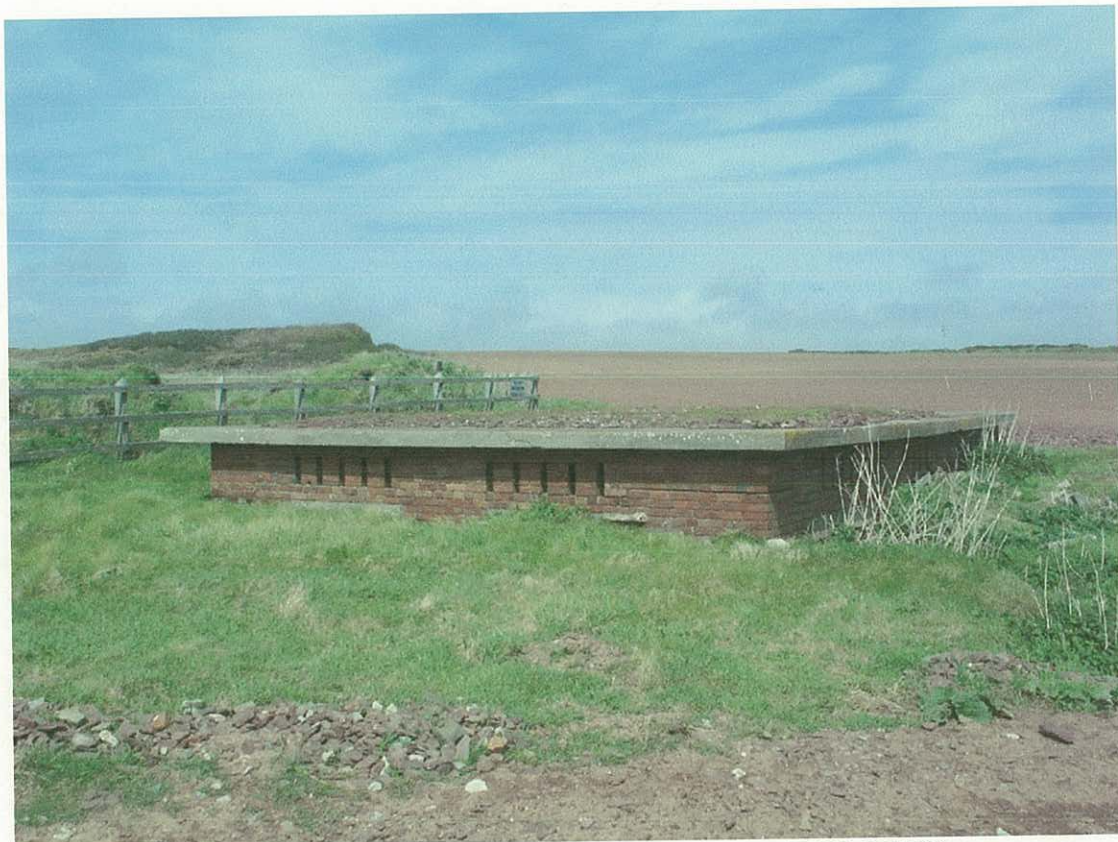
A military engine room near East Blockhouse (PRN 32780)

As described, the building is half sunk below ground level and the entrance has been partially blocked and backfilled with earth. The building is in a fair condition with occasional cracks in the brickwork (See frontispiece). Apparently this was latterly an engine room, housing the generators for a flame thrower. Aerial photographs show that a network of trenches radiated out from the building, no visible traces of these survive, however buried traces may still be present. Internally the concrete mountings for the generators survive.

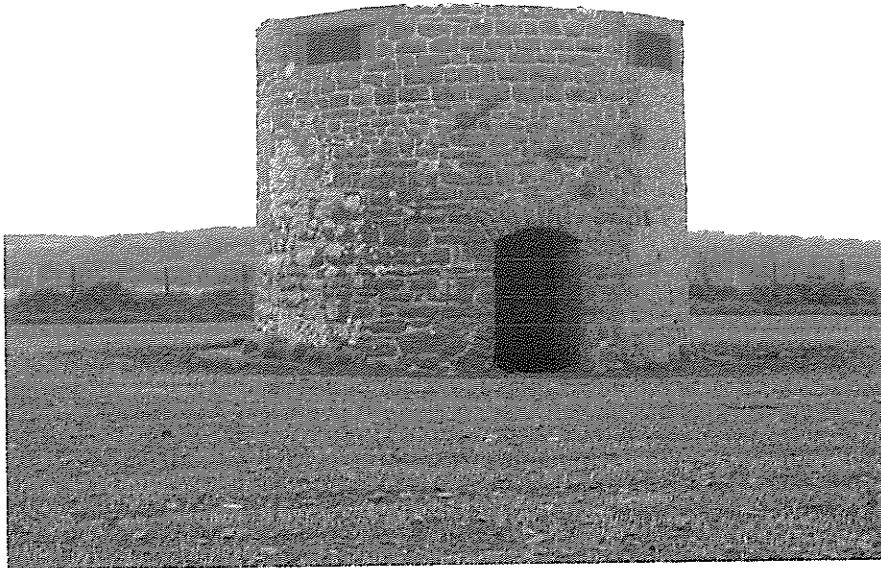
Currently the windmill is good condition and appears to have been recently restored, (Plate 1)

Plate 1 – Former windmill and defence post (PRN 4386)

The windmill should continue to be maintained in its current good condition.

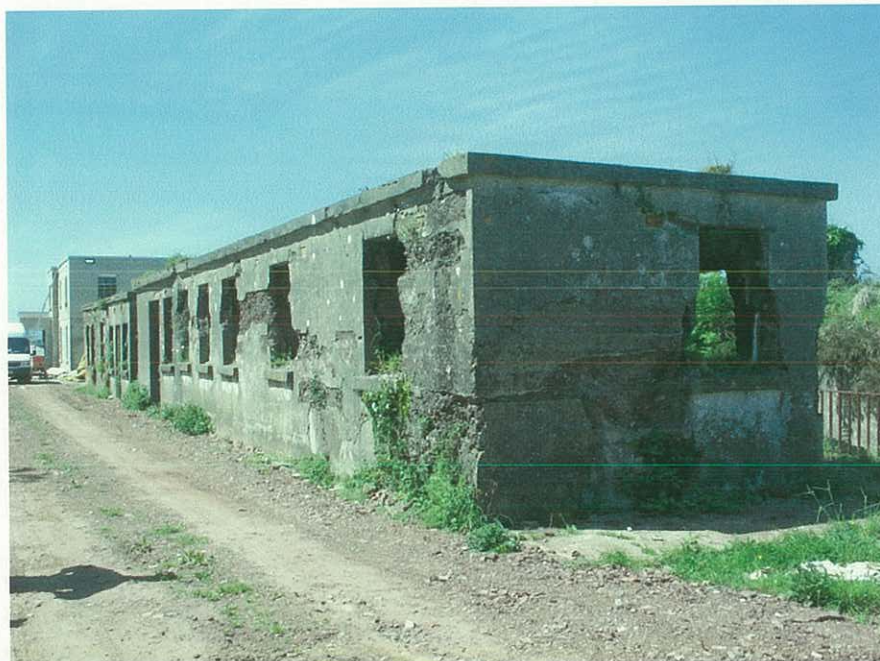
A two storey building is currently under construction at the west side of the fort. The other buildings along the south side are in a poor condition. To the far east is a single storey building of brick construction with deteriorating cement render finish which has largely fallen off the south face. The above mentioned ablutions block, constructed in unreinforced concrete is also suffering from the loss of its weatherproof cement render skin.

Plate 2 – Chapel Bay Fort (PRN 7655), this building is an early example of unreinforced concrete construction.

The derelict buildings which line the south side of the fort urgently require some remedial works to prevent their further deterioration. This should focus on making the buildings weatherproof. Since these buildings lie within the scheduled area, all works must be carried out with full consultation with CADW and will require scheduled monument consent.

In addition the accumulated rubbish and waste which has been dumped in the external ditch should be removed with care not to cause damage to the structure and the external ditch kept clear.

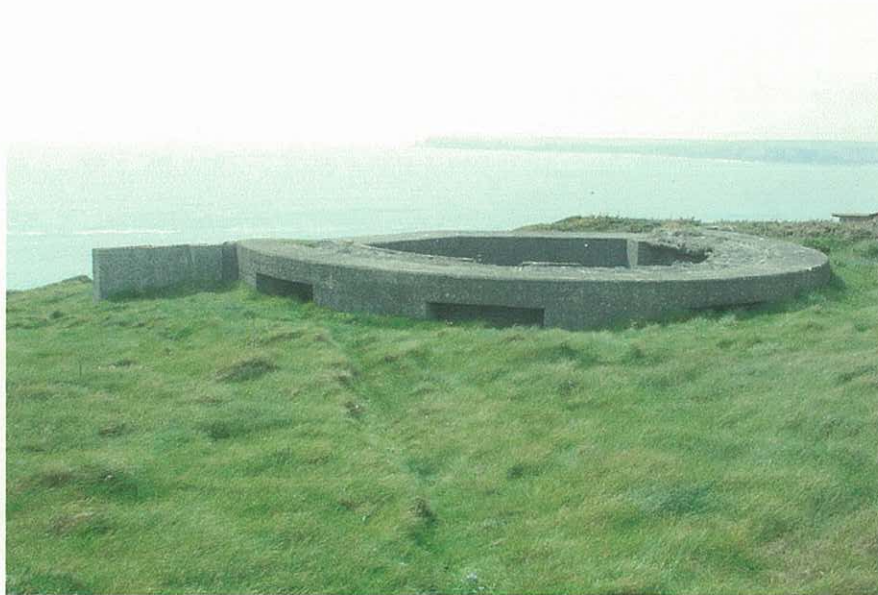
This feature is currently in a stable condition.

Plate 3 – Gun Battery (PRN 32643) at East Blockhouse

This feature should be retained in its current condition.

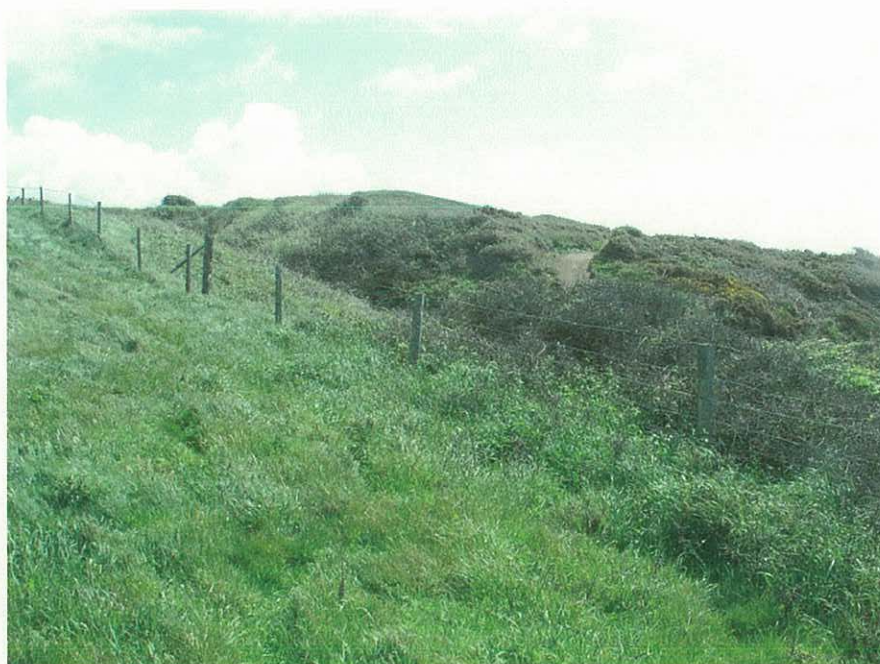
Plate 4 – the western ramparts of the hillfort at West Angle Bay (PRN 35019)

In order to protect archaeological remains relating to this monument the field on the eastern boundary of the hillfort should be given a greater margin from cultivation. A further 15 metres to the east of the field boundary should be excluded from any ground disturbing activities.

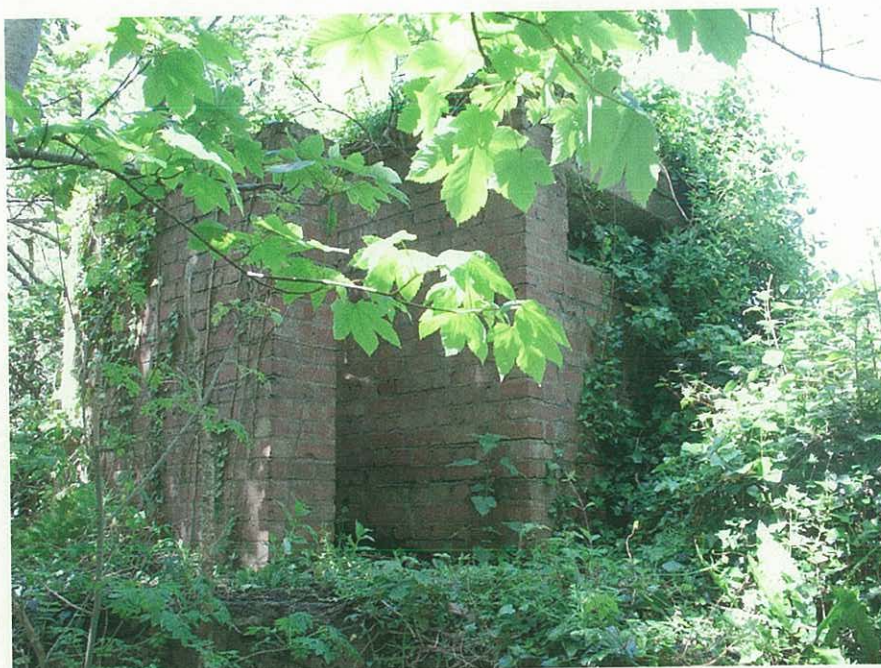
Plate 5 – Minewatchers post (PRN 35022) which stands above the gun emplacement (PRN 35023)

This minewatchers post should be retained and maintained using appropriate materials. It is important that the encroaching vegetation is cut back and the roots treated to prevent regrowth, this should help prevent further damage to the structure.

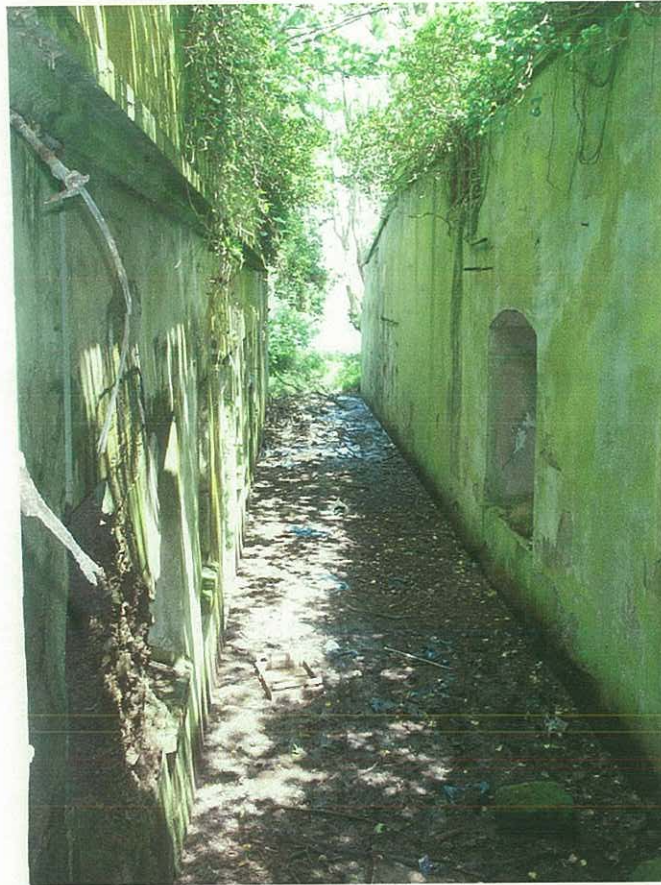
Plate 6 – Submarine mining establishment (PRN 35026)

This complex should be maintained in a stable condition. Urgent action is required to prevent the eroding of the concrete structure by water ingress, this will require specialist conservation advice. The vegetation also needs to be kept under control to prevent any structural damage.

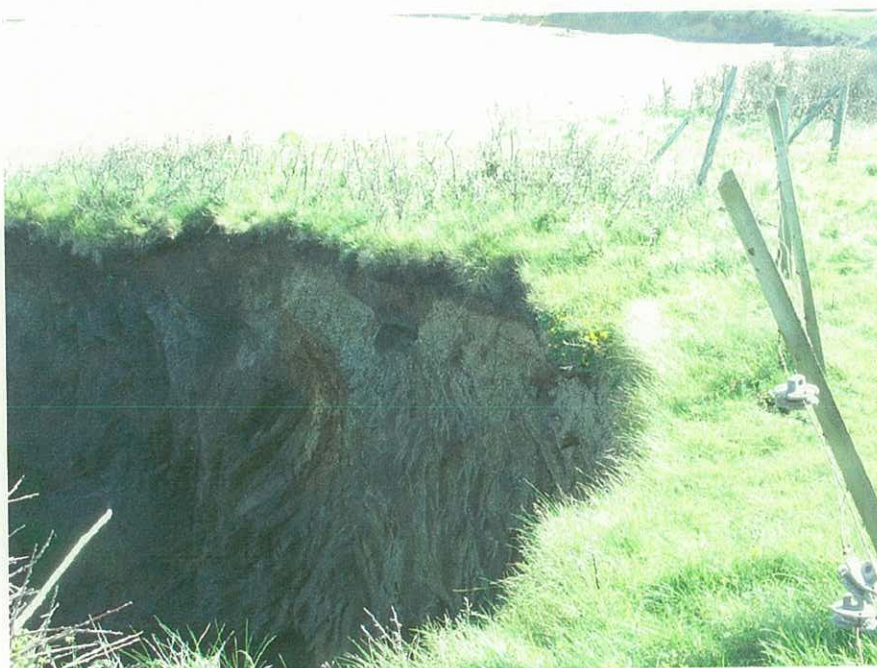
Plate 7 – cist graves visible in the cliff face (PRN 35095)

These graves are a valuable and important addition to the corpus of cist cemetery sites. Ideally an excavation should take place to record these graves and the inhumations they contain before they are lost. However, in the meantime the graves should be monitored to record further archaeological information as it comes to light.

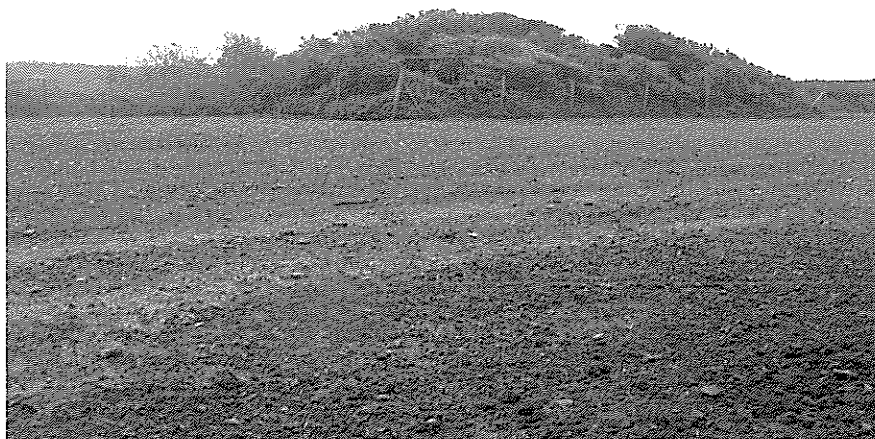
Plate 8 – Battle Headquarters (PRN 44599)

The vegetation should be monitored and kept under control to prevent any structural damage being caused to this site

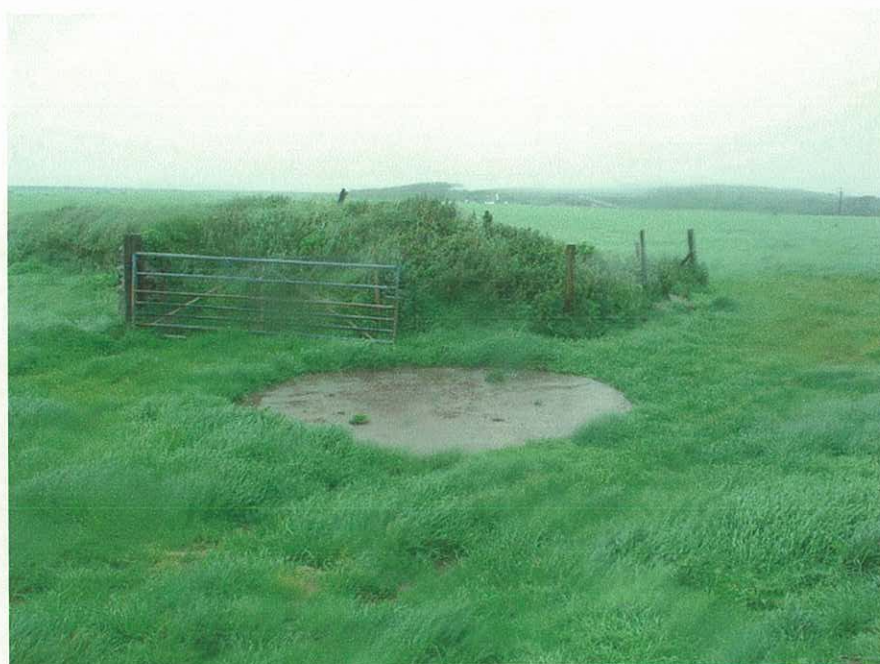
Plate 9 – the remains of an anti-aircraft battery (PRN 44603)

The fragmentary remains of what once was a Heavy Anti-Aircraft Battery should be retained and protected from any further damage.

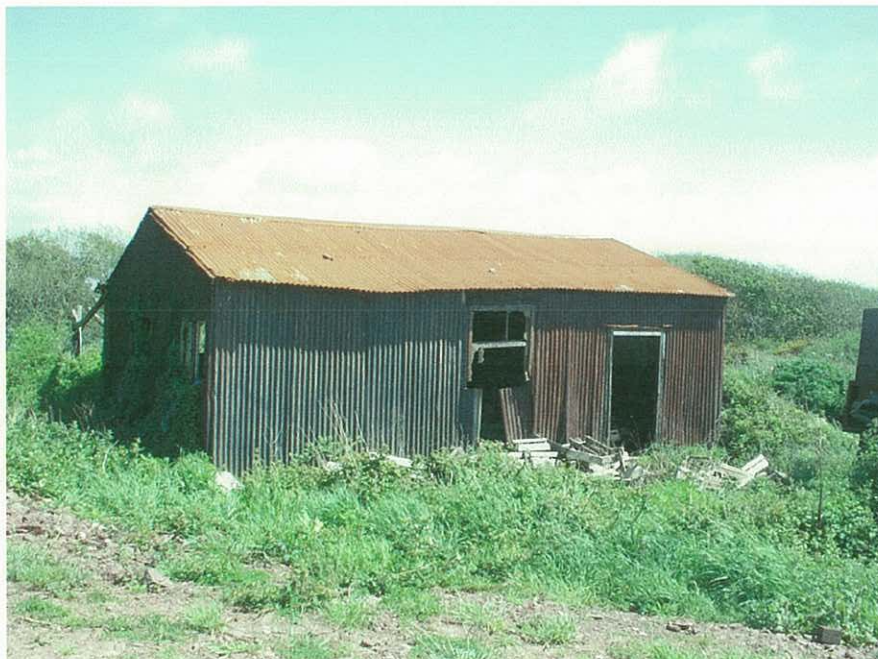
The guard room is as Roger Thomas describes, it has become very overgrown with ivy at the south west end and the corrugated iron is corroding. The windows are also smashed and the lean-to to the north has partially collapsed.

Plate 10 – a guard room (PRN 44606) to the east of Chapel Bay Fort

This building, if not attended to, will not survive very much longer in its current state. Although apparently vacant at the present time, has potential for reuse. Ideally it should be repaired and the corrugated iron treated to prevent its further decay.

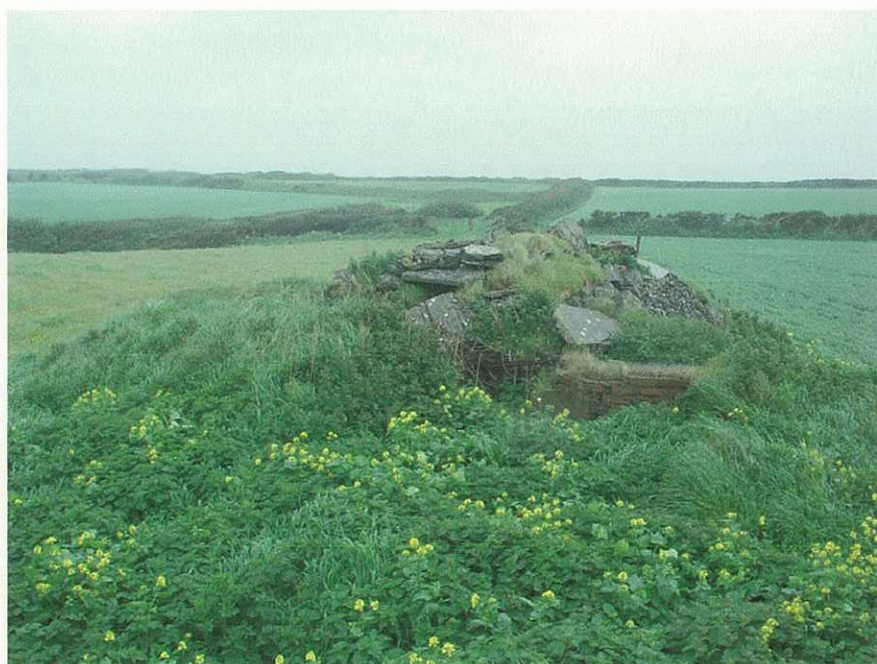
Plate 11 – gun pit associated with the anti-aircraft battery (PRN 44607)

This gun pit should be retained as a visible feature.

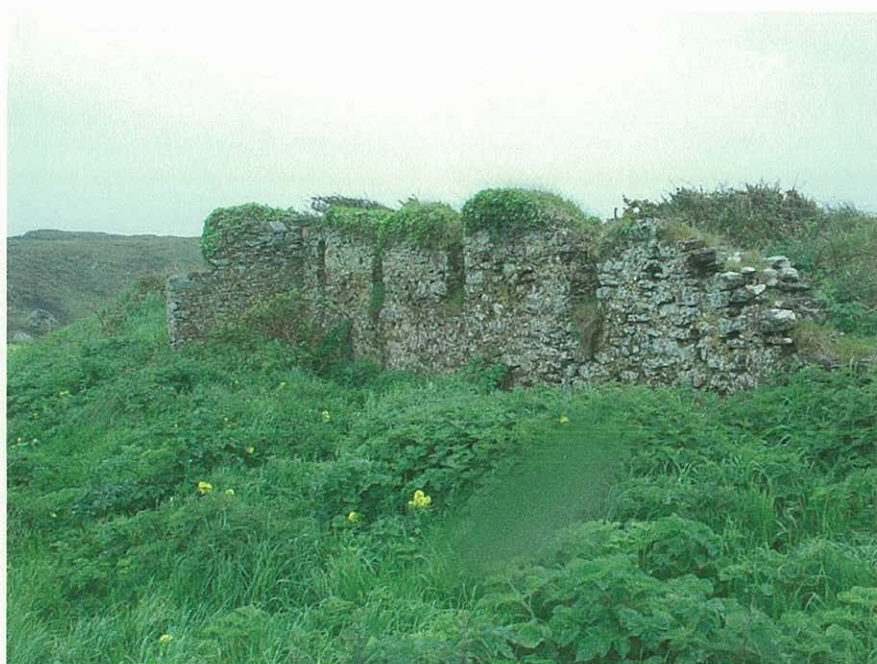
Plate 12 – the ruined remains of a building (PRN 44958)

This structure of unknown origin should be retained, and kept clear of intrusive vegetation. The proposed management regime of grazing; taking the adjoining field out of cultivation, should preserve any surviving archaeological remains which may relate to this structure.

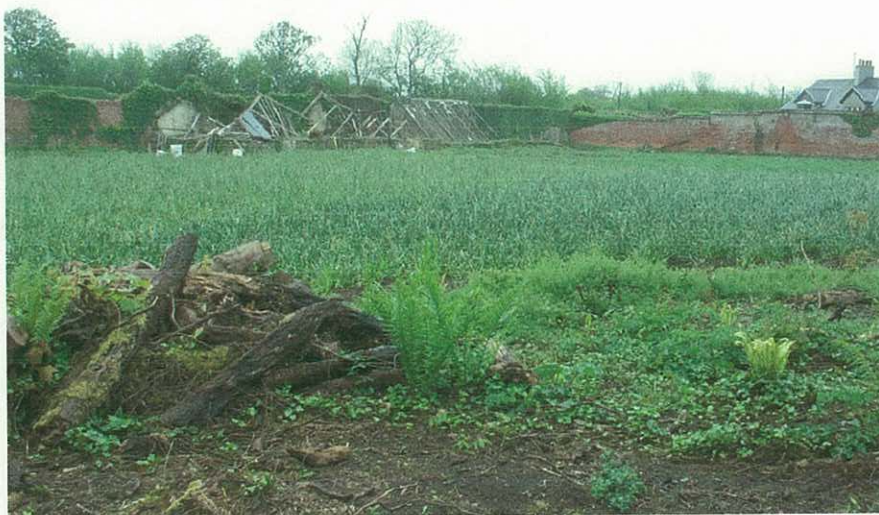
Plate 13 – a walled garden (PRN 44959) with glasshouses

This area presents great opportunities for the restoration of the walled garden and the associated garden structures. However, in the absence of such a project, these structures should be maintained to prevent their further deterioration. The vegetation should be cut back and allowed to die before being removed. The garden wall, which currently appears to stand to full height is particularly susceptible to damage from intrusive ivy growth and should be consolidated using appropriate materials.

Cambria Archaeology should be consulted prior to any works that are undertaken on these garden structures/features.

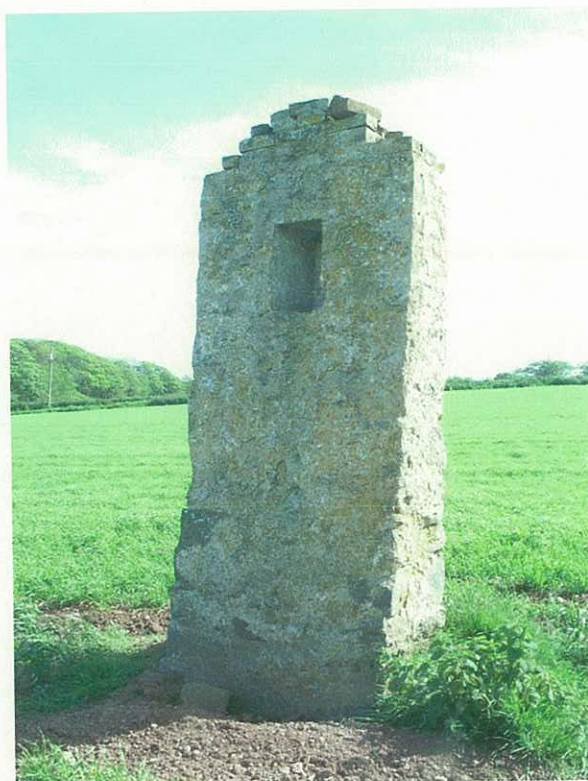
This feature is of unknown function and it is thought it may be a navigational marker of some sort. It is in a reasonably stable condition. However some brickwork at the top has become slightly loose.

Plate 14 – possible navigation marker? (PRN 44966)

Care should be taken that this feature does not deteriorate, and some consolidation of the brickwork maybe necessary.

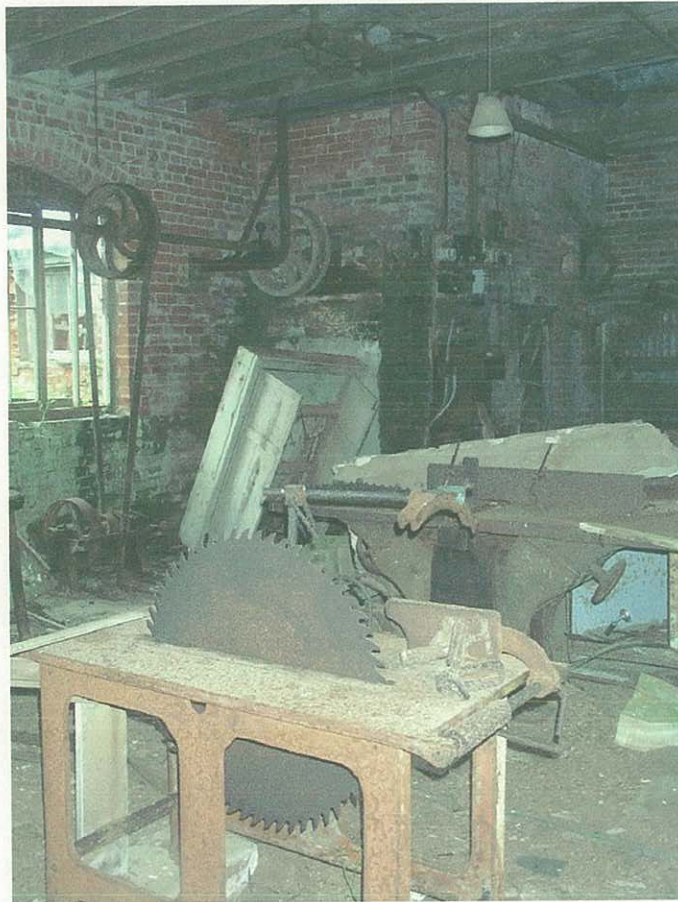
Plate 14 – the interior of the Home Farm workshop (PRN 44969)

The potential restoration and reuse of these buildings is to be welcomed. However, prior to any works being carried out an archaeological record should be undertaken of the buildings which should include the internal contents. Of great interest are the woodworking tools and smithing implements which survive *in situ*. The restoration should endeavor to retain the character of the building and should keep the historic fabric intact as far as possible.
