## **TIR GOFAL MANAGEMENT PLAN: HERITAGE MANAGEMENT INFORMATION (HE2)**

**Prepared for:  
The National Botanic Gardens of Wales**

**Tir Gofal Reference No  
W/12/0588**

**ACA Report No. 2006/61  
Project Record No. 39850**

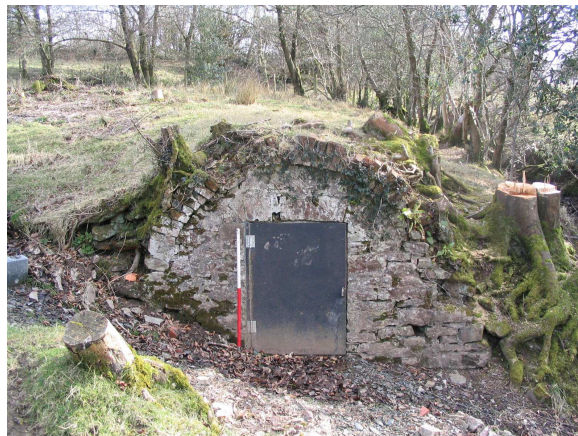
| | Name (& PRN) | Period/Site type | NGR | Status | SAM/listing | Management required |
|---|---|---|---|---|---|---|
| 1 | <b>MIDDLETON HALL</b><br><u>(31011)</u> | <b>Medieval?; Post Medieval well</b> | <b>SN53071804</b> | <b>B</b> | | <b>Specific</b> |

The well-head lies beneath a low brick barrel-vaulted building partly set into the hillside. Entered through a low door in the limestone north (end) wall. Undoubtedly the spring in the park mentioned in the 1824 Sale catalogue which formerly supplied Middleton Hall and outbuildings (also owner, Waun-las Farm, pers. comm.). The end wall is stone faced with brick arches over the doorway and the barrel vaulted top. Ash trees have seeded in the top of vault and brick have been pushed out from the face. Fortunately this damage has been arrested recently by the trees being felled and the roots left in place. *Visited 22/03/2006 (Alice Pyper)*

*The barrel vaulted well – head, fortunately recent work by the farmer has arrested the damage being caused by tree roots. It would be beneficial to continue this work and carry out some consolidation work of the structure.*

Appropriate action has recently been taken by the farmer to arrest the damaging root action by the ash trees. However, some consolidation should now take place to stabilise and repair the structure. Advice should be sought from a building conservation professional.

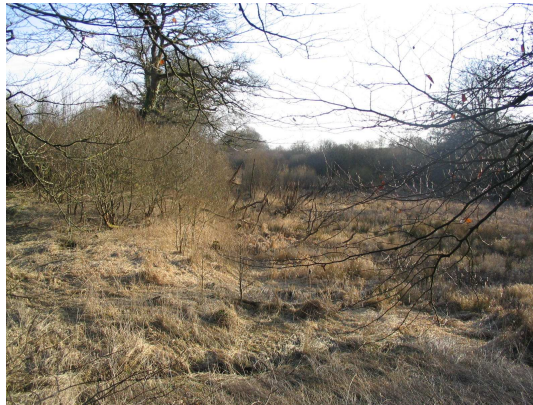
| | <b>MIDDLETON HALL</b><br><u>(30978)</u> | <b>Post Medieval ornamental lake</b> | <b>SN52511858</b> | <b>B</b> | | <b>Generic</b> |

Roughly 'L' shaped, fourth and largest of the series. Dam at southern end retaining higher Waun-las pond, northern end retained by dam, earthwork has survived. Horner (1815) depicts existing shape of lake with a subsidiary lake midway along eastern section, however on the Sale Plan (1824) it is only marked as an inlet. Path on eastern side of lake no longer evident, western section survives as earthwork set back from original lake edge, pronounced leading towards bath house (30984). Water remains in northern section, silted and colonised by trees. Pond du exits into the Lower Pond (30979) via two outfalls. One represents the natural stream valley (Horner, 1815; Sale Plan, 1824; Tithe map, 1849) the main outfall was via the extreme north east end and the channel was retained by a long earthwork dam leading to cascade (30980). NDL 1995

Due to breaches in the dam walls at the north end the lake water levels are currently low and quite choked with vegetation. *Visited 22/03/2006 (Alice Pyper)*

*A view looking south across the ornamental lake, which shows the accumulation of vegetation*

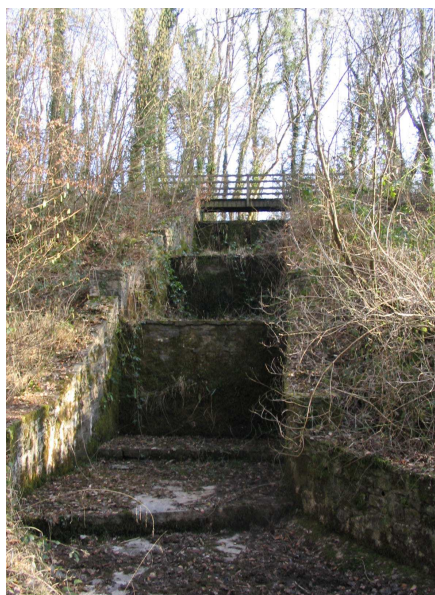
**MIDDLETON HALL**  
**(30980)**

The cascade leading from Pond Du to the confluence with the Gwynnon was dry when visited, 7/9/95. It may also be attributed to Grier. It was restored under MSC without prior recording. Southern half sympathetically restored to three limestone rubble tiers, each 2m high and floored with large regular slate slabs, between a downhill sloping limestone rubble parapet. The uppermost level now floored with concrete and crossed by a timber bridge. The lower northern half is a shallow curving chute with two low steps, floored with concrete in which limestone slabs have been set. NDL 1995 Condition in 2006 was much as described as that in 1995. *Visited 22/03/2006 (Alice Pyper)*

*The restored dry cascade*

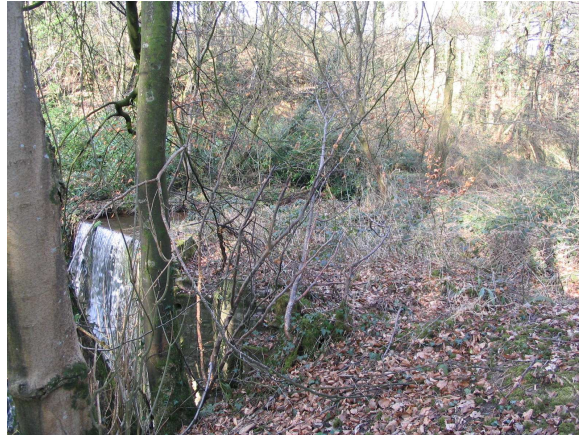
| <b>MIDDLETON HALL</b><br><b><u>(30986)</u></b> | <b>Post Medieval</b><br><b>reservoir</b> | <b>SN53011868 B</b> | <b>Generic</b> |

Pond supplying the waterfall (30990) and retained by its dam. Shown by Horner (1815) who terms it as the 'reservoir', called the 'Lower Warren Pond' in 1849 (Tithe map). Coeval with the waterfall. Formerly with a regular oval outline, now marsh. NDL 1995 When visited in 2006 the pond was choked with silt and populated with trees and scrub. *Visited 22/03/2006 (Alice Pyper)*

*The waterfall and pond beyond which has become engulfed in vegetation.*

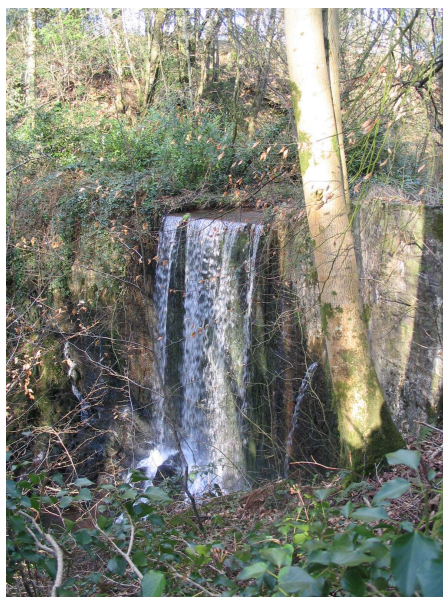
| <b>MIDDLETON HALL</b><br><b><u>(30990)</u></b> | <b>Post Medieval</b><br><b>water garden</b> | <b>SN52951872 A</b> | <b>Generic</b> |

A masonry faced waterfall supplied by the former Reservoir (30986). Doubtless part of Grier's original work it is marked as 'Cascade' on the Horner drawing (1815). Partly restored in the 1980s but largely original fabric. It is a curving limestone rubble dam, 5m high and over 2m wide, and vertical down which the Gwynon falls onto rocks below. There are the remains of a slight parapet on the downstream side. NDL 1995. The waterfall appears in 2006 much as it has been described in 1995. The pond behind it is silted up and brambles and self seeded trees have colonised the south side of it. *Visited 22/03/2006 (Alice Pyper)*

*The early 19<sup>th</sup> century waterfall – subsequently restored in the late 20<sup>th</sup> century*

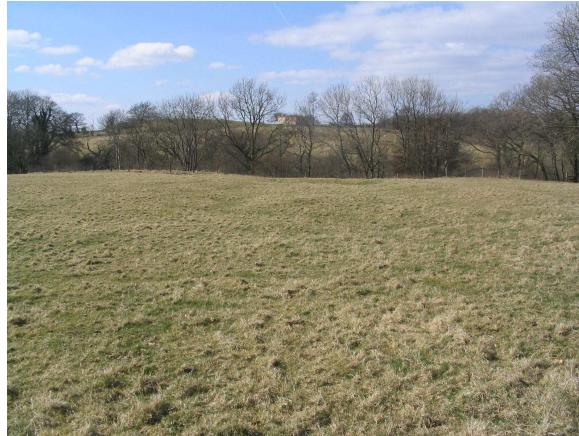
**MIDDLETON HALL**      **Medieval?; Post**      **SN52601823**      **A**      **Generic**  
(31009)      **Medieval mansion**

Complex of earthworks. Massive earthwork platform, defined by scarps substantially raised on the downslope side. The complex can be seen to lie beneath a park pathway, and has been interpreted as being the earlier mansion site (4570; Lloyd-Fern et. al), known only from documentary sources. The field name in the Tithe survey does not suggest any former function 'Lower Walks'. However a Farthing of 1773 was found here associated with an area of mortar. NDL 1995 This extensive area of earthworks occupies the area to the north of Waun-las and between the stream and the field boundary. The earthworks are up to 0.5m in profile in an area of pasture. The 1st edition shows that this area was planted with specimen trees however none remain. This archaeologically highly sensitive area is in stable condition at present and will remain so as long as no development or ground intrusive activities of any kind take place. *Visited 22/03/2006 (Alice Pyper)*

*The site of the former mansion can be identified by low earthworks shown in the photograph above, looking west.*

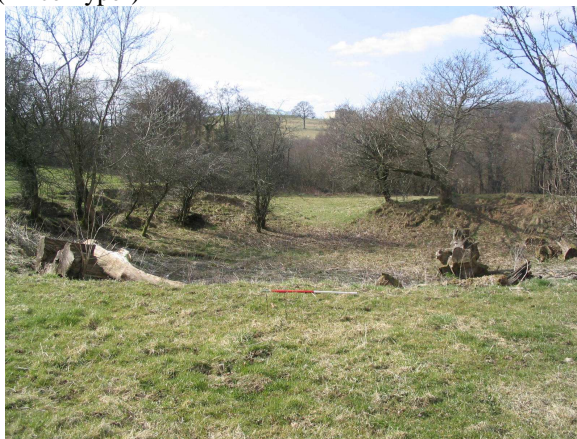
(56603)      **Post Medieval;**      **SN5266218378**      **U**      **Generic**  
      **Modern**  
      **earthwork**

A circular depression, marked on the 2nd edition Ordnance Survey map of 1906 but not on the 1st edition of 1888 (Carm sheet 40.11). The feature is approximately 18-20 m in diameter and c 2m deep. Trees stumps are found within the feature, but mostly not *in situ* and probably result from field clearance in the past. Scrub and thorn trees have now populated the banks. The bottom of the feature is flat but rough and poached. The banks are steep with a sharp break of slope and more gentle at the lower break of slope. An 'entrance' is located in the SW quarter of the feature with a linear depression leading from it to the pond below, this follows a line of sight to the location of Middleton hall. It is thought locally to be a horse training or lunging arena. Visited 22/03/2006 (Alice Pyper)

*The circular depression with a linear entrance in the southwest.*

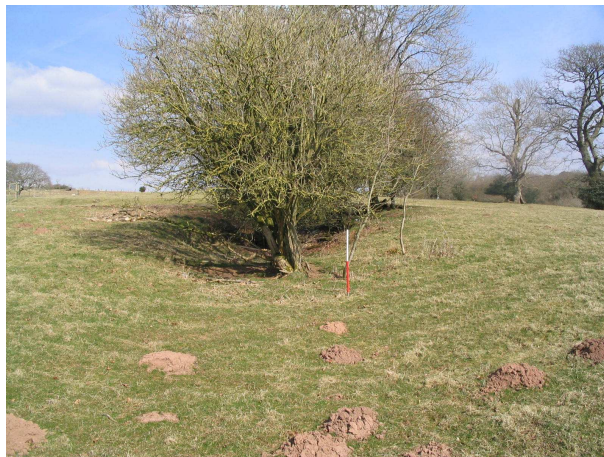
A linear depression running southwest to northeast, which may be a former trackway although no tracks are shown in this location on the tithe and 1st & 2nd edition Ordnance Survey maps. Up to 1m depth in places and c 4 m wide. Self seeded trees including thorn populate this feature. *Visited 22/03/2006 (Alice Pyper)*

*A linear depression of unknown origin but possibly a trackway.*

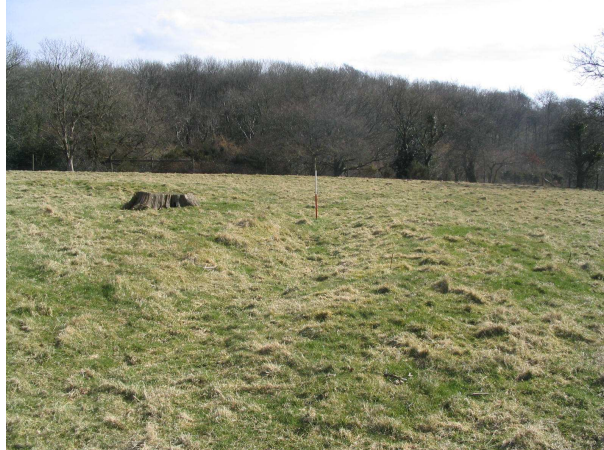
Circular or slightly elliptical enclosure c. 40m in diameter consisting of a low bank and outer ditch with some upcast on the lower slopes. Ditch c 0.2 m deep and banks 0.2 m high. Situated on a gentle south facing slope. Identified by the RCAHMW in aerial reconnaissance. Shown as a clump of planted trees on the tithe map which would have been visible from Middleton hall. A couple of relic tree stumps survive within the earthwork and interior is generally quite rough, which in common with the rest of the field, is semi-improved. It is possible that this feature has its origins in the Prehistoric period when farmsteads and small community groups were centred on a defended enclosure. It is possible that the existing feature was then reused to plant trees in a clump (a characteristic of the Middleton parkland landscape) and thus provide a landscape feature. *Visited 22/03/2006 (Alice Pyper)*

*The ranging pole is positioned in the outer ditch of what may be a prehistoric defended enclosure.*

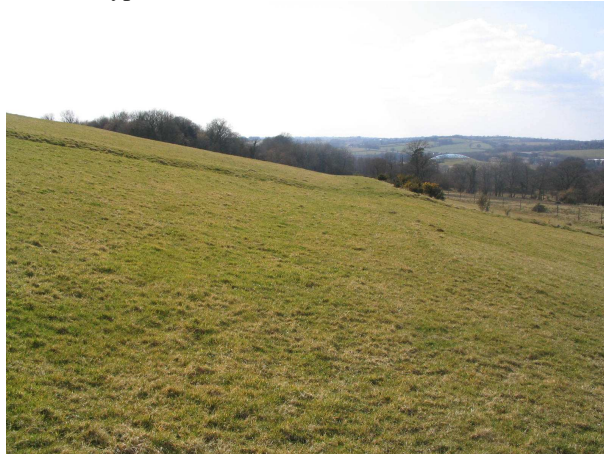
(56610)                      **Unknown                      SN5340418247   C                      Generic**  
                                 **trackway**

A linear earthwork running west-southwest by east-northeast and skirts around the contour before ascending towards the road. Terraced into the slope. It is likely that this is the remains of a path shown on the tithe survey. *Visited 22/03/2006 (Alice Pyper)*

*A former trackway shown on the tithe survey survives only as a low earthwork terrace in the hillslope.*

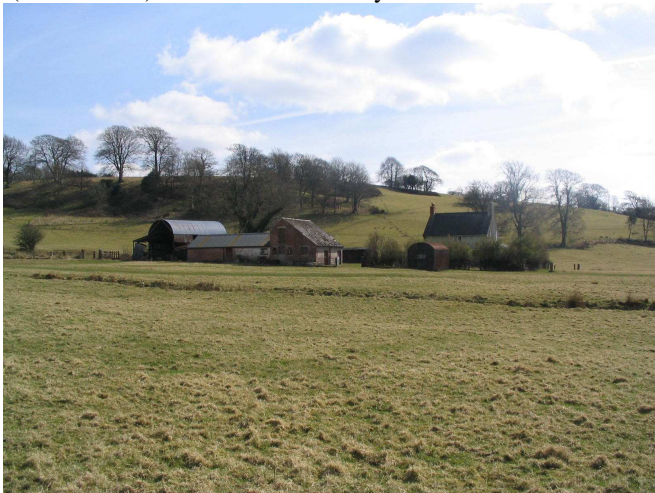
| Name (& PRN) | Period/Site type | NGR | Status | SAM/listing | Management required |
|--|---|---|---|---|---|
| <b>WAUN LAS (<a href="#">56605</a>)</b> | <b>Modern farmstead</b> | <b>SN5272318092</b> | <b>B</b> | | <b>Generic</b> |

| Name (& PRN) | Period/Site type | NGR | Status | SAM/listing | Management required |
|--|---|---|---|---|---|
| <p>Waun Las is a largely brick built farmstead, of 1930-40s origin. Rendered farmhouse. Single storey cow shed with a two storey stable/granary at one end and an adjoining outbuilding at the other. Roofed in slate except for corrugated box sheeting roof on low building. Corrugated iron hay barn. Mirrored layout to the farmstead at Pant Wgan (PRN 56612). Farmstead currently uninhabited. <i>Visited 22/03/2006 (Alice Pyper)</i></p> | | | | | |
| <p><i>The 20<sup>th</sup> century farmstead of Waun-las is currently uninhabited.</i></p> | | | | | |
