# Tir Gofal Farm Visit Report

## Ynysgreigiog

### W/11/49

ACA Project Record Nø9854

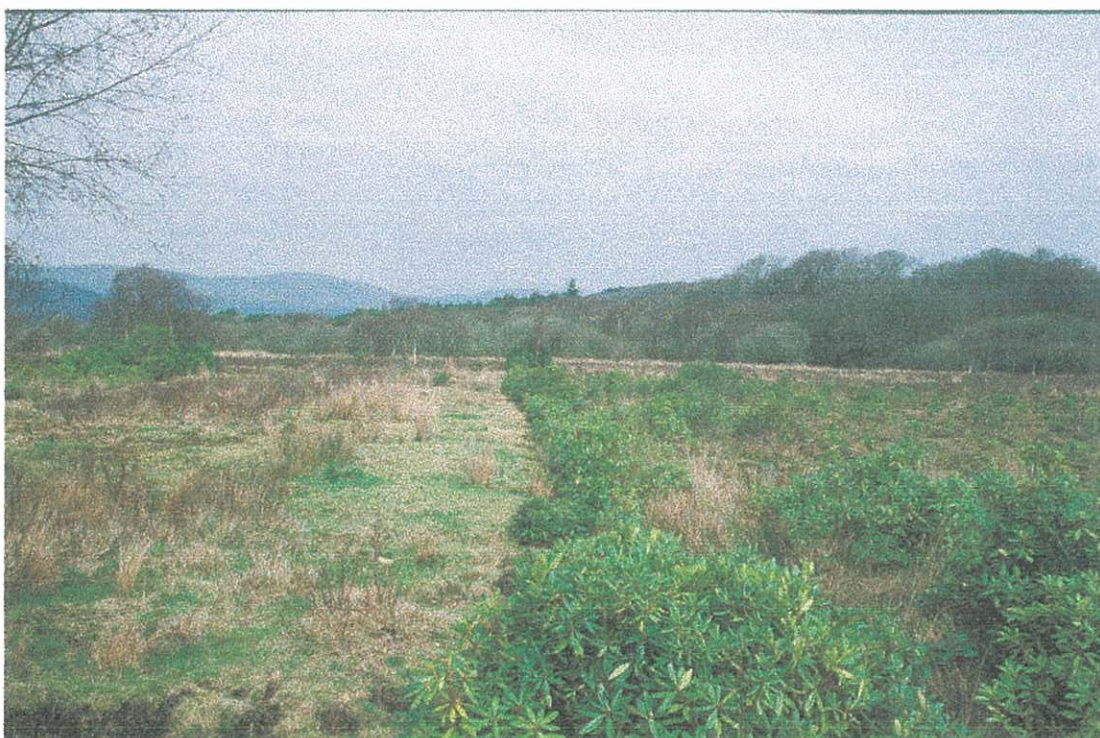
Area of peat bog formerly used by locals for peat cutting. The peat cutting has reduced the level of the area by some 0.5-1m below the surrounding ground surface. A strip of higher ground running across the area may have been an access route, or it may be an area left uncut when extraction ceased.

Plate 1: PRN 39394 - area of old peat cutting.

This area is being proposed as a habitat area within the Tir Gofal scheme and is therefore protected from further direct damage. This type of wetland environment has enormous archaeological potential (the waterlogged and often anaerobic conditions preserve a wide range of archaeological material not usually recovered from dry sites) and it should be kept waterlogged

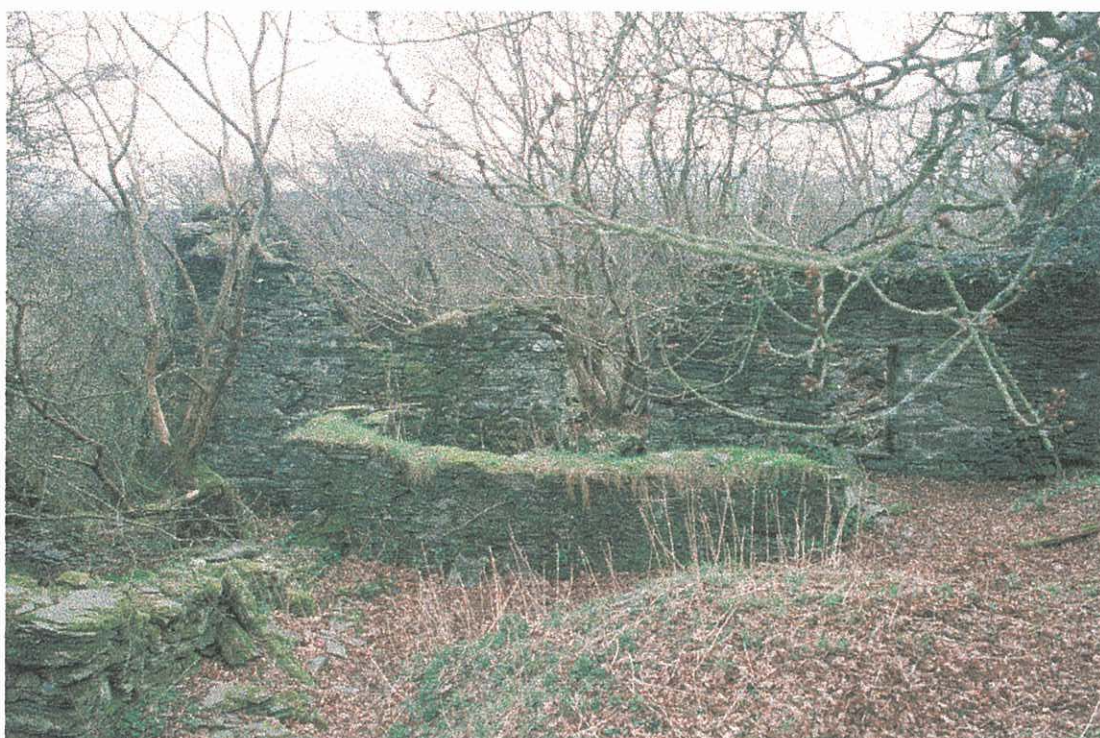
Remains of a stone-built house with a gabled roof. The house, which is now roofless and in a ruinous condition, consisted of a main northeast-southwest range with a smaller, gabled range on the northeast end of the northwest side. A small rectangular extension, that was central along the main range was located in the angle of the two ranges. The smaller gabled range had an enclosure on its northwest side. The site is now overgrown and is partially covered, with rubble and fallen masonry making it difficult to determine an exact ground plan. A door in the northeast wall of the main range leads from the small extension. There is a stone vent loop in the southwest end of the main range which suggests that this area of the building formerly held animals. It may be that the house was originally a longhouse, where people and animals were housed in the same building, before developing into its final form. The longhouse is one of the earliest types of farm buildings and if Ynys Fach farmhouse has developed from the longhouse tradition it may argue for a long occupation of this site.

Plate 2: PRN 39390 - the overgrown remains of Ynys Fach farmhouse.

Ynys Fach farm is included in a survey dating from 1788 which shows that the layout of fields, tracks and the main buildings were well established by the later 18th century. The possible origins of the house as a longhouse is interesting because it may indicate a longer history of occupation on this site. The house should be maintained in its present condition.
