Tir Gofal Farm Visit Historic Environment Report

Report No. 2003/77

REPORT NO. 2003/77
PROJECT RECORD NO. 39860

Caldey Island
Tir Gofal Farm Visit Historic Environment Report

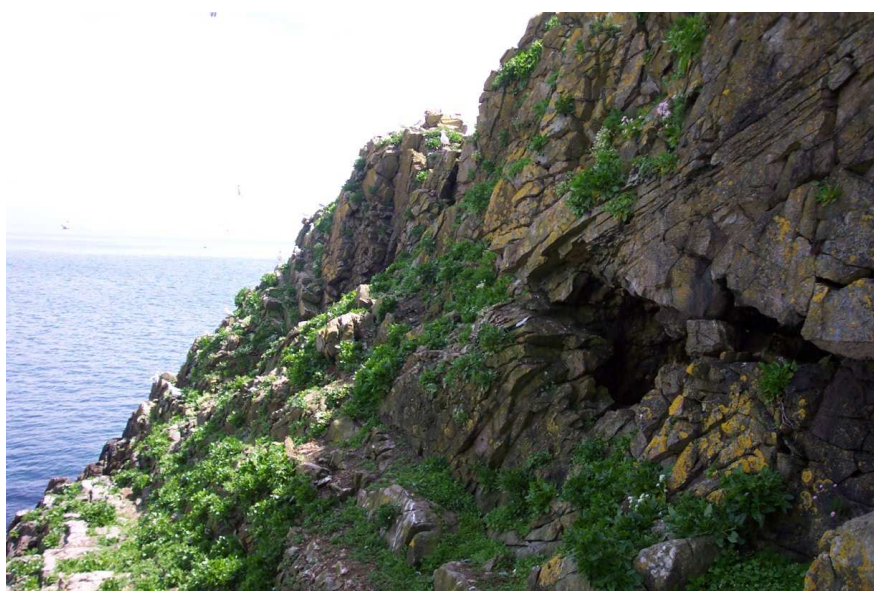
Plate 1. *looking towards the cave opening (PRN 3445) at Daylight Rock*

The ground surface within the scheduled area should not be disturbed. The rough grassland and scrub should be maintained under the current management regime. Access to the site should not be encouraged.

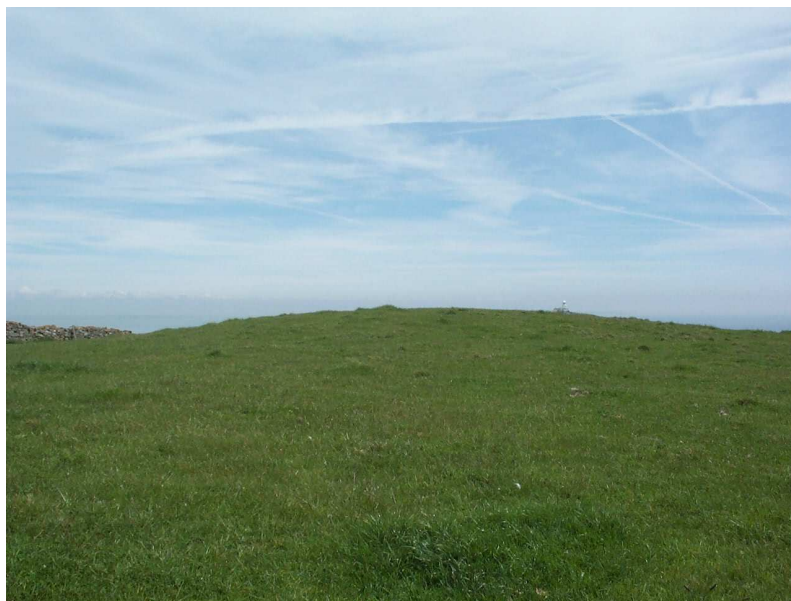
The site of a large round barrow. The barrow is about 20m in diameter and has a height of around 2m in its centre. It has an even, symmetrical circular shape, but the edges are not clearly defined. At present, the site seems to be in a good condition – it is under pasture, and has a stable turf cover.

Plate 2. *A substantial round barrow (PRN 3829). It is in a stable condition and the current management regime should be continued.*

The present management regime seems to be suiting this site very well, and should be continued. Grazing should be controlled in wet weather to prevent erosion of the turf covering over the site.

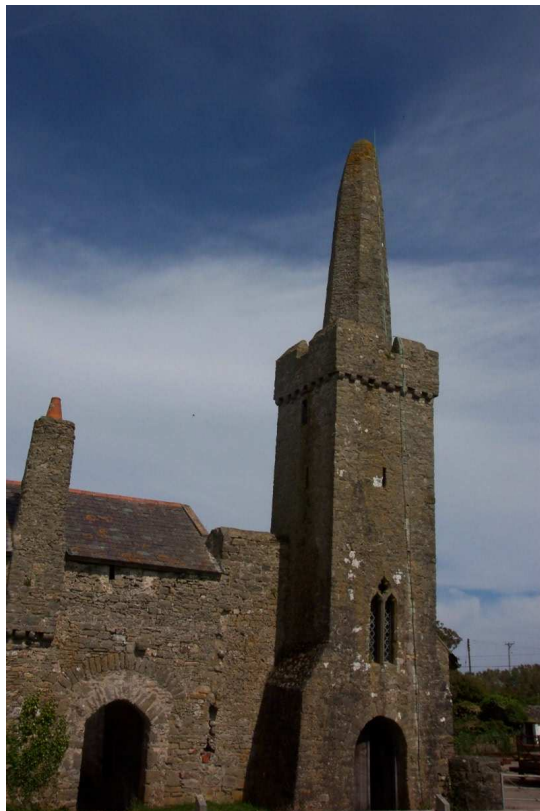
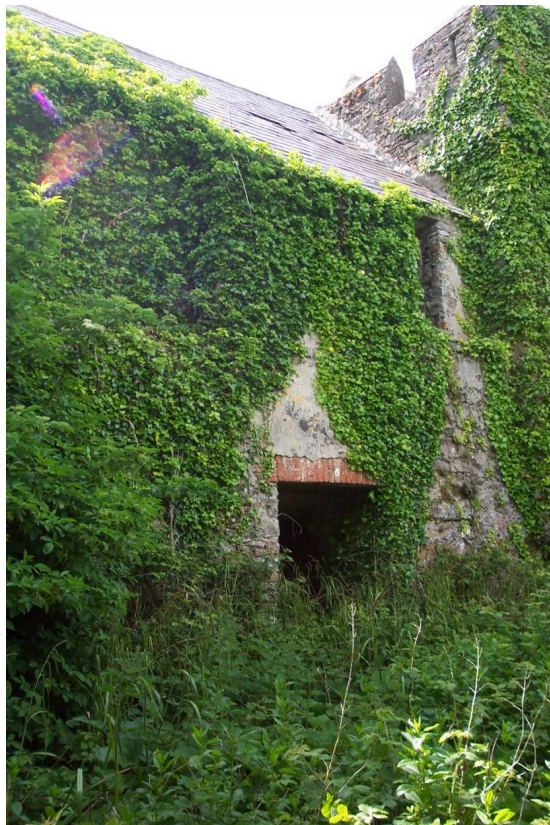
The pitched roof of the eastern range is in need of attention. Many of the roof slates are loose and several are missing, particularly from the eastern pitch of the roof. Of particular concern is the heavy ivy growth over the eastern elevation of the complex, which is penetrating under the eaves and may be damaging the roof structure. The ivy growth may also be eroding the lime mortar masonry bonds. Some of the masonry at the foot of the interior elevation was found to be crumbling and unstable at the time of the archaeological farm visit.

Structural weakness has been identified on the northern interior of the gate passage. A large crack projects up the wall from a door arch up to the first floor level. Windows in the interior of the west range are in poor condition, partly rotten and having lost the glass. Water ingress through these openings is a concern as it may be promoting rot and weakness in the floor joists, which provide an important binding influence to the structure. The cobbled floor in the chamber to the north of the entrance passage was found to be eroded and breaking up.

Plate 3. (left) *The priory (PRN 4278) viewed from the south. Compare this façade with plate 4.*
Plate 4. (right) *The east side of the priory complex. Vegetation has almost completely swamped this site and is causing structural damage.*

Repairs to the fabric and roof of the complex are long overdue. Missing roof slates should be replaced and damaged elements of the roof structure repaired. The ivy growth on the east elevation of the eastern range should be cut back, spot treated to prevent re-growth, allowed to die and then removed. Damaged areas should be consolidated using materials faithful to those of its original construction. This should be followed up by a programme of more general masonry consolidation in areas of the building with weakened masonry bonds. Missing windows should be replaced in order to bring the building back into a weatherproof condition. Ideally the cobbles on the northern interior of the gate passage should be replaced and consolidated. Any repair works should be in consultation with Cadw and the Pembrokeshire Coast National Park Authority building conservation officer.

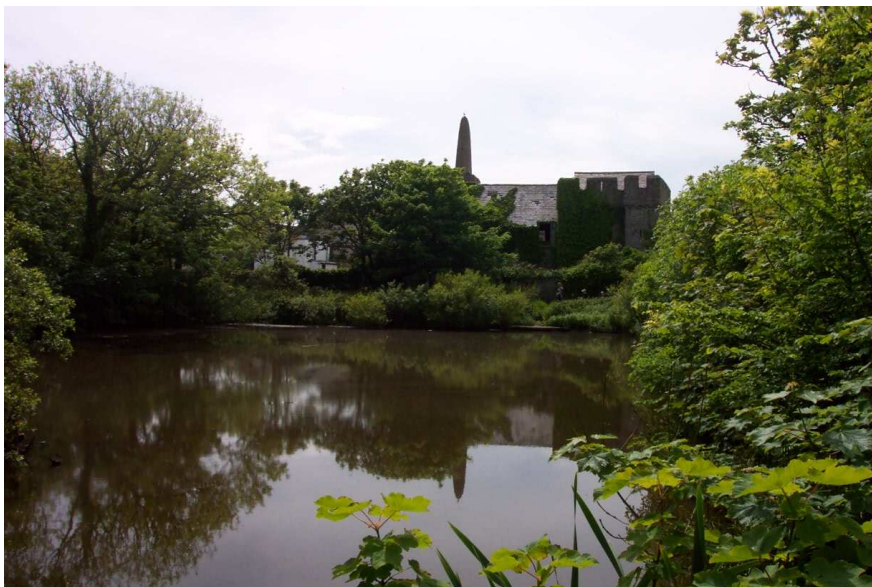
Plate 11. *View west from pond (PRN 4279) towards Caldey Priory (PRN 4278)*

The pond is an important historic element of both the priory complex and nineteenth century garden layout and should be retained. It is heavily silted and should ideally be dredged in order to ensure its long-term survival. Any restoration works should be in consultation with Cambria Archaeology and Cadw. Care should be taken not to damage the original pond lining or stone edging.

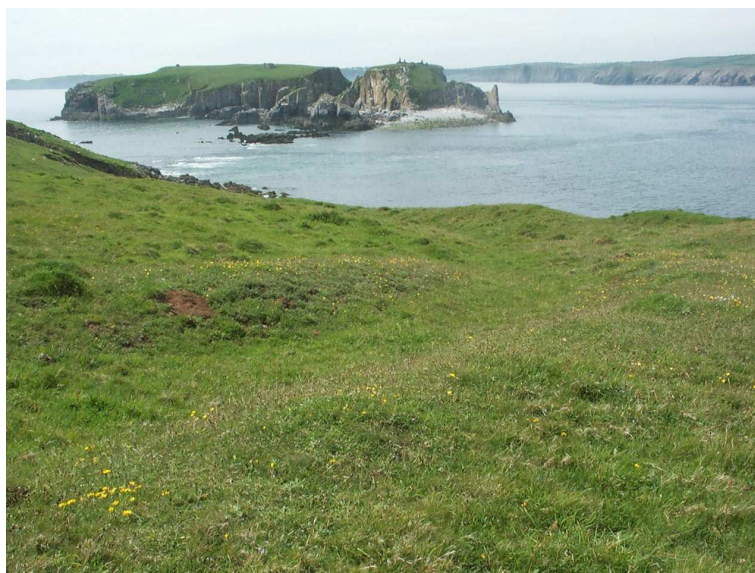
The site is in a good condition, and is under pasture.

Plate 5. *The hollow way (PRN 9777) can be seen in the middle of the picture, leading towards the causeway which connects Caldey with St Margarets Island.*

The current management regime of light grazing suits this site and should be continued. Grazing should be controlled in wet weather in order to ensure that the turf cover is not eroded.

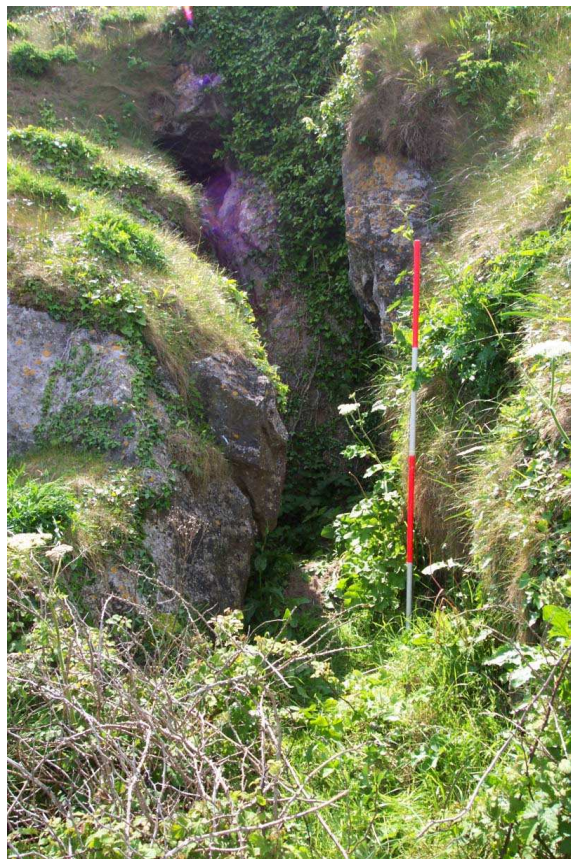
Plate 6. *The western mouth of Potters cave (PRN 13072)*

Potters cave is not easily accessible. At present, the opening to the east cave is overgrown with scrub. Nearby caves are open and appear to have been visited by members of the public. Potters cave appears not to have been disturbed due to the growth of vegetation outside the entrance. The ground surface within the scheduled area should not be disturbed. The rough grassland should be maintained under the current management regime. Access to the site should not be encouraged.

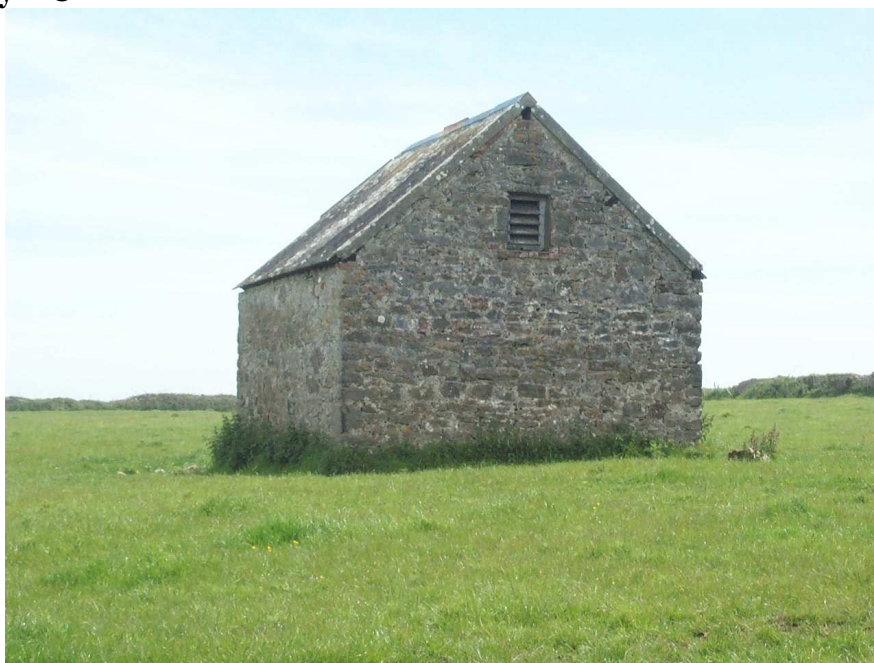
A small stone-built field barn or shelter, around 8m x 3m and orientated east-west. The building is in good condition, with wooden ventilation slats in the west gable end. It is now roofed with asbestos sheeting. The barn is first shown on the 1908 six inch to a mile Ordnance Survey map and is of an early twentieth century date.

Plate 7. *A small, stone-built field barn (PRN 48265).*

The building is in good condition, and seems to be in use. It should be ensured that future maintenance and repair works are carried out using materials and techniques which are sympathetic to the original construction of the building.

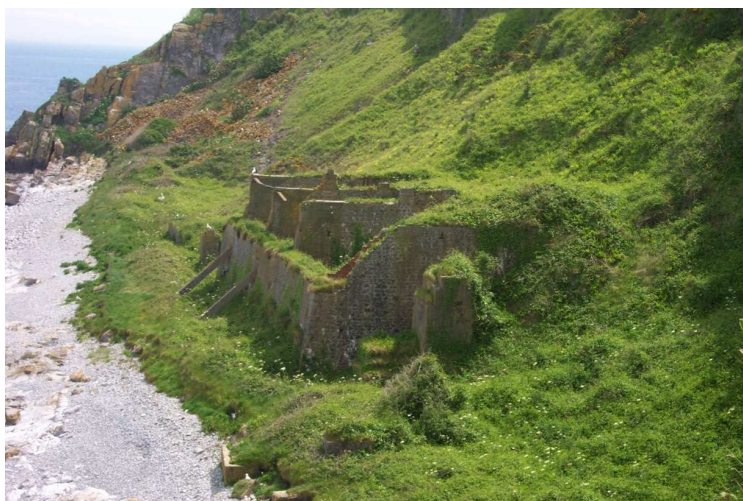
These hoppers may date to the most recent period of quarrying at High Cliff, between 1912 and 1921 (James 1999,p.3). They are currently in a ruinous condition and are heavily overgrown, particularly over the south and west elevations.

Plate 8. Looking east from High Cliff quarry (PRN 48270) to the hoppers (PRN 48301).

Ideally, the heavy vegetation growth should be cut back, allowed to die and then removed. This should be followed up by a programme of masonry consolidation where necessary in order to bring the structure back into a stable condition necessary for its long term survival. Any materials used should be compatible with those used in its original construction.

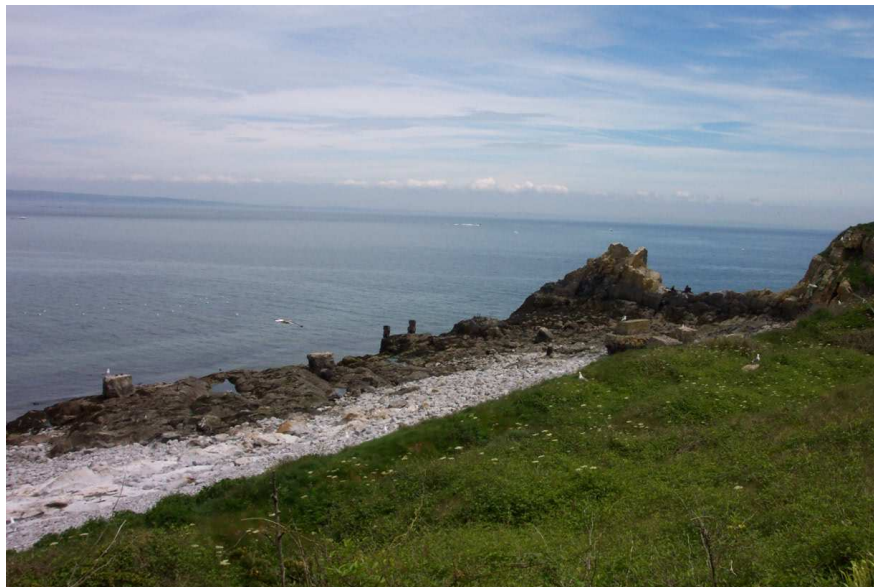
Plate 9. *Looking northeast towards the remains of the landing stage (PRN 48302) at High Cliff.*

Surviving elements of the landing stage should be retained as evidence of the limestone industry, which was an important part of the economy of the island from the early nineteenth century onwards.

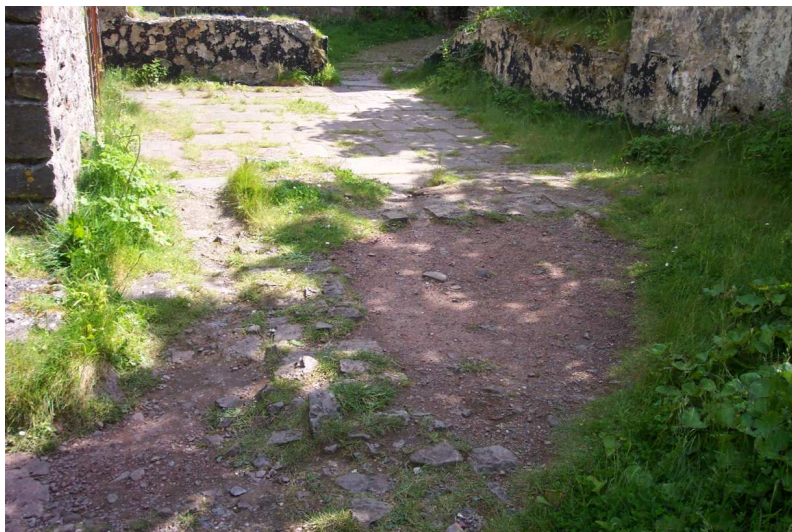
Plate 10. *Although demolished in 1970, the wall footings of Caldey House (PRN 48303) remain visible today.*

The mansion lies within an archaeologically sensitive area, which incorporates elements of both the present and former priory to the south and west, and nineteenth century garden features to the north. The remnant wall footings indicate the considerable potential for below ground archaeological remains relating to the mansion itself. In order to protect buried archaeological remains, no ground intrusive activities should be undertaken within 30 metres of the site.

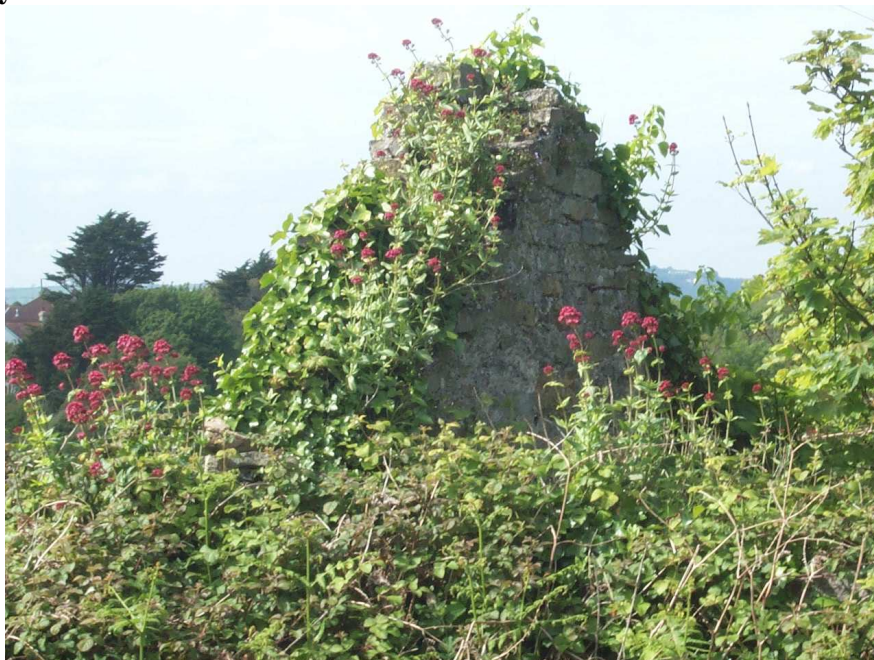
The building's relative isolation and its disuse are factors which are contributing strongly to its decay. With its views over the ponds to the east and farmland and coast to the west, it may be worth considering incorporating the remaining, stabilised structure into the 'nature trail' which leads through the garden, perhaps as a bird hide or wildlife observatory.

Plate 12. *The ruins of a garden building (PRN 4634), now heavily covered in vegetation.*

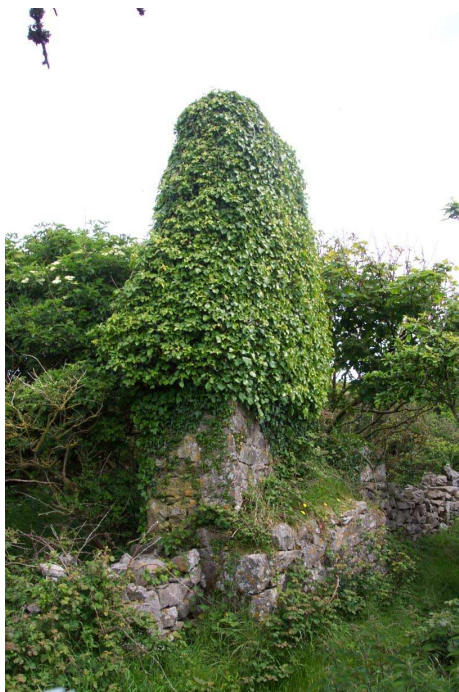
Plate 13. *The obelisk (PRN 48652), now heavily overgrown. It is not known who built this monument, or why.*

The ivy, which currently masks the obelisk is potentially damaging to masonry bonds. Ideally, the ivy should be cut off at the roots, allowed to die, and then removed. This should be followed up by a programme of masonry consolidation where necessary.
