**Tir Gofal Farm Visit Report**  
**Lower Hopshill**  
**W/13/2040**

REPORT NO. 2002/21

LOWER HOPSHILL  
TIR GOFAL FARM VISIT REPORT

**Tir Gofal Application Number** W/13/2040  
**Address** Lower Hopshill  
Hopshill Lane, Saundersfoot, SA89 9EU

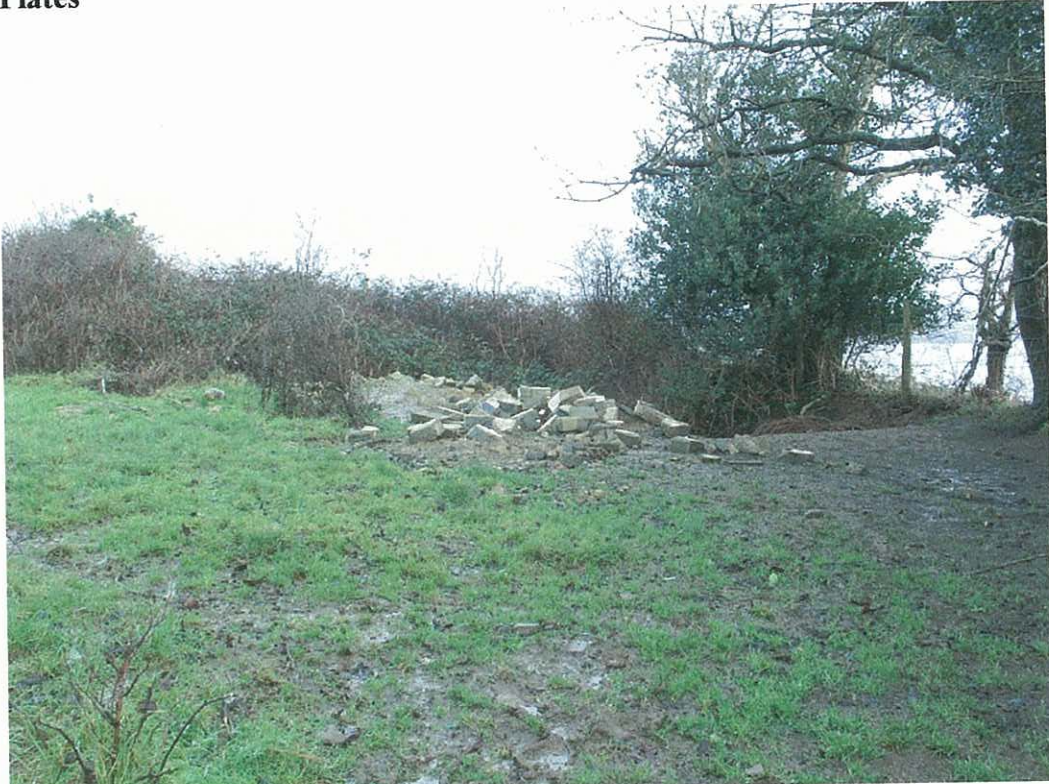
On the 1st edition Ordnance Survey map of 1891 to the east of the holding an 'Old Quarry' is recorded. The quarry has now been largely filled and has thorn bushes and brambles growing to the west side of it (plate 1). It is approximately 34m east west by 20m north south.

Plate 1 – the old quarry (PRN 44340) which has largely been infilled.

The farmer, Mr Merriman, has expressed an interest in opening up this quarry to obtain stone, this would be preferable to opening up new quarries elsewhere.

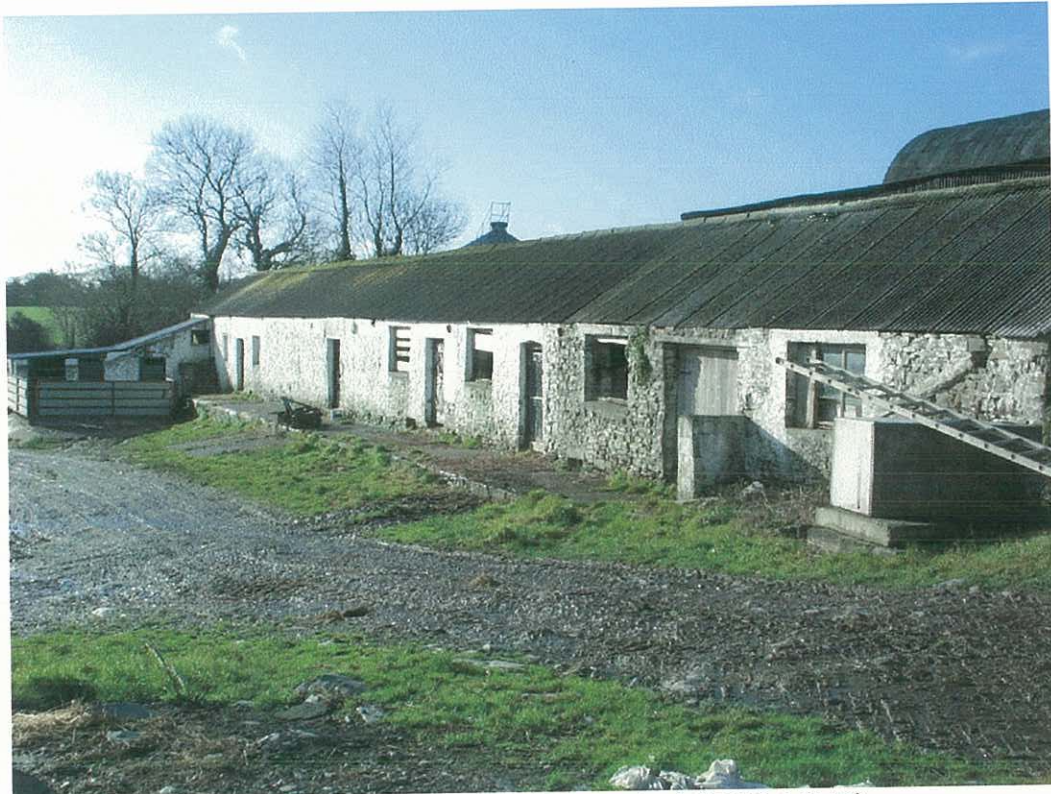
This long range of buildings is positioned on a north east south west axis, constructed out of whitewashed rubble walling built to courses with roughly squared quoins (plate 2). The roof is pitched and covered with corrugated iron. The cow shed extends across a slight gradient; with the lower, south west, end of the building two storeys high. The south west gable end has double garage doors at ground floor level, a central window above and three rows of nesting boxes built into the apex. Access to the 1st floor is gained through external stone steps on the south east elevation. A stone and block work lean-to is built against the south east end. There are nine doorways in the south east facing elevation alternately spaced with windows which have all been modified with concrete lintels and sills, in addition a single ventilation slit is positioned towards the lower end.

The documentary evidence suggests that the south west end of this range dates from the late 18th century. This could not be confirmed during the limited investigations of the farm visit, and it is possible that the whole range was rebuilt at a later stage in the 19th century. It seems that the building had taken its current form by the time of the 1st edition Ordnance Survey map in 1891. This building is currently in reasonable condition although there is a hole in the apex of the roof at the north east end.

Plate 2 – the south eastern elevation of the cow shed (PRN 44342).

The roof of the cow shed should be repaired to prevent water ingress damaging the structure and the building should be maintained using traditional materials. Mr. Merriman, the owner, states that although partially used as a store the cow shed is largely redundant. If alternative uses are considered which would involve alterations to the structure these should preserve the historic fabric as far as possible and retain the existing openings.

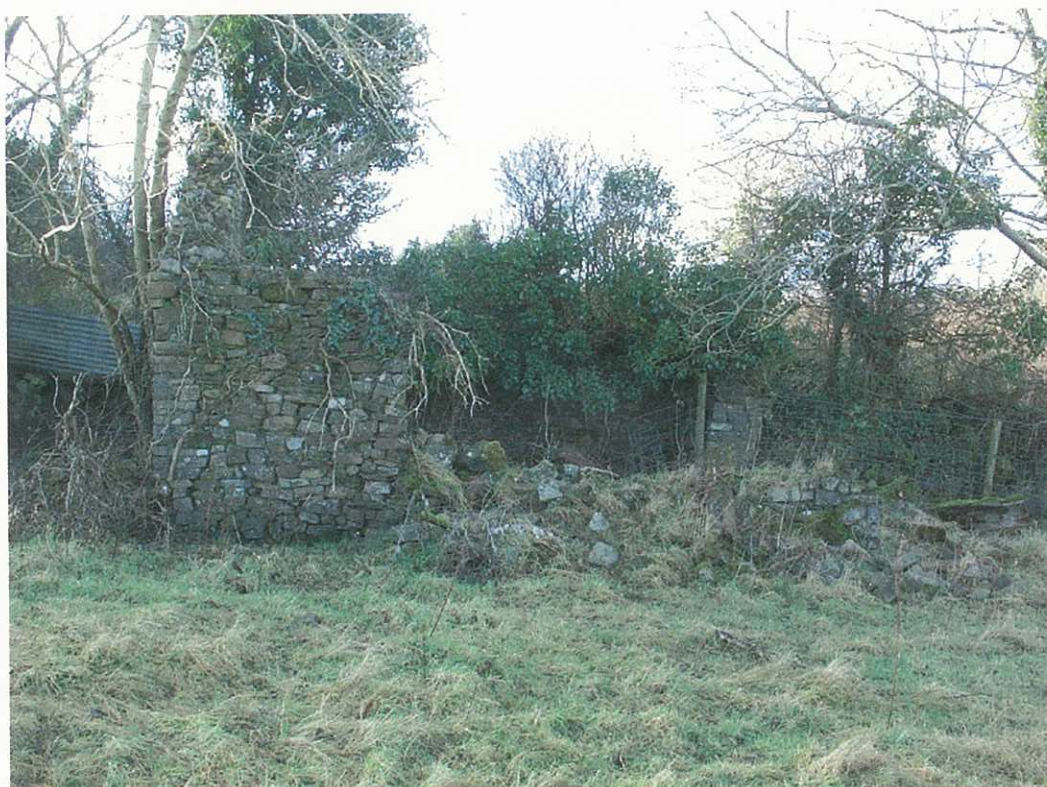
To the south of North Watson farm and adjacent to the western field boundary are the remains of a small stone built structure (plate 3). The building is approximately 5m by 6m, the only wall standing to full height is the south gable wall. The building is orientated on a north west to south east axis, constructed out of stone rubble walling and a lime mortar. A blocked cart entrance is visible within the southern gable wall. There may have been a cart entrance in the north gable end, however the masonry has collapsed to ground level and it is therefore uncertain. The roof was pitched and latterly covered with corrugated iron, indicated by the sheeting which lies strewn about. A small stone built recess is situated in the south east internal corner.

The cart shed is in a ruinous state; the south west gable is the only wall still standing to its full height and this is very overgrown with ivy.

Plate 3 – the remains of a cart shed (PRN 44344) to the south of North Watson farm.

This cart shed should be preserved as a visible feature; the ivy should be cut and allowed to die before removal. Ideally the masonry should be consolidated to prevent further collapse.

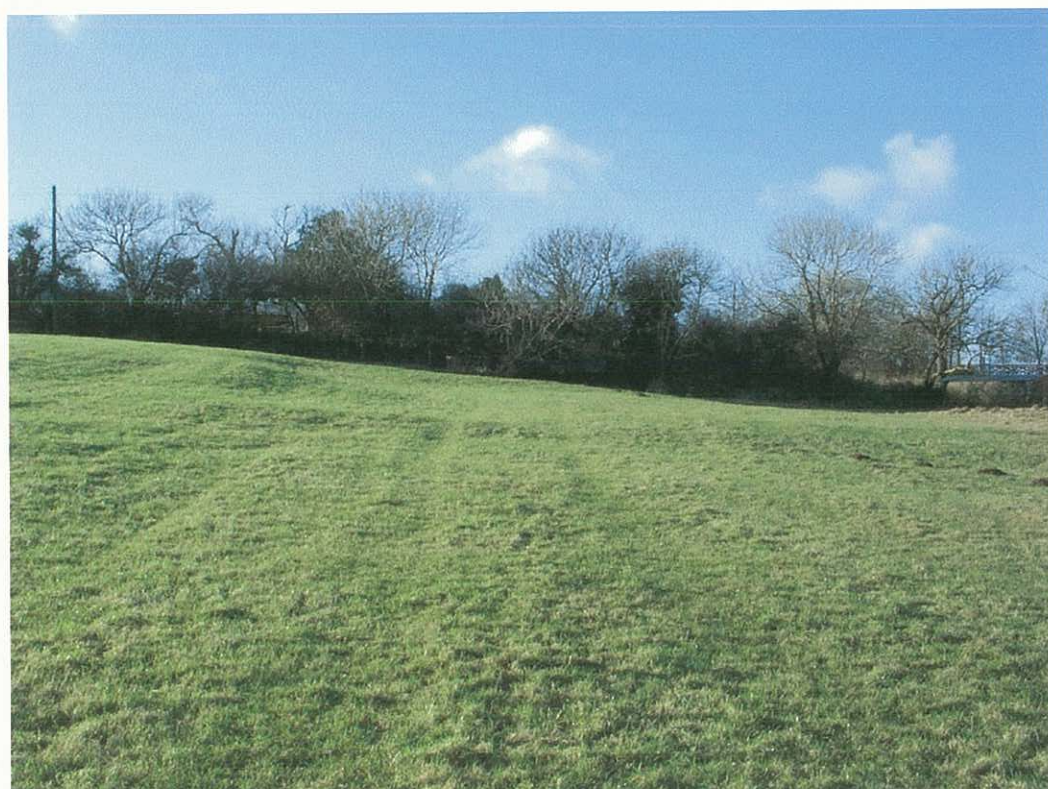
In the north east corner of the field, close to North Watson farm, is the L-shaped low earth bank of an enclosure (plate 4) together with other anomalous earthworks. The enclosure survives as a low bank approximately 21m east west by 27m north south. This earthwork appears to be shown on the 1787 map and identified in the associated schedule as 'Houses, gardens &c' although no built structures remain visible. The Tithe map also indicates various smaller enclosures that are referred to as 'House and Yard', 'Garden' and 'Haggard'.

The earthworks and associated documentary evidence suggests that there was once a much larger complex of buildings centred at North Watson farm. In addition the survival of ridge and furrow (PRN 44346) in the adjoining field indicates that this complex may have medieval origins. This area is currently under pasture.

Plate 4 - the low rectangular earthwork (PRN 44345) near North Watson Farm, looking west.

The survival of this earthwork indicates that sensitive archaeological remains are likely to exist below ground level. These upstanding earthworks should be protected from any damaging activity. No ground disturbing activities should take place in this area to protect the archaeological remains.

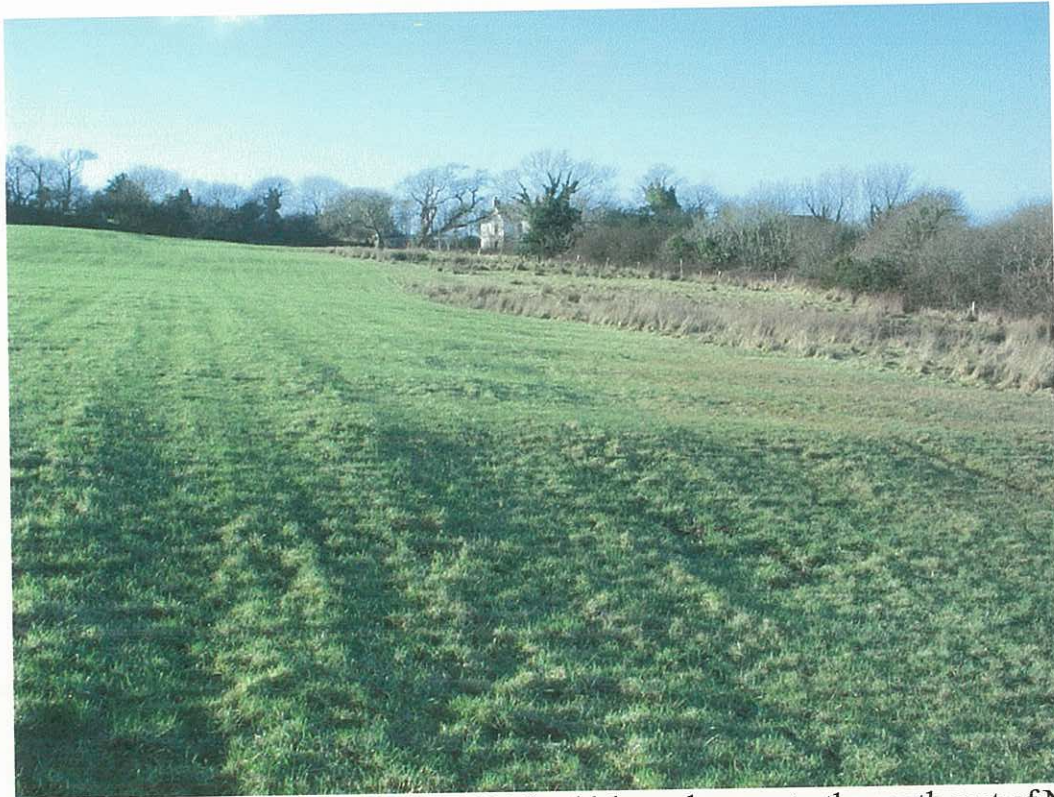
The remains of ridge and furrow survive in the field to the east of the enclosure PRN 44345 (plate 5). They are particularly noticeable towards the centre of this large field running in a north south direction. The best-preserved examples are on average c.3.5m wide and approximately 0.3m in height/depth.

These earthworks demonstrate that this area was farmed in the medieval system of strip fields, which can also be seen preserved within the field boundaries in the wider landscape.

Plate 5 – Ridge and furrow (PRN 44346) which can be seen to the south east of North Vatson Farm.

This field should be excluded from all activities that would damage the profile of the ground surface, such as ploughing or heavy erosion by livestock.
