GLYNEA COLLIERY BYNEA, LLANELLI

ARCHAEOLOGICAL DESK-BASED ASSESSMENT

PROJECT RECORD No. 39946

JANUARY 2000

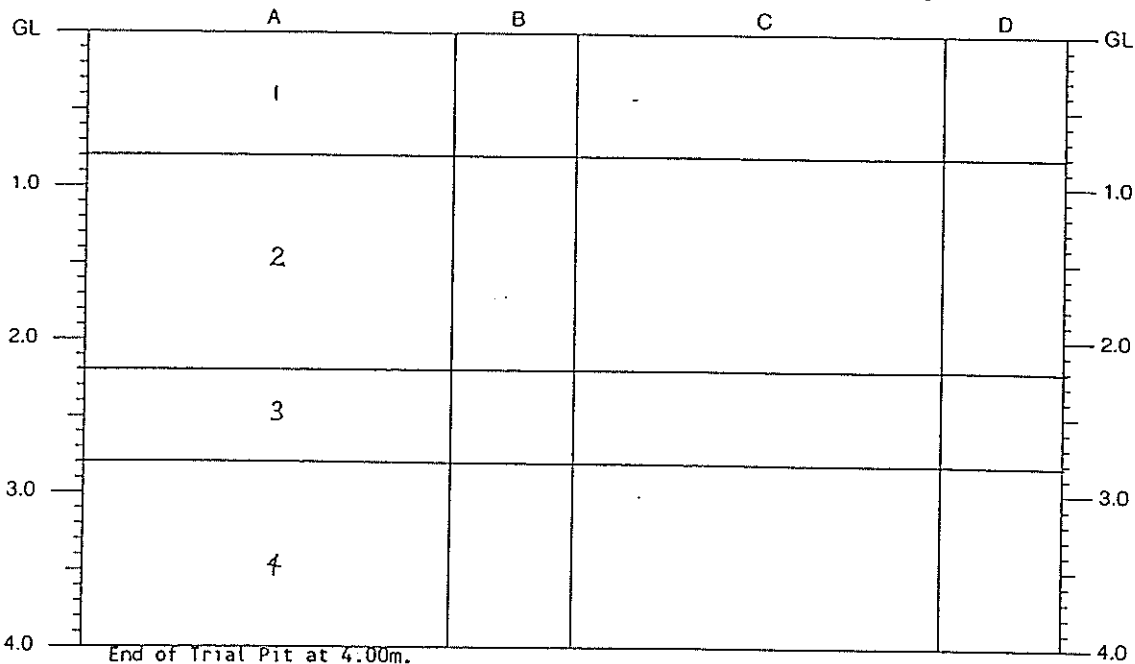
Strata			Samples and Tests		
Depth (m)	No.	Description	Depth (m)	Type	Results
0.00-0.80	1	MADE GROUND. (Loose) black grey slightly sandy fine to medium sub-angular gravel of ash with occasional sub-angular cobbles of slag (<190mm diameter)			
0.80-2.20	2	MADE GROUND. (Loose) red orange sandy fine to medium sub-angular gravel of ash with occasional sub-angular cobbles of slag (<190mm diameter).	0.80 1.80	B B	
2.20-2.80	3	MADE GROUND. (Loose) black brown clayey slightly silty fine to medium sub-angular gravel of ash.	2.80	B	
2.80-4.00	4	MADE GROUND. (Loose) red orange sandy fine to medium sub-angular gravel of ash with some cobbles of slag and occasional boulders of slag.	3.80	B

Date of Excavation 18/03/98
 Equipment Tracked excavator
 Stability Unstable below 3.00m

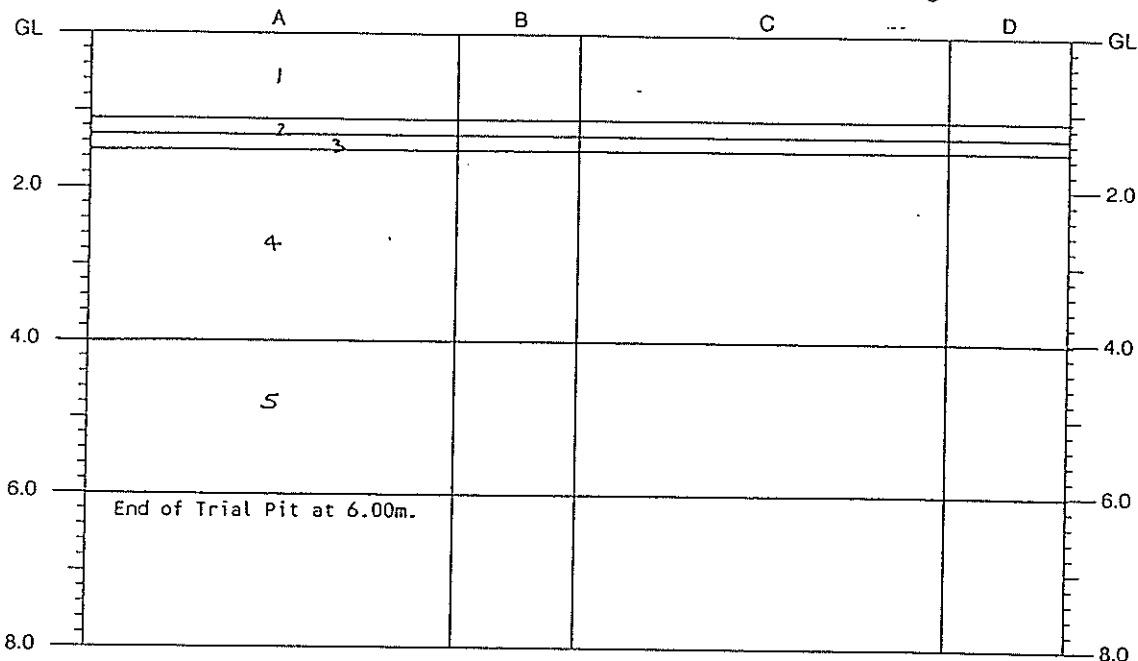
Strata			Samples and Tests		
Depth (m)	No.	Description	Depth (m)	Type	Results
0.00-1.10	1	MADE GROUND. (Loose) black slightly clayey fine to medium sub-angular gravel of ash.	1.00	B	
1.10-1.30	2	MADE GROUND. (Loose) red orange slightly sandy fine to medium sub-angular gravel of ash with occasional sub-angular cobbles of slag.	1.20	B	
1.30-1.50	3	MADE GROUND. (Loose) black grey clayey fine to medium sub-angular gravel of ash.	1.40	B	
1.50-4.00	4	MADE GROUND. (Loose) red orange slightly sandy fine to medium sub-angular gravel of ash with occasional sub-angular cobbles of slag.			
4.00-6.00	5	MADE GROUND. (Loose) grey brown clayey, slightly fine to medium sub-angular gravel of ash with occasional sub-angular cobbles of slag and occasional boulders of slag	3.00	B

Date of Excavation 18/03/98
 Equipment Tracked excavator
 Stability Unstable below 4.50m

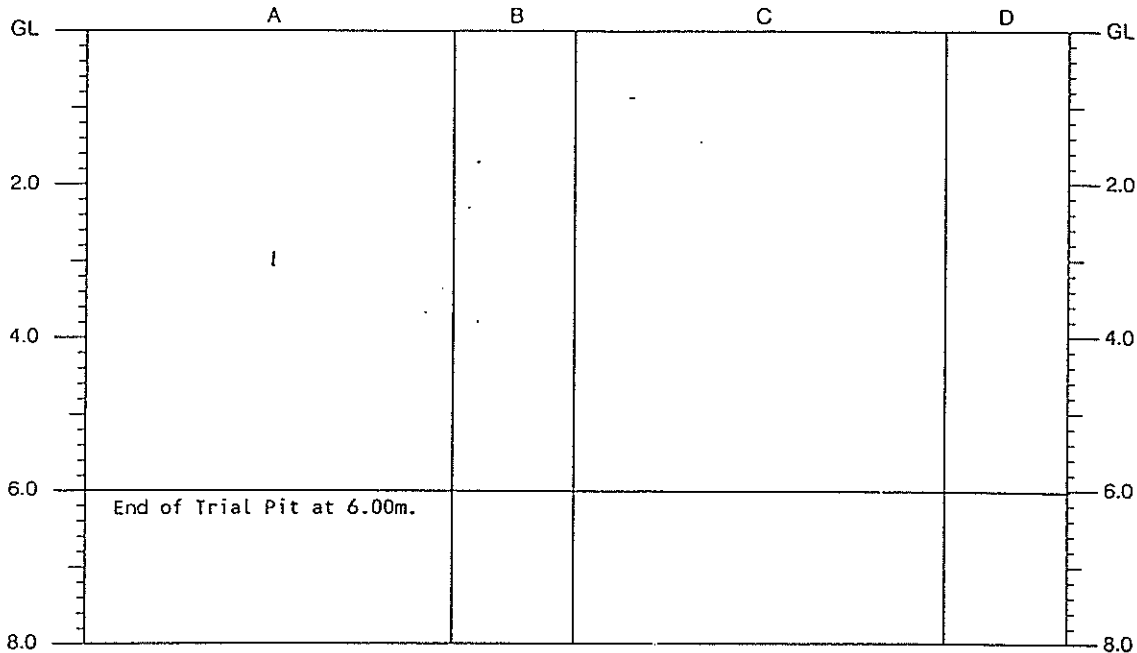
Strata			Samples and Tests		
Depth (m)	No.	Description	Depth (m)	Type	Results
0.00-6.00	1	MADE GROUND. (Loose) black grey slightly clayey fine to medium sub-angular gravel of ash, with much cobbles of slag, occasional cobbles of coal and occasional boulders of slag.	3.00 6.00	B B	
Date of Excavation 18/03/98 Equipment Tracked excavator Stability Unstable below 4.50m		Groundwater No. Struck Behaviour 1 4.50 Rapid		Logged by GL Checked by RHG	
Remarks See key sheet and appendices for explanations.					
Trial Pit Record		Project Glynea Tips Millenium Coastal Park		Contract 158041	
Exploration Associates				Trial Pit TP5

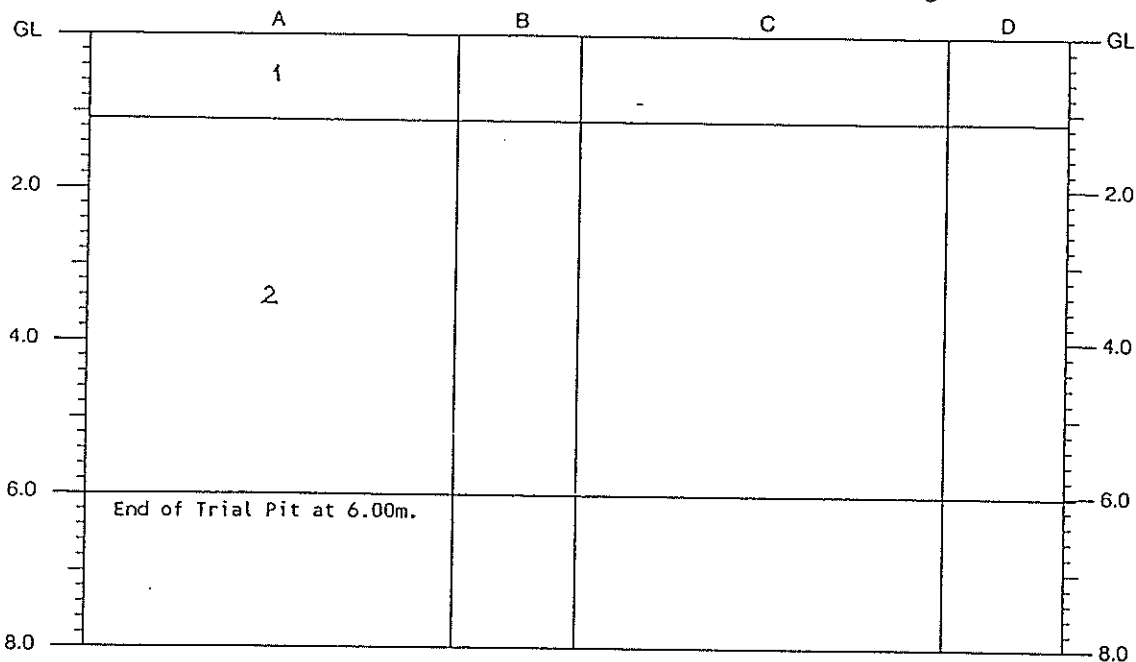
Depth (m)	No.	Description	Depth (m)	Type	Results
0.00-1.10	1	MADE GROUND. Topsoil over (loose) red orange slightly sandy fine to medium sub-angular gravel of ash with occasional sub-angular cobbles of slag.	1.00	B	
1.10-6.00	2	MADE GROUND. (Loose) grey black clayey fine to medium sub-angular gravel of ash with much sub-angular cobbles of slag and occasional sub-angular boulders of slag.	5.00	B

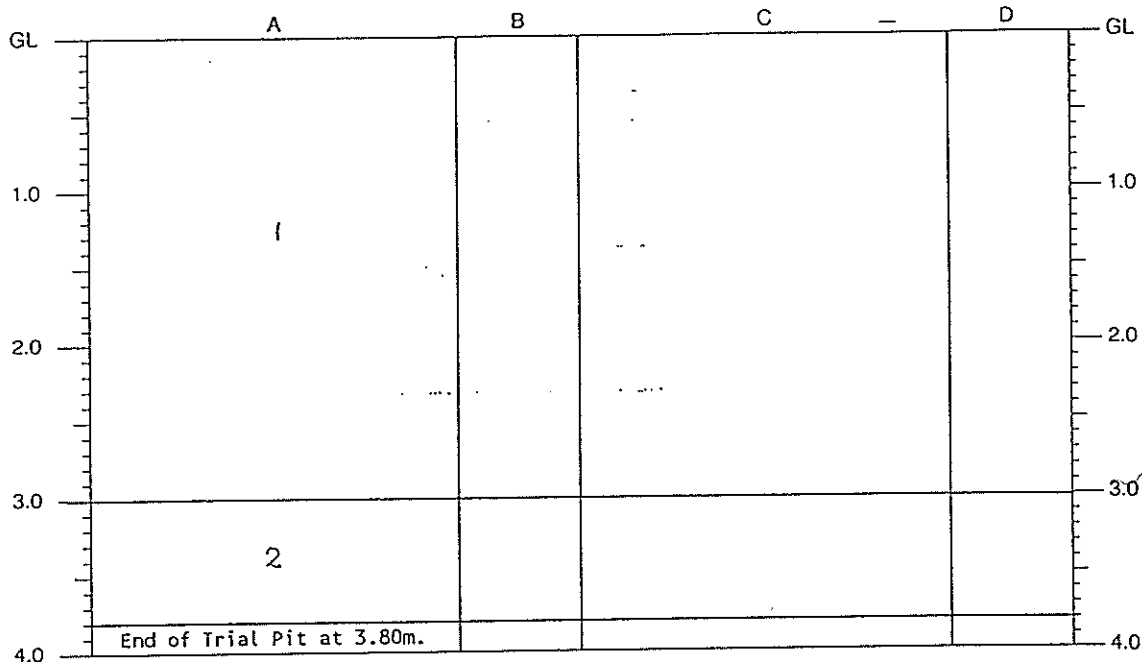
Strata			Samples and Tests		
Depth (m)	No.	Description	Depth (m)	Type	Results
0.00-3.00	1	MADE GROUND. (Loose) grey black slightly silty slightly clayey fine to medium sub-angular gravel of ash with occasional cobbles of slag	2.00	B	
3.00-3.80	2	Soft yellow orange very silty CLAY with occasioanl gravel of sandstone	3.50	B	
Date of Excavation 19/03/98 Equipment Tracked excavator Stability Unstable below 3.00m			Groundwater No. Struck Behaviour 1 3.00 Rapid		
			Logged by GL Checked by RHG

Remarks Pit terminated at 3.80m due to collapse.

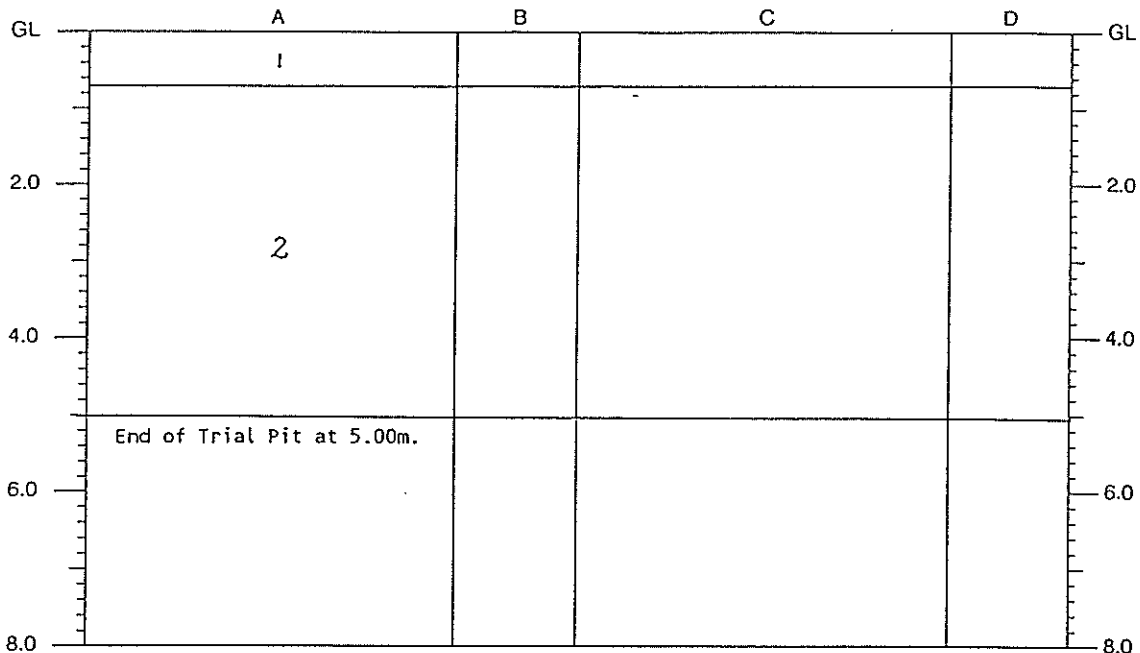
Depth (m)	No.	Description	Depth (m)	Type	Results
0.00-0.50	1	MADE GROUND. (Loose) grey black slightly silty fine to medium gravel of ash with occasional sub-angular cobbles of slag	0.50	B	
0.50-5.00	2	MADE GROUND. (Loose) red orange slightly sandy fine to medium sub-angular gravel of ash with some sub-angular cobbles of slag and occasional sub-angular boulders of slag	1.00 3.00	B B

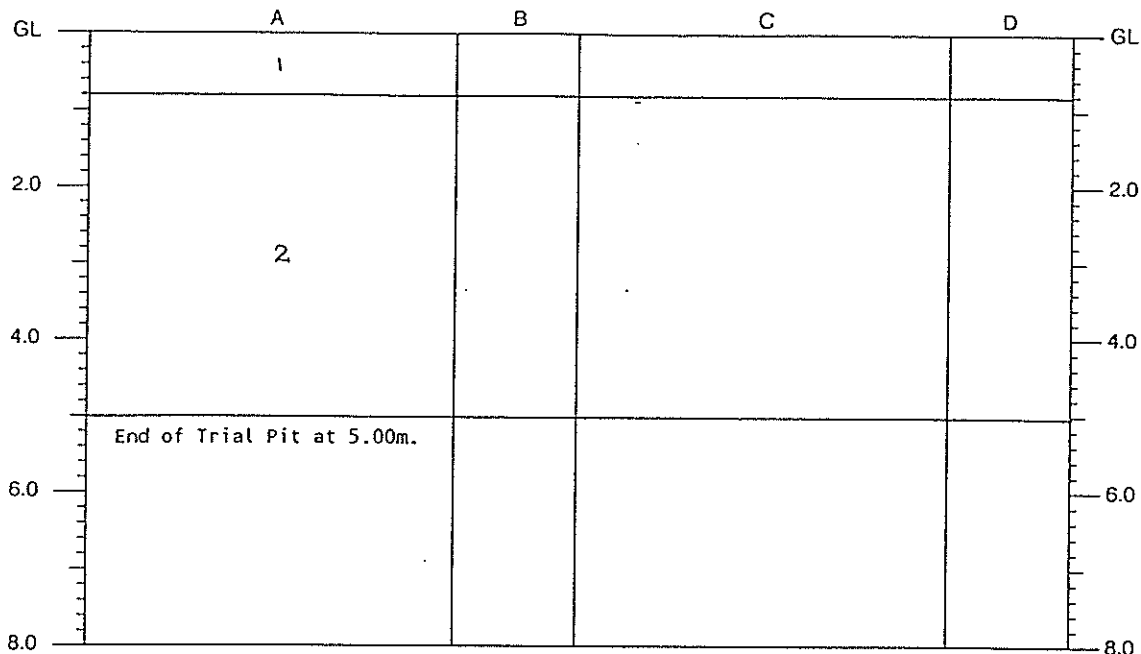
Depth (m)	No.	Description	Depth (m)	Type	Results
0.00-0.80	1	MADE GROUND. Topsoil over (loose) grey black silty fine to medium sub-angular gravel of ash with some cobbles of slag	0.50	B	
0.80-5.00	2	MADE GROUND. (Loose) red orange slightly sandy fine to medium sub-angular gravel of ash with some sub-angular cobbles of slag and occasional sub-angular boulders of slag.	2.00 4.00	B B
