A40 FISHGUARD WESTERN BYPASS

ARCHAEOLOGICAL WATCHING BRIEF, FEBRUARY 2000

Report prepared for Welsh Office Highways Directorate
by Neil Ludlow

Project Record No. 40362

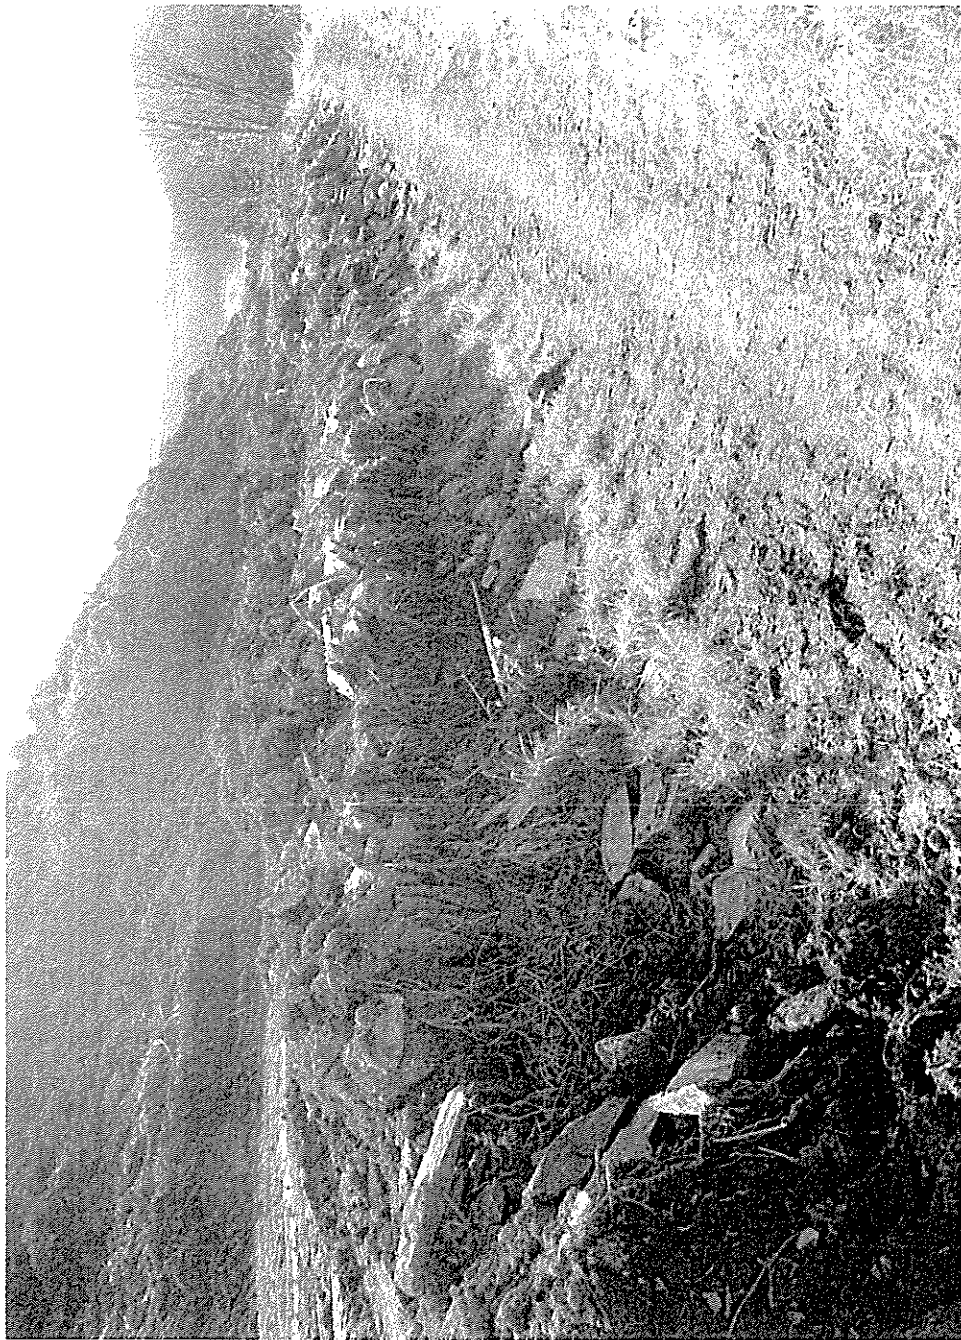
Photo 2 *Boundary 2 from the northwest*

2. Forms south-east side of trackway. 1m high, 1.5m wide with shale facing stones in a herringbone pattern laid over an earth core. Not shown on 1839 tithe map; possibly shown on Ordnance Survey 1:2500 maps of 1889 and 1908 (Photo 2).

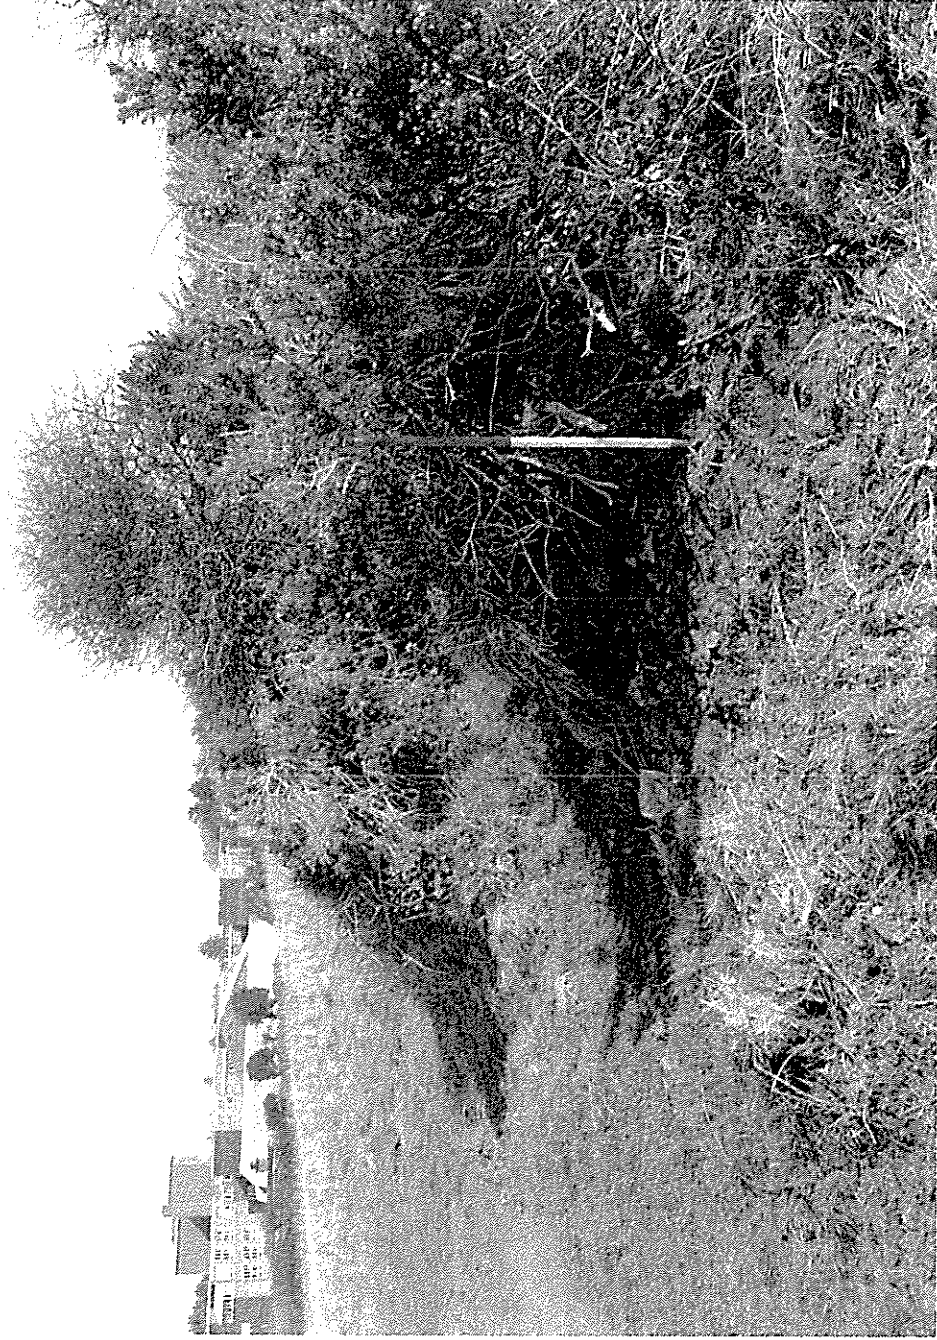
Photo 3 *Boundary 7 from the southeast*

6. (Not affected)
7. Forms south-east side of trackway. 1.7m high, 2m wide. Constructed entirely from limestone rubble, loosely laid with a loose soil matrix, some in a herringbone pattern. Contains some very large 'slabs'. Shown on 1839 tithe map (Photo 3).

Some boundaries contain very large rubble 'slabs' which are now recumbent. These are most conspicuous in boundary **7** and boundary **A**.

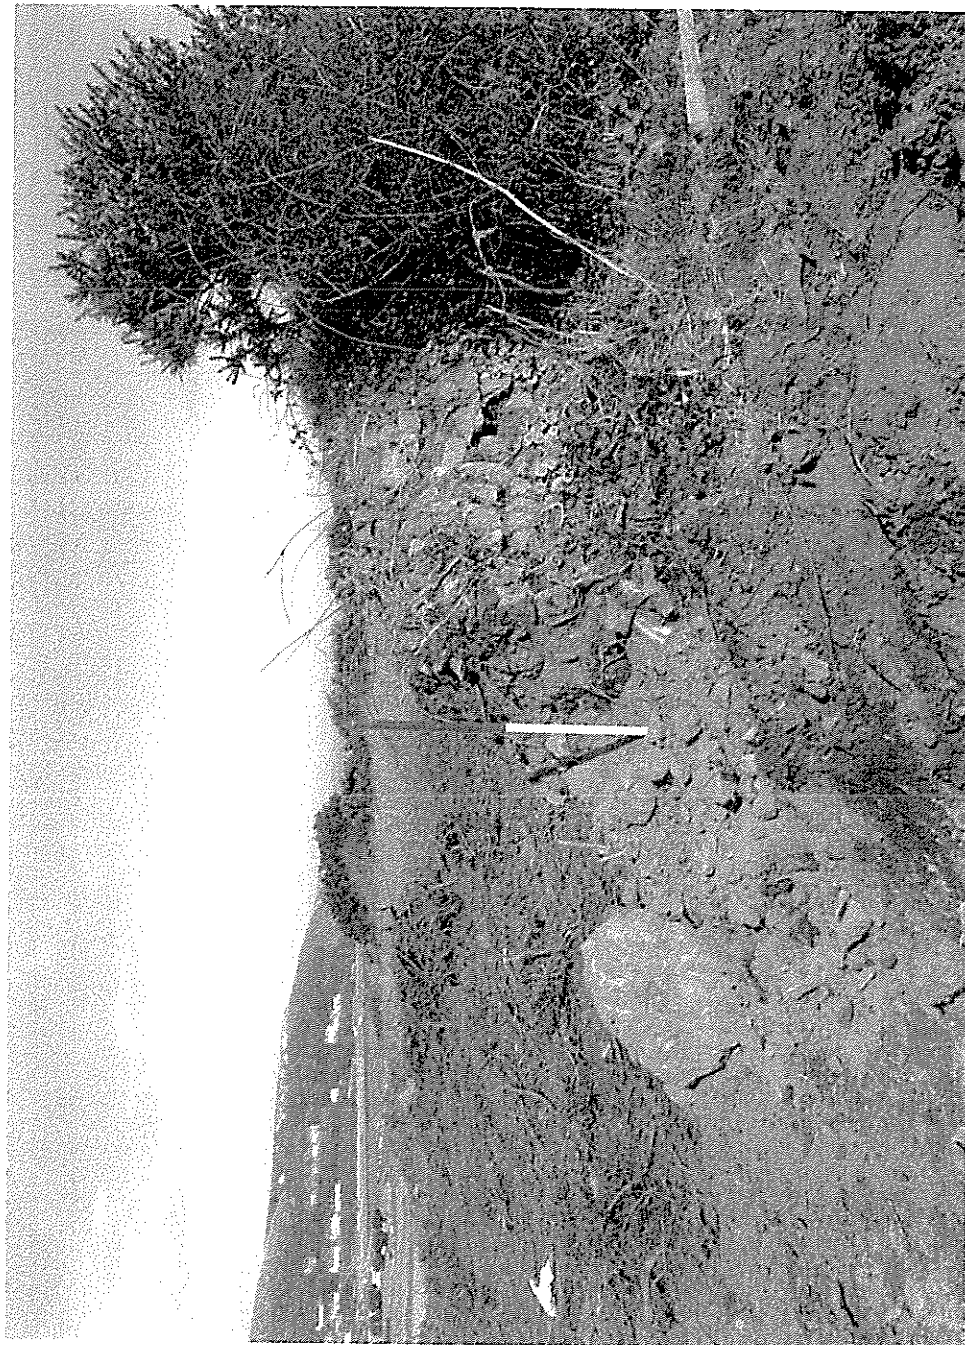
Photo 4 Boundary 11 from the southeast

8. (Not affected)
9. (Not affected)
10. (Not affected)
11. 1.5m high, 2m wide. Constructed from limestone rubble, loosely laid with a loose soil matrix, laid both horizontally and in a herringbone pattern. Shown on 1839 tithe map (Photo 4).

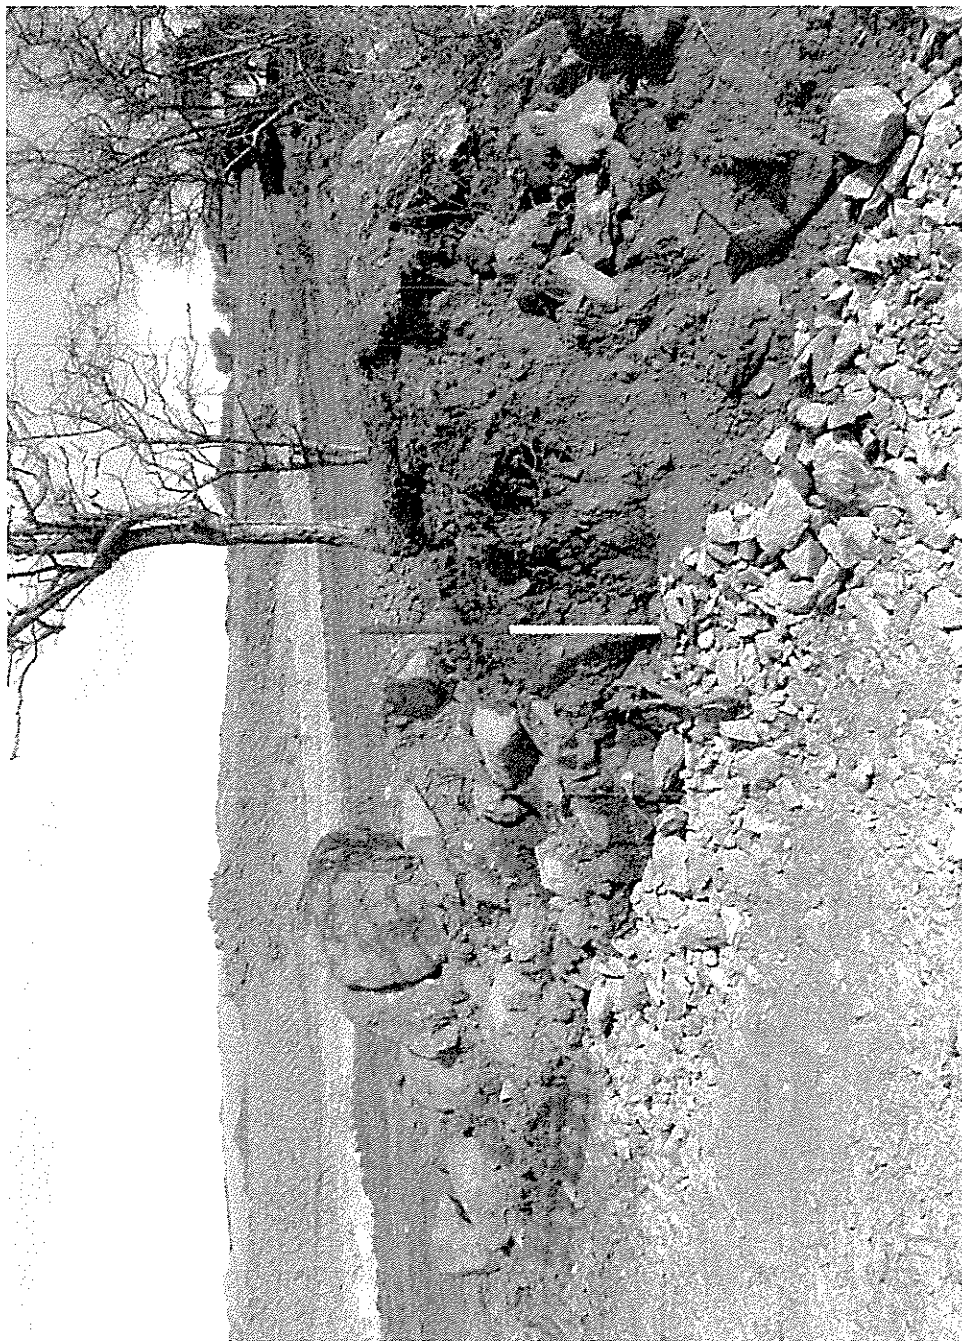
Photo 5 Boundary A from the west

- A. 0.9m high, 1.5m wide. Earth bank with some loose limestone rubble forming a crude facing. Contains some very large 'slabs'. Shown on 1839 tithe map (Photo 5).

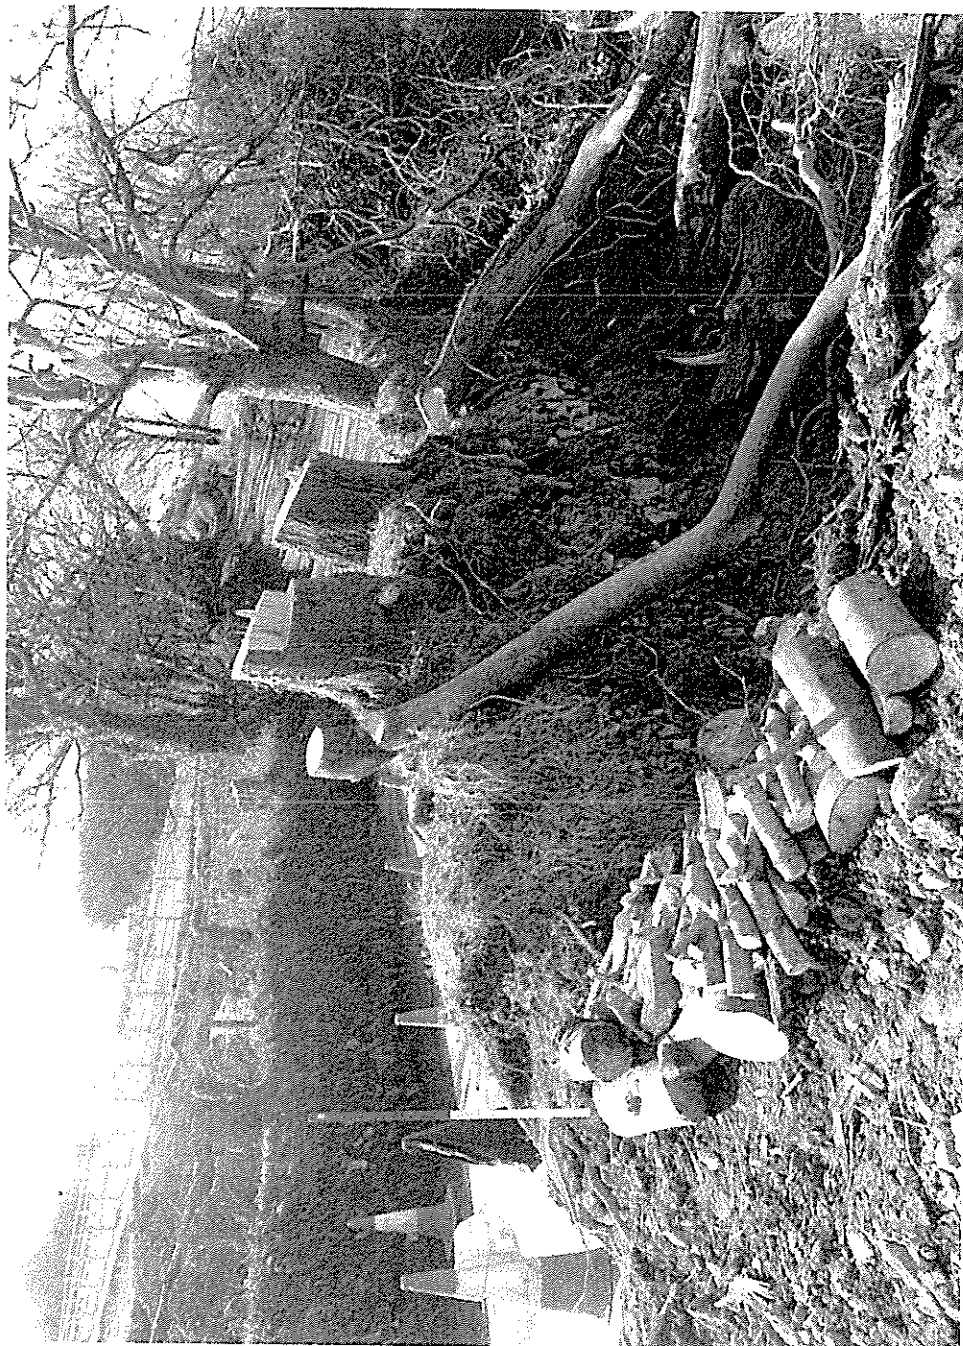
Photo 6 Boundary 12a from the northeast

- 12a. Forms north side of trackway. 1.2m high, 1.2m wide. Facing of medium limestone rubble, regularly laid in horizontal coursing and perpendicular, with an earth core. Shown on 1839 tithe map (Photo 6).

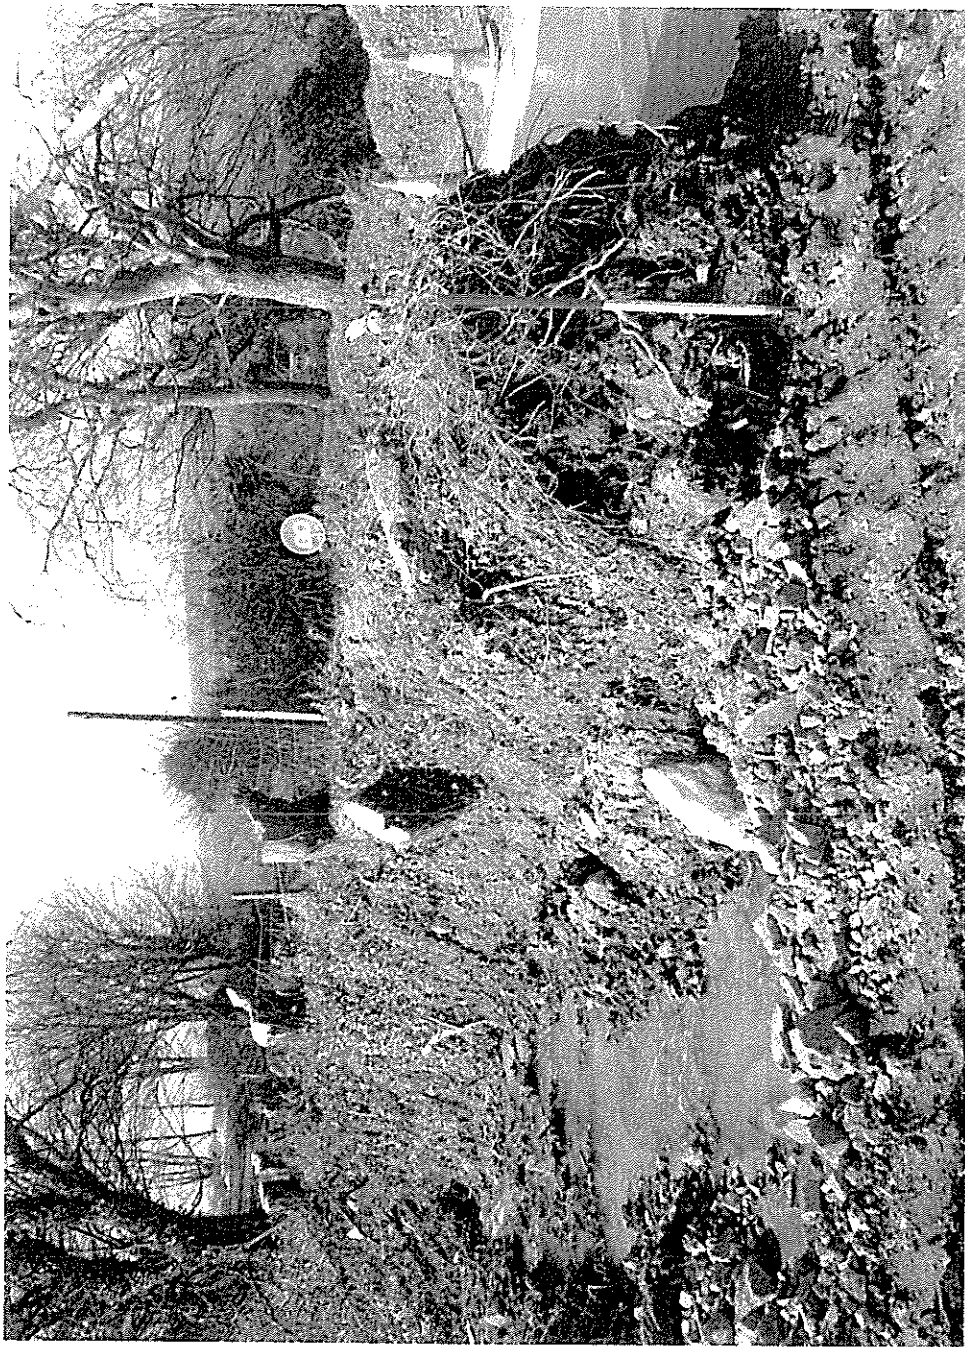
Photo 7 *Boundary 12b from the southeast*

- 12b. Forms north side of trackway. 1m high, 1.2m wide. Looser limestone rubble facing of medium stones, irregular and sloping, with an earth core. Shown on 1839 tithe map (Photo 7).

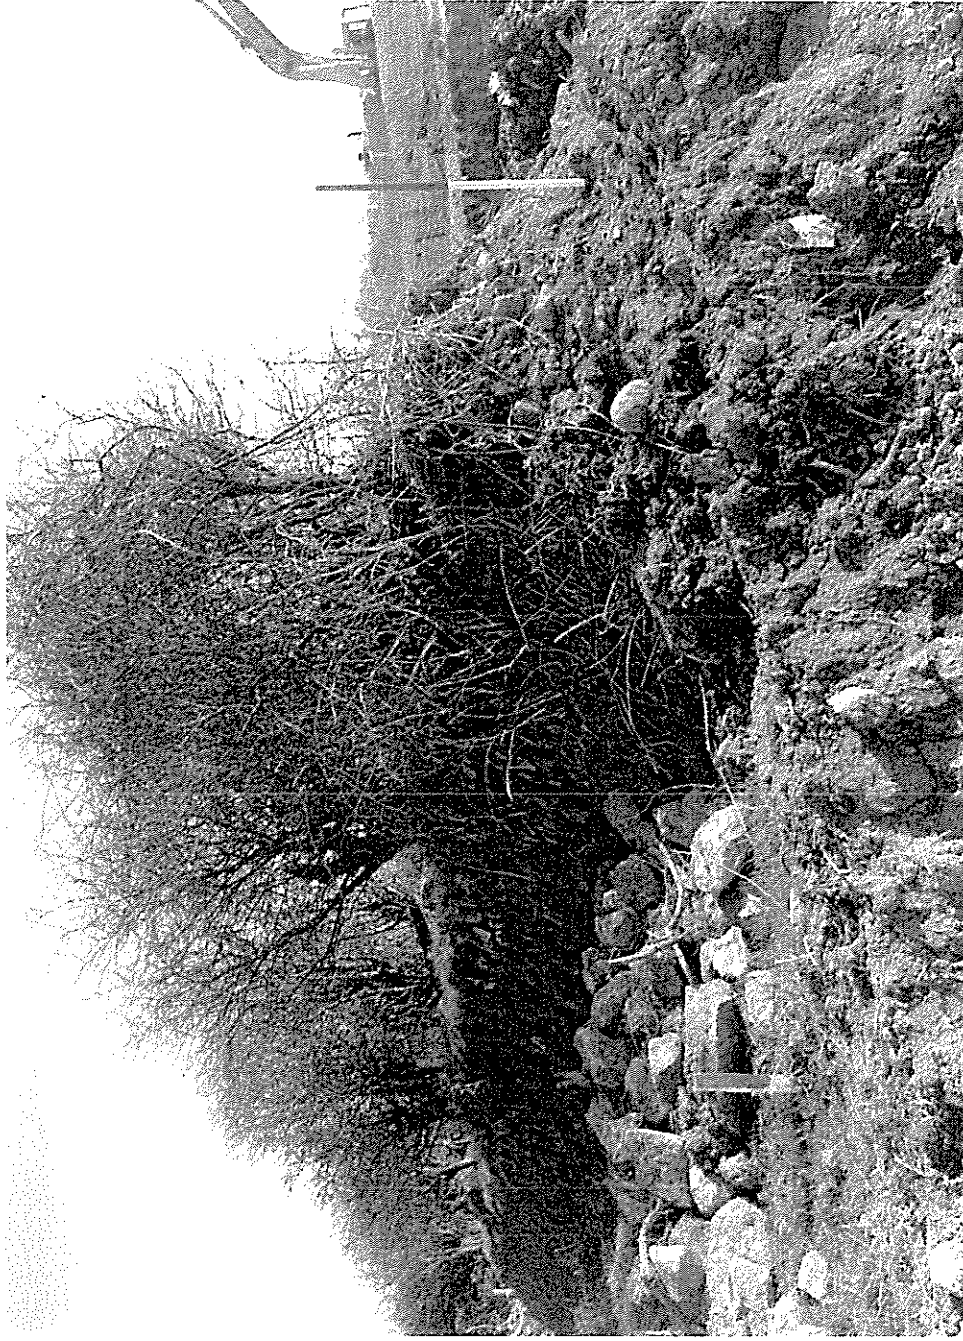
Photo 8 *Boundary B from the northwest*

- B.** 1m high, 1m wide. Facing of medium limestone rubble, regularly laid in horizontal coursing and almost perpendicular, with an earth core. Shown on 1839 tithe map (Photo 8).
- 13.** (Not affected)
- 14.** 0.7m high, 2m wide. Facing of medium limestone rubble, regularly laid in horizontal coursing and almost perpendicular, with an earth and loose stone core. Shown on 1839 tithe map (Photo 9).
- 15.** 1.5m high, 3m wide . Earth bank with some loose limestone rubble forming a crude facing. Shown on 1839 tithe map (Photo 10).
