**ARCHAEOLOGICAL SURVEY
OF THE
CATTLE MART SITE
&
GLYN SIW FARMHOUSE
Carmarthenshire**

MARCH 2000

Prepared
by
M Trethowan
of
ACA Field Operations
for
Carmarthenshire County Council

ARCHAEOLOGICAL SURVEY OF THE NEW CATTLE MART SITE (W/1345/RB) AND GLYN SIW FARMHOUSE

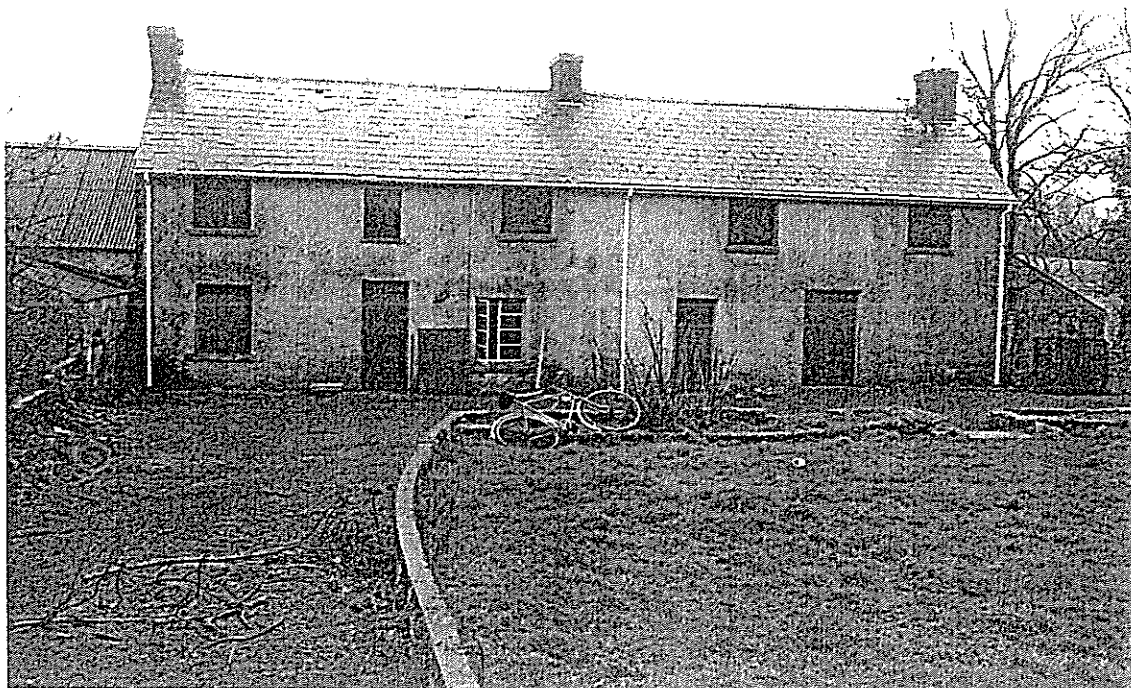
GLYN SIW FARMHOUSE (PRN 24977)
SOUTH FACING ELEVATION

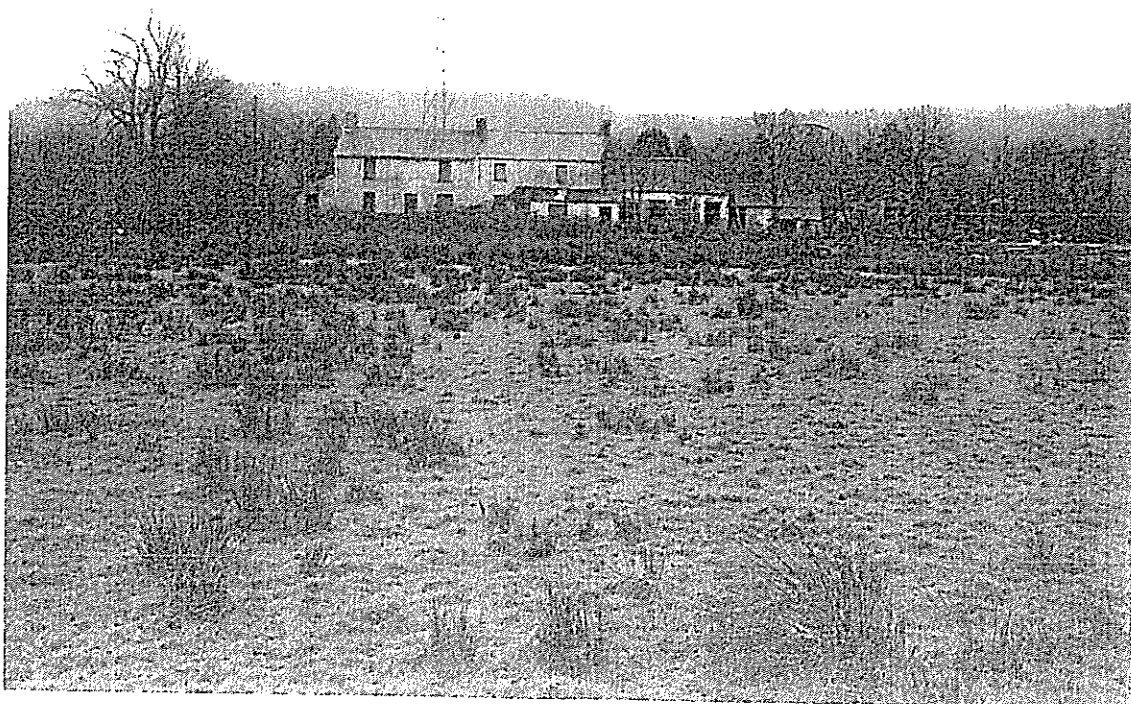
GLYN SIW FARMHOUSE (PRN 24977)
NORTH FACING ELEVATION

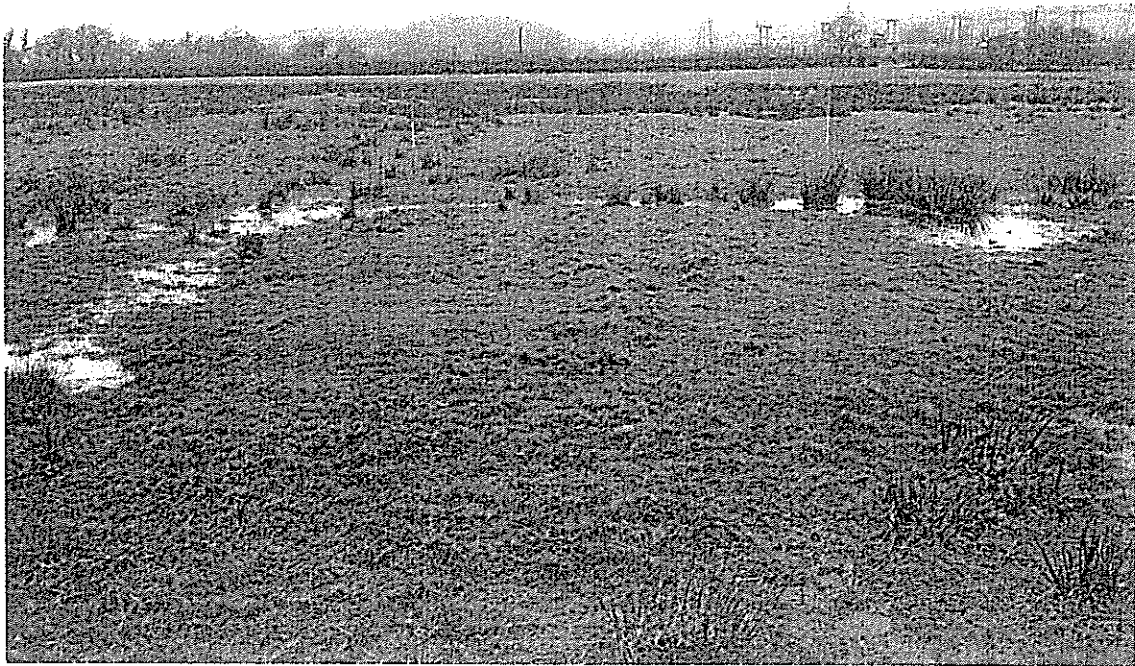
Possible ridge and furrow visible in field adjacent to field containing existing ridge & furrow (PRN11088). This is on the same alignment as PRN11088 although not as clearly visible.

RIDGE & FURROW EARTHWORKS (PRN 35829)
LOOKING NORTH-WEST

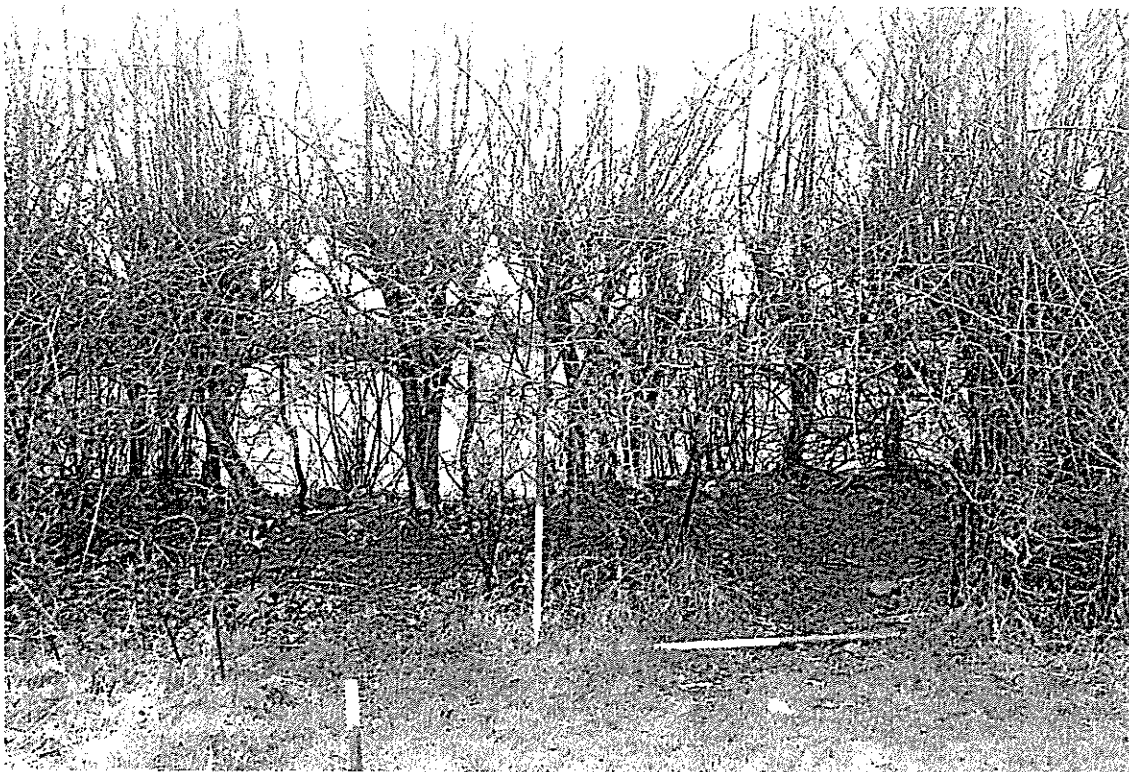
Earth bank c 0.5m high x 2m wide, topped with small hawthorn trees. Occasional medium angular and sub-angular stones in bank.

HEDGEROW (PRN35826)
LOOKING WEST

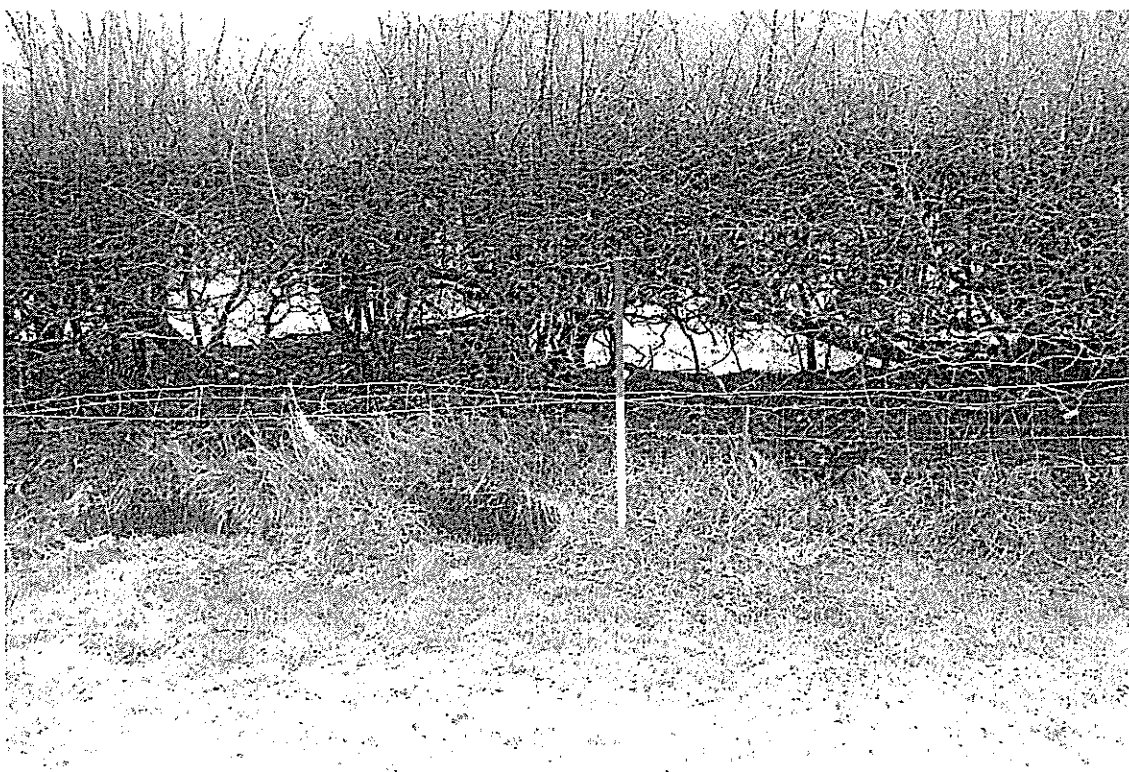
Earth boundary bank c. 0.5m high x 2m wide. Topped with small hawthorn trees. Extensive evidence of rabbit burrows in certain areas

HEDGEROW (PRN 35827)
LOOKING SOUTH-EAST

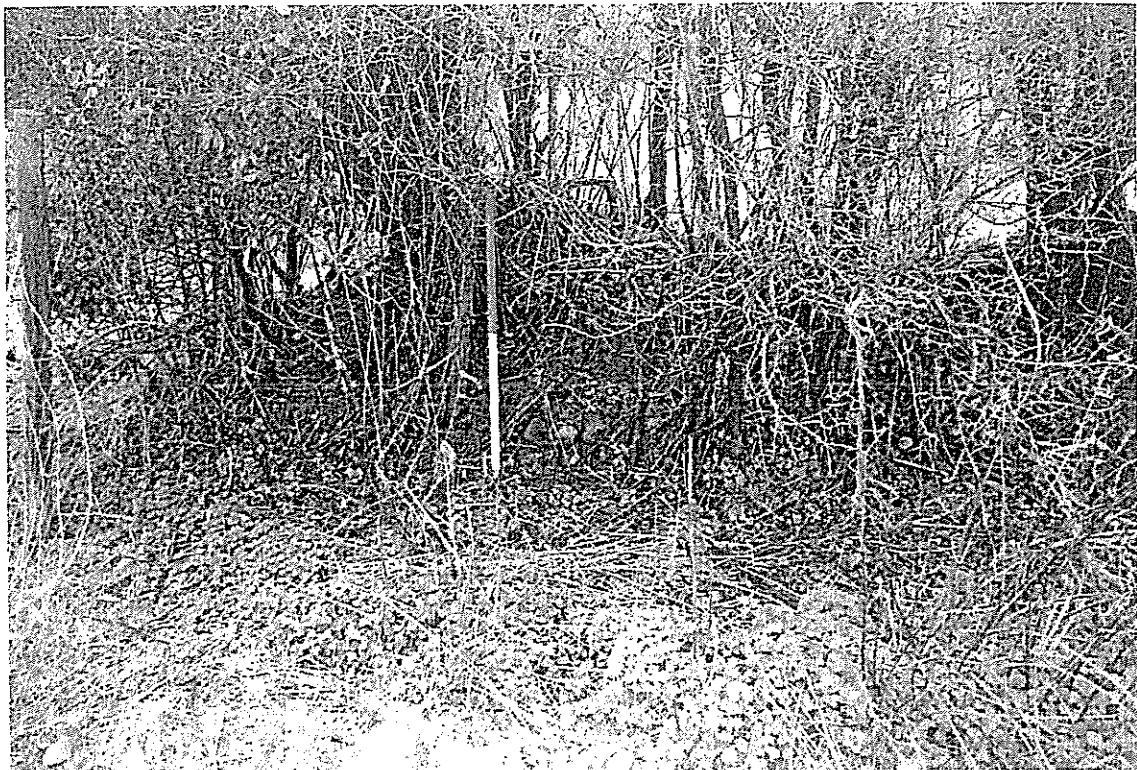
Earth boundary bank topped by frequent hawthorn trees. Eastern boundary is approx. 0.5m high and 2m wide. Northern boundary is higher on southern side (1m high x 2m wide) than northern side (0.5m high by 2m wide). This may be a results of the dumping of spoil north of the boundary during the construction of the A40 dual-carriageway. There is some evidence of stones being set into the earth bank.

HEDGEROW (PRN 35824)
LOOKING NORTH-WEST

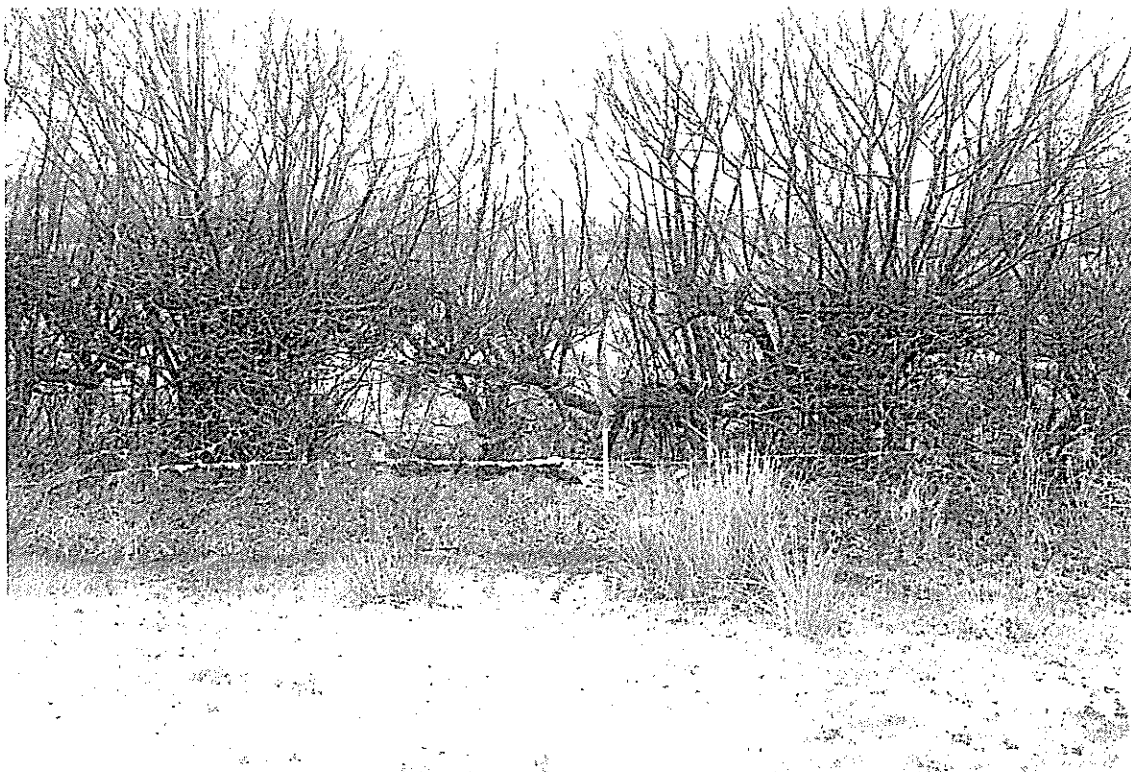
Earth boundary bank c.0.4m x 2m which is topped by hawthorn and ash trees. Evidence of layering which is now overgrown.

HEDGEROW (PRN 35825)
LOOKING NORTH-EAST

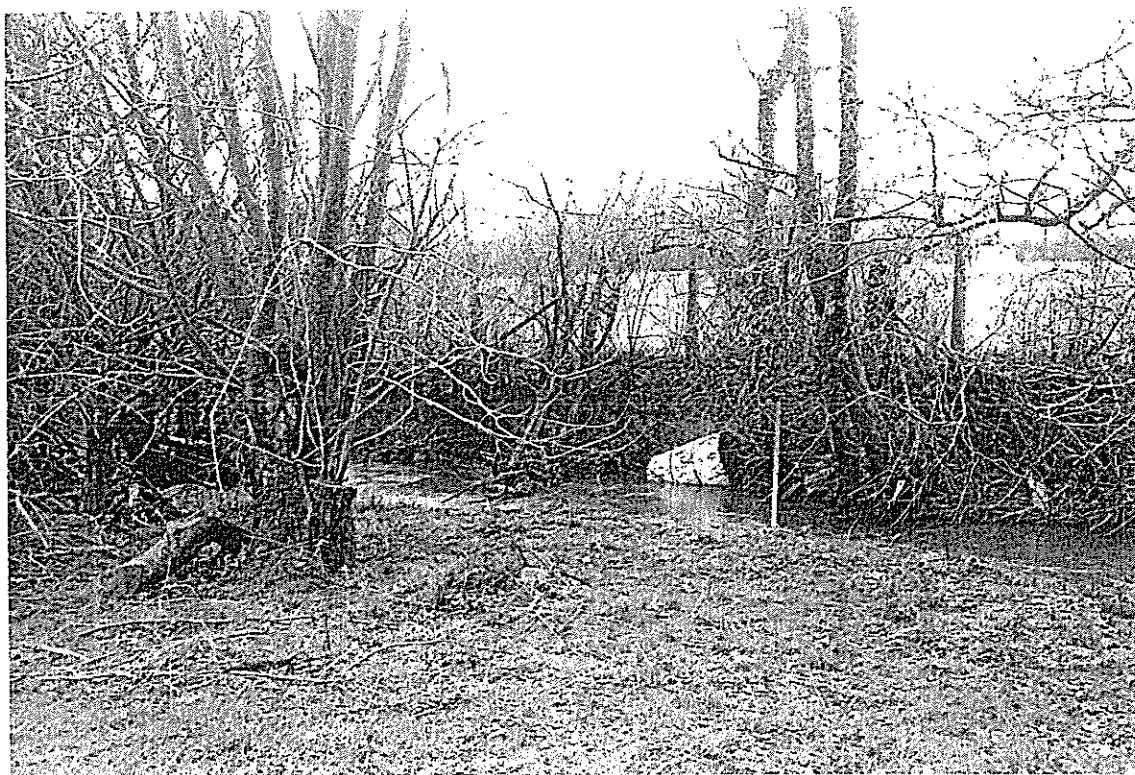
Natural boundary, i.e. a stream which has cut its own channel. No earth banks adjacent. Channel is lined by frequent mature trees such as oak ash and hawthorn

FIELD BOUNDARY (PRN 35828)
LOOKING WEST

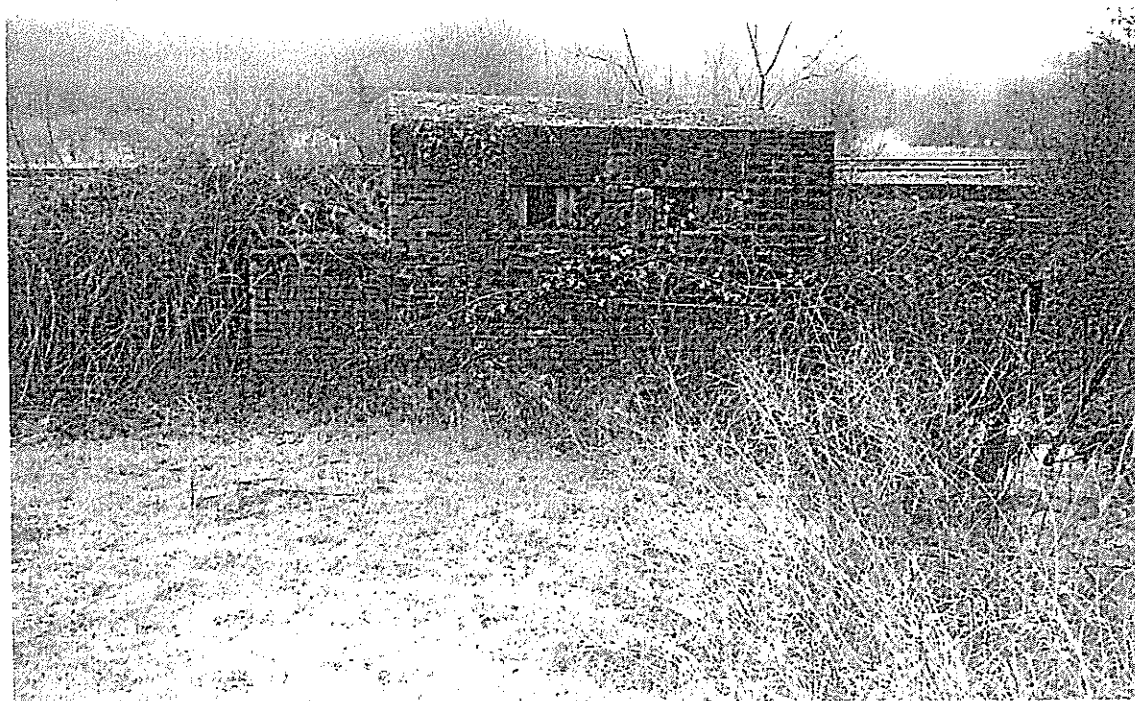
Rectangular brick built pill box, located at the intersection of the railway line and the stream (PRN 35828). Approximate dimensions are ; 5m long x 4m wide x 2m high. Concrete splays and lintels.

PILL BOX (PRN 35837)
NORTH FACING ELEVATION

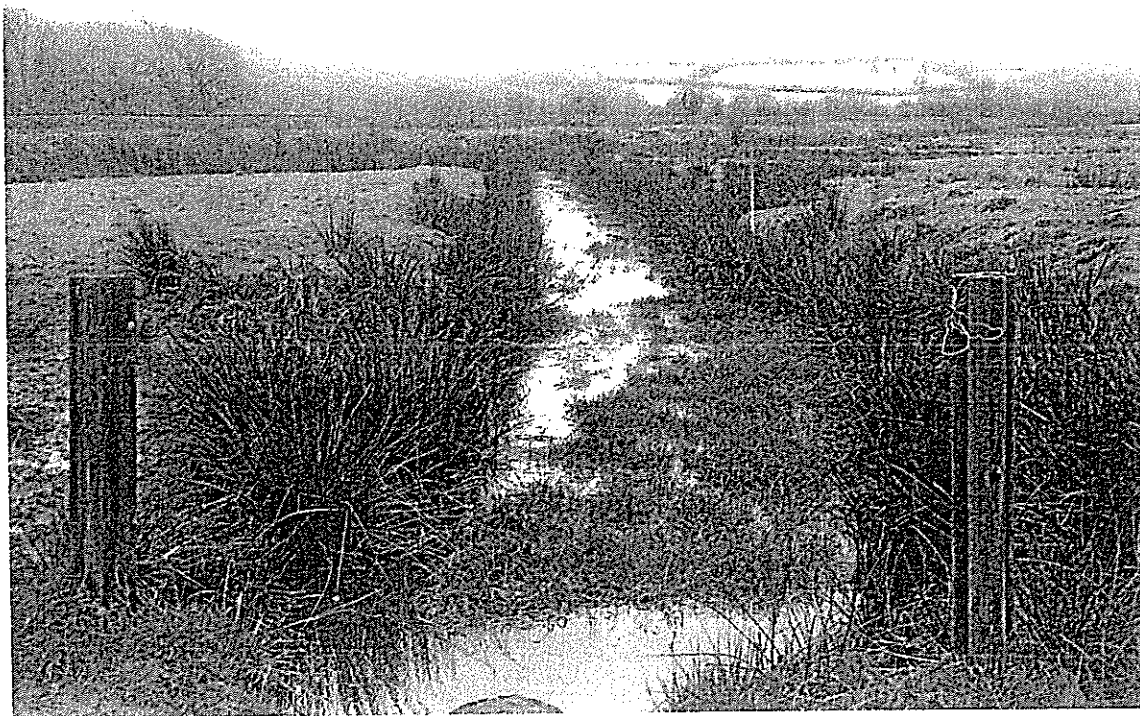
Curved drainage ditch which runs to the west of Glyn Siw farmhouse and Glyn Siw Isaf. Originally would have continued in a NE direction at eastern end of ditch although no longer visible. Continues running south until merges with stream running east west. Appears to be pre-enclosure in form.

DRAINAGE DITCH (PRN 35823)
LOOKING SOUTH-WEST

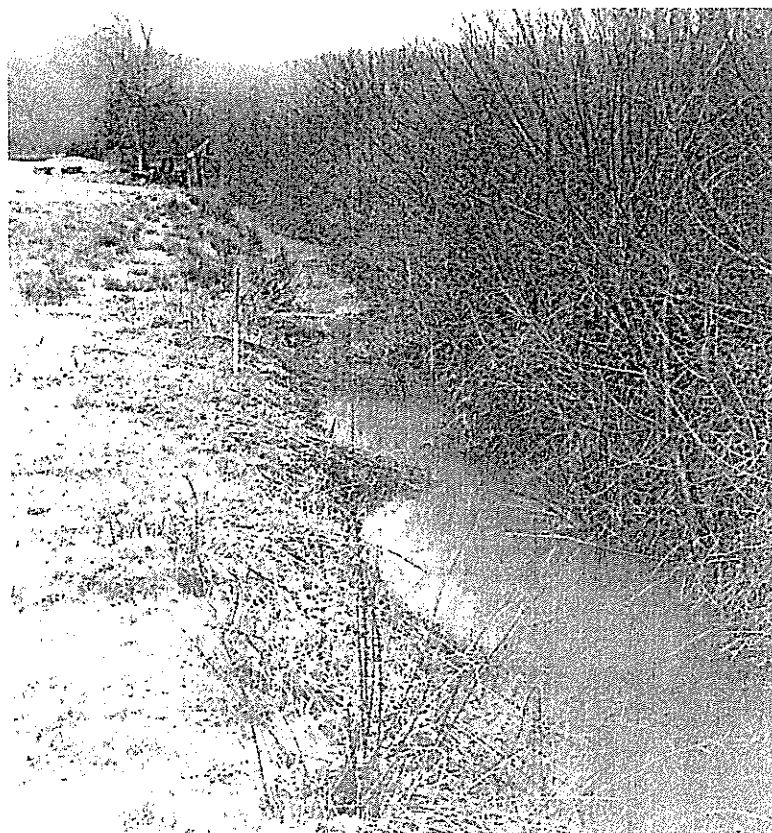
DRAINAGE DITCH (PRN 35823)
LOOKING SOUTH

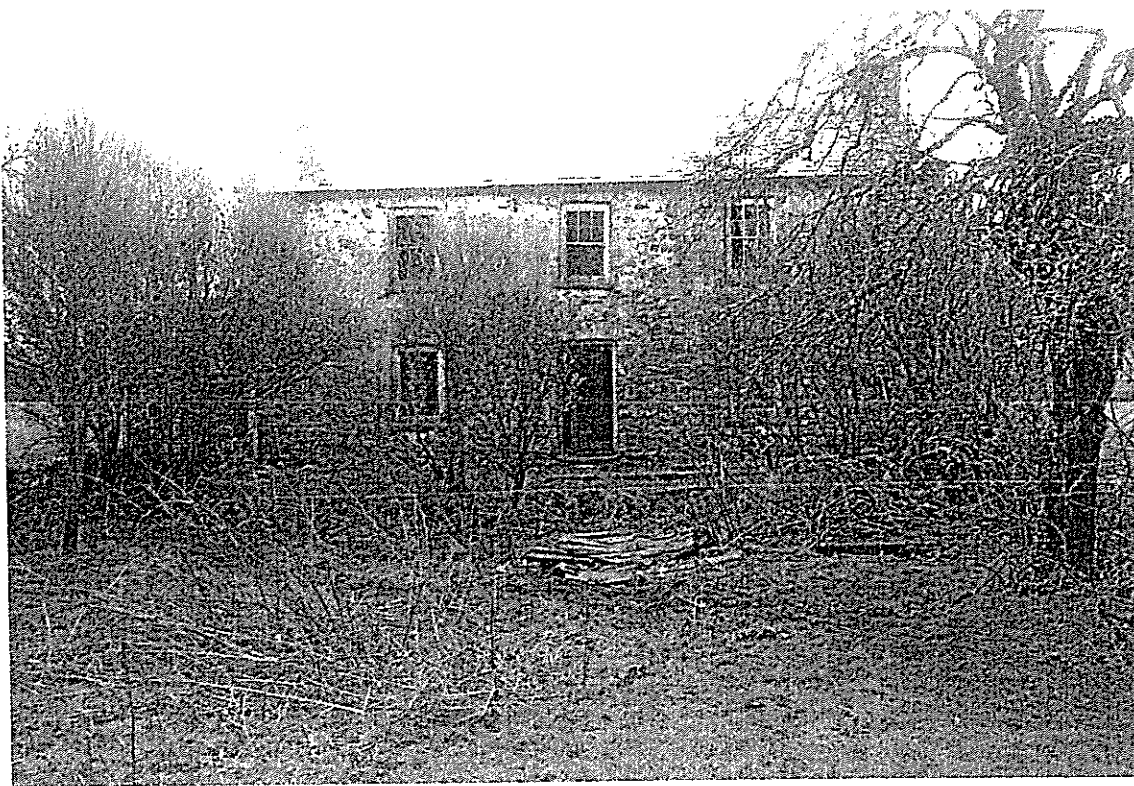
Small derelict farmhouse probably 19th century as is present building at Glyn Siw

GLYN SIW ISAF FARMHOUSE (PRN 35834)
NORTH-WEST FACING ELEVATION

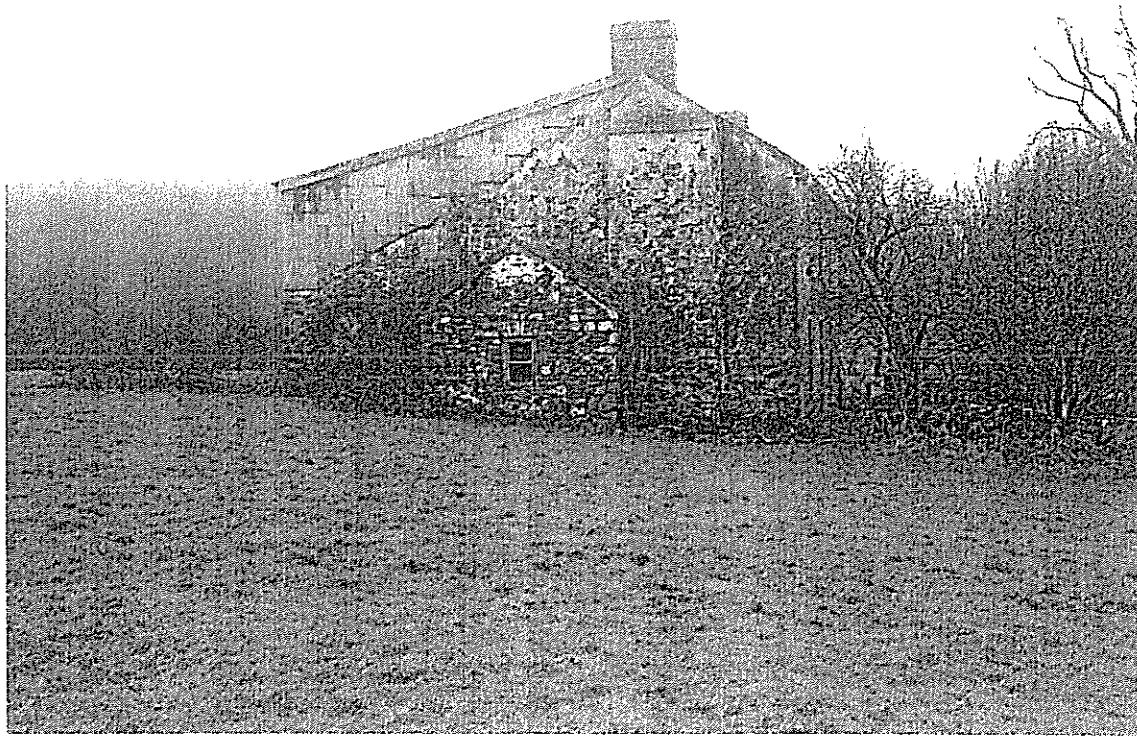
GLYN SIW ISAF FARMHOUSE (PRN 35834)
SOUTH FACING ELEVATION

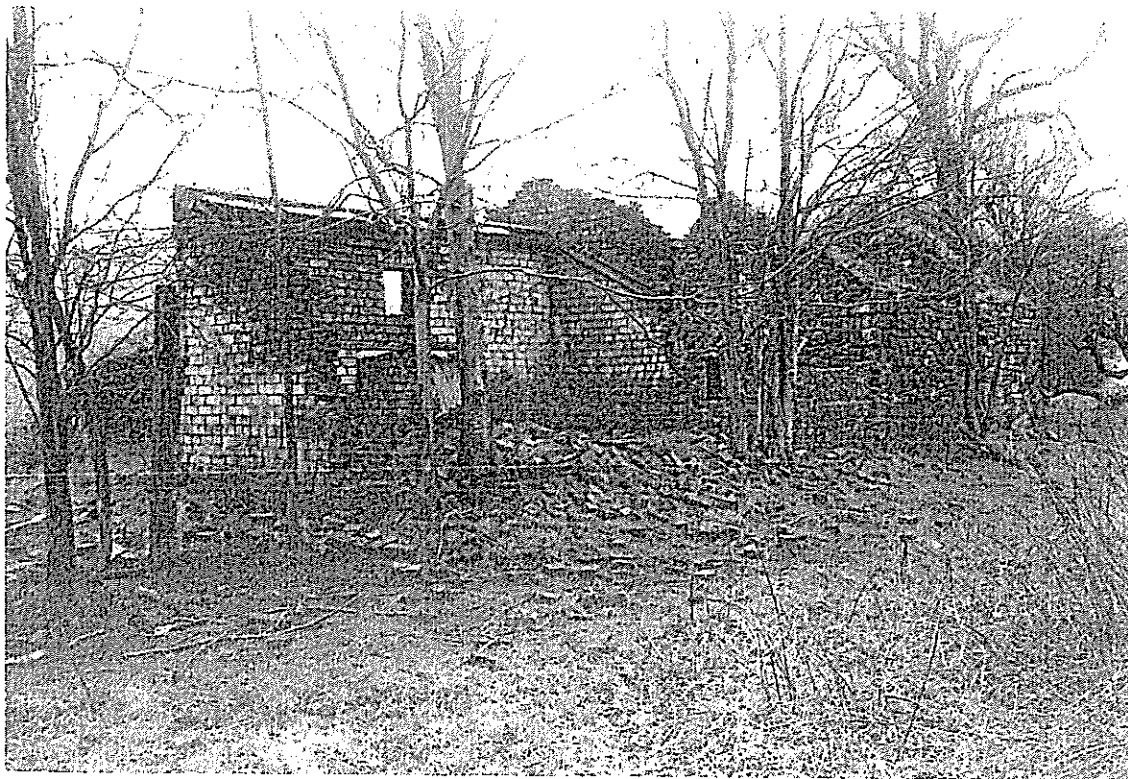
GLYN SIW ISAF OUTBUILDINGS
NORTH-WEST FACING ELEVATION
