# **Tir Gofal Farm Visit Report**

## **Pengelli**

### **W/11/1026**

ACA Report Number 2001/6

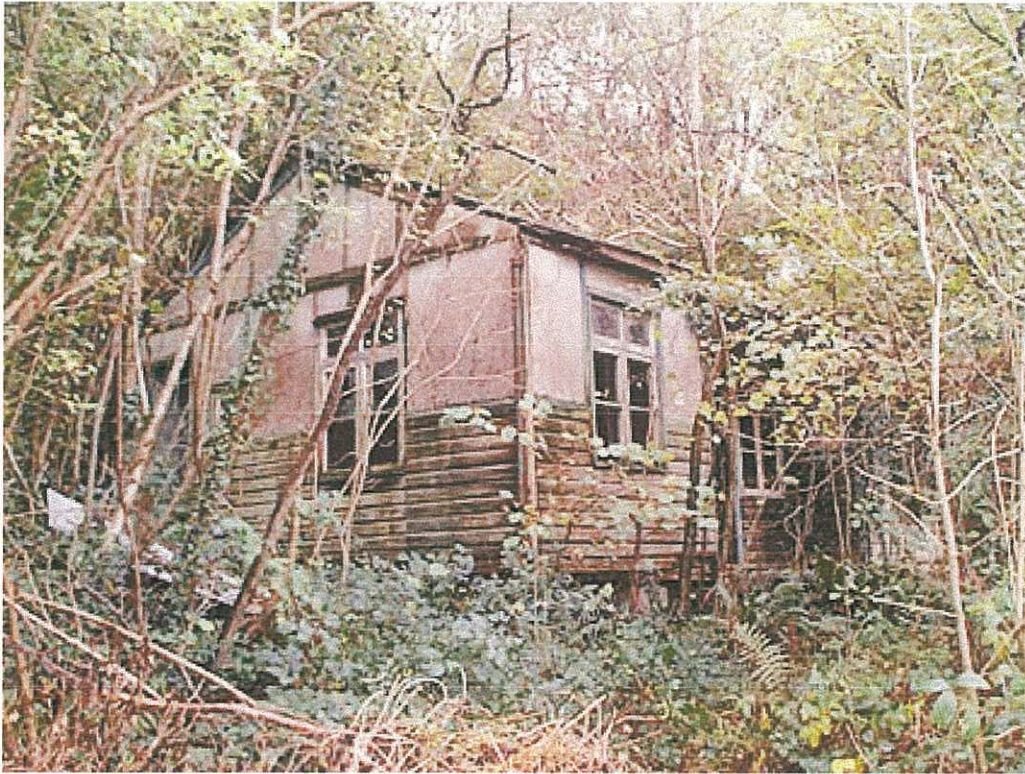
Single storey timber building on brick and breeze block stilts with an asbestos roof to the south west of Aberffrwd Farm. A building was first recorded on this site on the tithe survey of Llanbadarn Fawr in 1843, although this building is clearly later. It was first recorded as a station building on the 2nd edition OS map of 1906 and appears to be of early twentieth century origin. The building was clearly used for domestic purposes and may have provided accommodation for a station master. The internal decor and a brick and iron fireplace survive although the floor is in poor condition. A corrugated tin garage survives to the west of the dwelling (plate 1).

Plate 1 - the old station house at Aberffrwd (PRN 19155).

The station house is in poor condition and its state is rapidly deteriorating. The area around it is completely overgrown. The building should be fully recorded before its condition deteriorates further.

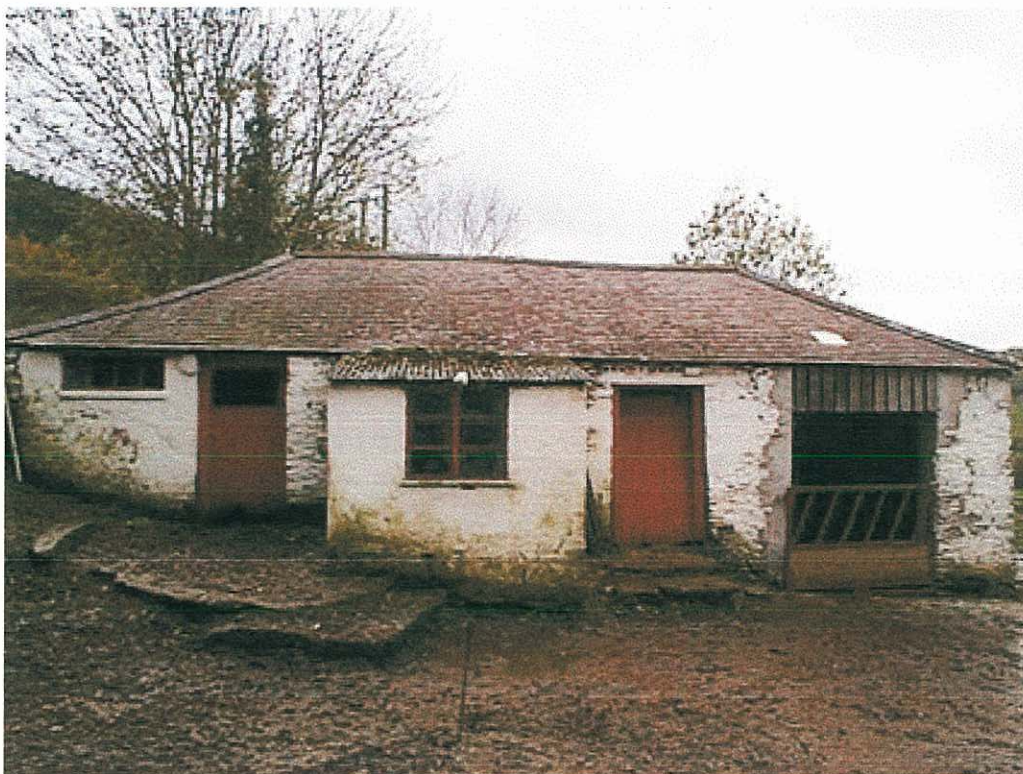
Single storey rubble and lime-mortar farm building with a hipped slate roof in a cluster of farm buildings to the south west of Aberffwrdd Farm (plate 2). Orientation north-south. First recorded on the 1st edition OS map of 1891. Very little of the original structure survives. Much of it has been rebuilt and none of the original openings survive. Whitewashed exterior. The interior was not examined.

Plate 2 - late nineteenth century farm building (PRN 42074).

The building has been considerably modified but what remains of the original structure is in reasonable condition. No specific management recommendations.

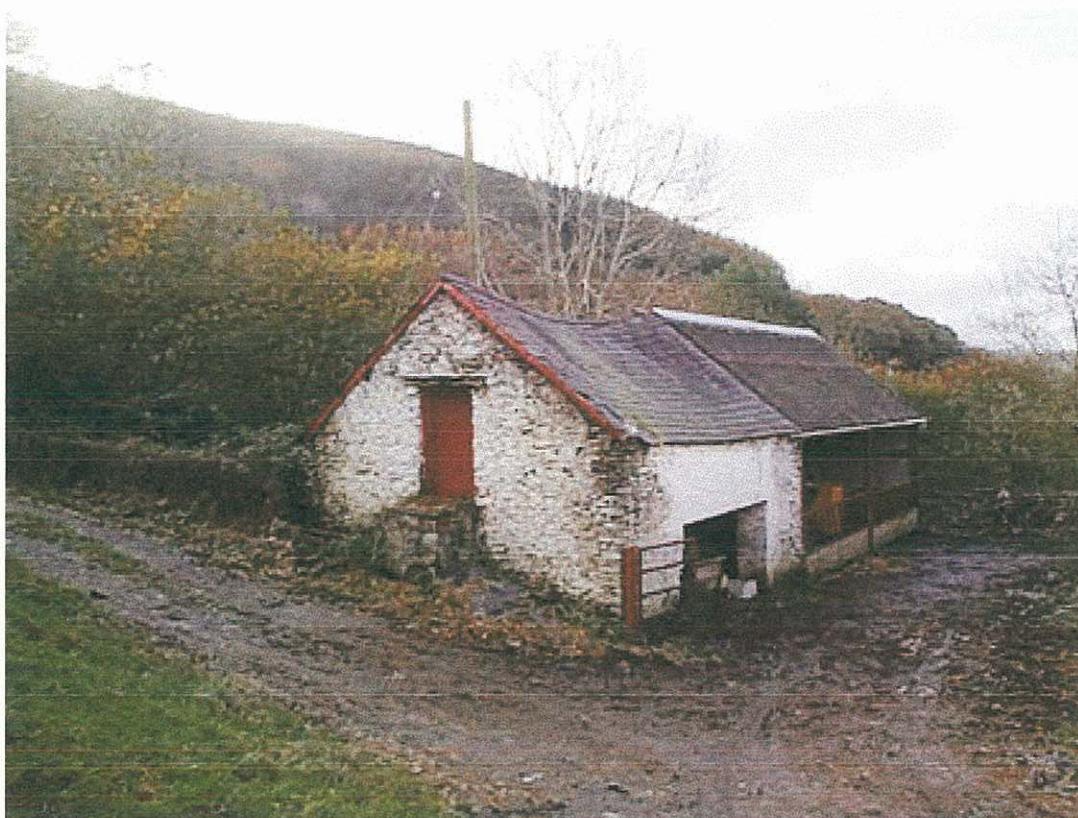
Two-storey whitewashed rubble cartshed with a gabled slate roof to the southwest of the farmyard at Aberffwrdd Farm (plate 3). First recorded on the 1st edition OS map of 1891. Orientation east-west. Parts of the building have been rebuilt with breeze block and brick and most of the openings have been modified. Accessed at ground floor level by a double width entrance in the north-facing wall, now with a concrete lintel. Accessed at first floor level via a brick and concrete stairway against the eastern gable wall through a low door with a square head and timber lintel. The interior was inaccessible. The roof was in a poor state of repair.

Plate 3 – late nineteenth cart shed building (PRN 42075).

The cartshed is generally in reasonable working condition although its roof is sagging and needs urgent repair. It should otherwise be maintained in its current state and any repairs or alterations should be carried out in a way that is sympathetic to the character of the original building.

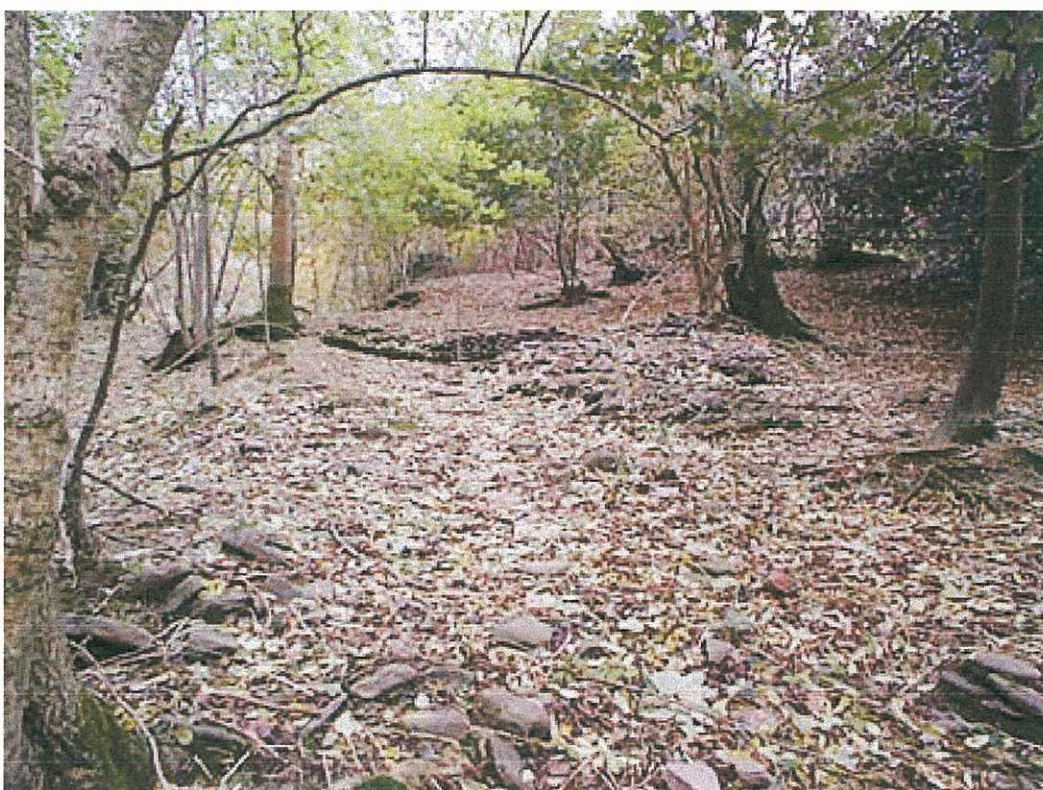
Ruined four-roomed mine building c.5m by 15m to the west of the trackway (PRN 42081) that runs through Aberffwrdd mine (plate 4). First recorded on the tithe survey of 1843. Orientation northwest-southeast. Rubble and soil construction. The footings stand to a maximum height of 1m. The roof does not survive although there were loose slate tiles amongst the rubble which may originate from the roof. A brick and iron fireplace survives in the internal wall of the southernmost room. The area is slightly overgrown with young trees, some of which are disturbing the footings.

Plate 4 - mine building at Aberffrw mine (PRN 42076).

The footings of the mine building are in a stable condition although they are being damaged by young tree growth in places. It should be maintained as a stable ruin and kept clear of rubbish and intrusive vegetation. Any loose stone should be left in-situ.

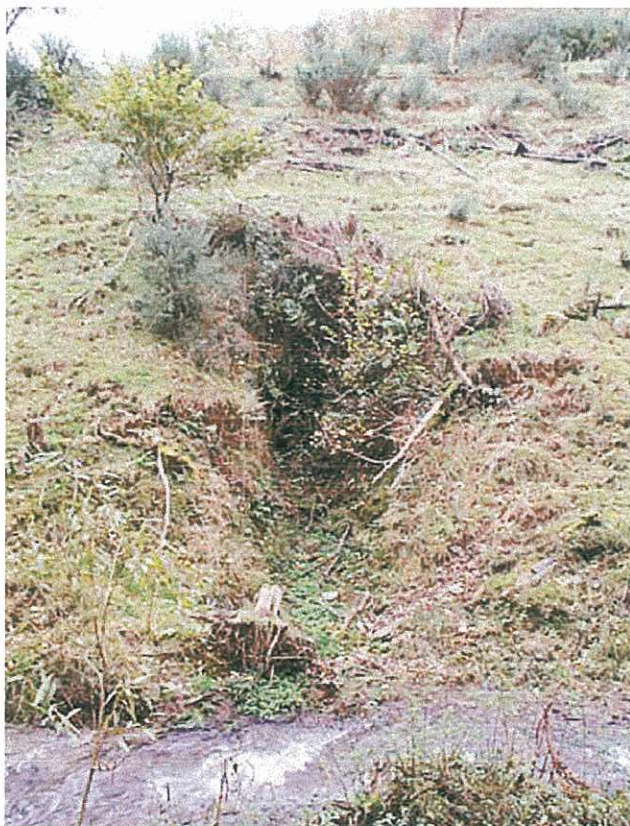
Rock cut level c.5m deep by 2m wide, alongside Nant yr Aber the east of Aberffrwd mine (plate 5). The top and side of the level are overgrown with gorse, ivy and young trees.

Plate 5 - level for Aberffrwd mine workings (PRN 42077).

The level is in a stable condition. No specific management recommendations.

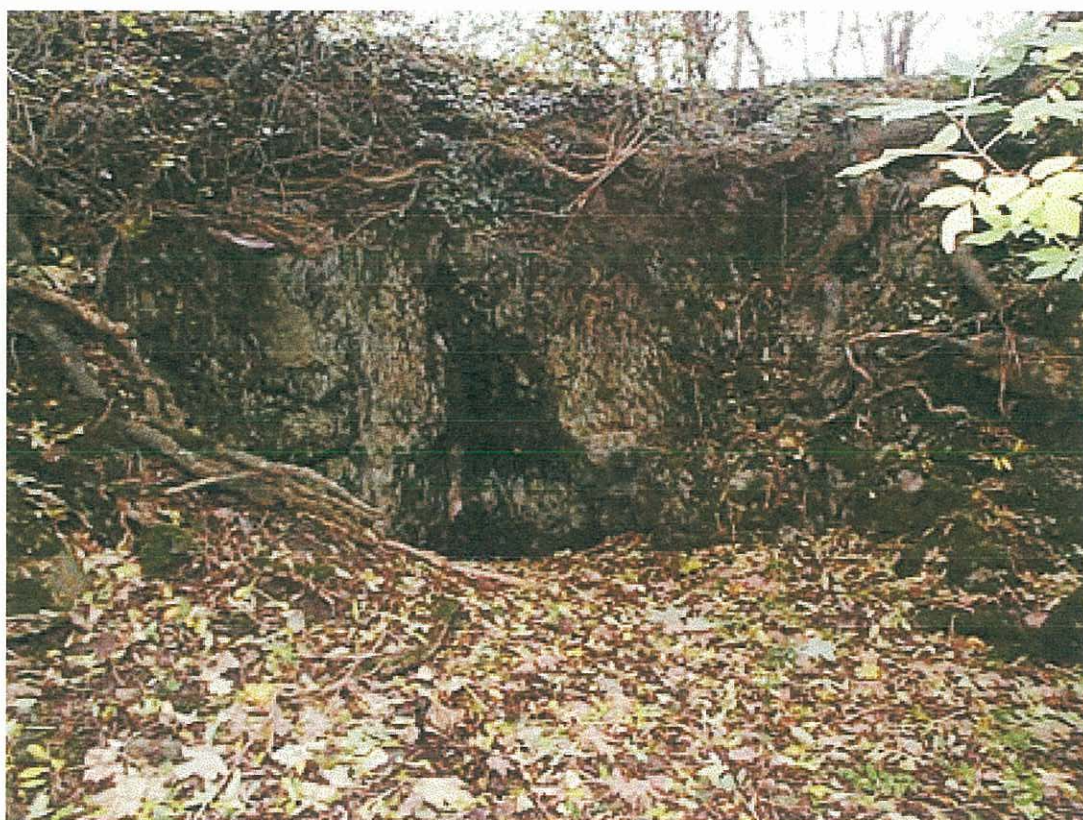
Open mine shaft of Aberffrwd Mine (PRN 25883) c.1m high by 2m wide, beneath a rocky ledge to the west of Nant yr Aber (plate 6). The entrance to the shaft is open and infilled with rubbish. The area is overgrown and wet.

Plate 6 - mine shaft at Aberffrwd mine (PRN 42078).

The mouth of the shaft is filled with rubble and rubbish but appears to be stable. The rubbish should be cleared.

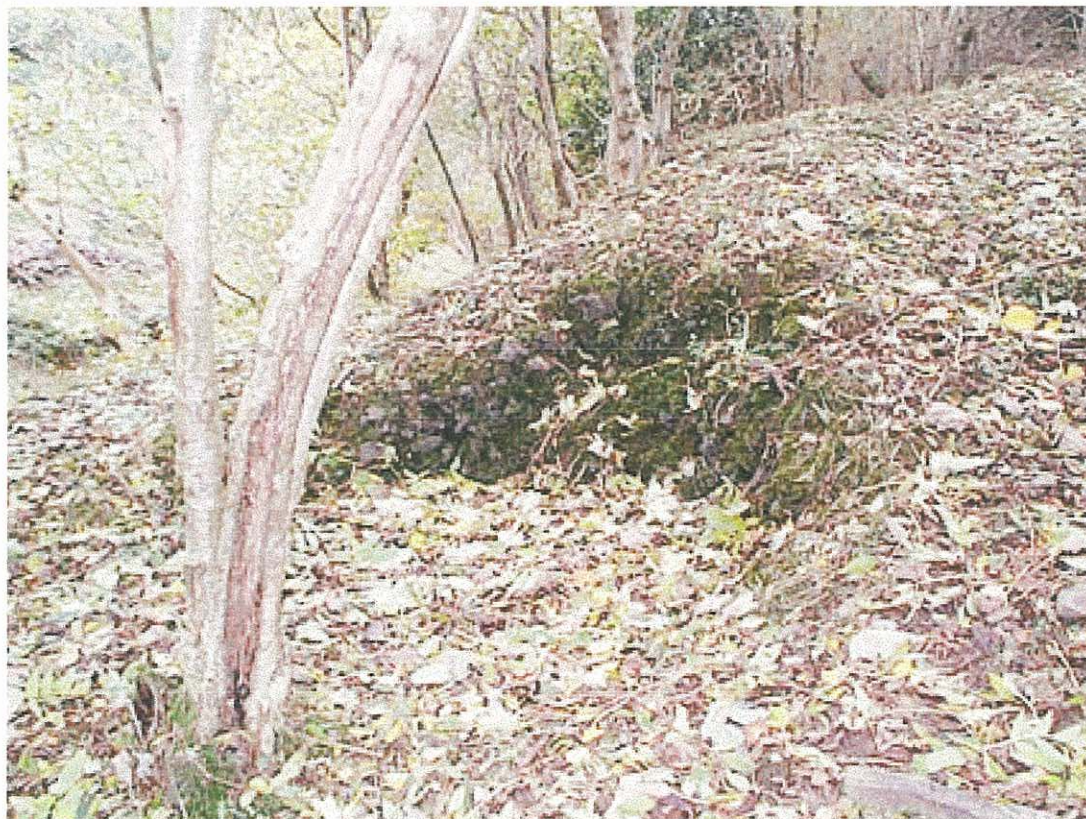
Rubble-built semi-circular structure c.1.5m wide and 0.8m high to the south east of the mine shaft (PRN 42078) at Aberffrwd mine (plate 7). Recorded on the 2nd edition 1:2500 OS map of 1906.

Plate 7 - magazine at Aberffrwd mine (PRN 42080).

The remains of the magazine are in a stable condition. It should be maintained as a stable ruin and any loose stone in this area should be left in-situ.
