Tir Gofal Farm Visit Report

Llwynnywormwood

ACA Report Number 2001/4

TIR GOFAL FARM VISIT REPORT

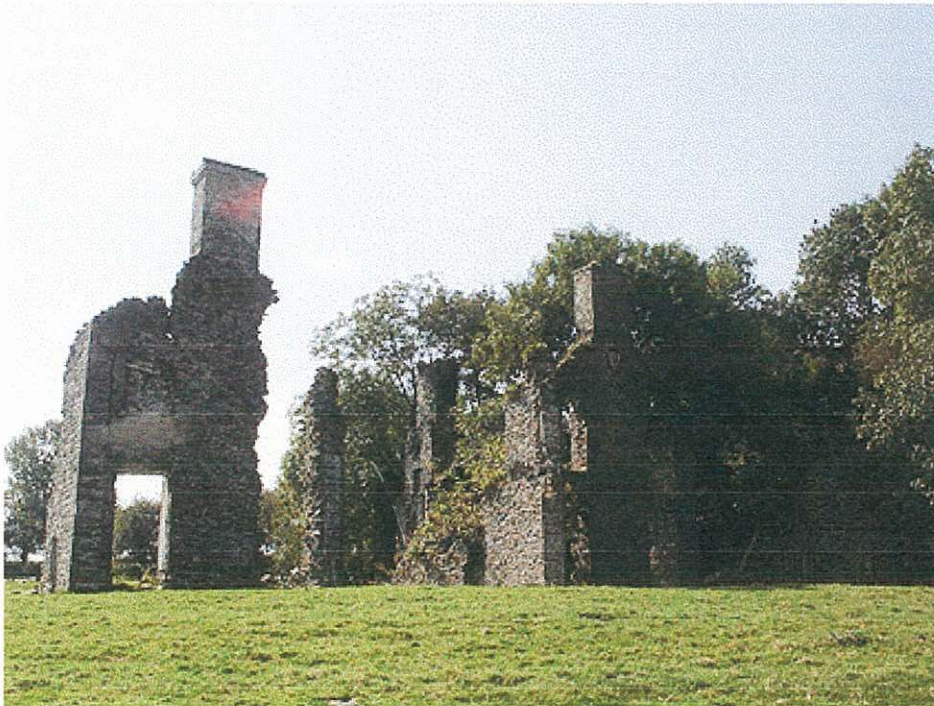
Llwynywormwood mansion house is essentially a ruin (plates 1 and 2). It sits on a levelled platform that is cut into a north-facing slope and has extensive views across the park. The building clearly has a complex history of construction which could be clarified by further survey work. It appears to have originated as a 3-storey random rubble construction that was later extended to the north. A single-storey structure to the rear of the main house provided a detached kitchen. The range from this survives in-situ (plate 3).

Plate 1 - Llwynywormwood mansion house from the north (PRN 19391).

Management Category B	Visited by AJC	Visited On 11/09/00
------------------------------	-----------------------	----------------------------

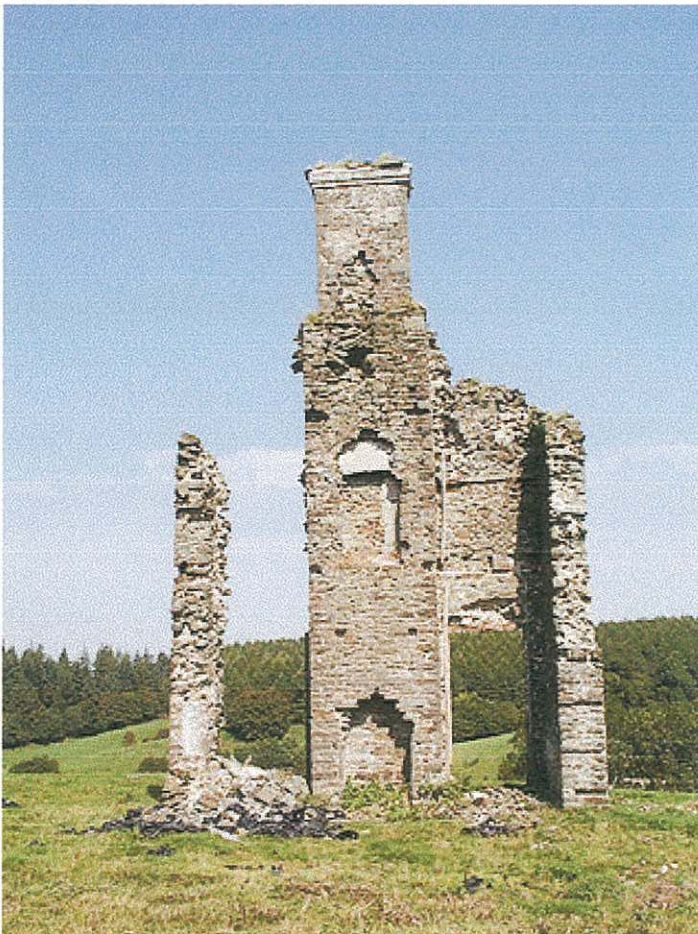
Plate 2 - Llwynywormwood mansion house, gable end (PRN 19391).

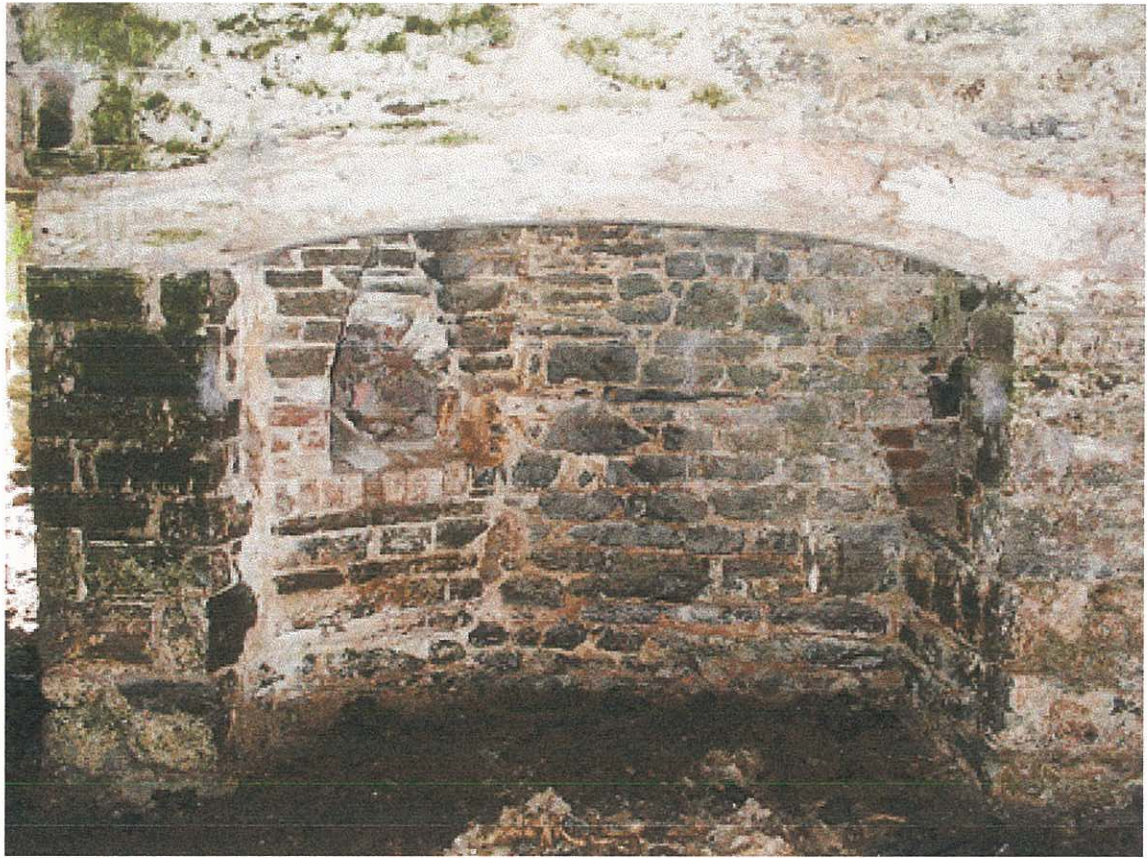
Plate 3 - the original detached kitchen for the mansion house (PRN 19391).

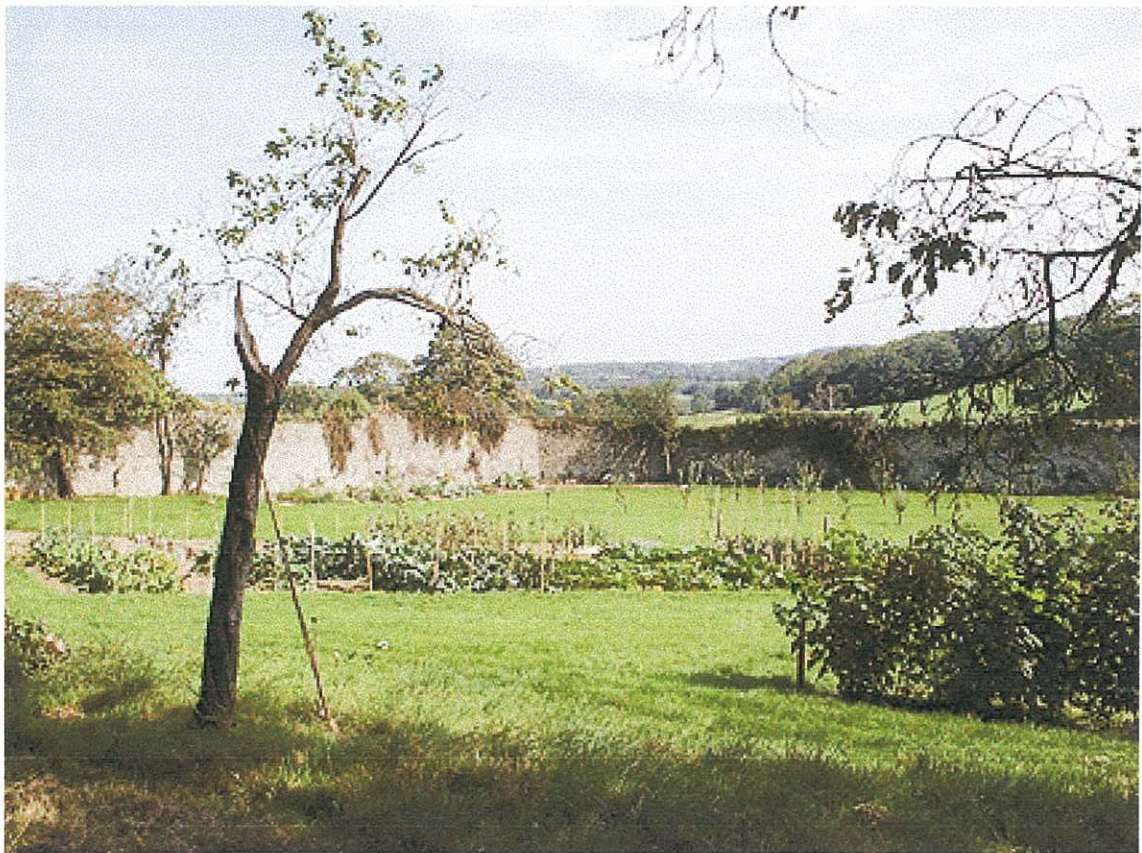
Fine, rectangular walled garden with an east-facing prospect and high (c.2m) rubble walls (plate 4). The garden would have been entered via an arched opening in the northwestern corner from the pathway (PRN 41376) that leads from the mansion. The entranceway is headed with stone voussoirs and gives extensive views across to the Black Mountain. An additional opening in the southern wall has been modified and enlarged but would originally have led through to an orchard that is recorded on the 1st edition OS map (1891). The walls appear to have been edged with a scalloped design and have bevelled corners. A raised platform runs along the length of the western wall upon which a garden house (PRN 41377) formerly stood in the southwestern corner. The area within the walls has been cleared for a vegetable garden and the erection of a glasshouse.

Plate 4 - the walled garden (PRN 41378).

Management Category B	Visited by AJC	Visited On 11/09/00
------------------------------	-----------------------	----------------------------

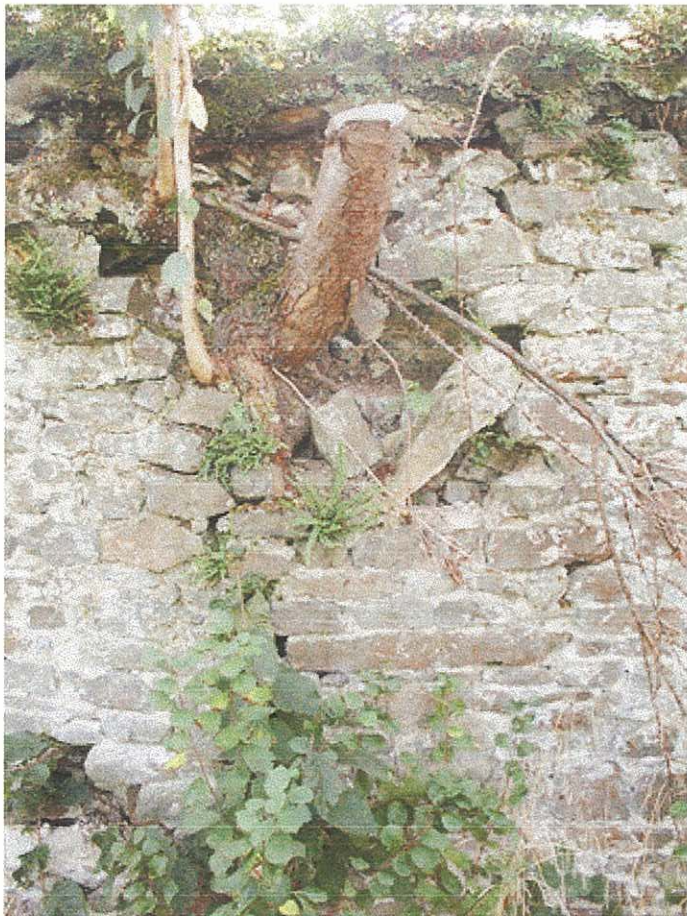
Plate 5 - damage to the walled garden (PRN 41378).

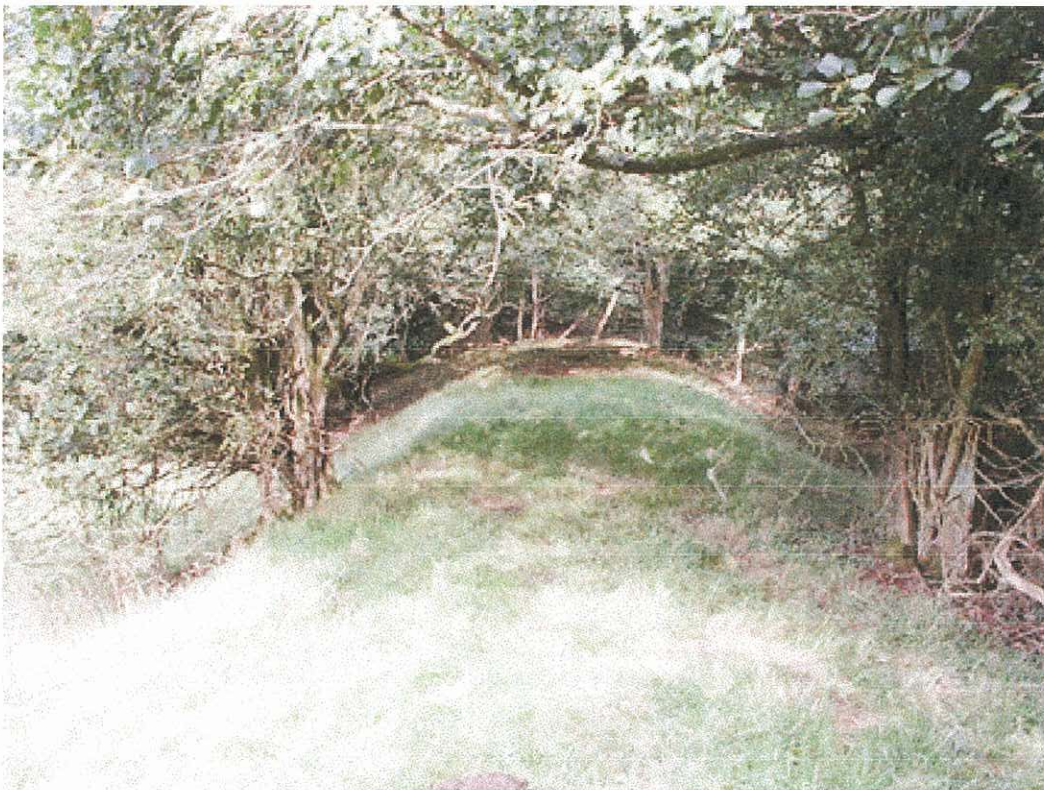
Substantial, raised bank leading downslope from Llwynywormwood mansion towards a former bridge across the Afon Ydw (plate 6). It continues beyond the bridge up the opposite hillside towards the main driveway (PRN 41383). The bank stands at a maximum of c.1.8m high and 3m wide in the valley bottom. Little evidence remains of the bridge other than its crumbling stone footings. The route is marked on 1st and 2nd edition OS maps (1891 and 1906) as a tree lined pathway. On recent maps it is shown as a more substantial trackway and may have been used as an alternative route to the entrance to the park avoiding the circuitous earlier drive (PRN 41383). The original form of the bridge is difficult to determine but was probably of wooden construction and ornamental in style.

Plate 6 - raised approach to the alpine bridge (PRN 41380).

Management Category B	Visited by AJC	Visited On 11/09/00
------------------------------	-----------------------	----------------------------

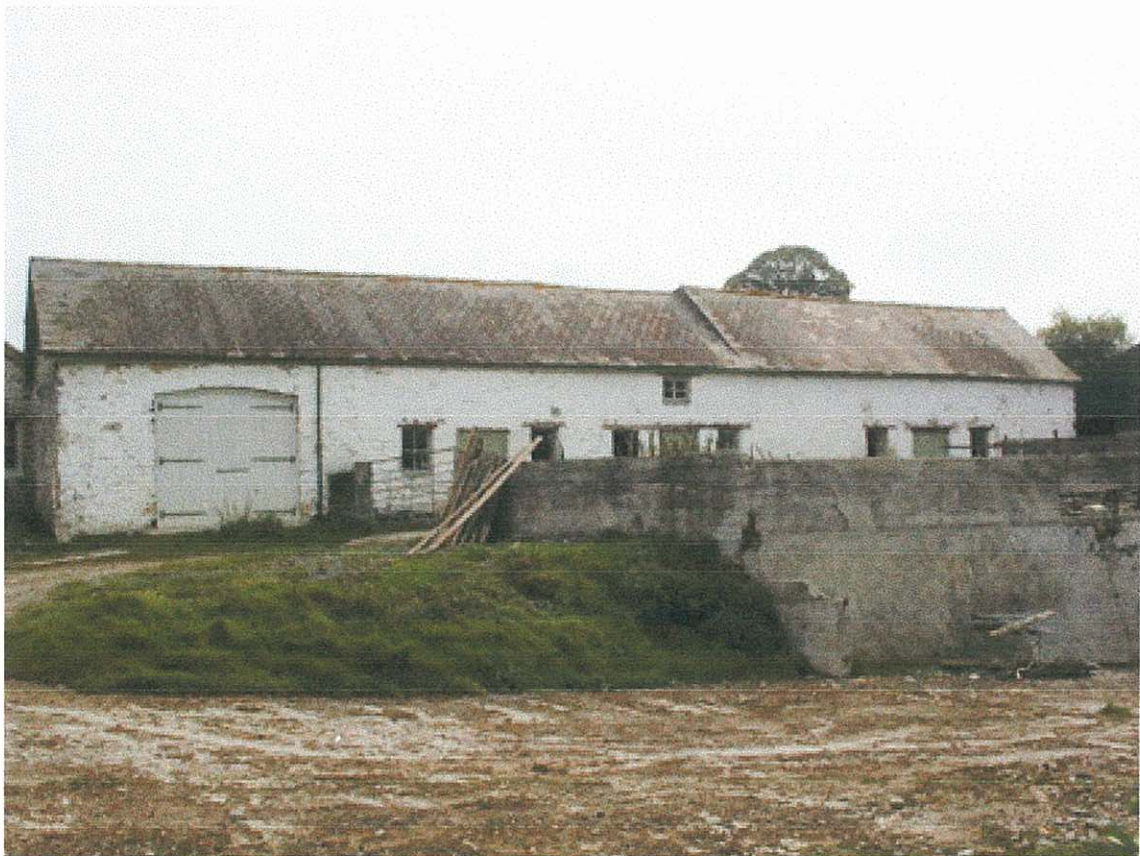
Large, double-pile farm building forming the northern range of the original late eighteenth century/early nineteenth century u-shaped arrangement of farm buildings at Llwynwormwood home farm. The entire building is of random rubble construction with a gabled slate roof and a whitewashed exterior. The existing structure has been built in three distinct phases - an original two-storey, single-range building built into the hillside which was later extended on two separate occasions at first floor level to the south. The roof of the original building was raised and replaced to accommodate the initial extension at the western end. The building includes a carriage house (PRN 42295), stables (PRN 42296), dairy? (PRN 42298), and pigsties and a smithy/brewhouse in the later extensions (PRN 42300). See individual descriptions for more details.

Plate 7 - original farm building (PRN 41387).

Management Category	B	Visited by	AJC	Visited On	11/09/00
----------------------------	---	-------------------	-----	-------------------	----------

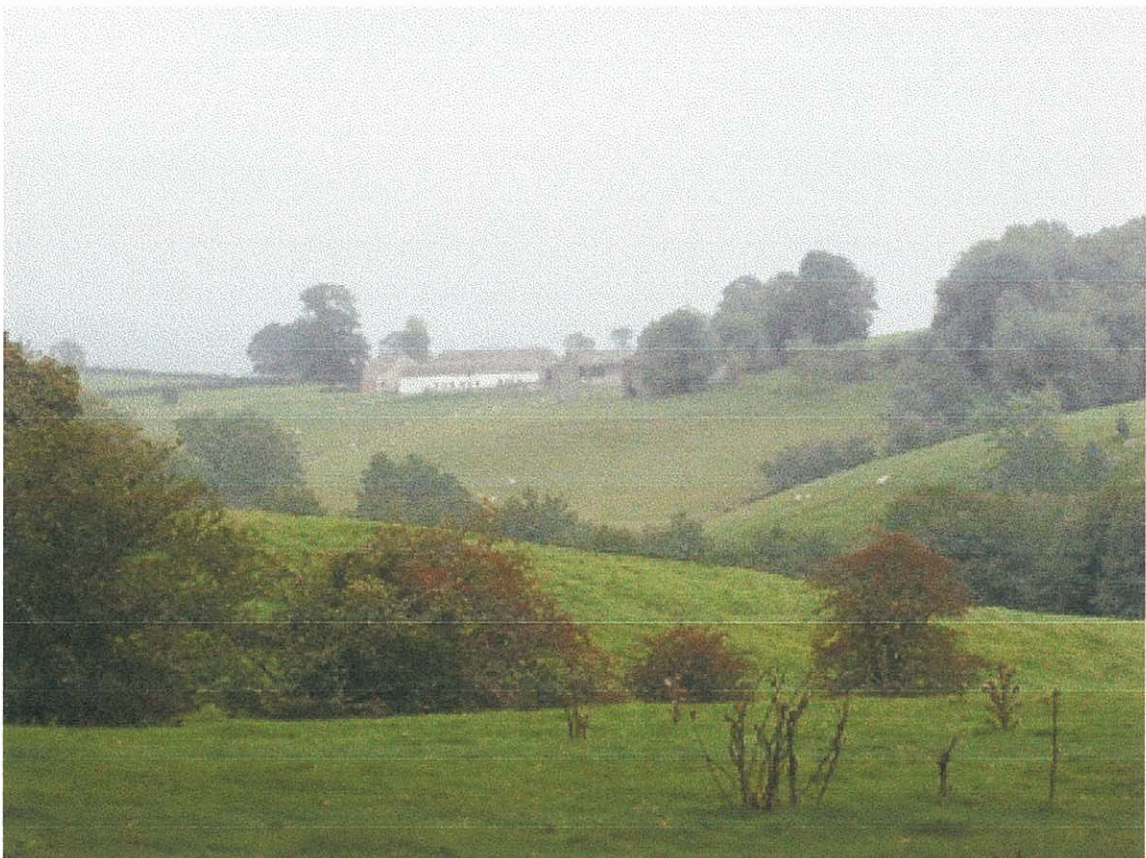
Low c.0.4m high, stone-faced, rectangular viewing platform c.2m by 3m in area. Situated on a prominent rocky outcrop on the western side of the park, commanding extensive views across to the house and along the valley (plate 8). No evidence remains of a superstructure.

Plate 8 - The farm from the viewing platform (PRN 41388).

Management Category	B	Visited by	AJC	Visited On	11/09/00
----------------------------	---	-------------------	-----	-------------------	----------
