# **Tir Gofal Farm Visit Report**

## **Blaengorlech**

### **W/12/0786**

ACA Report Number 2001/14

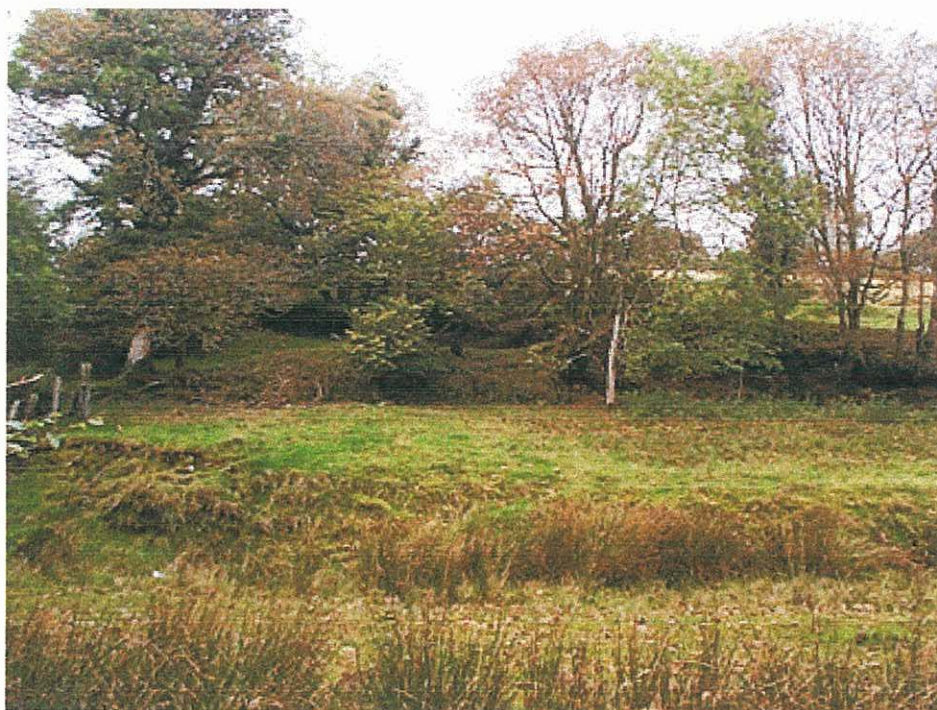
The site of the former medieval mansion Lletty-llwyn-chwith is marked by a substantial platform cut into the east facing hill-slope which is surrounded by trees (plate 1). Although buildings were recorded here on the 2nd edition OS map of 1907, there is very little evidence left of the form and layout of the mansion. The area is littered with large stones, some of which are dressed and were probably from the mansion itself or its surrounding outbuildings. A series of irregularly shaped sunken enclosures c. 1.5m deep with stone and earth internal divisions lie to the south and east of the mansion site although their original function is unknown. A terraced trackway leads from the rear of the house platform and zig-zags uphill to the main drive to the north. This could be the remains of a former service entrance.

Plate 1 - the site of Lletty-llwyn-chwith mansion (PRN 25089).

What remains of the mansion site is in a stable condition and should be kept clear of rubbish and intrusive vegetation. Any loose stones should be left in-situ. The history of the house and its desertion are important to the history of the local community and deserve further archaeological investigation.

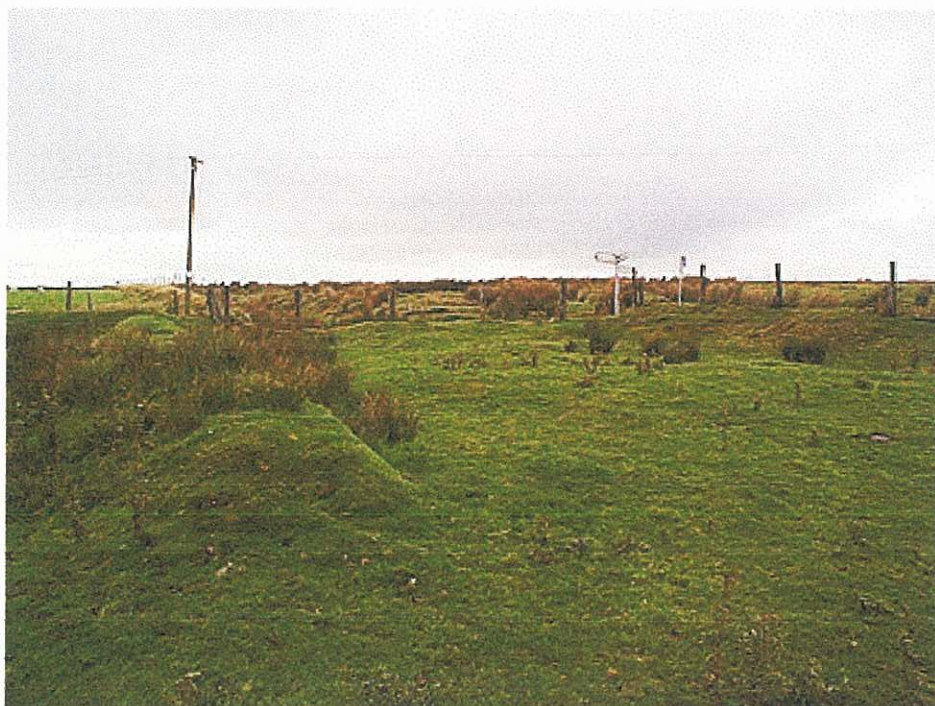
The site of the nineteenth century establishment of Cross Inn lies at the corner of a field at the intersection of two roads to the west of Blaengorlech Fach Farm (plate 2). It is first recorded on the tithe survey of 1841 and was deserted by the time of the 1st edition OS map of 1891. Its position is now marked by a single length of stone and earth bank c.0.8m high which protrudes from the field bank to the west and defines a small enclosure. The footings of the building itself are marked by a low rectangular platform c. 0.3m high. This is completely grassed over although loose rubble from the footings is visible in places.

Plate 2 - The site of Cross Inn (PRN 41449).

The site of the former inn is in a stable condition and lies within a lightly grazed pasture field. The bank that encloses it should be retained and maintained in its current condition.

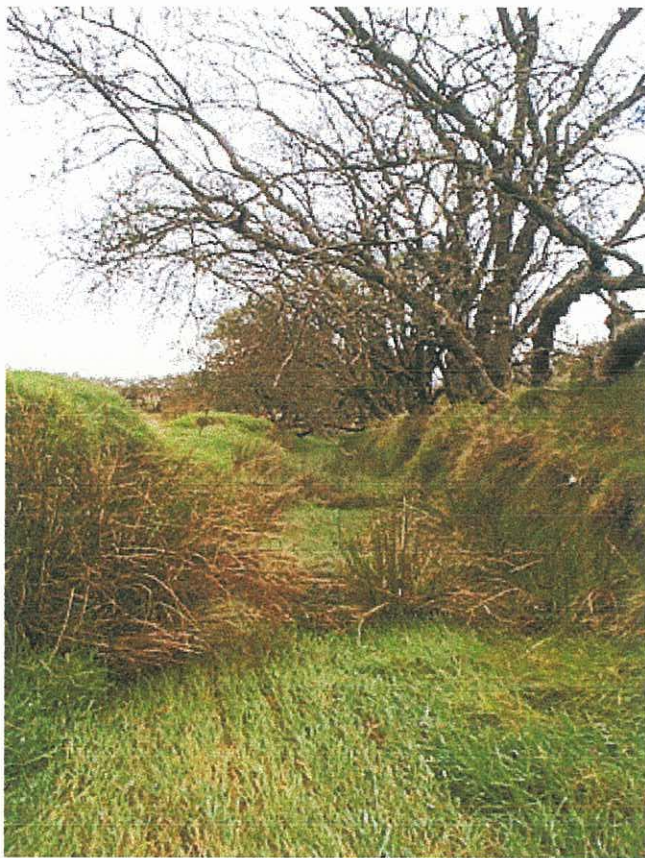
The deserted farmstead of Blaen-pant lies about 1km to the west of Llidiad-Nenog in an isolated patch of enclosed fields. The farm was approached from a track to the southeast and entered via a narrow (c.2.5m wide) drive defined by high (c.1.5m) hedged stone and earth banks, faced with laid rubble (plate 3). The drive runs into an enclosure in which the remains of a dwelling, at least one outbuilding a raised garden area and an animal pen(?) survive.

Plate 3 - the approach to Blaen-pant (PRN 41452).

Whilst the internal walls of the dwelling stand to gable height, the external walls are far lower and some sections of it are unstable. The interior of the building is overgrown and filled with rubble. The walls should be consolidated and the building should be maintained as a stable ruin. The area should be kept clear of rubbish and vegetation and any loose stones should be left in-situ.

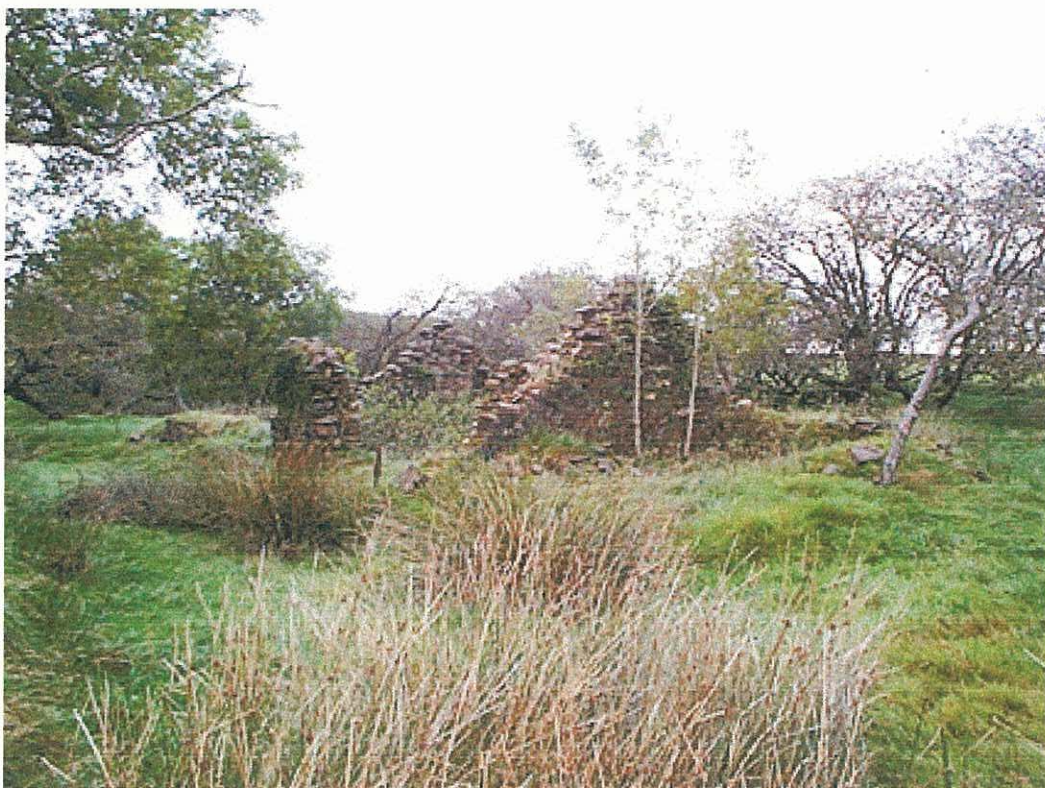
The dwelling was first recorded on the tithe survey of 1841 when it was occupied by Mary Gower. The single-storey rubble structure is made up of a linear arrangement of three rooms and survives in places to gable height (plate 4). No evidence remains of the roofing material. The main door to the house was on the southern wall of the central room. The western room was accessed via the central room and contains the remains of iron and brick fireplaces in the gable end and internal dividing walls. The easternmost room was accessed separately by an opening in the eastern gable wall. There is no evidence of any fenestration and the rooms are now rubble-filled and overgrown. The footings of a small, detached rectangular building c.2.5m by 1.5m, lie to the east of the house and stand to a height of 0.5m. A rectangular pile of rubble against the western gable wall may mark the position of another former outbuilding. The enclosure and fields that surround the farmstead are defined by low, hedged earth and stone banks c.0.8m high.

Plate 4 - Blaen-pant deserted cottage (PRN 41452).

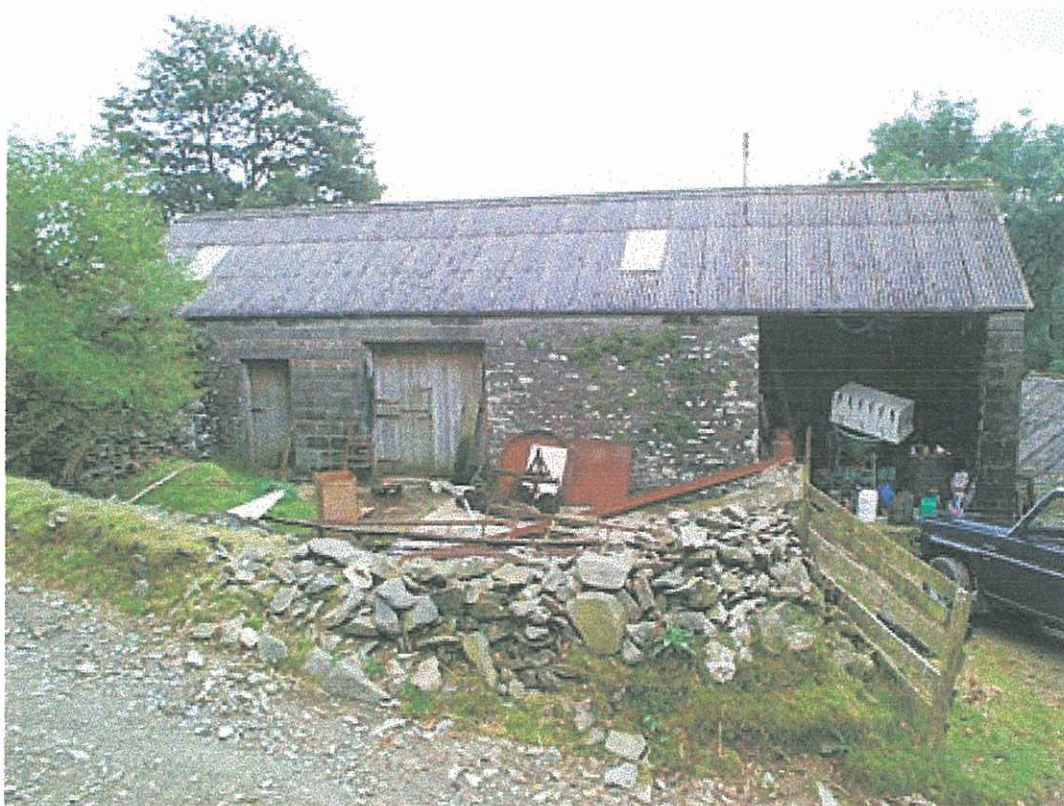
Two storey random uncoursed rubble construction with a gabled asbestos roof, built into the south facing hillside at Blaengorlech Fach Farm. Orientation north-south. First recorded on the 1st edition OS map of 1891. The western wall has been considerably modified and rebuilt with breeze blocks and its original form is hard to determine (plate 5). The original openings survive on the eastern and northern gable walls and are square headed with timber lintels (plate 6). It is accessed at ground floor level via a double width door in its eastern wall and at loft level from the hillside to the north via a low door in the northern gable wall. A large stone-faced platform lies along the eastern wall of the barn and may have provided a 'yard' area.

Plate 5 - Blaengorlech Fach barn from the west (PRN 41455).

The barn should be maintained in its current condition as a working building. Any further repairs or alterations should be carried out with materials that are sympathetic to the character of the original building.

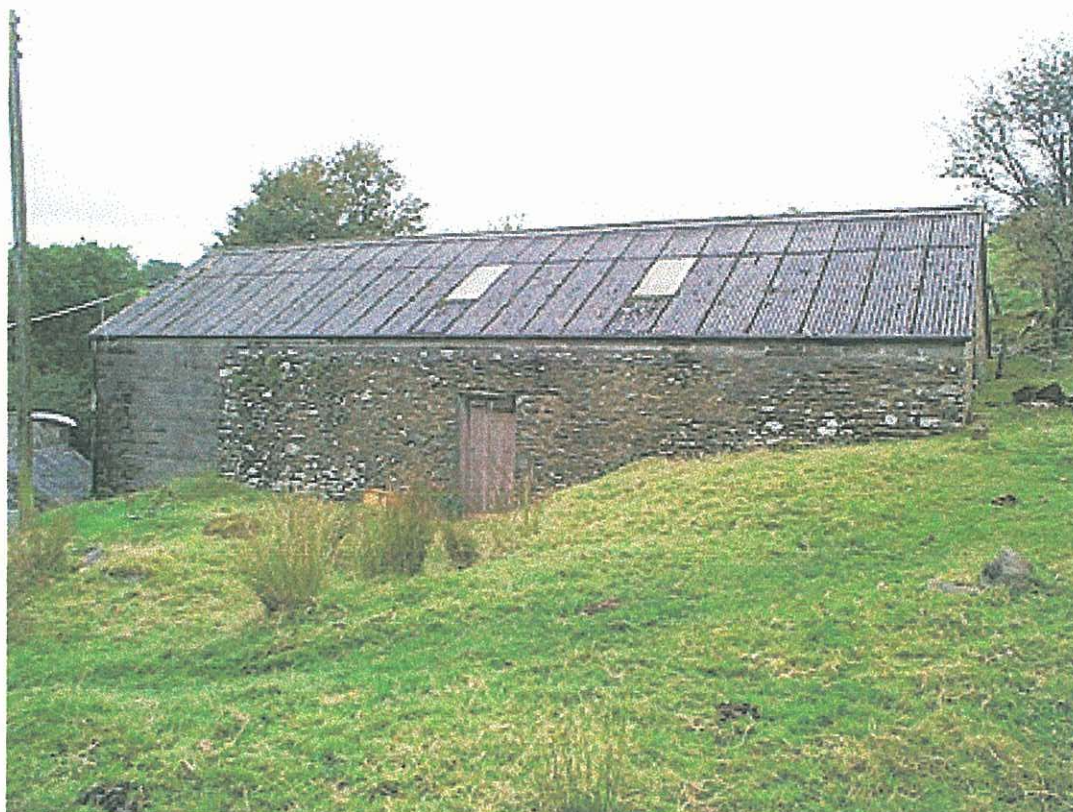
Plate 6 - Blaengorlech Fach barn from the east (PRN 41455).
