Tir Gofal Farm Visit Report

Pant-y-fen

W/12/0128

ACA Report Number 2001/8

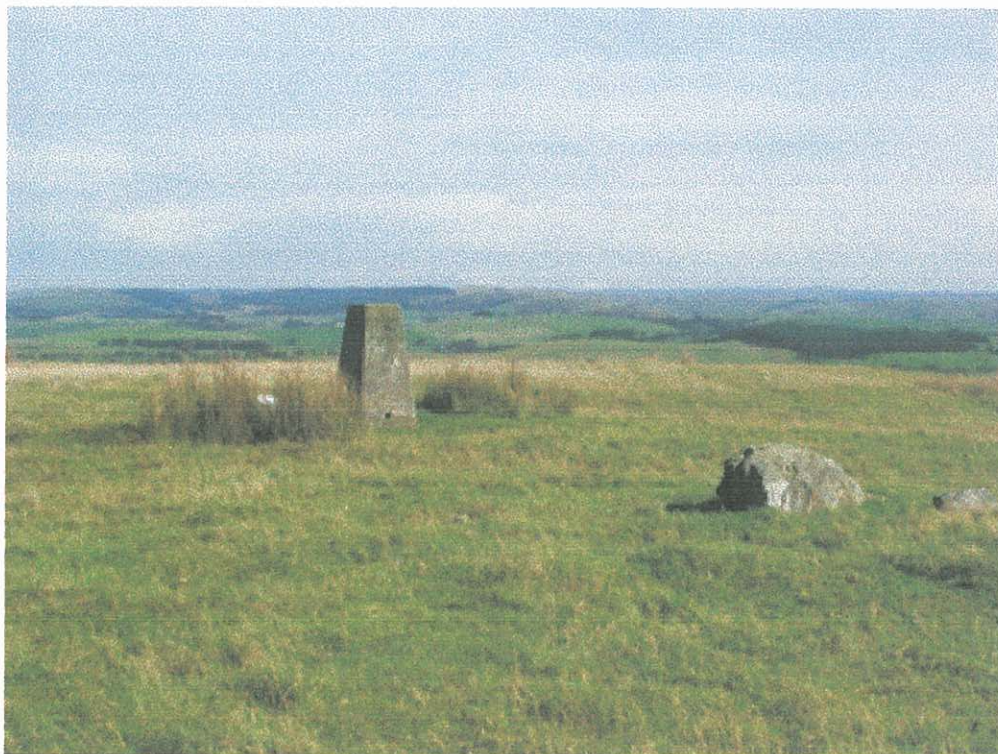
Plate 1 - Bronze Age barrow on Mynydd Pencarreg (PRN 1192).

Low, grassy stone and earthen mound, c. 0.4m high and 3m in diameter located on a prominent plateau with spectacular views on all sides. Possibly the last surviving example of a once extensive Bronze Age cairnfield that extended across the upper slopes of Mynydd Pencarreg. Little remains of the cairn and the placement of a trigpoint on its summit has damaged it further. The condition of this particular cairn and the cairnfield in general have deteriorated significantly since they were recorded in 1917 when it was described as "the ruins of a fine cairn" and the remains of other cairns on the hillside were also mentioned (plate 1).

The cairn is in a prominent position on the route of a planned footpath. The trigpoint on it will provide a further attraction for walkers to stand and admire the view. The survival of the monument is therefore threatened. Further survey work is needed to assess the survival of the cairnfield as a whole and to identify other features of the prehistoric landscape in the area.

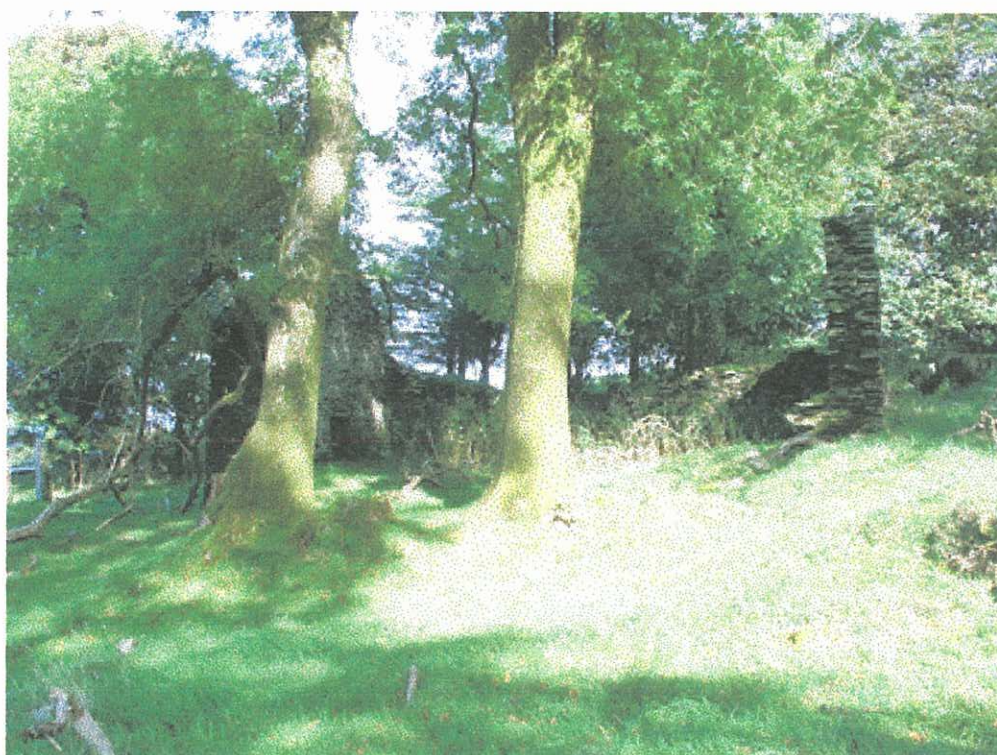
Plate 2 - the ruined cottage of Blaenbydernyn Lodge (PRN 7008).

The two storey dwelling of Blaen Bydernin Lodge, a cluster of outbuildings and a raised garden stand within a small, earth-banked enclosure on the south western side of Pantyfen farm (plate 2). The dwelling was approached from the road to the north by a narrow driveway that runs along the southeastern side of the enclosure. It was first recorded on the Pencarreg Tithe survey of 1841 when it was part of the Blaen Bydernyn Estate, although the last occupants were reputedly buried in Pencarreg churchyard in 1816.

It was recorded by RCAHMW in 1979 as a "ruined two-storey cottage, rubble in clay with rough quoins, some cut. Had wickerwork fireplace hood". Small fireplaces with slate lintels stand in both gable walls. The sockets that held the wicker fireplace hood also survive in the eastern gable wall. The dwelling was accessed through a centrally positioned doorway in the northern wall (now blocked). The gable walls survive to roof height, the northern wall stands to a height of 1.8m and the southern wall has been completely demolished. No roofing material survives. The footings of a square, c.2m by 2m building with a southeasterly-facing entrance stand to a height of 0.5m to the northwest of the dwelling. A raised stone-faced platform c.10m by 5m by 0.8m high lies to the southeast of the dwelling and may mark the position of a former garden. The footings of another small c.2m by 5m building foundation stand to a height of 0.5m at the southern corner of the enclosure. The boundaries of the enclosure are defined by low, earthen banks planted with beech trees.

The cottage and the surrounding earthworks are in a ruinous but stable condition. The owner would like to renovate the property when finances allow it but has previously been refused planning permission to do so. The dwelling should be consolidated and maintained as a stable ruin. Restoration work should be carried out in a way that is sympathetic to the character of the original building. The enclosure should be maintained in its current state and kept clear of rubbish and intrusive vegetation.

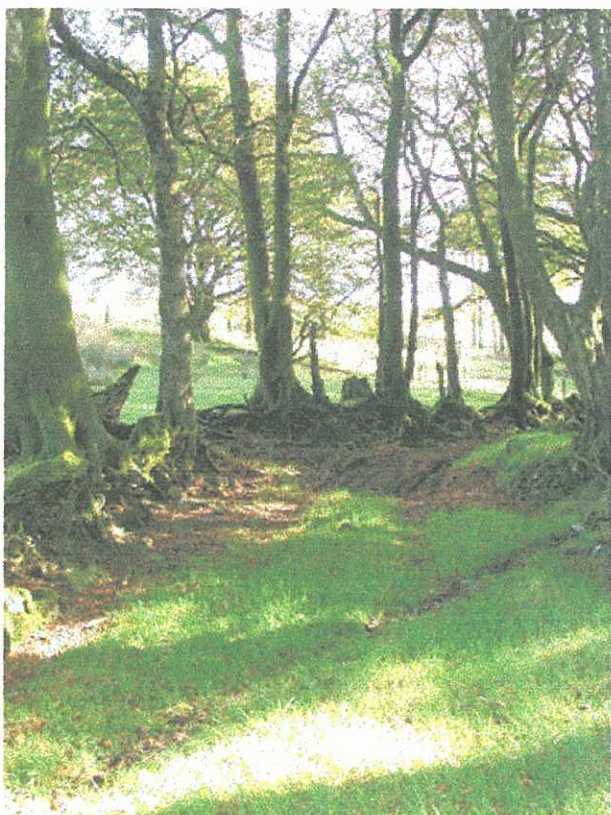
Plate 3 - the driveway to Victoria Park Farm (PRN41407).

Ruined farmstead of Victoria Park Farm, consisting of an L-shaped arrangement of ruined farm buildings, a cottage, a garden, a mill pond and a well set within a triangular, earthen-banked enclosure to the northeast of Pantyfen Farm. The enclosure is approached from the road to the east by a broad driveway, defined by low (c.0.5m high) banks to either side (plate 3) and planted with beech trees. It is bordered to the south by an arrangement of small, enclosed paddocks. The farm was first recorded on the 1st Edition OS map of 1891 when it included land to the south and east. The fields here are defined by low earthen banks which are planted with beech trees and give the area a very distinctive appearance. The entire farmstead probably dates to the enclosure of Mynydd Pencarreg in 1850. It was reputedly burnt down by local army trainees in the 1950's. The building footings stand to a maximum height of c. 0.5m and are completely grassed over. The circular mill pond is defined by low (c.0.6m high) rubble banks which survive in a reasonable condition. The garden includes a fine yew tree and is defined by low earth and stone banks (c.0.4m high).

The remains of the farmstead should be maintained in their current condition and kept clear of vegetation. The walls of the millpond should be consolidated. The surviving gateposts should be retained in their current positions. Any loose rubble should be left in-situ. The farm stands alongside a public road and the route of a proposed footpath. It would be an ideal site for the installation of an interpretation board, outlining the history of the occupation of Mynydd Pencarreg.

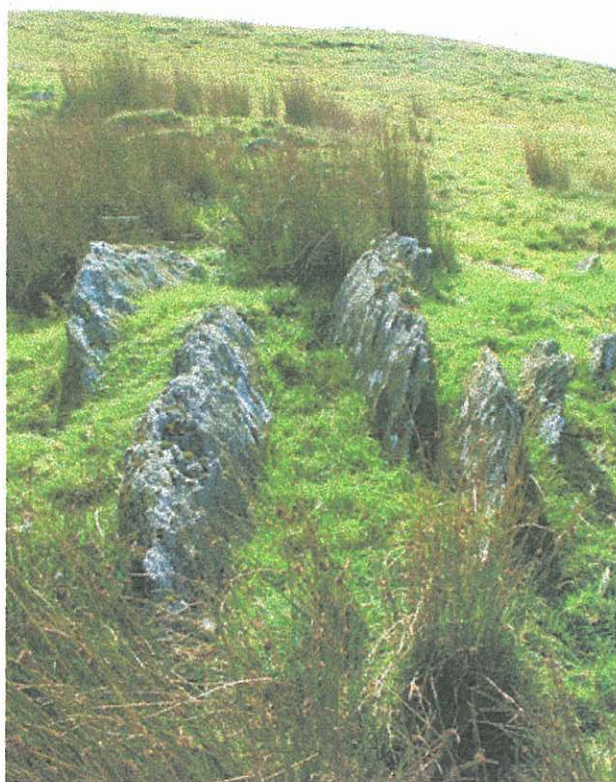
Plate 4 - possible chambered tomb (PRN 41417).

Two parallel rows of large, tabular stones set on their sides, beside a natural rock outcrop. Their form is clearly different to that of the natural rock formation although there was no evidence of a distinct cist (plate 4). Possible late neolithic burial monument.

The stones should be left in-situ and the site should be re-examined as part of a wider survey of the prehistoric landscape on Mynydd Pencarreg.

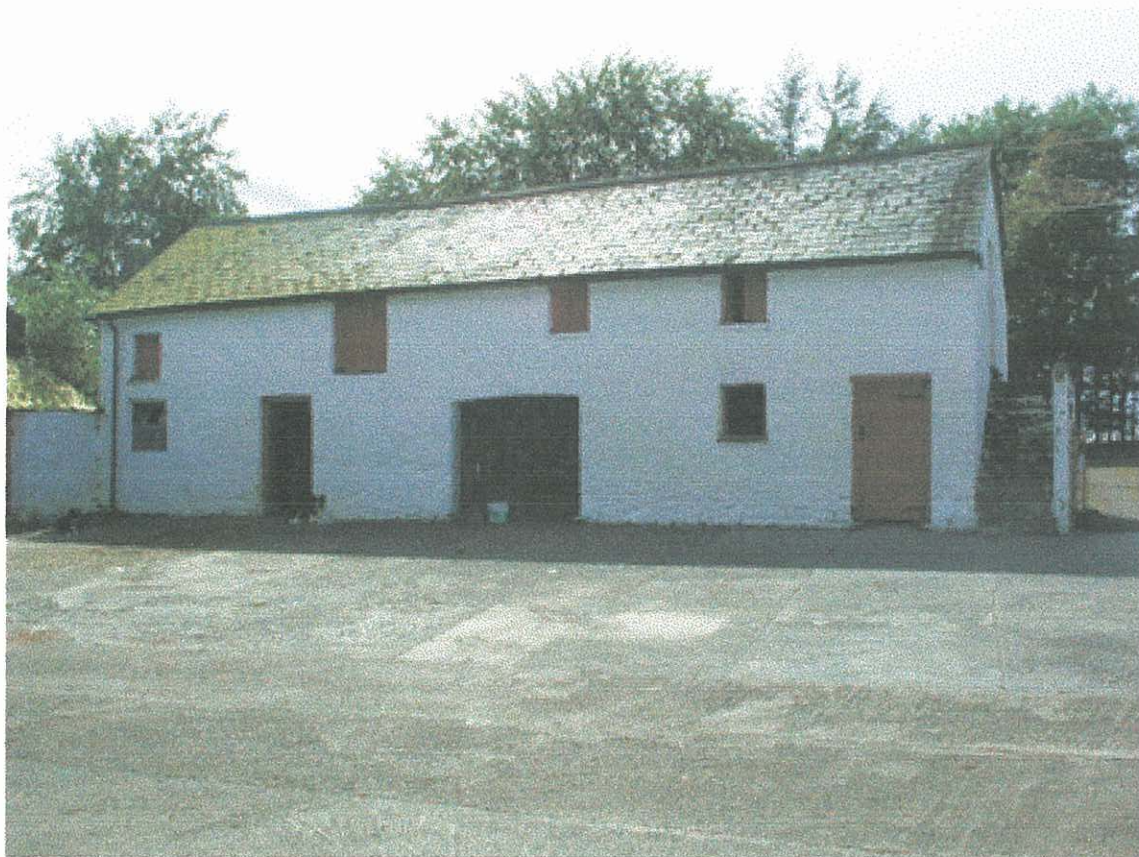
Plate 5 - late nineteenth century farm building at Pantyfen Farm (PRN 42071).

Mid to late-nineteenth century cowhouse, chaff room and stable, forming the southern side of a u-shaped arrangement of farm buildings at Pantyfen Farm (plate 5). Whitewashed rubble construction with a gabled slate roof. The openings vary in style and appear to have been modified on several occasions. All of the openings are located in the north facing wall. The stable is entered at ground floor level via a single width, square-headed door with a timber lintel. The chaff room is entered via a double width door, headed with brick voussoirs. The cowhouse is accessed via a single width door, again headed with brick voussoirs. The ground floor windows are all headed with brick voussoirs. The first floor loft is accessed by a stone and slate stairway attached to the western gable wall via a single width, square headed door with a timber lintel. The windows at first floor level are positioned directly beneath the eaves. None of the original internal fittings survive.

The building is well maintained and in good working condition. It should be maintained in its current state. Any alterations and repairs should be carried out in a way that is sympathetic to the character of the original building.
