**PONTIETS TO BANCYFELIN  
GAS PIPELINE ROUTE**

**ARCHAEOLOGICAL ASSESSMENT  
JUNE 2000**

**Project Record No. 40762**

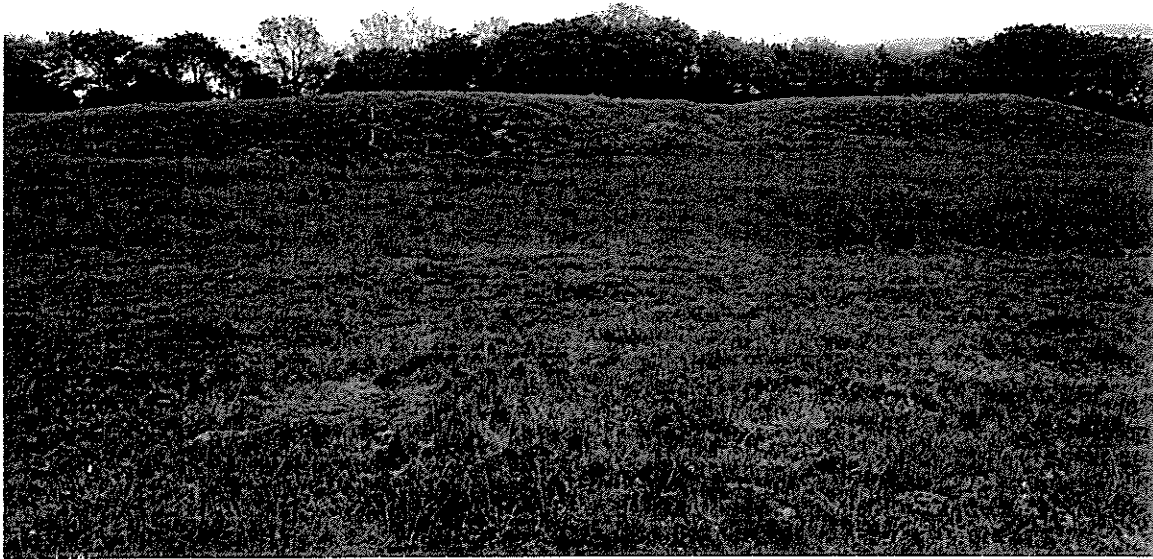
<b>Site type</b>	SPOIL TIP	<b>Period</b>	Post Med	<b>Form</b>	Earthwork
<b>Description</b>					
Complex of small, coal-slag shown on aerial photographs, averaging 3-4m in height and now grassy, occupying rough pasture field NW of Pont-iets. Appear to be associated with the former Llyn-y-wiwer Colliery immediately SW (PRN 30608), established in 1838. Marked, but not labelled, on 1907 OS map.					
<b>Recommendation</b>					
<b>Coal mine covers area cut by route. Record any features revealed during pipeline cutting.</b>					
<b>Condition</b>		<b>Site Status</b>

*Photo 1: PRN 40768 Rhas-Fach spoil tips, view ENE (PRN 40762/215)*

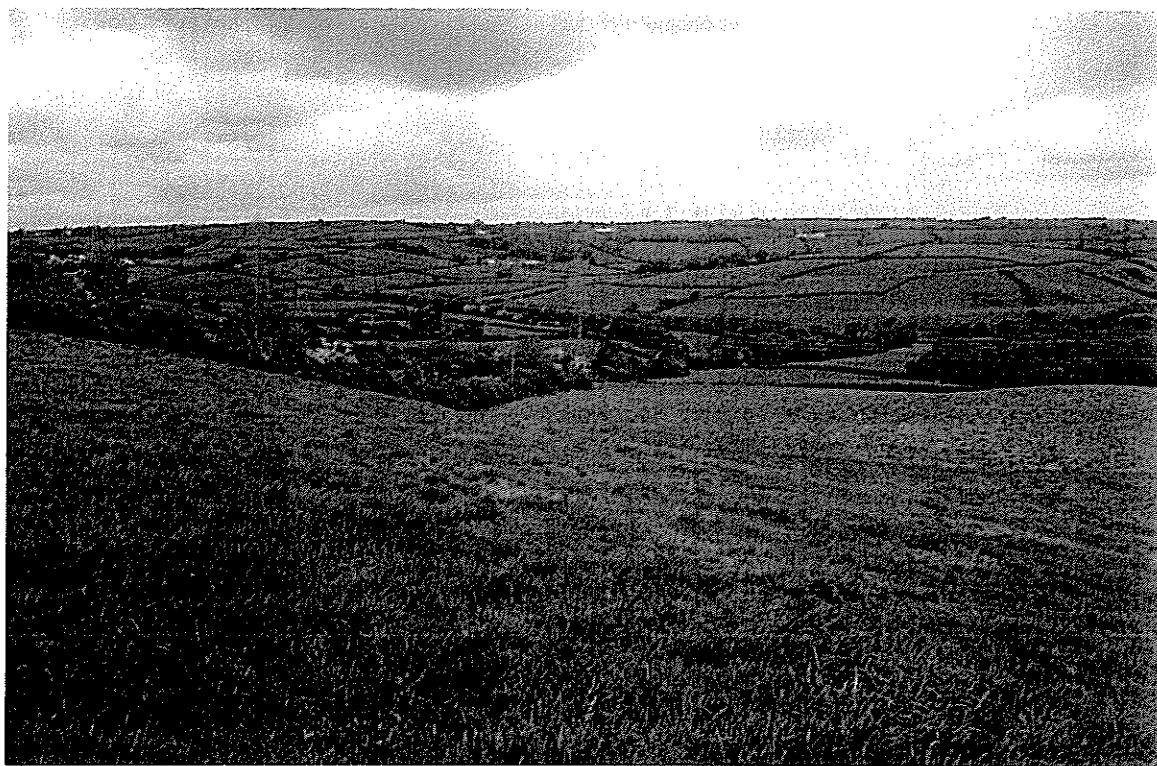
Photo 4: Up the stream running across 40860-61 with so called barrow PRN 5357 below mainly white cow to right of photo, view E (PRN 40762/218)
