**ARCHAEOLOGICAL WATCHING BRIEF  
NEW FLOODLIGHTING  
AT  
KIDWELLY CASTLE  
KIDWELLY,  
Carmarthenshire**

**SEPTEMBER 2000**

Prepared  
*by*  
**Cambria Archaeology Field Operations**  
*for*  
**The Kidwelly Trade and Tourism Association**

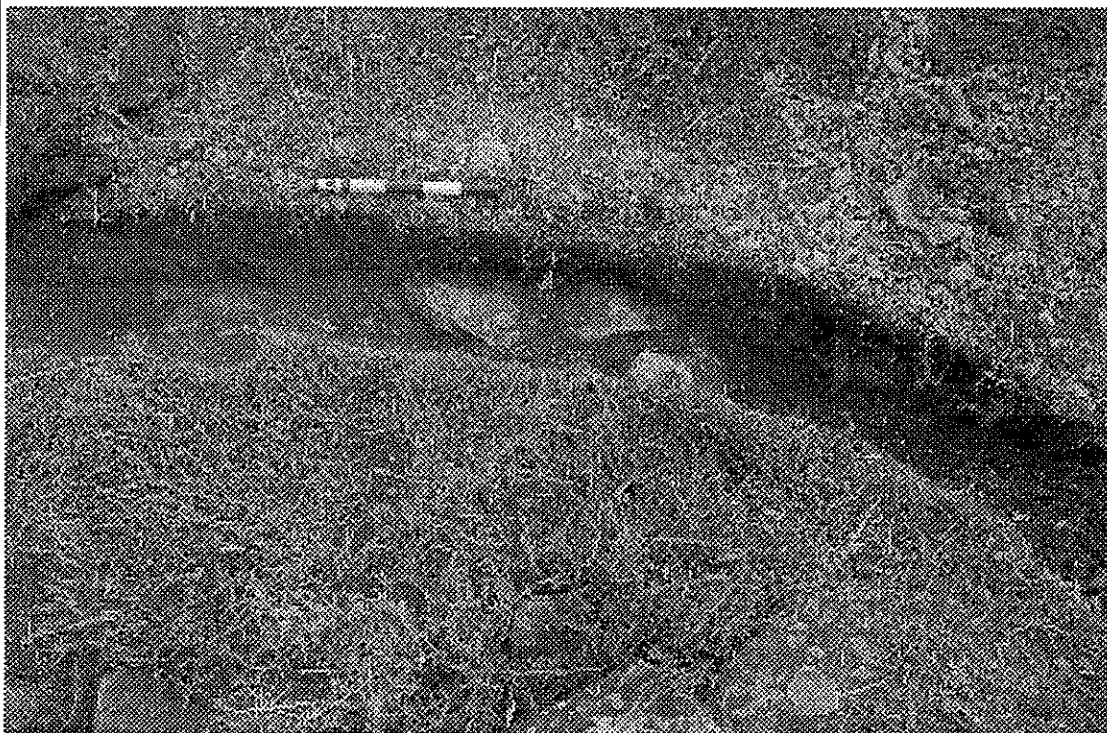
The cable trench was a narrow, v-shaped trench measuring on average 12cm wide at the top, 5cm wide at the bottom and 10cm-15cm deep. Where the trench passed the southern end of the spur wall that extends south across the ditch from the corner of the gatehouse it was slightly bigger, 19cm wide at the top x 12cm at the bottom x 15cm deep. This was the only section of trench that exposed any archaeological features. A continuation of the spur wall, which dates from the 14<sup>th</sup> century (Kenyon 1986), and consisted of a layer of mortared stones was exposed in the base of the trench (Plate 1). The exposed section of wall was 84cm wide, which accords well with the width of the surviving spur wall which is 90cm wide. The trench stopped at the top of the stones.

Plate 1: continuation of 14<sup>th</sup> century spur wall exposed in cable trench

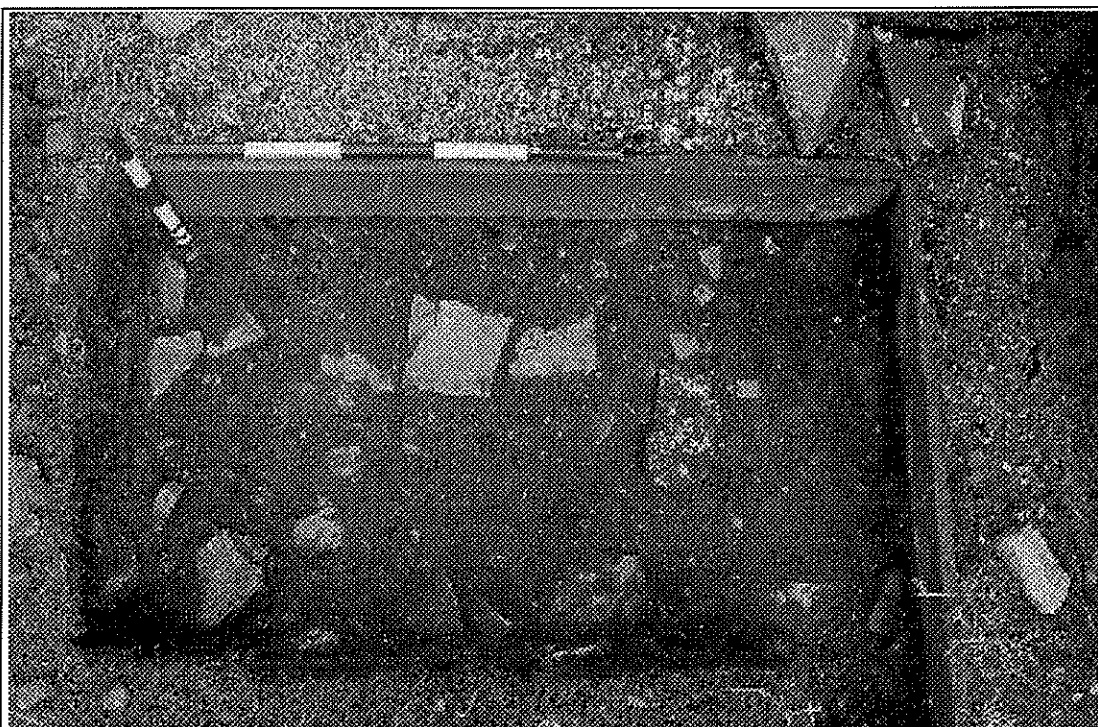
The excavation for the floodlight base measured 87cm x 53cm x 15cm. Two stones exhibiting mortar patches were recorded in this area, although neither was *in situ*, nor associated with other stones. They were laying on a layer of burnt red/brown loamy clay that contained charcoal flecks and it appeared to be a burnt deposit (Plate 2). Like the stones this deposit did not appear to be *in situ*, rather it is more likely to have been redeposited when the interior of the castle was turfed, although it may have been redeposited from close by.

Plate 2: Floodlight base near oven after excavation.

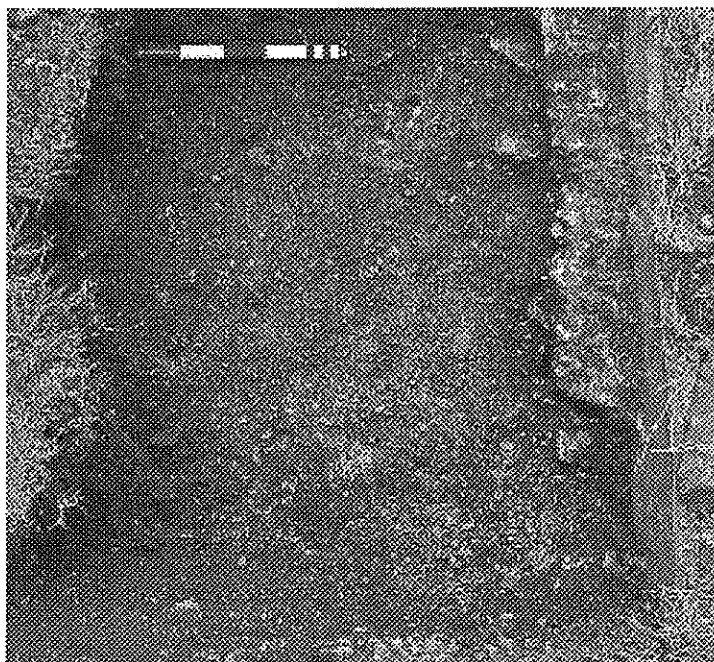
The excavation for this base measured 80cm x 60cm x 24cm. The only features of potential archaeological interest in the trench were a patch of mortar in the northeast corner and a small patch of shellfish shells in the southeast corner (Plate 3), although neither appear to have been *in situ*. Both were laying on a light brown loam soil which contained mortar patches and flecks of charcoal and like the deposits in the other floodlight base they were most likely redeposited during turf laying, or when the concrete edging around the interior was laid.

Plate 3: Floodlight base near southeast tower after excavation.
