Tir Gofal Farm Visit Report

Pwllcymbyd

Report Number 2001/61

TIR GOFAL FARM VISIT REPORT

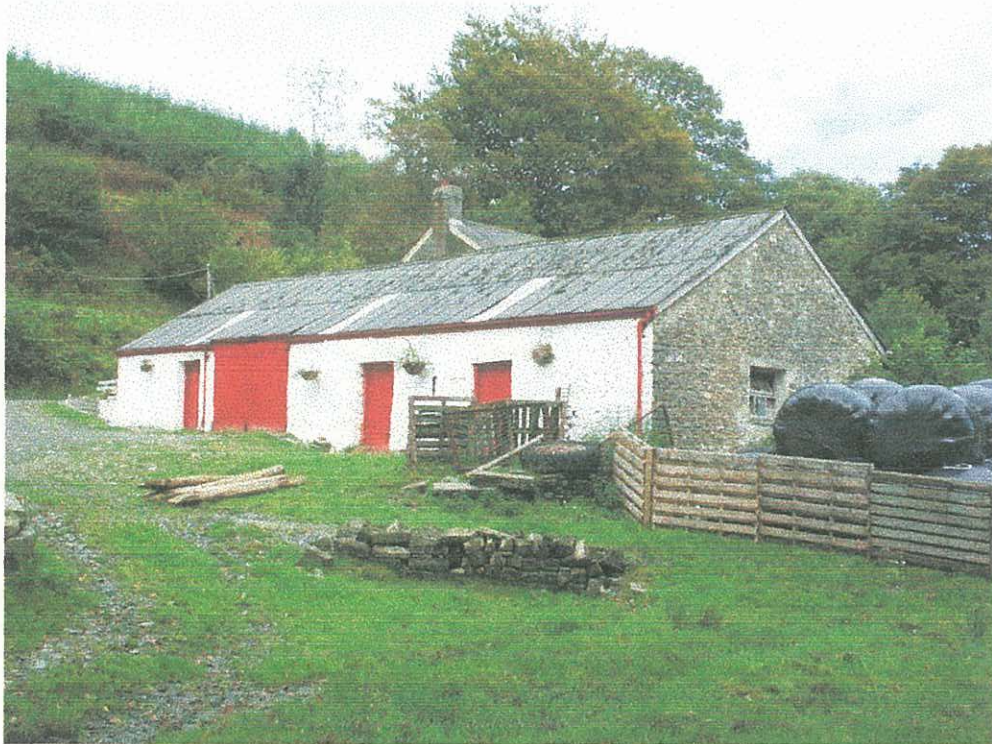
The northern row of buildings is a one-storey rubble walled cart shed and cow house with a pitched, corrugated asbestos roof, (plate 1). The south eastern end has stalls with a feed passage running across the cow house. There are two low doorways in the south elevation one providing access to the feed passage and a second to the manure passage. Internally the building is open to the roof and some of the wooden stall partitions still remain. Two windows in the north east facing elevation and another in the south east gable provide ventilation to the cowhouse. To the north west end a pair of double doors in the south west facing elevation provide access into the cart shed. A further low doorway gives access into the upper end of the building which is currently used as a workshop. The cow house is in good condition, the masonry appears to be intact and the roof watertight.

Plate 1 – cow house and cart shed to the north east of the farmyard (PRN 43638)

No specific action required, but the building should be maintained using sympathetic materials. Where original internal fixtures survive, such as the timber stall partitions, these should be retained.

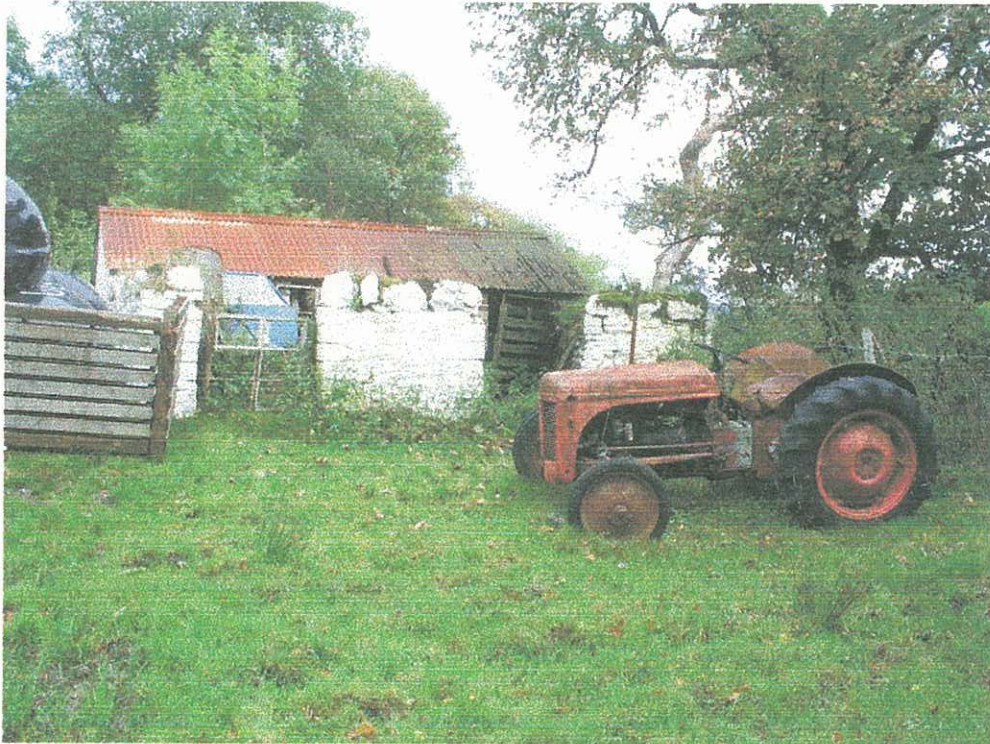
A single storey pig sty is situated to the south east of the farm yard (plate 3). The sty is rubble walled with a whitewashed finish and a corrugated iron pitched roof. It is divided into two units with enclosed yards to the front, the walls of which are capped with large chunks of quartz. The entrance jambs are constructed with some dressed stone, which may be reused. The front wall to the sty is covered with lime render and crudely inscribed as ashlar.

Plate 3 – pig sty to south east of farm yard (PRN 43640)

PRN 43640 - The pig sties are becoming overgrown, the vegetation should be cut, left in place, and the roots treated to prevent new growth. The stonework should be consolidated.

The pig sties are becoming overgrown, the vegetation should be cut, left in place, and the roots treated to prevent new growth. The stonework should be consolidated.

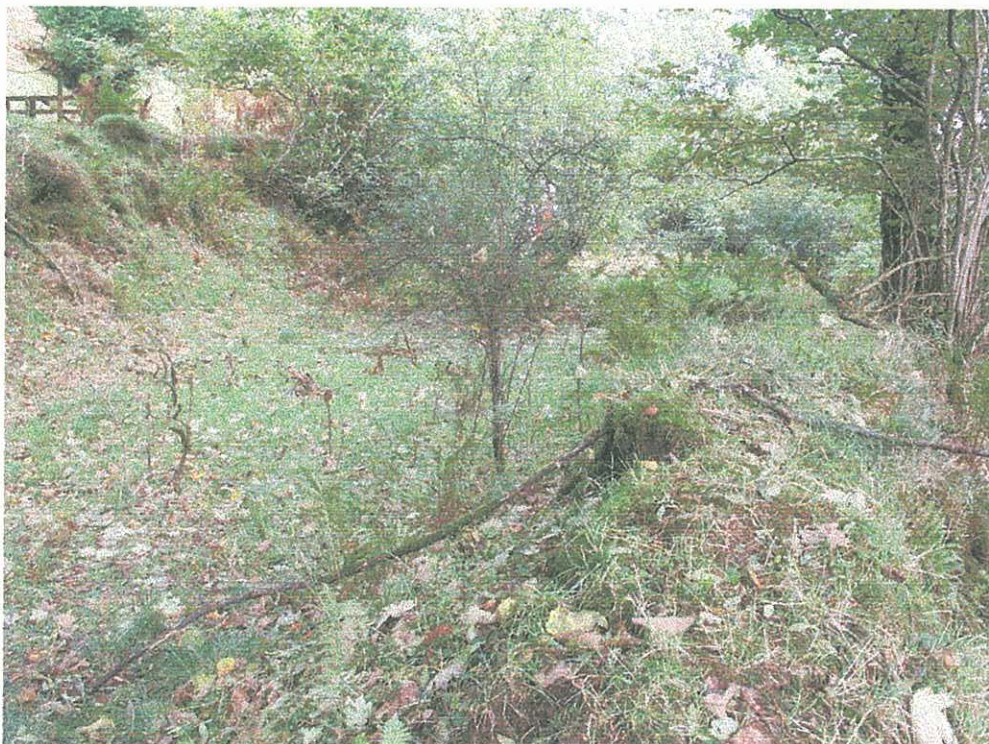
The remains of the mill pond are sited in the western corner of the enclosure to the south west of the farm buildings. The mill pond is roughly rectangular in shape, it currently does not hold water, but is defined by earth banks which stand approximately a metre high (plate 4).

Plate 4 – north east end of mill pond (PRN 43642)

PRN 43642 - The pond area should be excluded from ploughing, or any other form of ground breaking operations to protect the earthworks and any surviving buried remains. Clear intrusive vegetation and scrub growth and introduce a light grazing regime to keep the vegetation down.

This area should be excluded from ploughing, or any other form of ground breaking operations to protect the earthworks and any surviving buried remains. Clear intrusive vegetation and scrub growth and introduce a light grazing regime to keep the vegetation down.

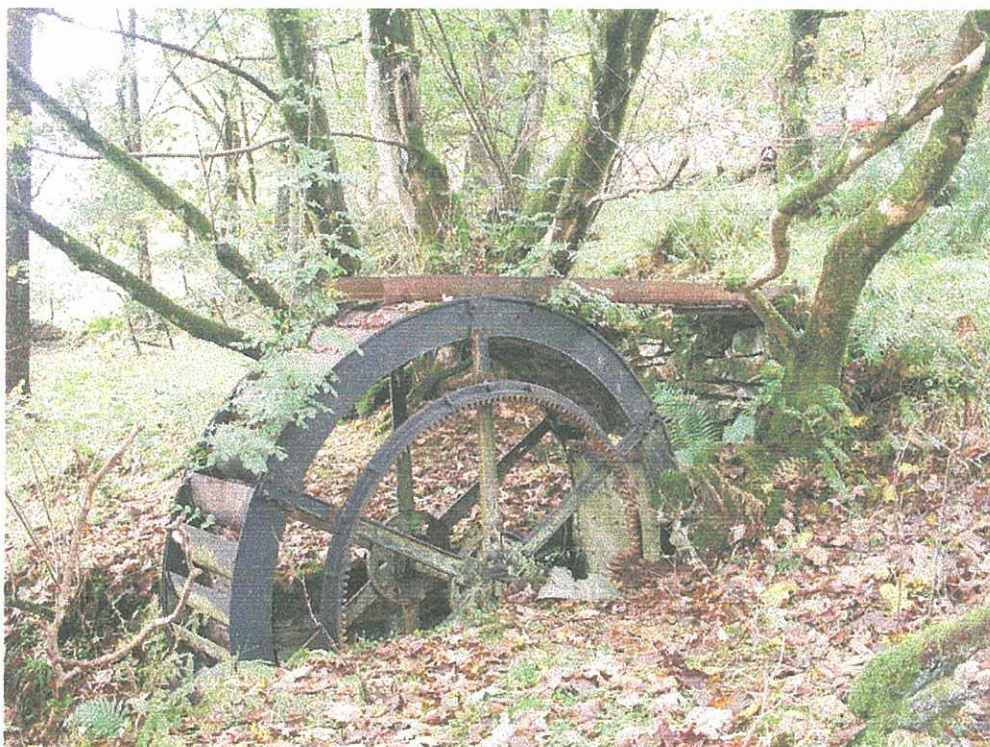
An overshot water wheel is positioned well away from the buildings to the southwest, set in a stone lined pit (plate 5). The wheel is entirely constructed of iron with an iron top race directing water from the millpond (PRN 43642) above. A linear depression leads from the wheel's axle towards barn PRN 43639, however this has become quite overgrown. The waterwheel is currently intact, however where vegetation has become established within the paddles the iron is corroding.

Plate 5 – water wheel and stone lined wheel pit, facing west (PRN 43643)

PRN 43643 - Clear vegetation from the paddles of the waterwheel. Intrusive vegetation in the stonework of the wheel pit should be cut, left in place, and the roots treated to prevent new growth. Consolidate stonework in the wheel pit.

Clear vegetation from the paddles of the waterwheel. Intrusive vegetation in the stonework of the wheel pit should be cut, left in place, and the roots treated to prevent new growth. Consolidate stonework in the wheel pit.

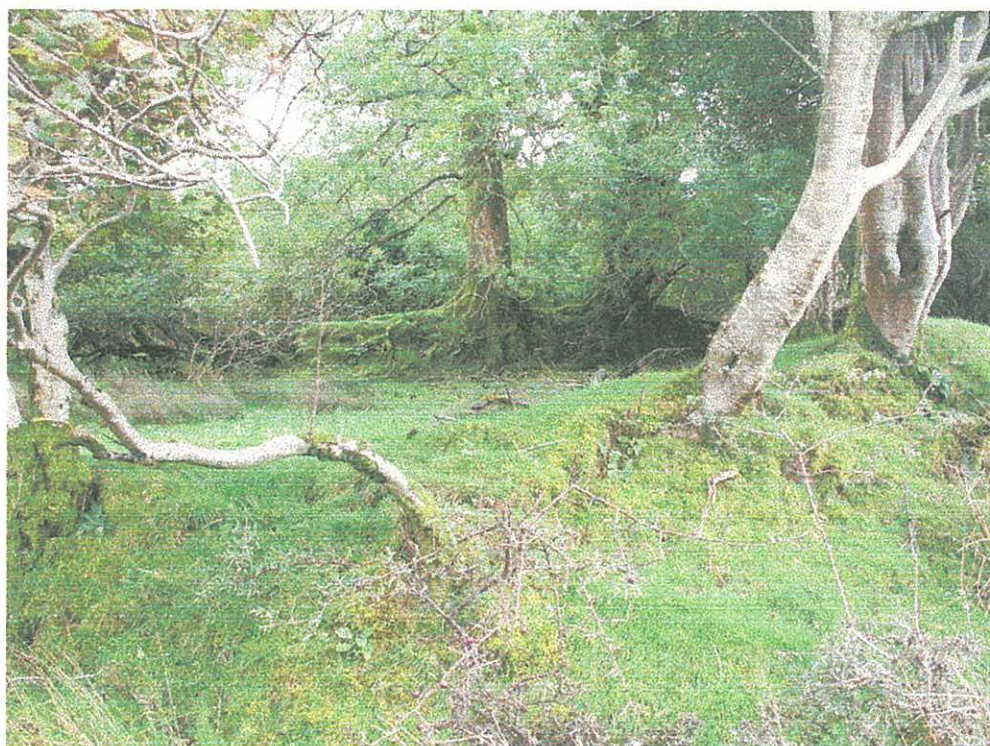
The remains of an enclosure associated with the derelict farm of Trawsgoed (PRN 30198), which lies outside the farm boundary. The enclosure is visible as earth banks of up to a metre high and with the remnants of an overgrown hedgerow on top (plate 6). The enclosure is roughly rectangular with a track leading from the south corner. The farm of Trawsgoed is depicted on the tithe map and recorded as owned by Reverend Thomas Jones and occupied by John Williams. The farm itself is shown as two parallel ranges of buildings at the end of a track, however there is no indication of the layout of the enclosure or associated field boundaries. The enclosure and field boundaries are shown on the 1st edition OS map with the track leading from the farm to the south.

Plate 6 – enclosure at Trawsgoed (PRN 43644)

The enclosure, trackway and field boundaries should be retained as visible features and maintained in a stable condition.
