Tir Gofal Farm Visit Report

Tre Gynan Isaf

W/11/1856

ACA Report Number 2001/26

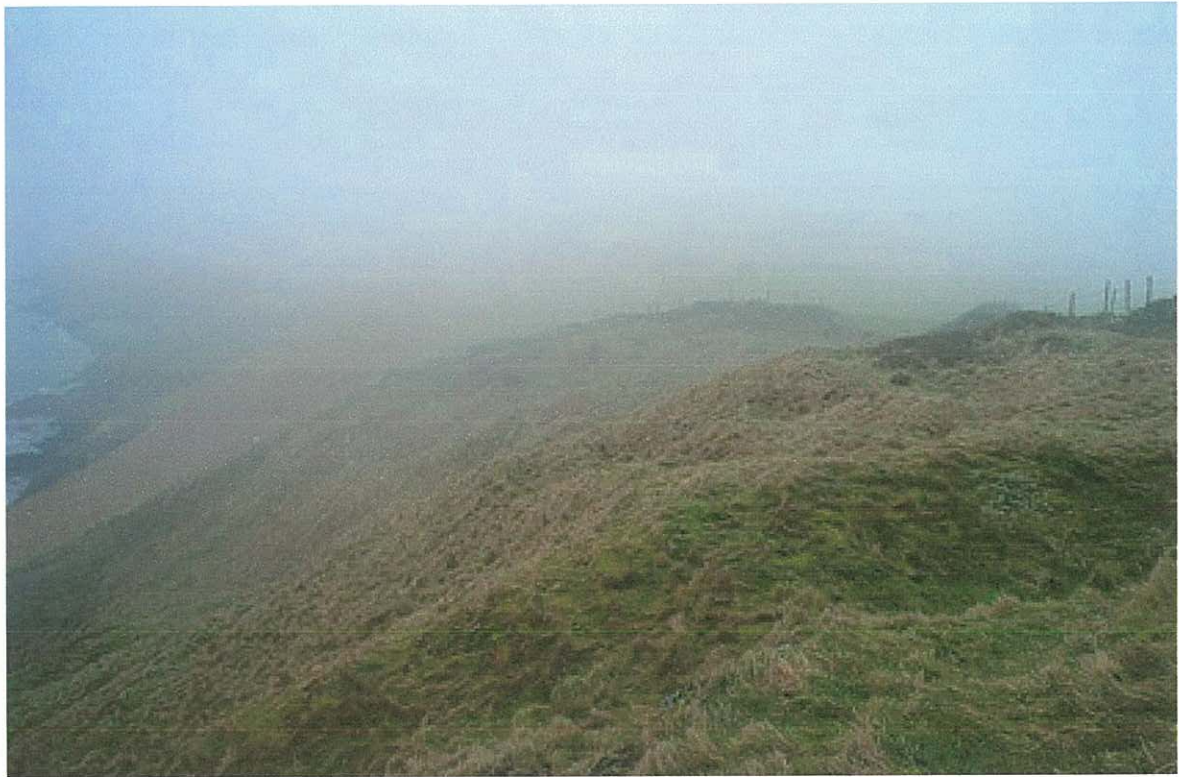
Site of possible deserted settlement recorded in an archaeological survey of Cardigan Bay in 1997. The site sits high on the clifftop to the west of Tregynan Isaf Farm and consists of an area of disturbed ground made up of terraced platforms and excavated hollows (plate 1). None of these appears to be structural and it seems more likely that the earthworks relate to some sort of quarrying or mineral extraction. Much of the uneven ground surface in this area may also relate to the natural geology.

Plate 1 - possible settlement site/quarrying (PRN31433) along the cliffs.

The earthworks are completely grassed over and in a stable condition. The ground in this area should not be disturbed. Further documentary and field investigation may clarify the nature and extent of the site.

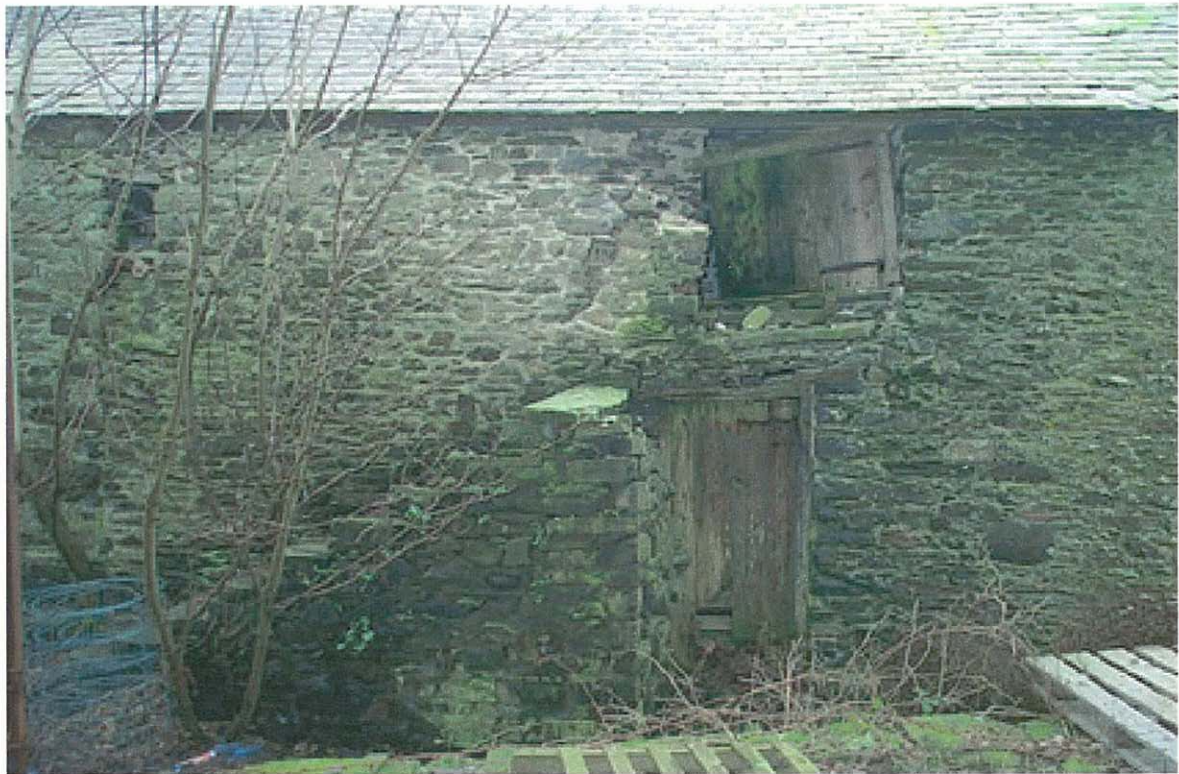
Two storey rubble and lime mortar stable block with dressed stone quoins and a gabled slate roof. It lies at the southern end of the range that makes up the western side of the farmyard at Tregynanisaf Farm, orientation north-south. First recorded on the 1st edition OS map of 1890. It appears to have been a later addition to the barn that lies immediately to its north. The openings vary but are generally square headed with stone or timber lintels and stone sills. The main entrance to the east is headed with stone voussoirs. The original fittings for these survive but are in poor condition. It is accessed at ground floor level by centrally positioned doorways in the eastern and western walls and a further single width doorway at the northern end of the eastern wall which has been blocked in. Access to first floor level is via a stone stairway and wooden balcony against the western wall through a half-height loft door (plate 2). It is lit at ground floor level by a single, square window to the south of the main east-facing entrance and at first floor level by opposing windows at the northern end of the eastern and western walls. The interior was fitted to house eight horses and many of the original features survive including the pitched stone floor, remains of the oaks stalls and hay manger, tack hooks, and storage recesses. The loft floor survives in poor condition.

Plate 2 - unstable wall and stairway to the rear (west) of the stable (PRN42346).

The stable is in need of restoration. It is now used to house sheep. The roof has a pronounced sag and may need replacing. The southern wall is completely overgrown with ivy and this should be removed. The stonework along the western wall is unstable in places, especially around the openings and should be consolidated and rebuilt where required. The building should be maintained in a stable condition. The original features should be retained and any repairs or alteration should be carried out using appropriate traditional materials in a way that is sympathetic to the character of the original building.

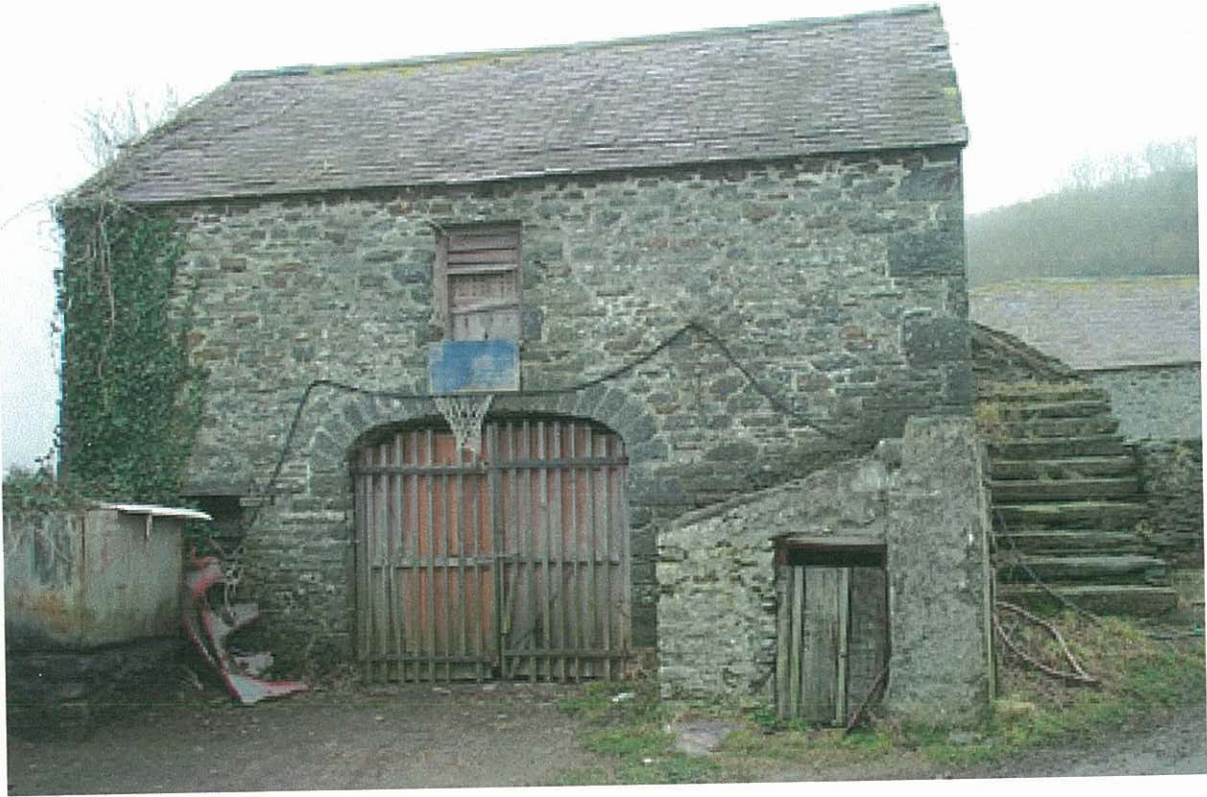
Two-storey rubble and lime mortar cart shed with dressed stone quoins and a gabled slate roof. It lies in the southeastern corner of the farmyard at Tregynanisaf farm, orientation north-south. It was first recorded on the 1st edition OS map of 1890. It is accessed at ground floor level by a double-width arched cart entrance in the eastern wall (plate 3). Access to first floor level is via stone steps against the northern gable wall. It is lit by a single square window to the south of the entrance at ground floor level and small, centrally positioned windows in the southern, eastern and western walls at first floor level. The entrances are headed with stone voussoirs, the windows are square headed with stone lintels and sills. The original fittings for these survive but are in poor condition. The interior was not examined but the loft floor is apparently in good condition.

Plate 3 - cart shed (PRN42353) showing poor roof repair and overgrown southern wall

The cart shed is in reasonable working condition. The owner would like to restore it as part of his Tir Gofal Agreement. This would considerably enhance the survival and continued use of the building. The walls are in reasonable repair but should be repointed. The stonework on the steps is loose and overgrown. They should be cleared of intrusive vegetation and consolidated. The window fittings have decayed and should be replaced. The southern gable wall is completely overgrown with ivy and this should be cleared. The roof is in poor condition (particularly at the southern end) and probably needs replacing. These repairs should be carried out using appropriate traditional materials in a way that is sympathetic to the character of the original building.

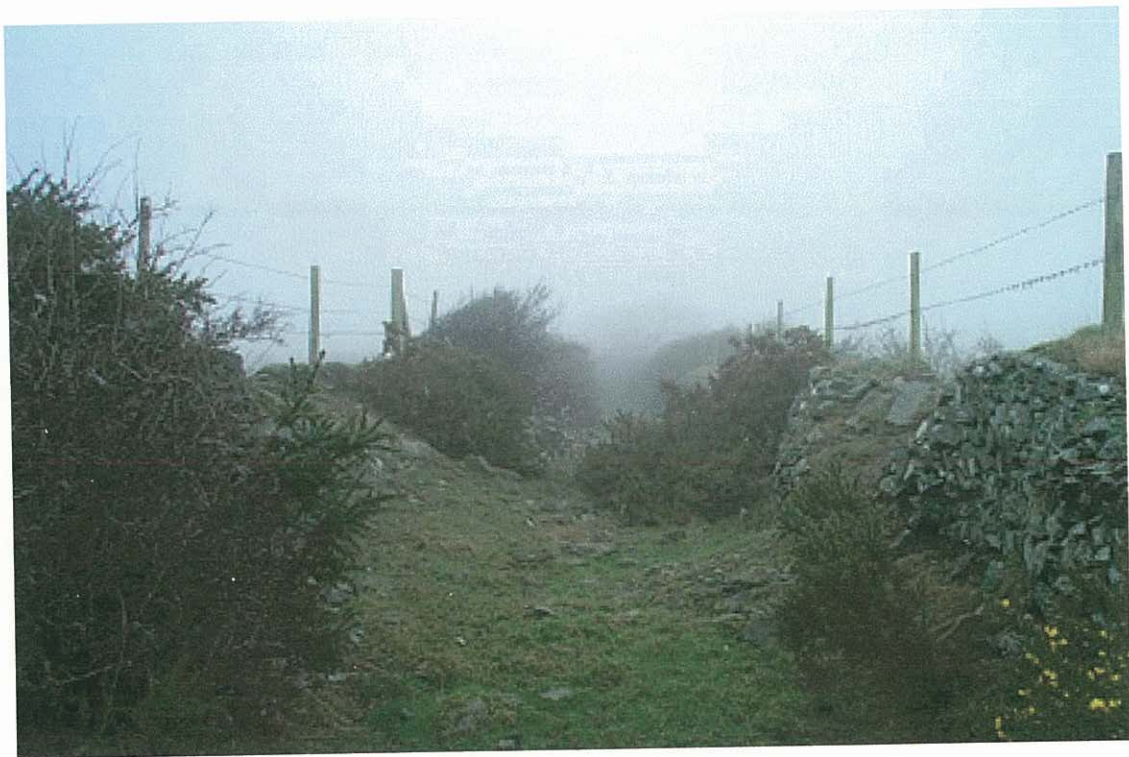
Plate 4 - eighteenth century trackway (PRN 42356) showing unstable banks and overgrown interior.

The trackway is overgrown and very wet in places. Some of the stonework on the banks is loose and the hedges have not been maintained. The banks have also been eroded by grazing animals. The track is no longer used as a route of access but the owner would like to reinstate it as part of his Tir Gofal Agreement. He would like to fence the field boundary to the south of it and clear the itself trackway of intrusive vegetation. This would considerably enhance the condition and promote the use of this feature. The banks should also be maintained in a stable condition.

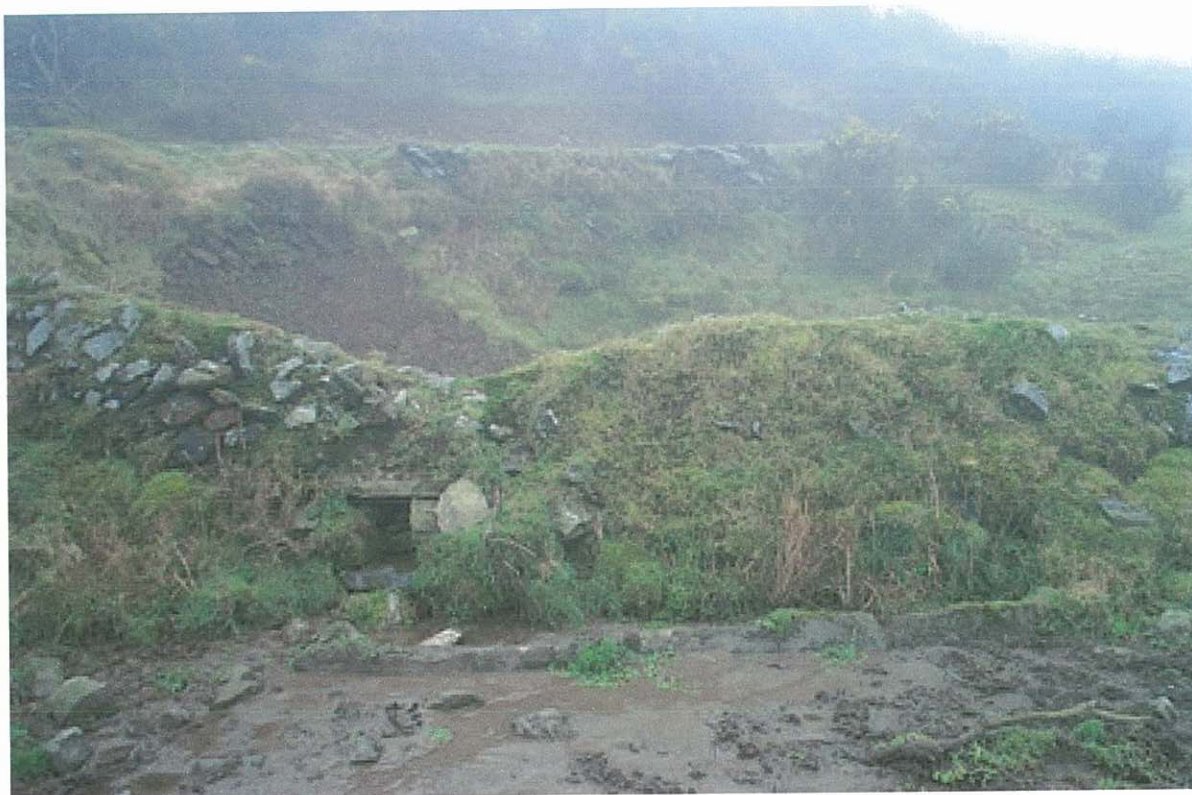
Plate 5 - eighteenth century well (PRN42360) showing silted up trough alongside field boundary.

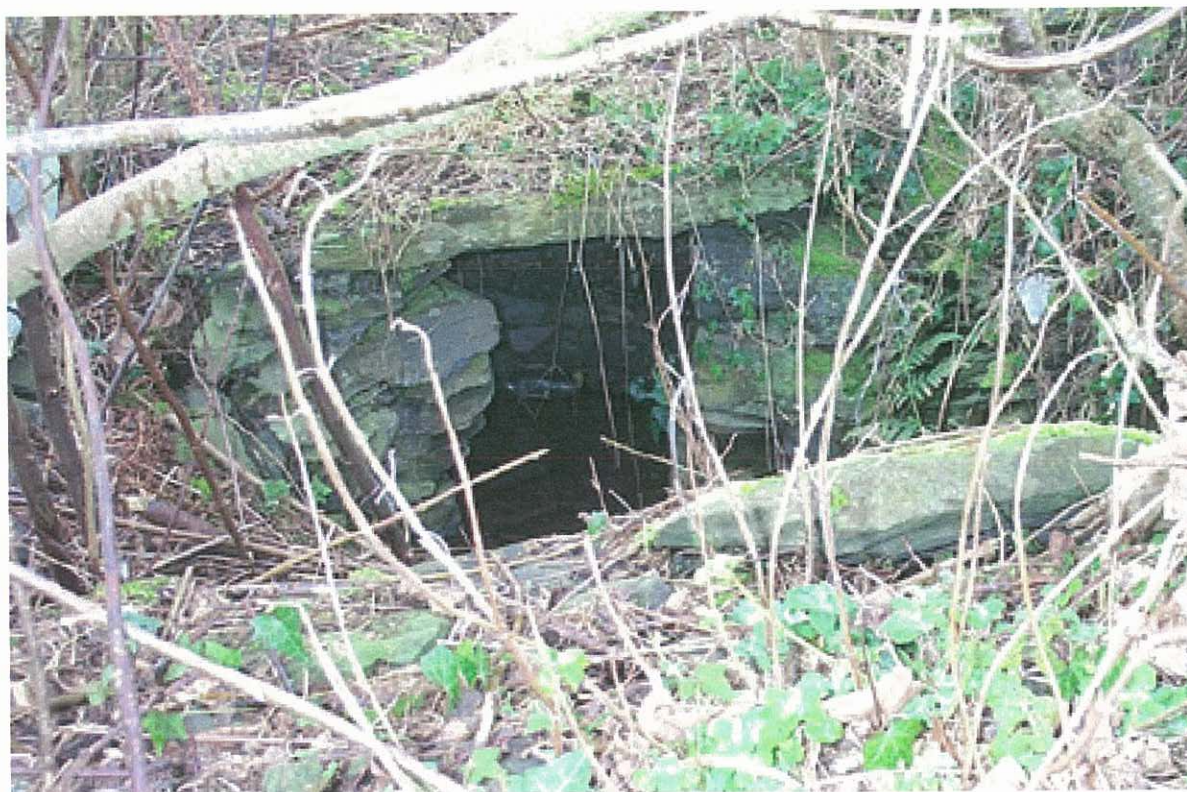
Plate 6 - overgrown well (PRN42362) to the southeast of the farmyard.

The well is in good condition but is overgrown and the owner would like to restore it. The adjacent hedge has grown over it and may be affecting the stonework. Any intrusive vegetation should be removed. The stonework is in reasonable condition but should be consolidated and maintained in a stable condition.

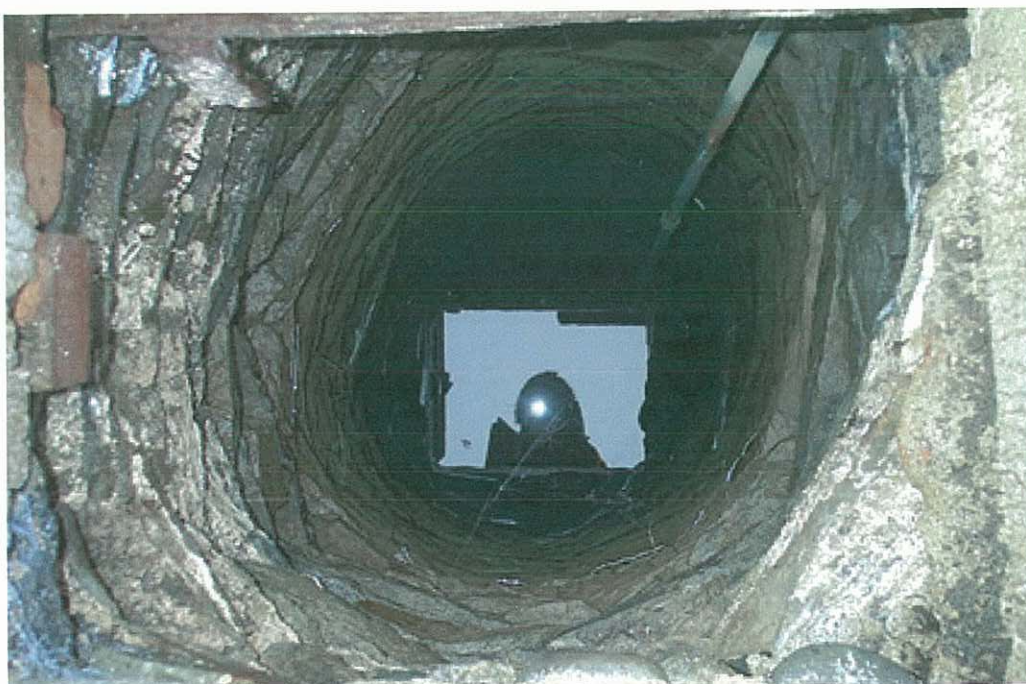
Plate 7 - rubble lined well (PRN42364) to the south of the farmhouse, showing the typical form of the many wells on the farm.

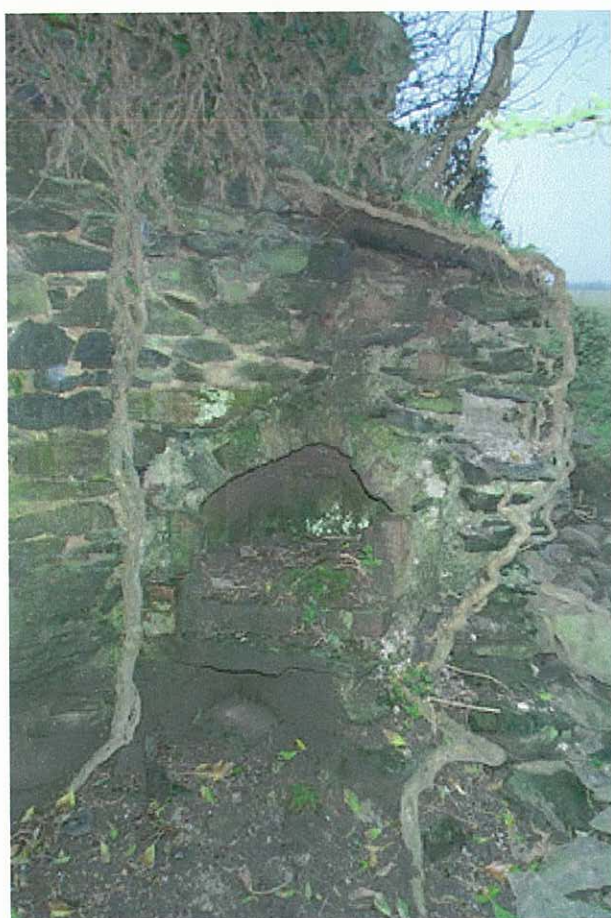
Plate 8 - remains of the bread oven in Treodyrhiw house (PRN42370).

The ruined house and garden are both extremely overgrown and the standing walls of the house are unstable. Any intrusive vegetation should be removed and loose stonework should be consolidated. The interior of the house and the area around the enclosure is also littered with rubbish, much of which has probably been left from visitors to the adjacent layby. The site is clearly of interest to visitors to the layby and the unstable state of the ruin may be problematic. The site should be considered for more extensive clearance and consolidation. An interpretation board could be erected in the adjacent layby to inform visitors and warn them about the unstable condition of the ruin.
