Tir Gofal Farm Visit Report

Moor Farm

W/13/1747

Report Number 2001/39

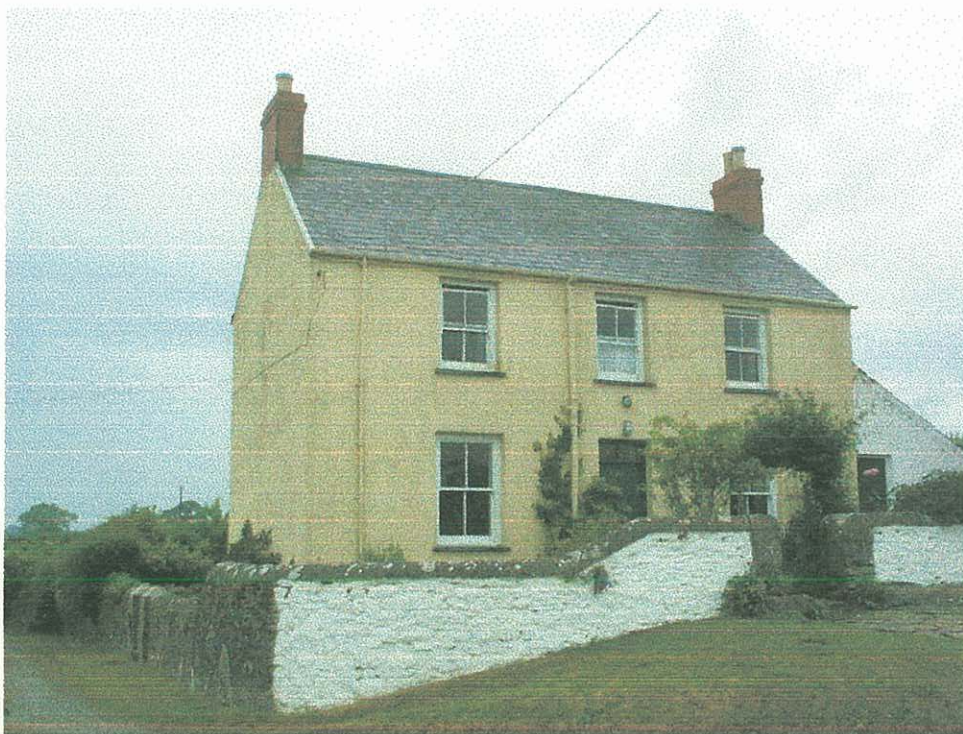
Two storey farmhouse with rendered walls and gabled slate roofs, to the west of the farmyard at Moor Farm (plate 1). The house has been built in at least two stages including an older part to the east (orientation north-south) and a more recent nineteenth century extension to the west (orientation east-west). The earliest part was recorded on the tithe survey of 1841. The more recent part had been added by the time of the 1st edition OS map in 1887. The main doorway is now to the east. Some of the nineteenth century fittings for the doors and windows have been retained. The owners have restored the interior with great care and retained many of the original features. This includes a stratigraphy of floors with a clay floor overlain firstly with flags and later with tiles; and an inglenook fireplace and bread oven in the eastern wing of the house. The house is surrounded with a low rubble-walled garden.

Plate 1 – the farmhouse (42901) at Moor Farm.

The owners of the farm live in the farmhouse. No specific management recommendations.

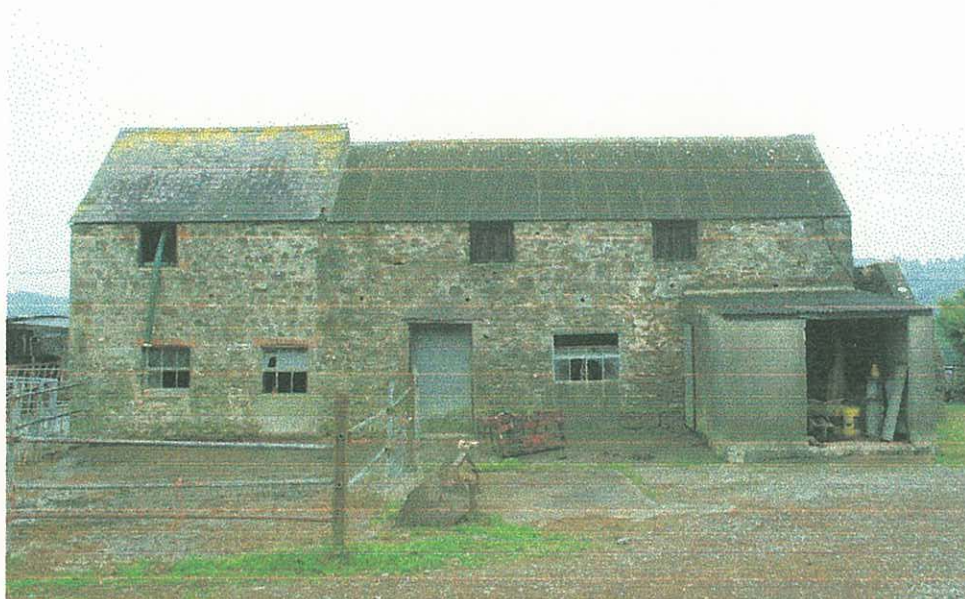
Two storey cow house to the south of the farmyard at Moor Farm (plate 2). It is built of roughly dressed stone and lime mortar and has dressed stone quoins and a gabled roof and aligned east-west. It has been built in two stages with an earlier building to the west and a later, taller building to the east. A building was first recorded here on the tithe survey of 1841 although the current building may well be more recent. The part to the east is roofed with asbestos has a single-width door with a timber lintel in the northern wall at ground floor level and a possible second door to the west of this which has now been blocked in and contains a window. It is lit at ground floor level by two windows in the southern wall both of which have been modified and have modern fittings. There are stone steps with a small, stone lintelled recess for ducks against the western gable wall which lead up to the doorway to the loft. This floor is lit by four, symmetrically positioned windows in the northern and southern walls positioned directly under the eaves. The original doors and windows at this level have been retained. The interior has been used until recently as a milking parlour. The walls and floors have been surfaced with concrete, the cow stalls have been refitted and the wall at the eastern end has been knocked through so that the space is continuous with the building to the east. A low breeze block building for the milking machine has been built against the western end of the northern wall. The building to the east is roofed with slate and has a single-width door in the eastern gable wall. It is lit at ground floor level by two windows in the northern wall with brick lintels and a single window to the south. There is no external access to the loft floor and it was presumably reached from the building to the west. It is lit at loft level by a single window to the north and one to the south, both of which are positioned directly beneath the eaves. None of the original fittings survive. The interior is continuous with the building to the west and has been similarly modified.

Plate 2 – the cow house (42902) to the south of the farmyard showing its two phases of construction and modernised openings.

The building is in reasonable condition and is no longer in use. The walls appear to be unstable in places and have been re-pointed with cement. The loft floor has been replaced with hardboard but the timbers appear to be in a reasonable condition. The roof timbers were not examined but the roofs are otherwise in good condition. Any unstable stonework should be consolidated. Any repairs and alterations should be carried out using traditional materials in a way that is sympathetic to the character of the original building.

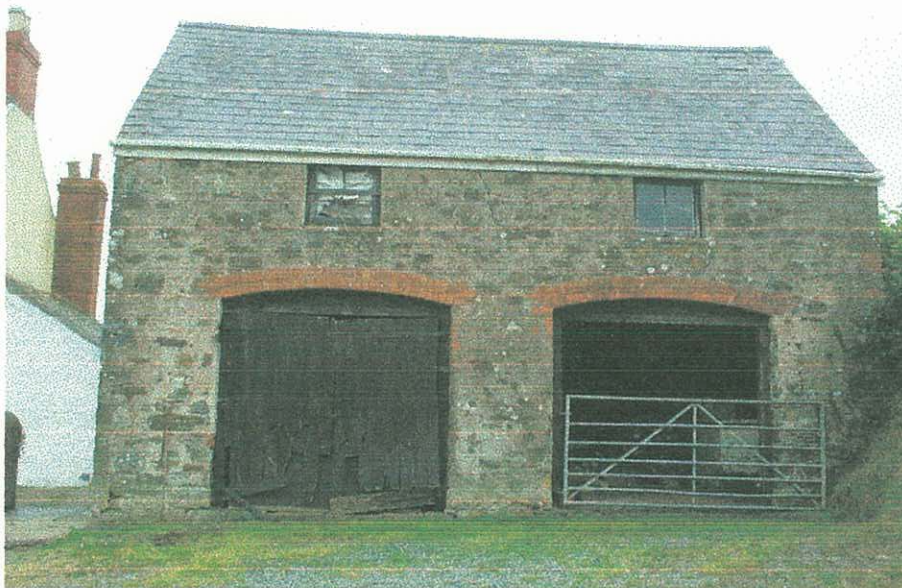
Two storey cart shed to the north of the farmhouse on the western side of the farmyard at Moor Farm, aligned north-south (plate 3). It was first recorded on the 1st edition OS map of 1887. It is built of dressed stone and lime mortar and has dressed stone quoins and a gabled slate roof. The openings are uniformly headed with brick voussoirs. It has two cart entrances to the east and a single-width door and centrally positioned window in the southern wall at ground floor level. Stone steps, positioned at right-angles to the building lead up to the door to the loft in the western wall. This floor is lit by small, square windows which are positioned directly under the eaves. Most of the original doors and windows survive. The floor at ground floor level has been partly concreted but is otherwise earthen. There are two small storage recesses in the northern gable wall.

Plate 3 – the cart shed (42905) to the northwest of the farmyard.

The cart shed is in good condition and is now used for storage. The walls have been re-pointed with cement and there are several large cracks in the eastern and southern walls which may need to be repaired. The roof is in excellent condition. Any repairs and alterations should be carried out using traditional materials in a way that is sympathetic to the character of the original building.

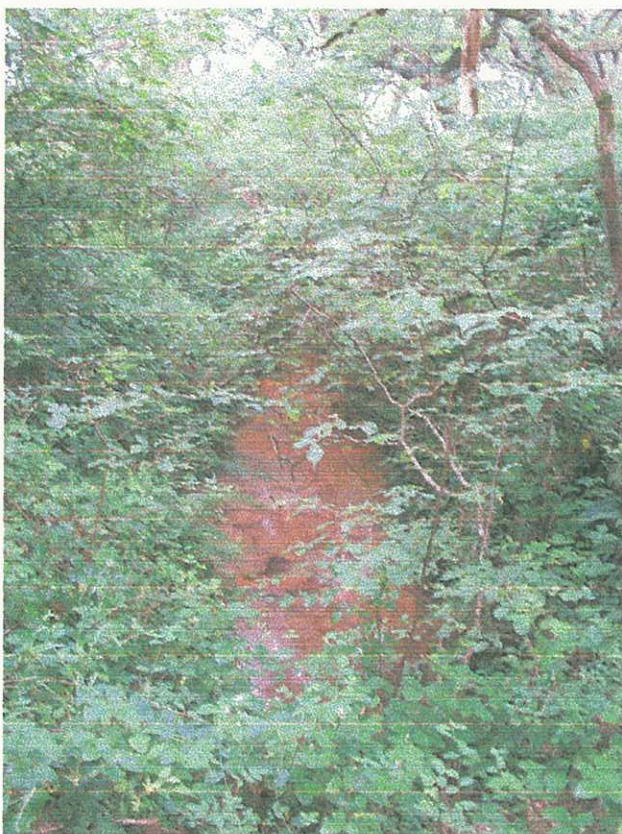
Plate 4 – the level (43004) associated with coal mining on the eastern side of the farm.

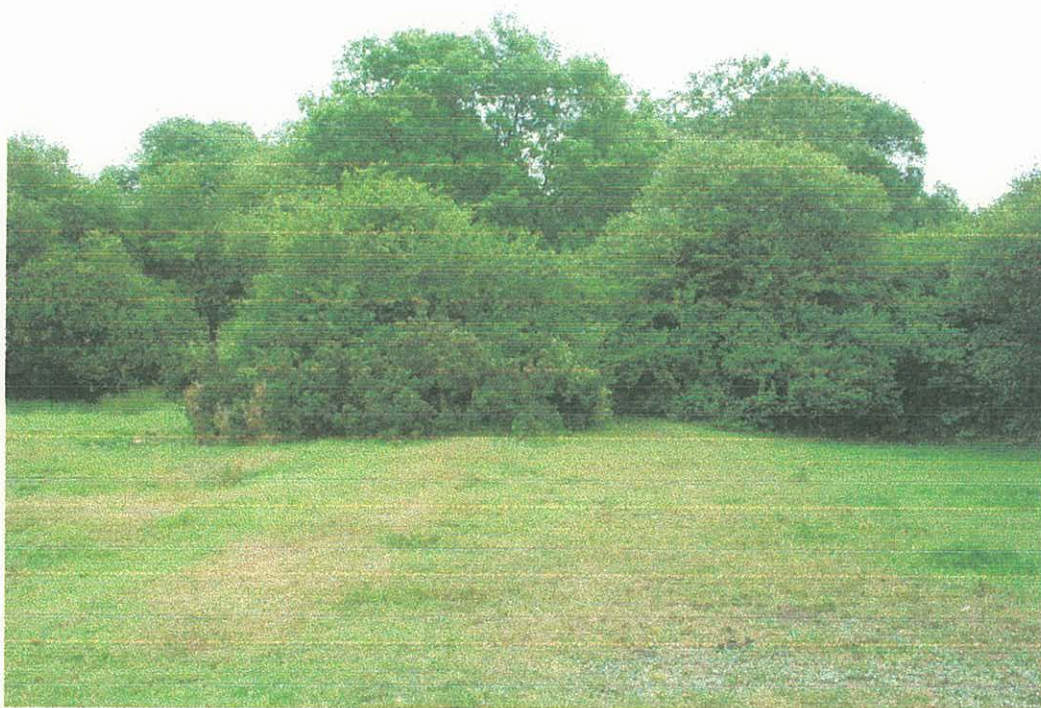
Plate 5 – the raised trackway to Loveston (43007) which was probably built to access the mines.

The trackway is in good condition and is now along the route of a Public Right of Way. It should be maintained in its current condition and ideally should not be ploughed.
