Tir Gofal Farm Visit Historic Environment Report

REPORT NO. 2002/48
PROJECT RECORD NO. 41598

Kilanol W/13/2240 Tir Gofal Farm Visit Historic Environment Report

Tir Gofal call out visit to Kilanow Farm W/13/2240 20 June 2002

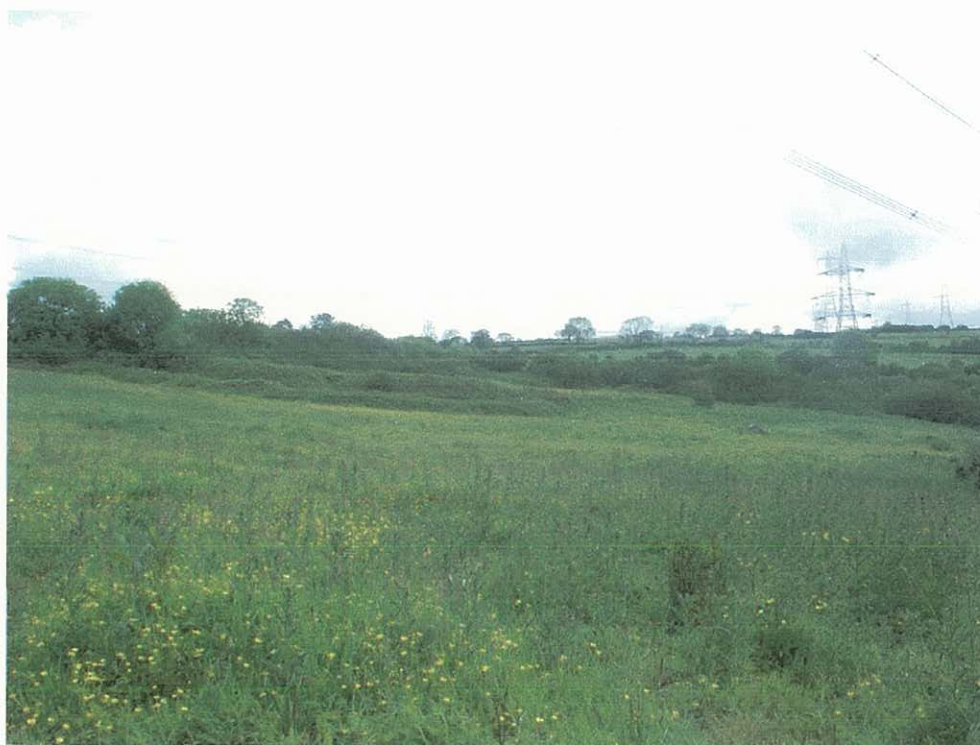
Parts of the site are currently very overgrown with scrub (Plate 1). In order to make the site more visible and to limit and prevent damage to buried archaeological remains the following is recommended. The scrub should be cut and removed from the site leaving the roots in the ground. Scrub should not be burned on or near the site. There are a number of boulders within the scheduled area that form part of the monument (see cover photograph). It is likely that further stones will be encountered during clearance work. No stones should be moved or removed from the site. Machinery should not be used on the site in wet conditions and should not leave tracks on the site. All works involved in hedgerow restoration to the north and east of the site should follow the same guidelines. If any fencing is to be undertaken within the scheduled area this will require scheduled monument consent from Cadw: Welsh Historic Monuments.

Plate 1 Longstone Camp showing the scrub covered western part of the site

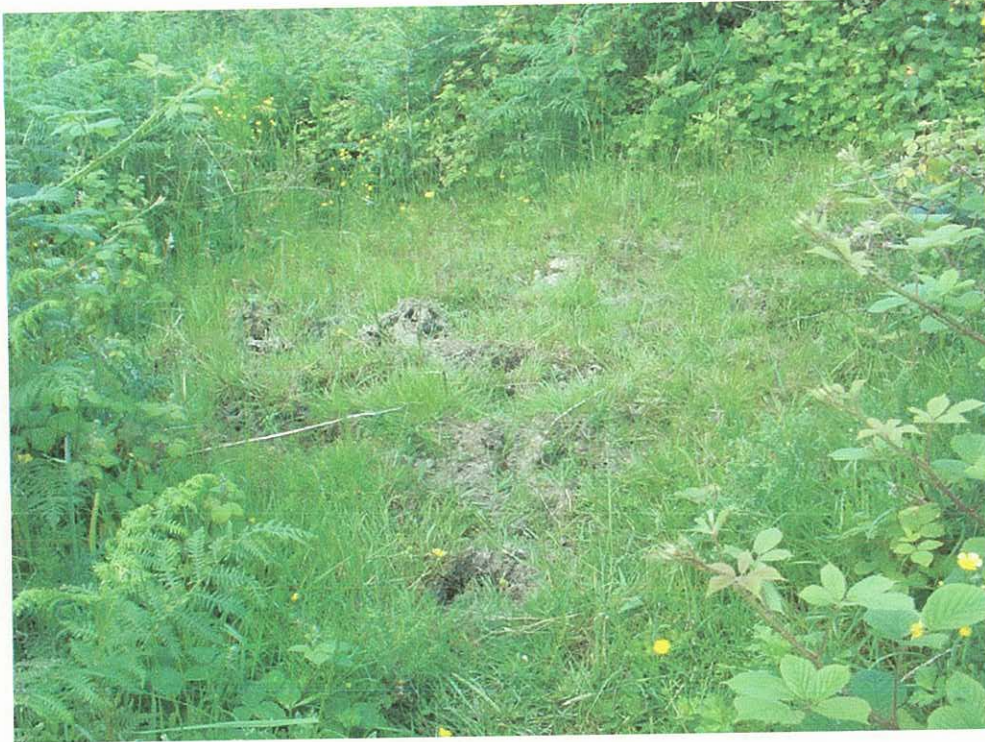
There is a small area of erosion on one of the banks on the west of the site (Plate 2). The density of scrub on the site allows only narrow pathways for stock and this erosion would appear to be caused by the concentration of animals though this narrow path. Scrub clearance may solve the problem. However, to ensure regrowth as quickly as possible it is recommended that the area be covered with brash to keep stock off until the grass has a chance to regrow following the scrub clearance. The stocking level should be kept at an appropriate level in this field to prevent further erosion to the site. This is particularly important during wet conditions.

Plate 2 Area of erosion to west of Longstone Camp

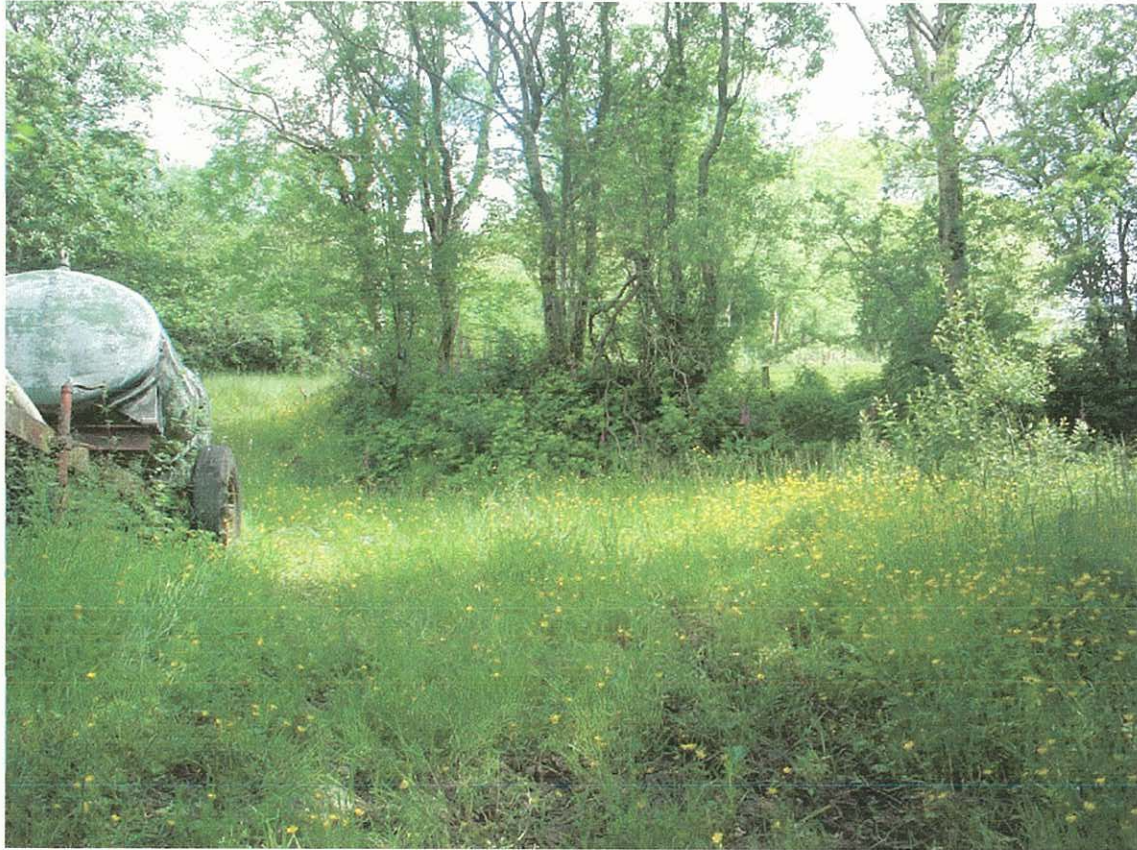
The field containing the hillfort is accessed from Rosemary Lane via a very overgrown trackway that is very wet underfoot (Plate 3). The trackway has a stone faced bank in part, in addition to hedge topped earthen banks. The proposal to restore the trackway is to be welcomed. It is recommended that any works should enhance the existing features and material should not be removed from the banks.

Plate 3 Overgrown trackway leading from Rosemary Lane
