Tir Gofal Farm Visit Report

Rogershook

Report Number 2001/58

ROGERSHOOK
TIR GOFAL FARM VISIT REPORT

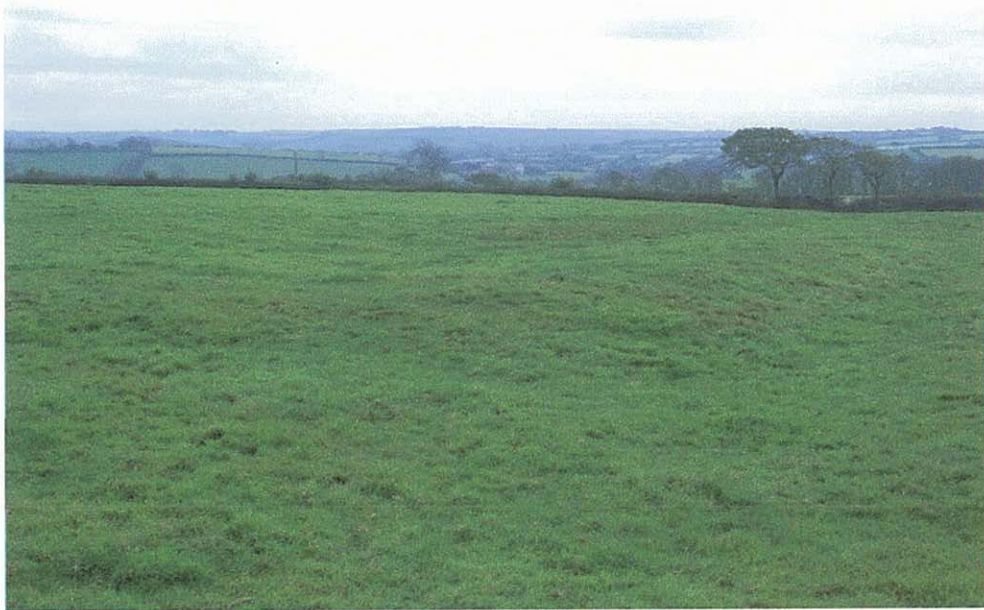
An area of earthworks surrounding an irregular hollow. The hollow, which is an irregular tear-drop shaped is defined on its west side by the most prominent of the earthworks, a low straight bank, approximately 50m long x 4-5m wide. It stands to 0.3-0.4m high. The bank appears to return at its northern end to form a north bank along the edge of the hollow. A flattish area at the southeast corner of the hollow may be a terrace. There is another low, spread bank at the southwest corner of the site, which curves around the south end of the large straight bank. This field is called Upper Croft on the Llawhaden parish tithe map probably published in 1843. The exact nature of the site is unclear. The bottom of the hollow is very wet, but the site has a good covering of grass.

Plate 1: PRN 43629 – view south of earthworks, the long linear bank is clearly visible to the right of centre.

This site should be excluded from ploughing, or any other ground breaking operations to protect the earthworks and any surviving buried remains. Grazing on the site should be regular, but light and stock levels should be kept low in this area.

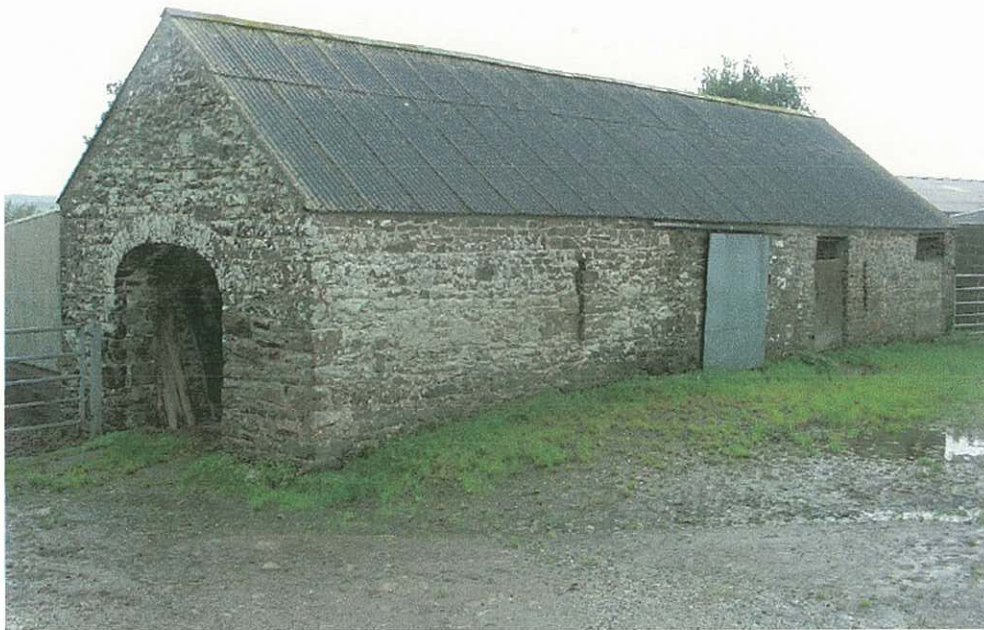
Single storey cowshed with attached cartshed. Which forms the south range of the U-shaped yard. The buildings of rubble construction, built to courses with a gabled corrugated asbestos roof. The cartshed occupies the east end and it has an elliptical stone arch. The building probably dates from the mid - late 18th century. The cartshed and cowshed are in good condition and the roof appears to be watertight. There are no obvious cracks or movement in the walls.

Plate 2: PRN 43626 – 18th century cartshed and cowshed, forming the south range of the yard.

Maintain the building in its present condition. The structure should be monitored on a regular basis to ensure that it remains watertight and that the walls remain sound.

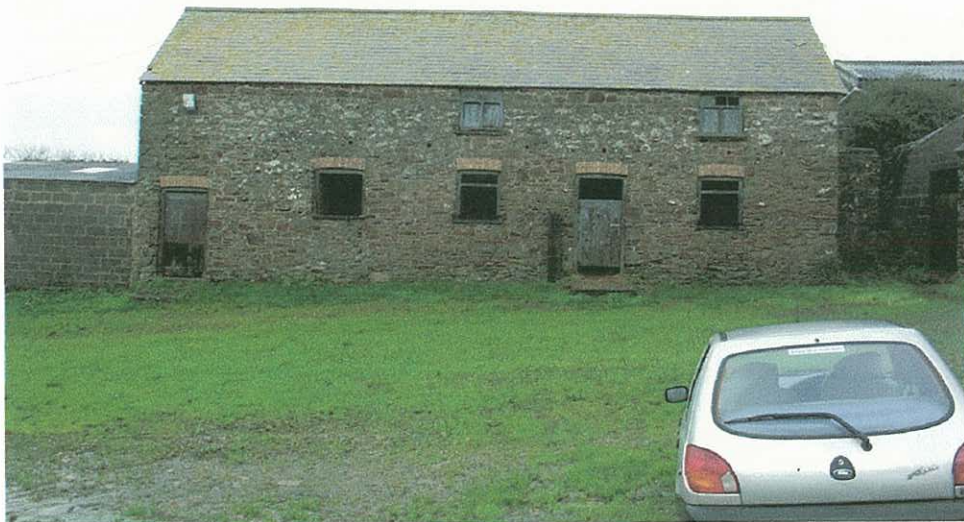
Two-storey building consisting of a cowshed with grain loft over, which forms the west range of the U-shaped yard. It is rubble built with a slate gabled roof. The building is divided into two with a separate loose box with loft in the south end. All the ground floor openings have flattened arches in yellow brick. The main loft has square, shuttered pitching eyes at eaves height. A set of external steps on the north wall provides access to the loft. There is a date, 1838, carved into one of the roof timbers in the loft above the loose box, although the building is not shown on the Llawhaden parish tithe map possibly published in 1843. It does appear on the Ordnance Survey 1st edition map of 1891, so it seems that the building was constructed during the third quarter of the 19th century, using reused materials, including the dated roof timber. The use of the yellow bricks for the arches of the openings also suggests a mid - later 19th century date.

Plate 3: PRN 43627 – later 19th century cowshed. The dated roof timber is in the loft above the door on the left.

The building is in good condition and is currently used as a calf shed. The structure should be monitored on a regular basis to ensure that it remains watertight and that the walls remain sound.

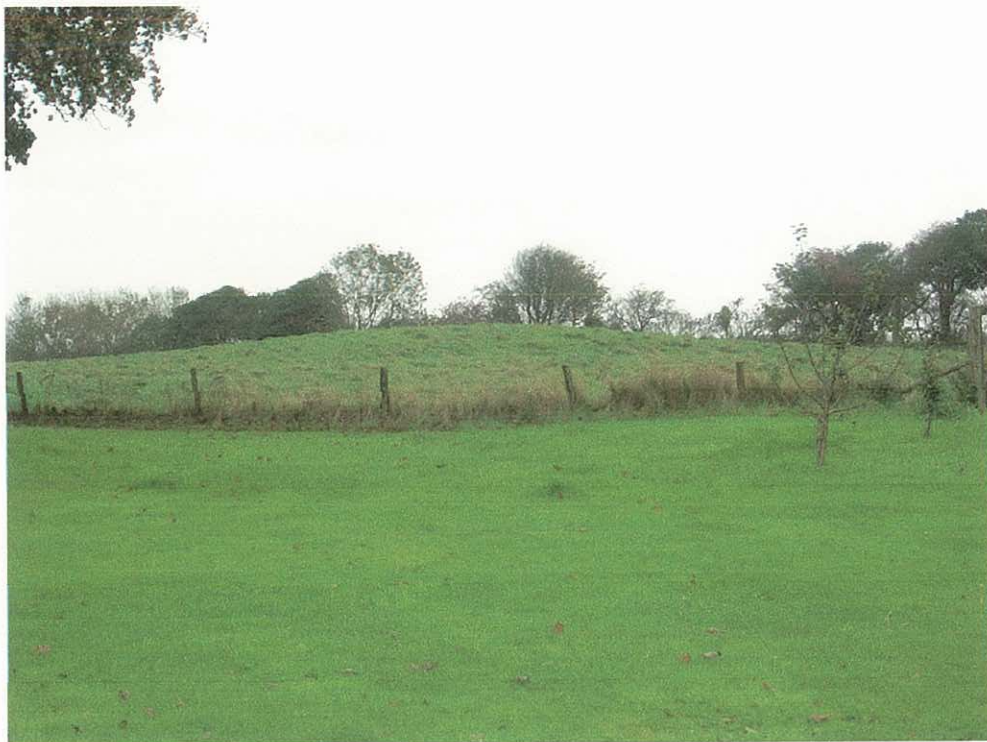
Large circular grass covered mound, c.30m diameter, located in the field immediately north of Colby Moor farmhouse. The mound survives up to 1.5-2m high. The mound lies within the Colby Moor Civil War battlefield and local legend maintains that the mound contains the dead from battle (information from Ordnance Survey record card), but it is more likely to be Bronze Age in date. The mound is in good condition with extensive grass cover.

Plate 4: PRN 3548 – view north of the probable Bronze Age burial mound.

The mound is considered to be of potential national importance and should be grazed a few times a year to maintain the monument in its present condition. The field in which it stands should not be ploughed or have any other form of ground breaking operations undertaken.
