# **Tir Gofal Farm Visit Report**

**Pentwd Uchaf**

**Report Number 2001/41**

PENTWD UCHAF FARM  
TIR GOFAL FARM VISIT REPORT

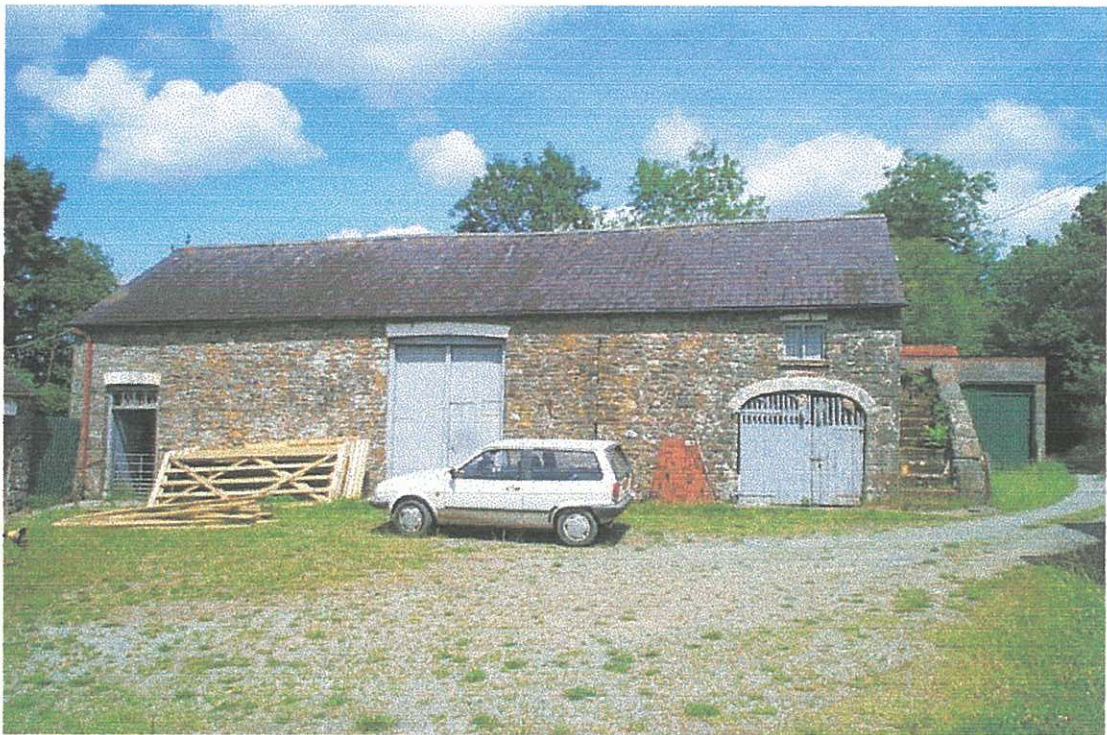
Two storey farm building to the north of a quadrangle of farm buildings at Cwm Dawe Farm, orientation east west. It was first recorded on the 1st edition OS map of 1884 and is part of a planned set of buildings that were built in the mid-nineteenth century. It includes a stable to the west, a threshing barn at the centre and a cart shed to the east. It is built of dressed stone and rubble with lime mortar and has dressed stone quoins and a gabled slate roof. The openings are uniformly headed with yellow brick voussoirs and have slate sills. All of the original doors and windows have been retained and some include diamond-lead panes that are characteristic of farms of the Dolaucothi Estate. The stable is situated at ground floor level at the western end of the building. It is entered by a single-width door in the southern wall with a small, diamond leaded window above it. There is a narrow window in the northern wall which also has diamond leaded panes. The interior is whitewashed and has more recently been converted for use as a cow pen. The hay stall along the eastern wall has been retained as well as the opening to it from the hay loft above. The floor has been concreted. The threshing barn occupies the central part of the building. It is accessed by opposing, full-height double doors in the northern and southern walls and was ventilated by a tall ventilation loop in the southern wall. The central part of the barn is open to roof height and would have been used for off-loading carts. The areas to either side of this are half-lofted and include a hay loft to the west and a threshing platform to the east. The hay loft is above the stable and is accessed internally by wooden steps. There is also a single width doorway at loft level in the western gable wall although there is no evidence of access to this on the outside of the building. The loft floor has been replaced more recently but the opening to the hay stall beneath at its eastern end has been retained. The floor of the threshing platform to the west has also probably been replaced. The threshing machine and cast iron drive shafts have been retained, as has the oil engine in the cart shed to the east. The floor at ground level has been surfaced with concrete although the stone flags have been retained in the doorway the south. It is now used for storing farm materials. The cart shed is situated at ground floor level to the east of the building. It is accessed by an arched cart entrance to the south and was lit by a tall vent loop in the northern wall. The walls are whitewashed and the original pitched stone floor has been retained. There is a small storage recess in the western wall. It has been used more recently to house the oil engine for the threshing machine and is now used as a workshop. The engine and the openings through to the threshing machine in the western wall are still in place. The room above the cart shed is accessed by a flight of stone steps against the eastern gable wall, through a single-width door. It is lit by small, shuttered windows in the northern and southern walls. The inside has been plastered and whitewashed and has a low plastered ceiling. It was originally used for storing corn but has more recently been converted for use as a farm office.

Plate 1 – the farm building to the north of the farmyard (42853) including a stable, threshing barn and cart shed.

The building is in excellent condition and unusually all of the original fittings have been retained. This well preserved building is regarded as being of considerable importance and is comparable with other listed examples of Dolaucothi Estate farm buildings. The roof and loft floors have been replaced fairly recently and are in good condition. The fittings for the doors and windows are in good condition and should be retained and maintained. Some of the glass is missing from the diamond-lead windows and this should be replaced. It should otherwise be maintained in its current condition. Any repairs and alterations should be carried out using traditional materials in a way that is sympathetic to the character of the original building.

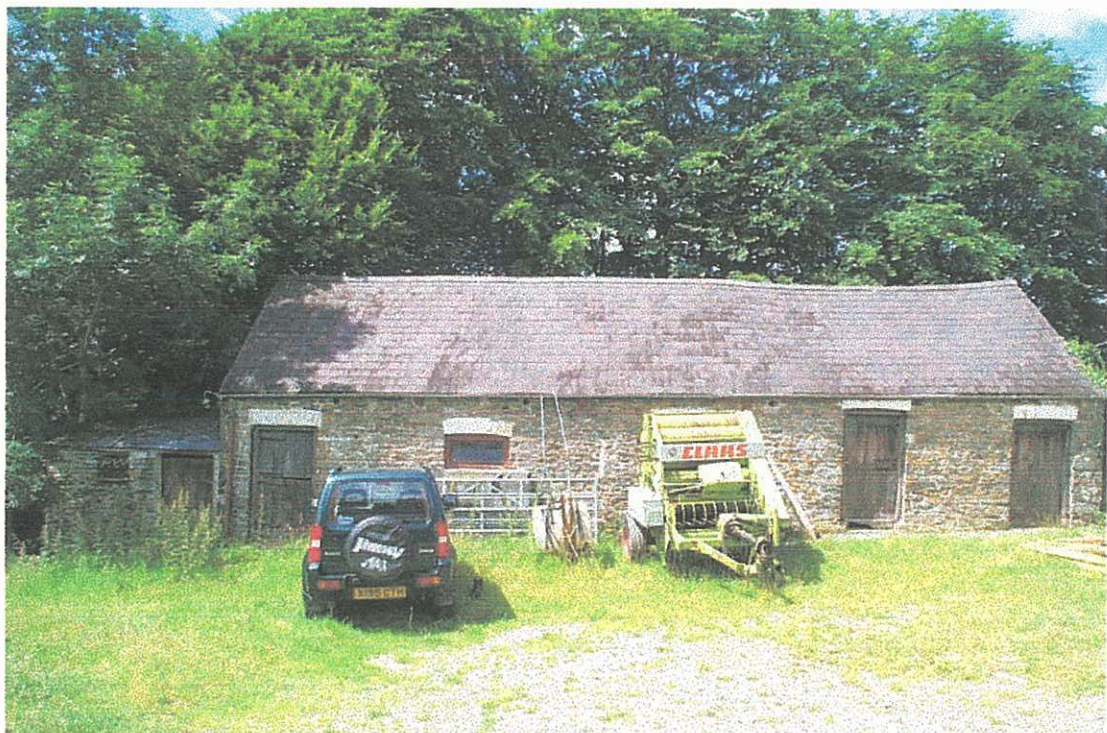
Single storey cow shed to the south of a quadrangle of farm buildings at Cwm Dawe Farm, orientation north-south. It was first recorded on the 1st edition OS map of 1884 and is part of a planned set of buildings that were built in the mid-nineteenth century. It is built of dressed stone and rubble with lime mortar and has dressed stone quoins and a gabled slate roof. The openings are uniformly headed with yellow brick voussoirs. It is symmetrically designed with five equally spaced openings in the eastern wall (one of which has been blocked in and its fitting replaced with a car window) and two opposing doors in the western wall. It is ventilated by a single loop in the eastern wall which has been filled in. The doors and windows are wooden but are probably not original. The interior has been modernised and has until recently been used as a milking parlour. The northern end is half-lofted and was used for extra accommodation. It is accessed internally by a set of wooden steps. The internal walls are whitewashed and have been rendered to chest height. There are small storage recesses centrally positioned in the eastern and western walls. The floor has been surfaced with concrete.

Single storey pigsty at the southern end of the cow shed on the western side of a quadrangle of farm buildings at Cwm Dawe Farm. It is probably part of the planned set of buildings that were built in the mid-nineteenth century were first recorded on the 1st edition OS map of 1884. It is built of dressed stone and rubble with lime mortar and has dressed stone quoins and a slate roof that slopes from west to east. There is a small doorway at the northern end of the eastern wall and a small window to the south, both of which are directly beneath the eaves. The window is fitted with diamond-lead panes that are characteristic of farms of the Dolaucothi Estate. The door appears to be more recent. The interior was not examined and is now lived in by a barn owl.

Plate 2 – the cow shed and pigsty to the south of the farmyard (42854-5).

The cow shed is in very good condition and should be maintained in its current state. It is no longer in use as a farm building. The roof has been replaced fairly recently and is in very good condition. Any repairs and alterations should be carried out using traditional materials in a way that is sympathetic to the character of the original building.

The pigsty is in good condition although the area around it is slightly overgrown. It should be maintained in its current condition. Any repairs and alterations should be carried out using traditional materials in a way that is sympathetic to the character of the original building.

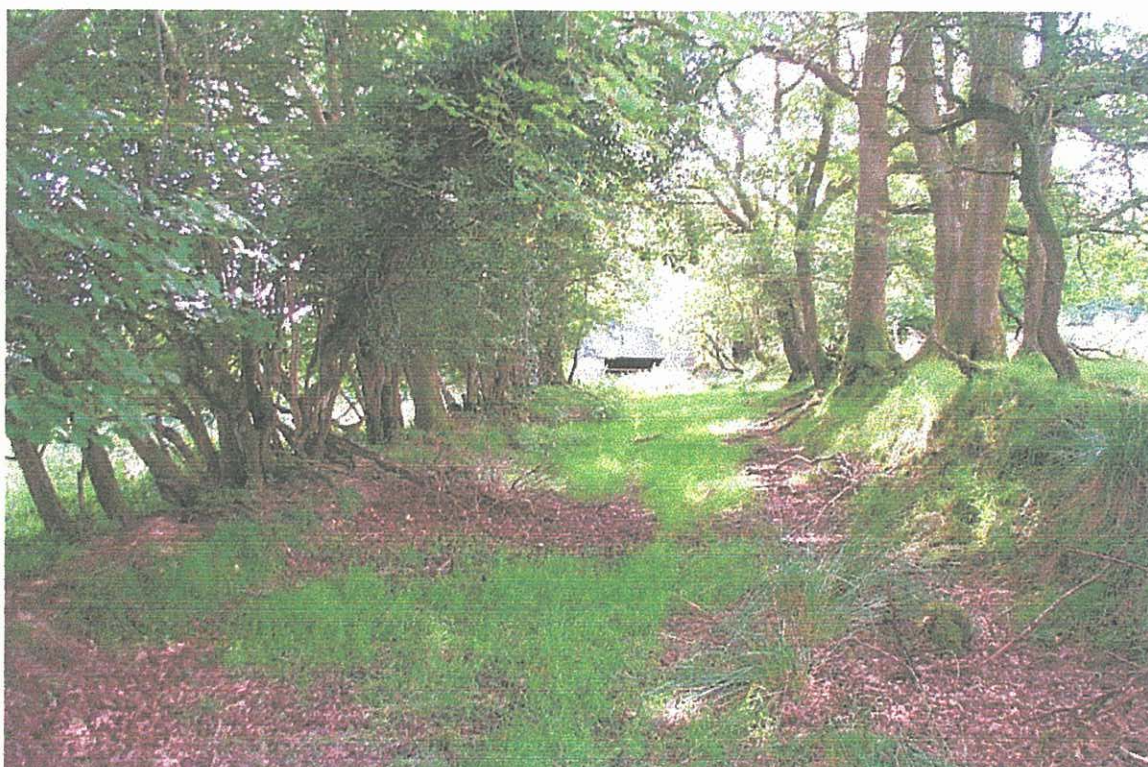
The site of Alltgydr-isaf Farm lies on east-facing slopes to the west of Cwm Dawe Farm. It was first recorded on the 1st edition OS map in 1884 when it consisted of a single range of buildings (orientation northeast-southwest) with a garden to the west. Before this farm was bought by the current occupier's father, it was lived in by two brothers, one of whom married the sister of the farmer at Alltgydr-uchaf. The brothers eventually fell out in a dispute over a threshing machine and one of them left to live in a farm to the north of the holding. The farm fell into disuse in the mid twentieth century. The site is approached from the road to the northeast by a broad driveway defined to either side by low earthen banks (c.0.6m high). The bank to the south has a mature hedge. That to the north has been planted with oak trees. The drive was formerly surfaced but is now grassed over. The farm buildings stand in a rectangular enclosure defined by low earthen banks (c.0.4m high) and were demolished by the current occupier's father. The current occupier thinks that it was thatched. A breeze-block animal pen (c.5m by 8m) has been built directly over the foundations of the original farmhouse. The wall footings of the original house are still visible at the base of the modern structure. There is a low building platform (c.8m by 4m by 0.4m high) to the north of the old farmhouse which according to the current occupier of the farm was a cow shed and pigsty. This is now grassed over and in a stable condition. There is also a pile of rubble at the southern end of the enclosure which the current occupier thinks was a stable. A corrugated tin building has been built to the south of this but has now collapsed. The garden (c.15m long by 15m wide) to the west of the buildings is also defined by low earthen banks (c. 0.4m high) which are planted with mature trees.

Plate 3 – the trackway to Allt-fudr-isaf (43016).

The remains of Alltgydr-isaf Farm are in a stable condition. Any loose stone should be left in-situ and the area should be kept clear of rubbish and intrusive vegetation.

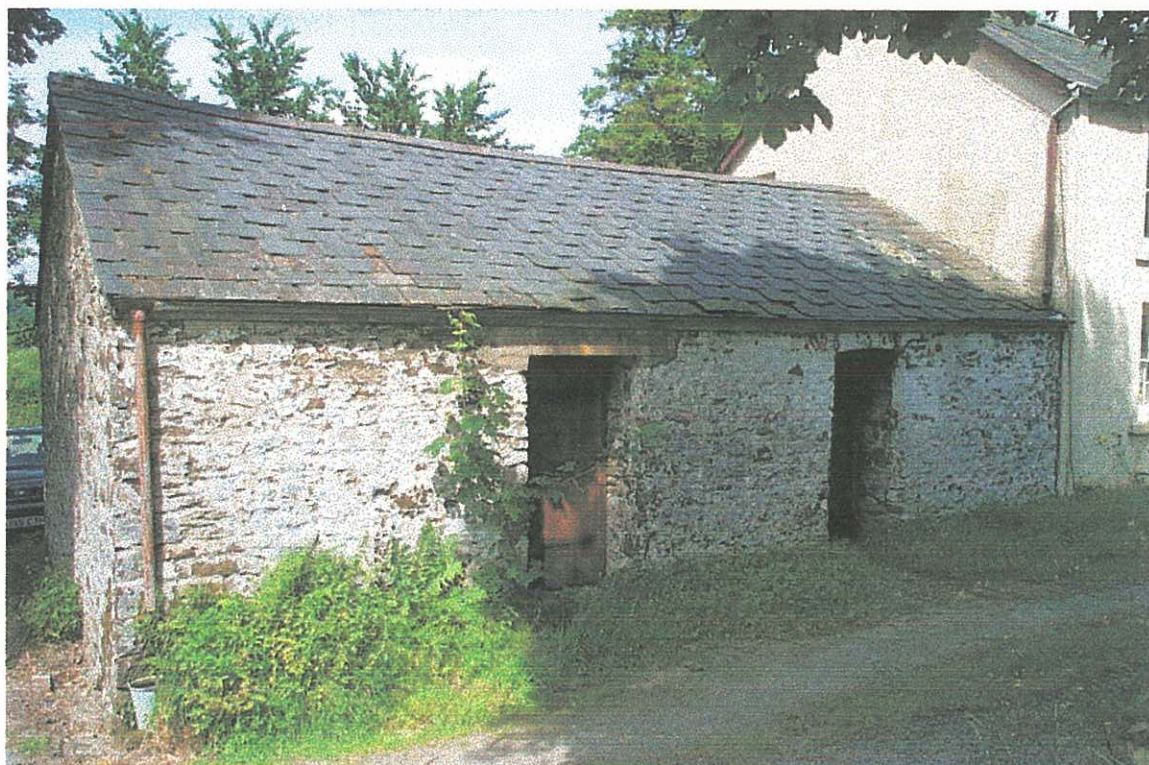
Single storey cow shed at the western end of a single range of farm buildings at Groes Farm, orientation east-west. A building was first recorded here on OS Surveyors drawings in 1811-12 although the current building is probably more recent. It is built of rubble and lime mortar with dressed stone quoins and a gabled slate roof. The walls are whitewashed. The roof has a distinctive arrangement of overlapping slates for ventilation purposes. There are two doors in the southern wall and a single door at the eastern end of the northern wall. The fittings for the doors and windows are modern. The openings were originally headed with brick voussoirs but all but one of these has been replaced with timber or concrete lintels. The interior was not examined. It is no longer used for farming purposes.

Plate 4 – the cow shed at Groes Farm (43019) showing the overlapping tiles for ventilation.

The cow shed is in good condition and should be maintained in its current state. Any repairs and alterations should be carried out using traditional materials in a way that is sympathetic to the character of the original building.
