**Tir Gofal Farm Visit Report**  
**Fferm Tresinwen**  
**W/13/1831**

**Report Number 2001/69**

PROJECT RECORD NO. 41629

FFERM TRESINWEN  
TIR GOFAL FARM VISIT REPORT

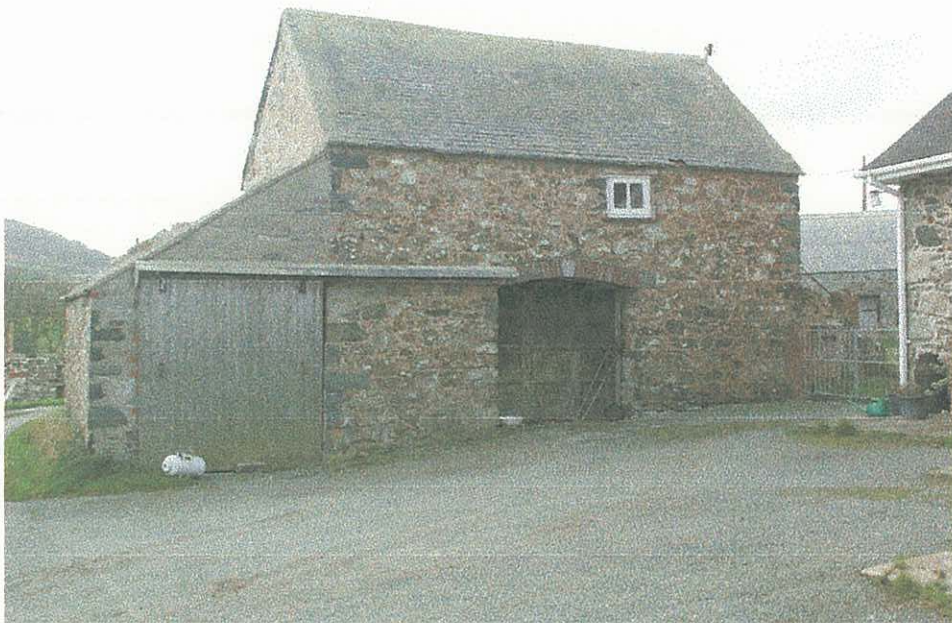
Plate 2: The old Carhouse (PRN43864) at Tresinwen.

Old carthouse at Tresinwen Farm. Stone built, slate roofed two-storey building in good condition. On a WNW- ESE axis. The arched doorway is in the north-facing wall. A set of stone steps built against the outside of the WNW gable wall leads to a doorway into the loft. A small stone lean-to is built against the ESE gable wall. Stands at the top (eastern) end of the modern Tresinwen farmyard. Does not appear on the 1843 parish tithe map, but shown on the 1891 6" OS map series.

**Recommendations**

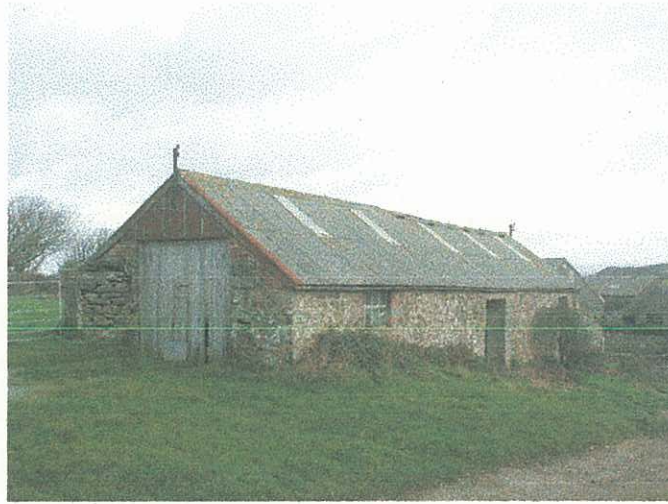
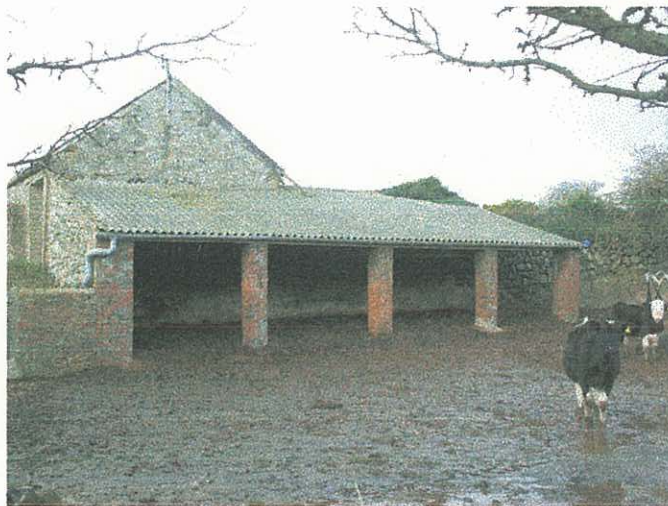
Plate 3 & 4: *Glowty* (PRN43870) at Tresinwen, with the cattle shelter (PRN43871) built against its eastern gable wall.

Stone building in reasonably good condition, now with an asbestos roof. This is the "glowty" or cattle byre at Tresinwen. A building is shown on this spot and on the same E-W alignment on the parish to tithe map of 1843. The present building seems to be bigger than that shown in 1843 and on the 1891 and 1908 OS maps, and it is possibly that the western half marks an early 20th century extension. A lean-to (PRN 43871) has also been added at right angles to the eastern gable end of the byre since 1908.

**Recommendations**

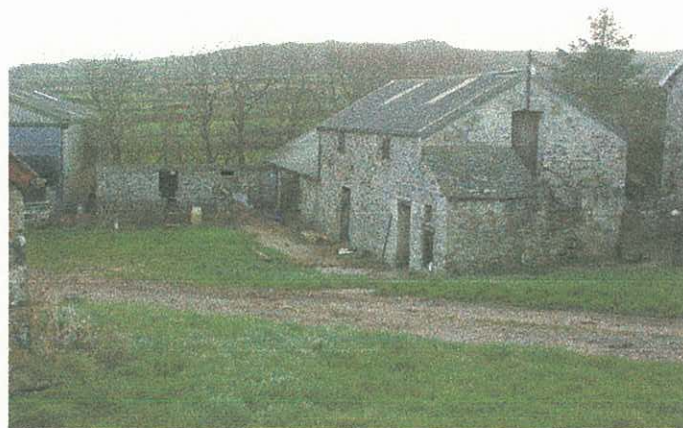
Plate 5: The old stable and grain store (PRN43868) at Tresinwen, with the pigsty (PRN43869) at right angles to the bottom of the main building

19th century pigsty. Stone built, with some more modern repairs and modifications, such as a course of breeze blocks added to raise the wallplate and a corrugated asbestos roof. The pigsty does not appear on the 1843 parish tithe map, but is seen on the 1891 6" OS map series, appended at a right-angle to the souther end of the stable/grain store (PRN 43869). Still in good condition and apparently in use, though no longer for keeping pigs.

**Recommendations**

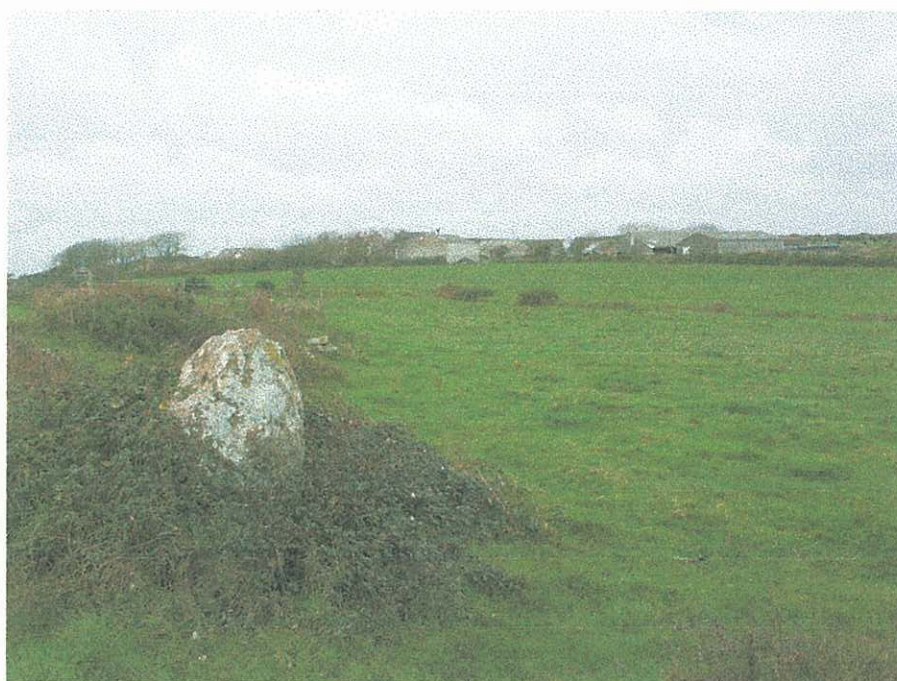
Plate 7: The large standing stone PRN43856 with the Tresinwen farmyard complex in the background.

A substantial monolith, over 1.5m high x 1.25 long x 1m thick. The stone is partly obscured by a bramble bush which grows around its base. Its antiquity is unknown, but it is noteworthy that the field boundary to the south appears to go around it and respect it (although it is equally possible that the stone was put up in the corner of the field after the boundary had been established. Nevertheless, this may be a prehistoric monument. The stone itself is a rough conglomerate with large chert pieces set in a fine grey, oxidised matrix. A smaller stone (PRN 43856) stands 25m to NNW (PRN 43855). A number of other, loose stones lay on the surface between the two stones and may signify that a more complex stone alignment once existed here.

It is uncertain as to whether this is a prehistoric monolith or a more recent rubbing stone. However, in conjunction with the other monoliths on the farm it is of historic interest and should be preserved. At present there does not appear to be any direct threat to this stone. Current land management regime does not seem to require changing, unless public access is intended in which case the brambles which are growing around and over the stone need to be either cleared or reduced. Future ploughing should avoid breaking the ground close to the stone and any future ground breaking activity should take into account the possibility that buried archaeology associated with the stone may survive.
