# **BRECHFA FARM**

## **W/13/2271**

### **Tir Gofal Farm Visit Report**

Report No. 2002/39

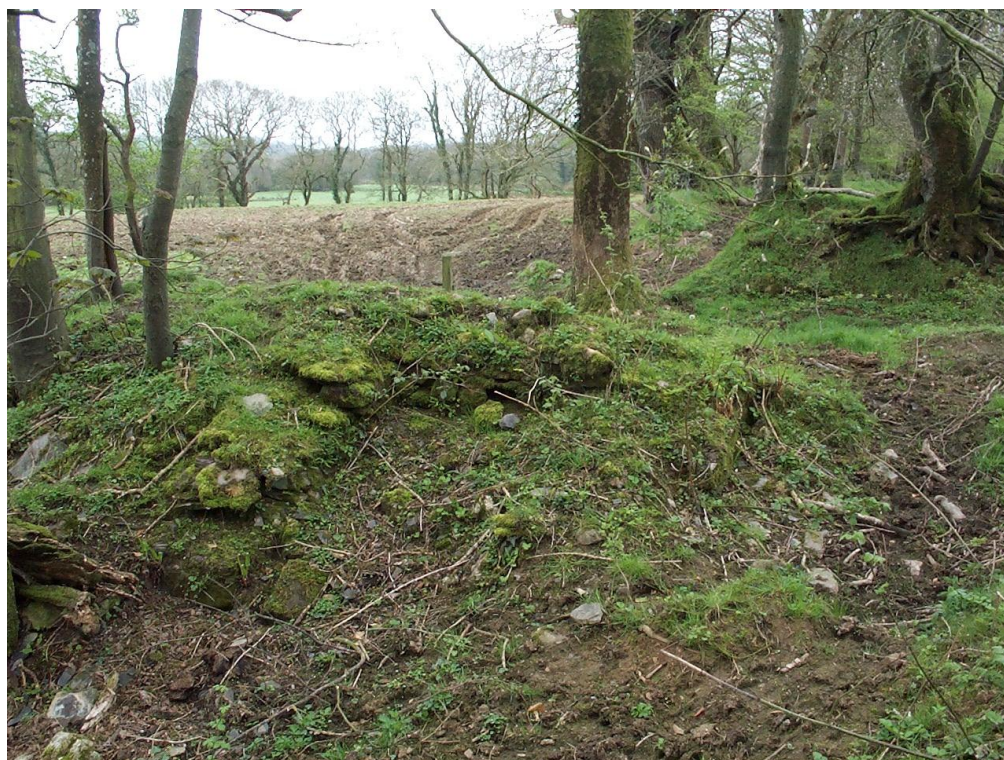
An 18<sup>th</sup> century farm shown on a Picton Castle Estate map of 1773 as Vrechfa Issa. The farm and has now been incorporated into modern Brechfa Farm and the house and yard area was abandoned in the early 20<sup>th</sup> century. Today the site consists only of a few low walls, which survive as earth covered banks, from the house and outbuildings and vestiges of the enclosure banks. Trees grow on most of the banks, some of the walls and inside the enclosures; the trees are used as shelter by cattle, which is causing severe erosion. Material created by the construction of a new track has been dumped on the south side of the former buildings. It is difficult to assess the extent of the surviving buildings from the surface evidence, but a reasonable amount of internal detail may survive.

PRN 23242 – The remains of Brechfa Isaf farm, showing the tree growth on the site.

The site of the buildings should be cleared of brambles and regenerating vegetation. Cattle should be excluded from the site of the buildings. No material should be dumped on or removed from the site of the buildings.

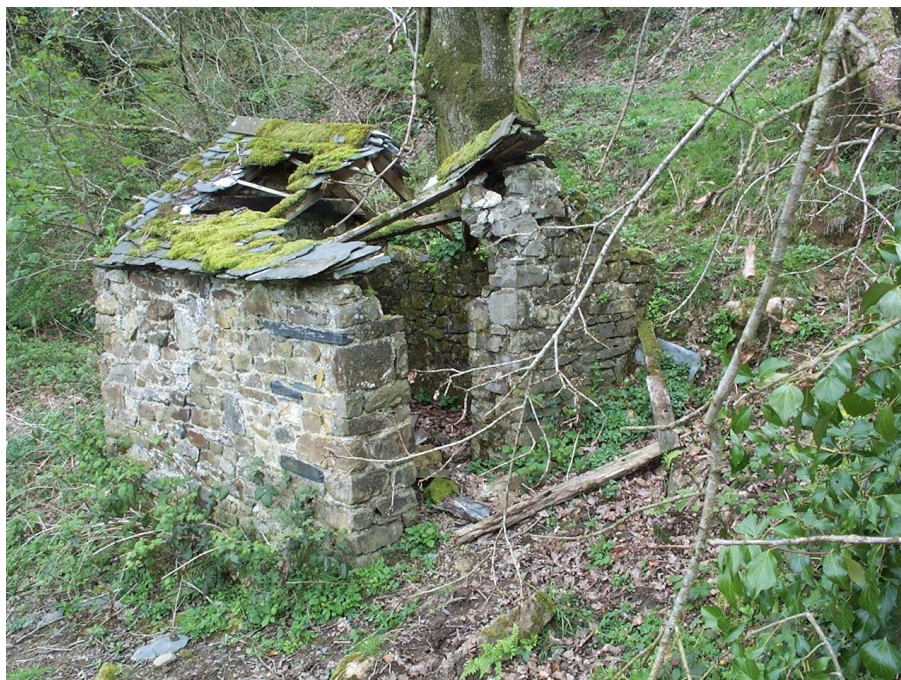
Cottage and outbuilding shown on the Llan-y-cefen parish tithe map of 1844. The site was still shown on the Ordnance Survey 2<sup>nd</sup> edition 1:10560 (sheet Pembs. XXIV.NW) map of 1908, but it had been abandoned by the early 20<sup>th</sup> century. Today, the cottage is visible only as low, vegetation-covered walls, sitting on a terrace cut into the steep wooded slope. The outbuilding survives in better condition, as a single-cell building, c.2.5m x 2m with a slate gabled roof.. Entry was gained via a single door in the south gable wall. Low stone walls forming a second cell are visible to the south of the structure. It is possible that the second cell was a small yard and the building was an in-and-out pigsty.

PRN 44875 – The remains of the small outbuilding, possible pigsty, showing the collapsed roof.

The remains of the cottage should be maintained in their present condition. Vegetation could be cleared and regular monitoring should be carried out to ensure that no trees become established on the surviving structure. The outbuilding/possible pigsty should be retained in its current condition. No stones should be removed from either structure. These features along with PRN 44876 make interesting features along the footpath, which is shown on recent Ordnance Survey maps.

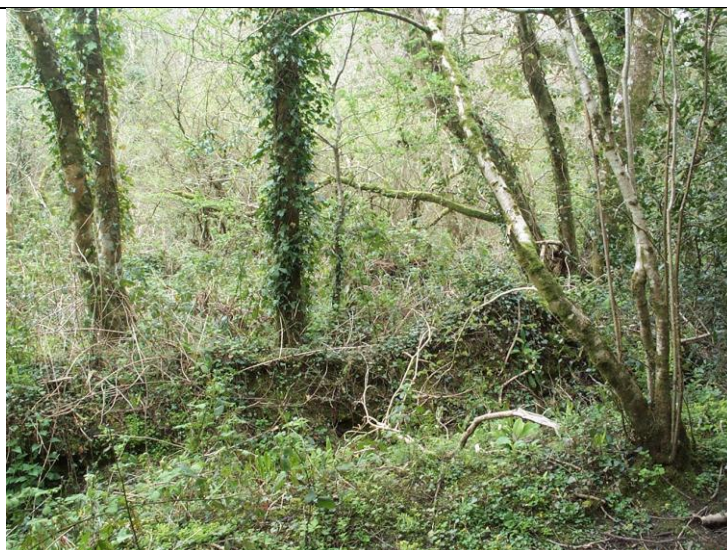
Small settlement shown on a Picton Castle estate map of 1773 (NLW ref: Picton Castle Volume 1, pg.31) on a small terrace on the bank of the Afon Rhyd-afallen. On the Llan-y-cefen parish tithe map of 1844 two buildings are shown, but only one was shown on the Ordnance Survey 2<sup>nd</sup> edition 1:10560 map (sheet Pembs.XXIX.NW) of 1908. The building that survived until the early 20<sup>th</sup> century is in an area of dense woodland, although the external walls and several internal walls are visible surviving to a height of c.1m. The building is positioned just below a large flat terrace cut into the steep hillslope, which was formerly occupied by the second building shown on the tithe map. There are no visible traces of this building, although there is a large amount of roof slate spread across the surface.

This settlement site is now very overgrown and despite there being a footpath marked on recent Ordnance Survey maps it does not appear to have been visited for many years. Enclosures associated with the settlement are just visible within the woodland, but they are in poor condition and frequently difficult to trace. The site well outside the area of normal farming operations and the woodland is not actively managed.

PRN 44876 – The very overgrown remains of the cottage.

The surviving building should be cleared of vegetation, although major trees could be left, to expose the remains of the building. The associated enclosure banks could also be partially cleared. The footpath should be cleared and this site and the nearby settlement PRN 44875 would make interesting features along the path. The vegetation should be cut and allowed to die back before it is removed, in order to protect as much of the surviving structure as possible.

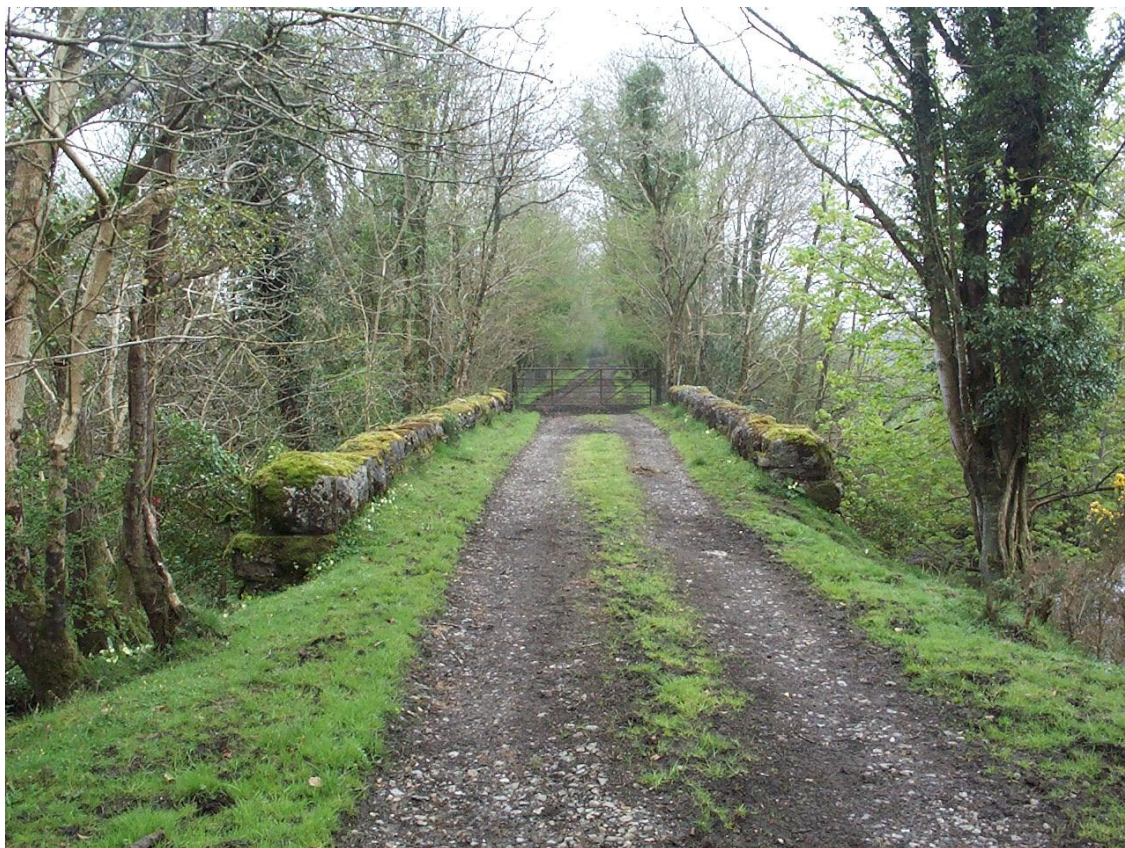
The line of the former Maenclochog Railway, constructed in the mid 19<sup>th</sup> century. In places the line survives as a large embankment, up to 3m high and 6m wide. It crosses the Eastern Cleddau on a single span stone bridge at SN10290979. Most of the disused track-bed is now utilised as a farm track. The embankment survives in good condition and the bridge over the Eastern Cleddau is also in good condition, although there is some ivy growth on the low parapet walls.

PRN \*\*\*\* - a view southwest along the former track bed of the Maenclochog Railway across the bridge over the Eastern Cleddau. The track bed and the bridge and the bridge are in good condition.

To protect the structure of the bridge, the ivy should be removed by cutting the main stem at the base and allowing the plant to die back before removing it. The embankment and track-bed should be maintained in its present condition.

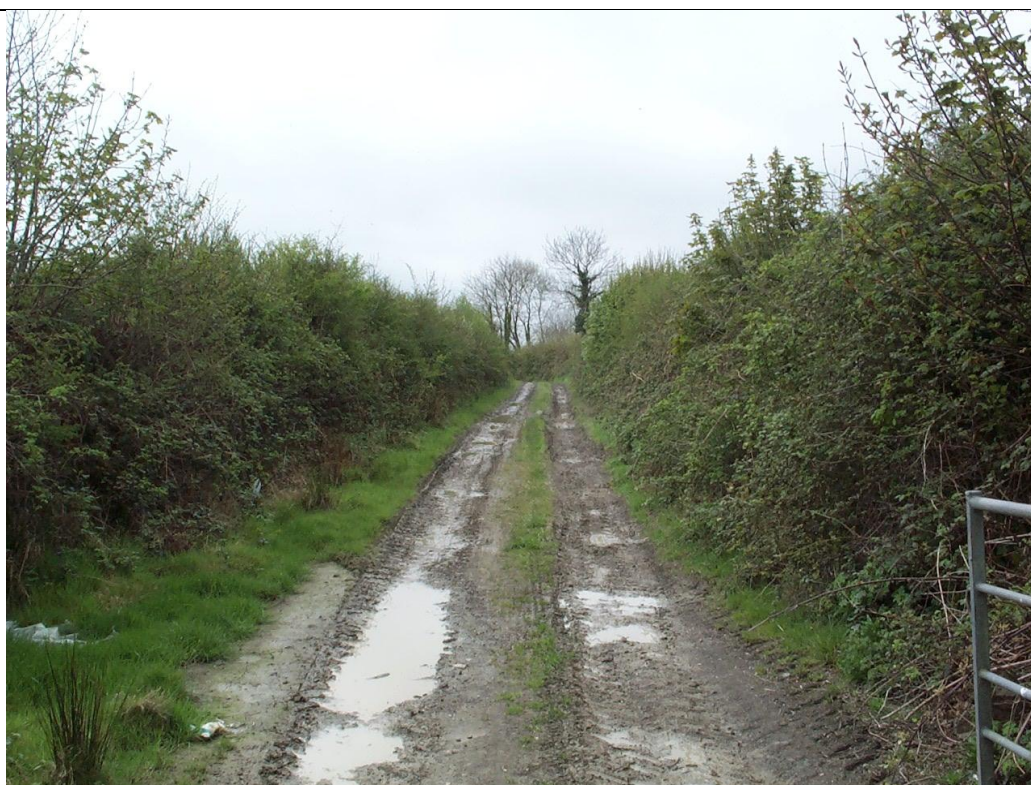
Embanked track leading from Llandre farm to an area of woodland on the edge of the narrow valley of the Afon Rhyd-afallen. This track, which has existed in its present form since at least the later 18<sup>th</sup> century, is 3-4m wide and the banks are c.1m high and topped with mature hedges. It is still maintained and used as a farm track.

PRN 44881 - view west along Llandre Lane.

The track should be maintained in its present condition.
