# **Bowett Farm W/13/2223**

## **Tir Gofal Farm Visit Historic Environment Report**

Report No. 2002/32

11<sup>th</sup> April 2002

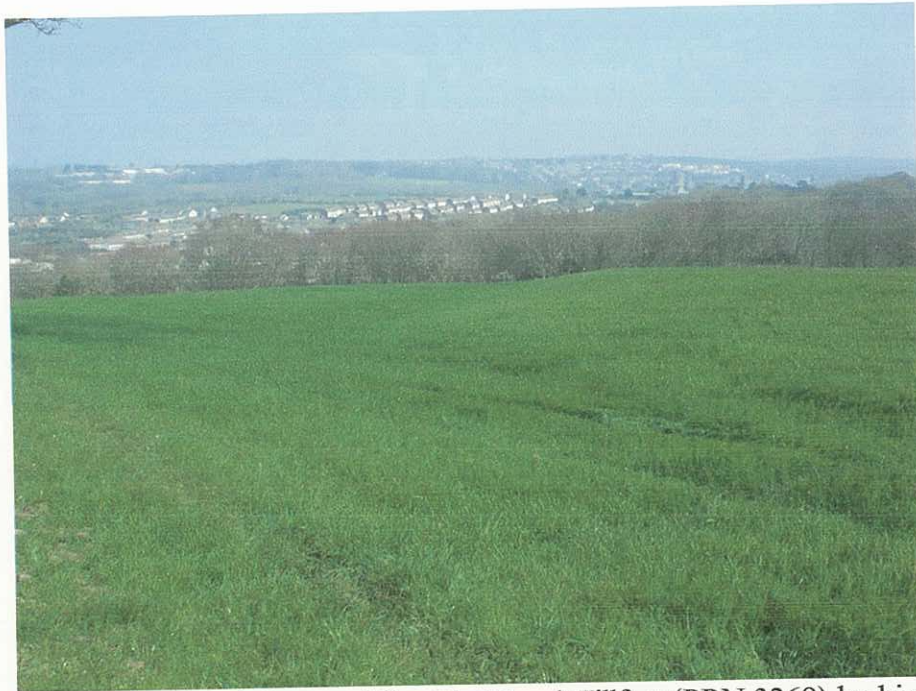
The remains of a large enclosure are visible on the gentle north facing scarp above Quoits Wood and Quoits Water Pill. The enclosure is approximately 175 metres from north to south and 127 metres from east to west. Although the earthworks are much diminished by ploughing the remains of a defensive bank and ditch are particularly noticeable to the north west; the ditch approximately 0.3 metres deep and the bank rising to 1.2 metres (plate 1). To the east and west the earthworks follow the current hedgeline and are less visible. The field in which the enclosure is located is entered from the south by a track lined with earth banks and mature trees. Where the field is accessed the earthworks have been eroded although to either side the banks rise to between 0.5 and 0.75 metres high. These banks have little turf cover which may in part be caused by a badger sett within the bank. The field in which the enclosure is located is currently used for pasture.

Plate 1 – the north western defences of Quoits Wood Hillfort (PRN 3269) looking north east

This enclosure is the remains of an Iron Age defensive settlement, which although eroded by ploughing in the past is nevertheless considered to be of national importance. Accordingly this area should be protected from any further ground disturbing activities, such as ploughing or erosion through livestock. The area to be excluded from ground breaking activities should include a margin of at least 12 metres beyond the known earthworks. This will extend beyond the existing field boundaries into the adjacent fields to the west and the woodland to the east.

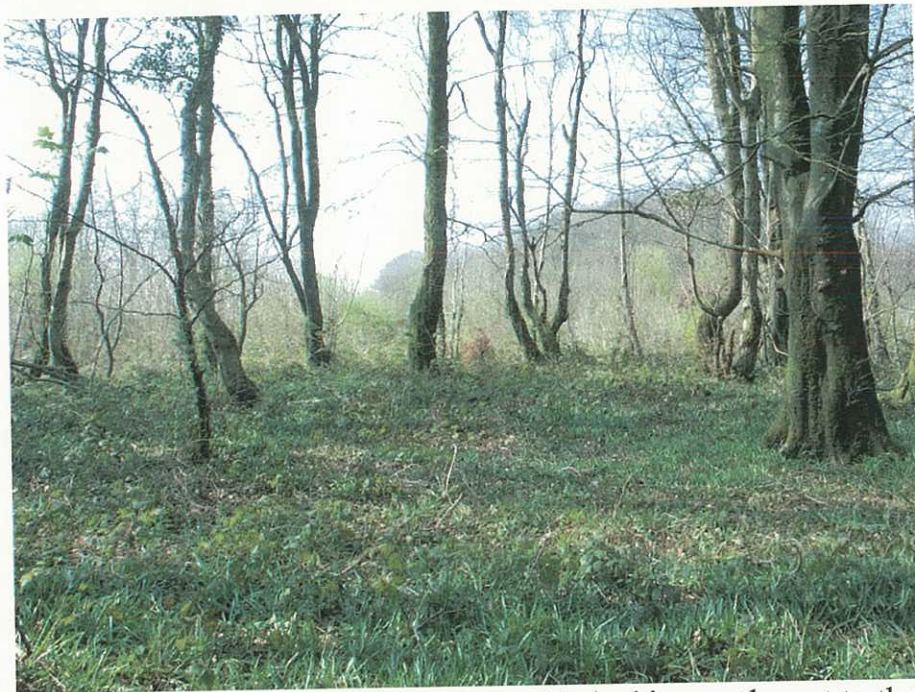
Plate 2 – the interior of Bowett Wood Camp (PRN 3270), looking south west to the dense undergrowth beyond.

Situated on the spur of a hill above Bowett bridge is an earthwork enclosure defended to the north west and north east by steep natural slopes, and to the south by a bank and ditch. The interior of the earthwork is level and accessible, and is currently covered by mature beech trees. Overhead power lines pass over the south west of the enclosure, consequently the regular topping of woodland species below has led to dense growth of scrub and brambles. This area, in which the most impressive of the earthwork ramparts are situated, is now impenetrable (plate 2). To the south west of the enclosure a post and wire netting fence runs against the external edge of the ditch.

A quarry, first recorded on the 1st edition Ordnance Survey map of 1891, has cut into the northern slopes of the spur. This quarry appears to be in continued use.

The current condition of the monument could be improved if the dense scrub and undergrowth were cleared from the south west area of the enclosure. It has been proposed that the monument should be cleared of undergrowth and subsequently lightly grazed to prevent the re-establishment of scrub. This would appear to be the best long term solution to the problem and would require fencing the monument. This should be undertaken using existing boundaries as far as possible. To the south east of the enclosure an old hedge bank survives which could be utilized and to the east a watercourse would provide an obvious boundary line. The existing fence line to the south west is situated too close to the external ditch and ideally should be set a further 12 metres away from the edge of the ditch. It is recommended that the fence line should be extended on the shortest course to the road and continue along the roadside. Any fencing within the scheduled area will require scheduled monument consent.

No further quarrying should be undertaken within the scheduled area.

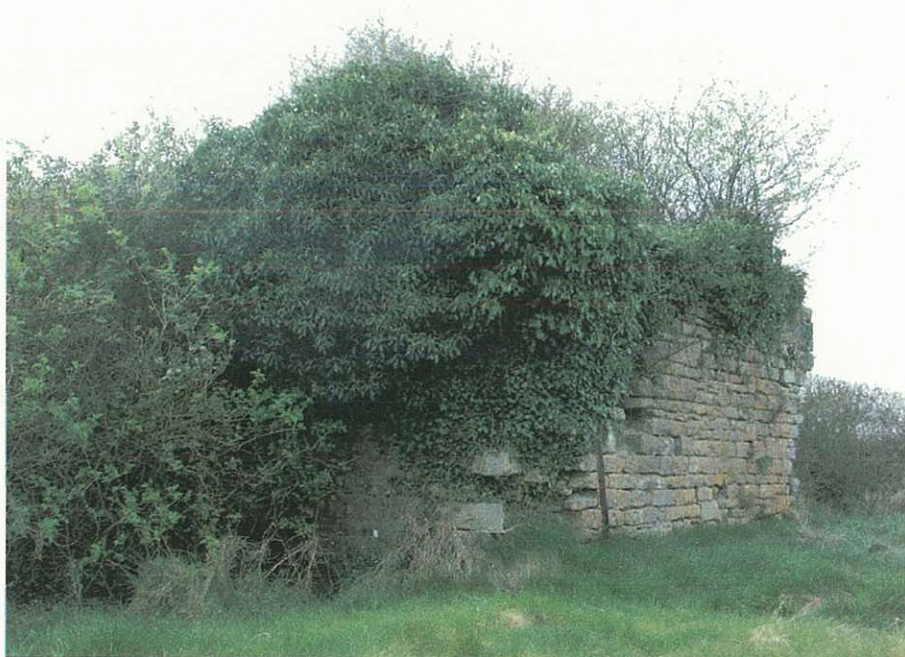
The following description is based upon a visit in 1997. Square built lime kiln, c.6 across built against a bank with access ramp to pot. Opposing draw holes, kiln open with brick lining *in situ*. Corners of kiln beginning to collapse. Generally good condition.

The kiln is as described, although it is becoming very overgrown with intrusive woody vegetation on top and ivy is becoming established within the masonry walls (plate 3).

Plate 3 – the lime kiln (PRN 17903) now becoming engulfed by ivy and woody vegetation.

The vegetation which is becoming established on the top of the lime kiln should be cut and allowed to die before removal and subsequently the masonry should be consolidated using traditional materials.

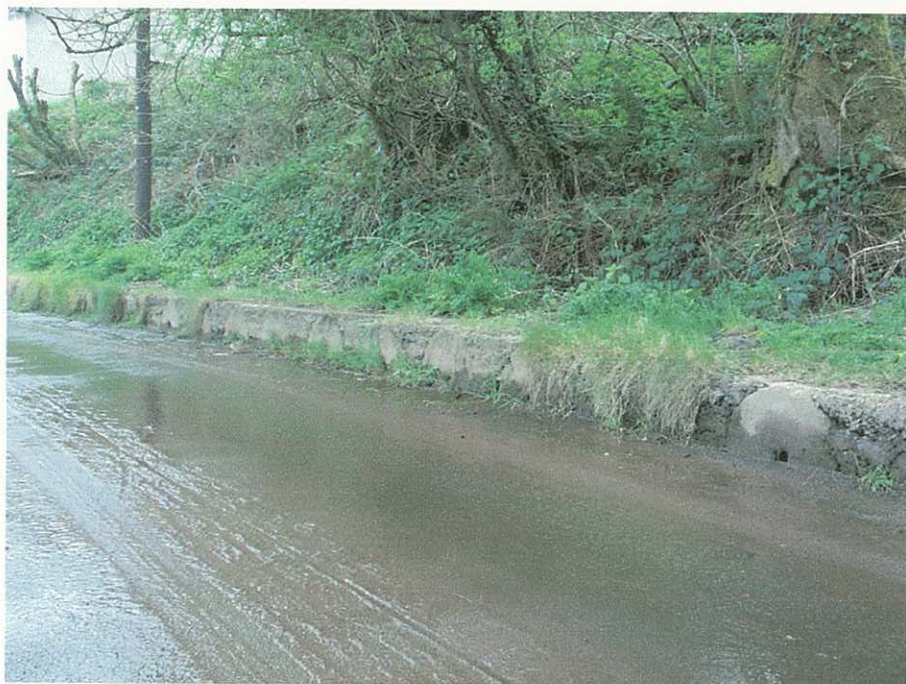
A row of concrete circular blocks have been incorporated into the revetment of the roadside footpath (plate 4). Apparently the concrete blocks are originally part of a World War II barbed-wire entanglement blockade and have subsequently been reused to provide a raised walkway.

Plate 4 – concrete barbed wire entanglement blocks have been reused to provide a raised walkway

These blocks should be retained as existing.

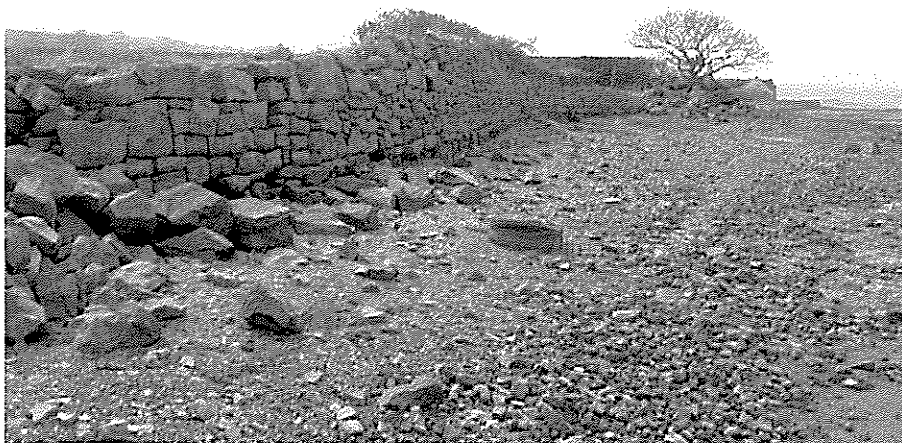
The following description is based on a site visit in 1997. A stone built sea wall, approximately 500 metres long and 2 metres high. Now collapsed in long sections and partly washed away.

The sea wall is as described, of dry stone construction with battered sides. It is constructed with uncoursed rubble stone blocks, with a stone offset approximately 0.25 metres high. A chamfered stone coping along the top survives in a few places (plate 5). Gateways are also positioned sporadically along its length. The wall survives to its full height in only a few places and has collapsed along much of its length, this process has been exacerbated in places by intrusive vegetation.

Plate 5 – the partly collapsed sea wall (PRN 35060) looking west.

The wall should be retained as a historic landscape feature, which would entail the control and removal of the intrusive vegetation. The vegetation should be cut back and treated to prevent regrowth, and removed with care.

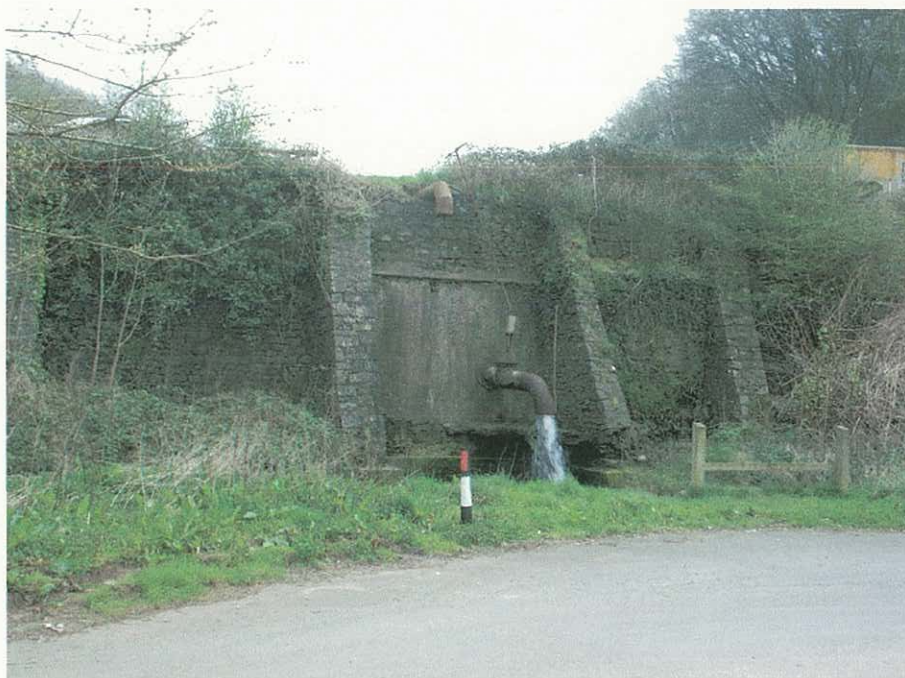
A large stone built dam, approximately 6 metres high and 50 metres wide, across the Quoits valley. The dam is constructed in roughly squared masonry with a series of full height buttresses against the north side. In the centre of the construction two large diameter pipes project, one above the other. Behind the dam are two large reservoirs, the first is approximately 100 metres long and 50 metres wide. The second smaller reservoir is 80 metres long by 20 metres wide.

PRN 49684. Apparently the dam and associated reservoirs were built by James Williams Narberth as part of a scheme to generate electricity for Pembroke (Mr. Morris, pers. comm.). The water levels in the reservoirs are currently very low and a number of abandoned vehicles have been discarded in the reservoirs themselves.

Plate 6 – the north face of the dam (PRN 44555)

The reservoirs should be cleared of refuse and maintained as visible landscape features.

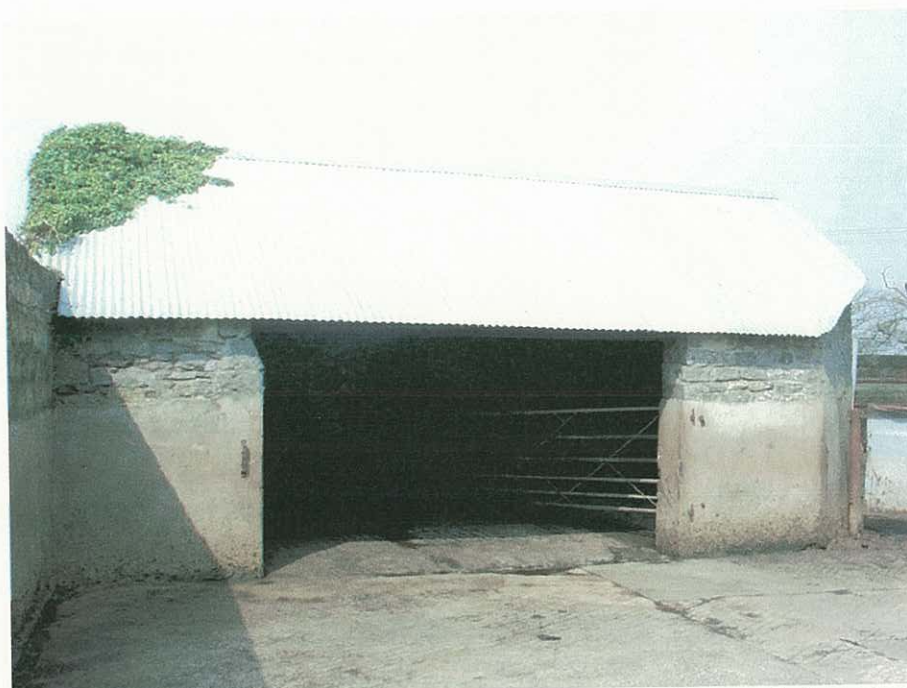
A small one storey cow shed is situated to the north west of the farmyard at Quoits Hill. The building is constructed in uncoursed rubble stone walling approximately 8 metres long and 5 metres wide with a pitched corrugated iron roof (plate 7). A large opening has been inserted into the south elevation, providing an open access onto the fold yard. The lower half of this elevation has also been rendered. Internally wooden feed racks survive on the north west lateral wall. This building is first identified on the 1<sup>st</sup> edition Ordnance Survey map of 1891. The building is currently being used as shelter shed and is in reasonable condition although some ivy growth is beginning to engulf the west end.

Plate 7 – the cow shed (PRN 44556) now converted into a shelter shed.

The ivy which is engulfing the west end of the cow shed should be cut and allowed to die back, otherwise the building should continue to be maintained using traditional materials. The internal wooden fitting should also be retained if possible.

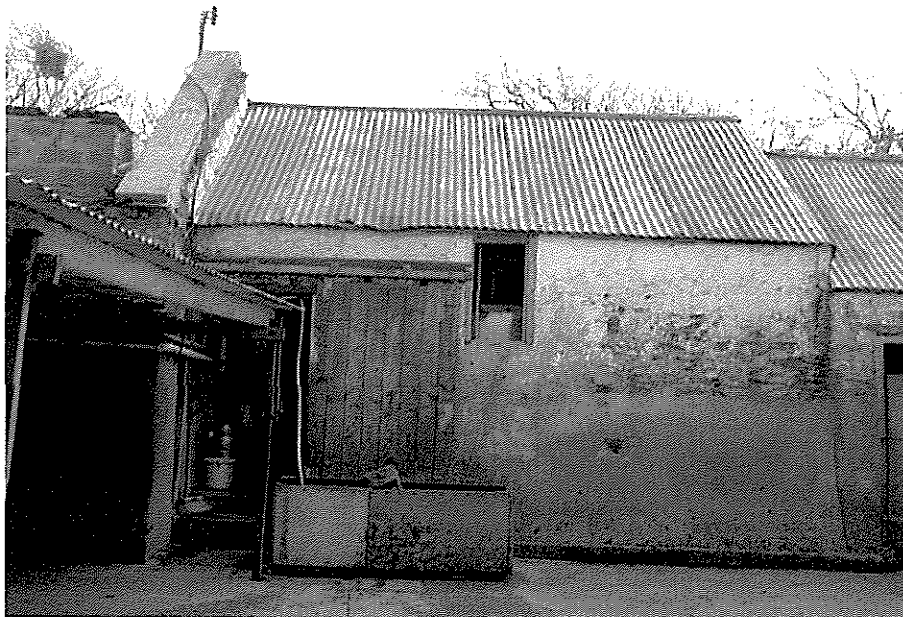
A low range of buildings situated to the south of the farmyard are currently used as dairy unit. It is constructed of whitewashed rubble stone walling and has a pitched corrugated iron roof, with a slated hipped roof at the west end. The western end of the building is accessed by a low doorway with a timber lintel. The eastern end has been modified for use as a dairy unit, with a raised concrete floor and large doorways inserted in north and south elevations. The east gable wall is considerably higher than the existing roof pitch suggesting that a further building to the east has subsequently been demolished, this may have originally been the site of the farmhouse which is now lost (plate 8). The 1<sup>st</sup> edition Ordnance Survey map of 1891 indicates that this range of buildings extended much further to the east than the existing range of buildings. The buildings are in a stable condition at present.

Plate 8 – the east end of the former cow shed (now dairy unit) showing the high gable wall.

The buildings should continue to be maintained in a stable and watertight condition.

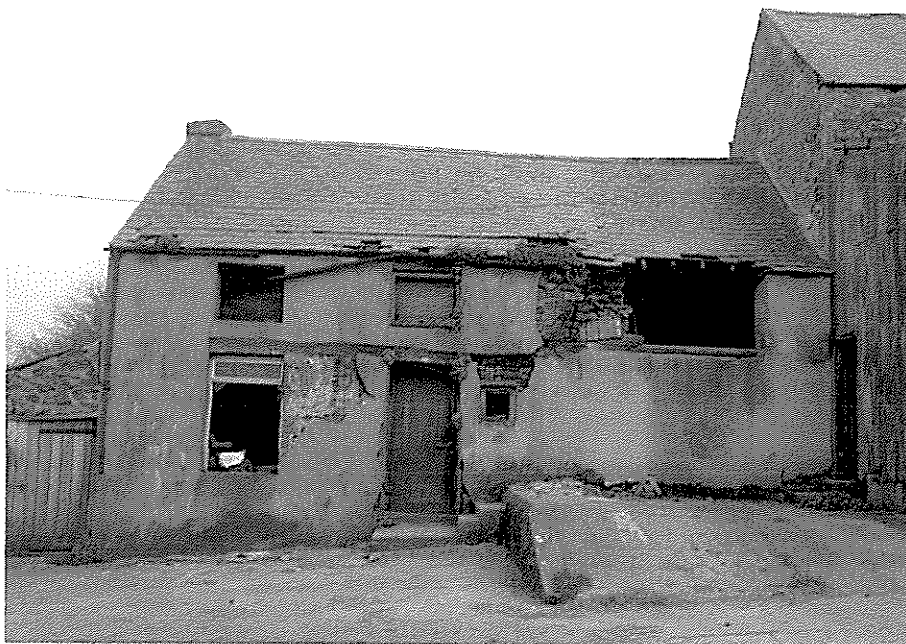
To the east of the farmyard is the old farmhouse, now used for storage. It is orientated on a north south axis, facing west across the yard. The house is two storey, constructed of rendered rubble stone with a pitched slate roof (plate 9). The west elevation has been heavily modified, and the historic fabric is largely obscured by render. The openings are arranged asymmetrically in the front elevation, with the doorway situated to the north of centre. To the north of the doorway the windows survive, on the ground and first floor. To the south of the doorway a large opening has been inserted into the 1<sup>st</sup> floor and a loading ramp built up against the ground floor to provide access. Although heavily modified in certain areas this building is significant in that it represents the earlier farmhouse. There is undoubtedly historic fabric surviving and there may well be evidence of earlier phases of construction which are at present obscured.

The farmhouse is in poor condition at present, many of the roof slates are missing to the west allowing water into the wall tops and the roof structure is failing at the eaves. Water ingress into the masonry is also causing the west wall to bow out.

Plate 9 – the west facing elevation of the old farmhouse (PRN 44558).

The building is in a deteriorating condition, and urgent works are required to stabilize the structure. Ideally the roof should be repaired and made watertight and the masonry repaired and consolidated. Archaeological advice should be sought prior to works being undertaken.

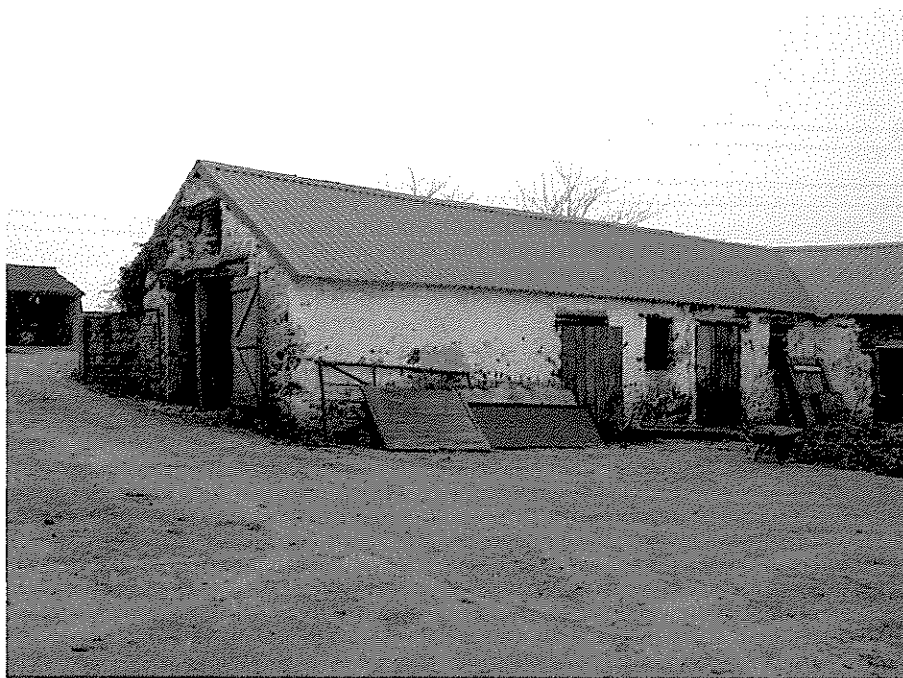
To the south of the farmyard is a low one storey cow shed, constructed in whitewashed rubble stone walling with a pitched corrugated iron roof (plate 10). At the east end is a cart shed with double doors in the gable end. In the north elevation are alternate doors and windows with timber lintels (some reused) and sills. The window frames show evidence of square sectioned mullions which have since been lost. The roof is constructed with timber pegged collared trusses. Internally a timber feed rack survives along the south lateral wall.

Plate 10 – the southern range farm buildings, including the cow and cart shed (PRN 44560)

The cow / cart shed is in reasonable condition at present and should be maintained using traditional techniques and materials.

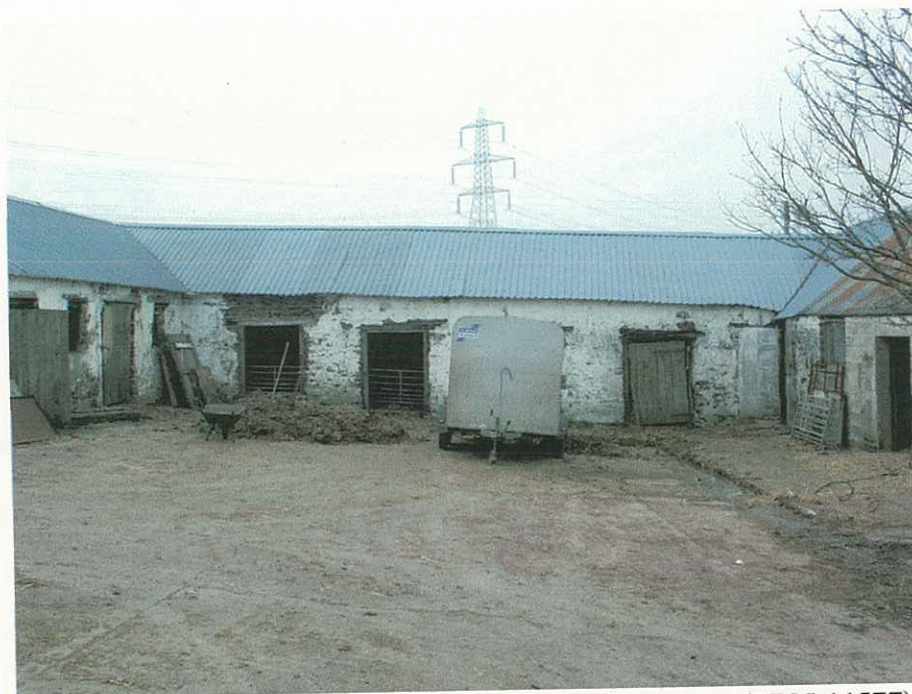
To the west of the farmyard is a low one storey cow shed, constructed in whitewashed rubble stone walling with a pitched roof of corrugated iron to the east and slate to the west. The east elevation has four low wide doorways with timber lintels that may be reused from another location. Along the east side of the building is a raised stone slabbed walkway (plate 11). This cow shed is in reasonable condition everywhere except above the southern doorway, where the lintel is missing and the stone facing above it has collapsed.

Plate 11 – the west range of cow sheds at Bowett Farm (PRN 44577)

The lintel above the doorway to the cow shed should be reinstated and the wall above it made good.

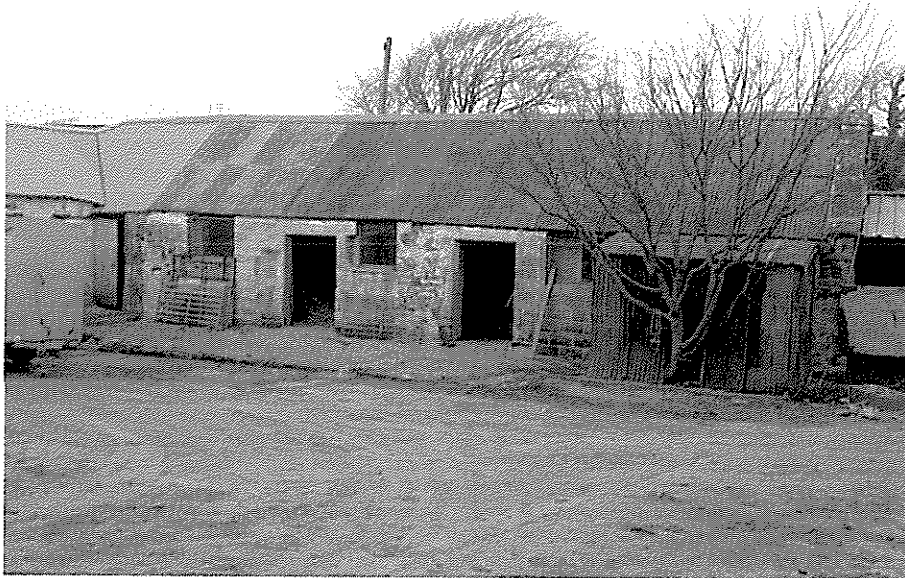
On the north side of the farmyard is a cow shed constructed mainly in rubble stone walling with breeze block infill (plate 12). The roof is pitched and covered with corrugated iron. The south elevation four low doorways alternately spaced with window openings. This elevation has been greatly modified. To the east a small corrugated iron outshoot has been constructed against the south elevation and a further modern corrugated iron shed has been built against the east gable. The cow shed appears to be in fair condition.

Plate 12 – the north range of cow sheds (PRN 44578) at Bowett Farm.

This cow shed should continue to be maintained using tradition materials.
