# Syddyn-Melyn W/12/1531

## Tir Gofal Farm Visit Historic Environment Report Call Out

Report No. 2004/08

Syddyn-Melyn  
Tir Gofal Farm Visit Historic Environment Report  
Call Out

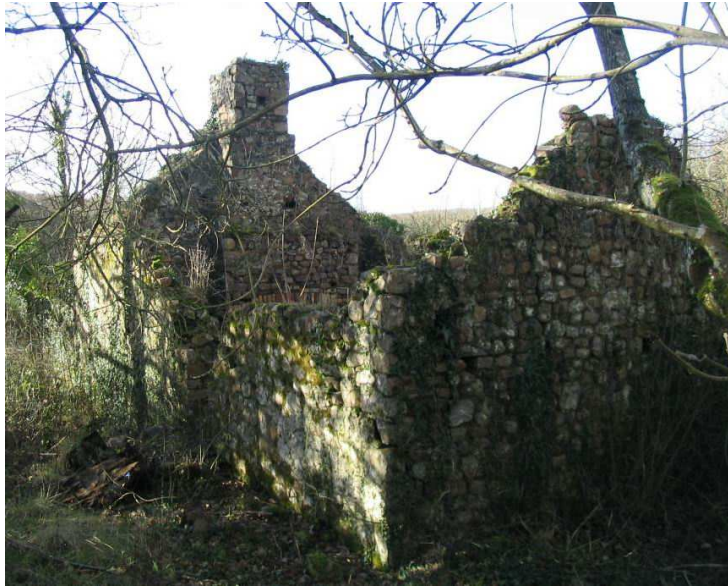
Plate 1- Ty'r Eithin cottage viewed from the south-east.

It is rectangular in plan and measures approximately 9m E-W by 6m N-S. It is of stone rubble construction and substantially built, with walls averaging 0.5m thick and roughly squared quoins. None of the original roofing materials survive, although like similar examples, it was probably slated originally.

The front (north) wall of the cottage faces on to a garden enclosure. A central doorway is flanked on either side by rectangular windows. This wall survives to eaves height at either end, although is diminished around the door and window heads where the lintels have collapsed. The rear (south) wall survives to near full height for the entire length. A small rectangular ground floor window arranged centrally is the only opening in this wall. The east gable end is complete and is dominated by a wide fireplace, offset from centre to the right. It is about 3m wide by 1.5m high with yellow brick dressings supported on an iron lintel.

Despite its derelict state, the cottage remains in a relatively stable condition. Water ingress continues to wash out masonry bonds in the exposed wall tops however. Some mosses and ferns have become rooted in the masonry. Young trees have become established in the wall footings and inside the building.

The cottage will require some masonry consolidation and rebuilding before it can be re-roofed. It is important that these works are in keeping with its historic appearance. Rebuilt wall sections should not project beyond original wall height and original door and window openings should be retained. The original stone from the walls remains where it has fallen around the edge of the building and will provide appropriate material for the rebuild. If additional stone is required, it should be similar in appearance to that used originally.

The roof trusses, purlins, battens and slates are also to be replaced. The true appearance of the roof is not known. It is important that the replacement trusses are of traditional materials, made with traditional techniques in this instance. The timbers in the nineteenth century agricultural buildings at Syddyn Melyn farmstead will provide a useful source of comparison to inform these restoration works.

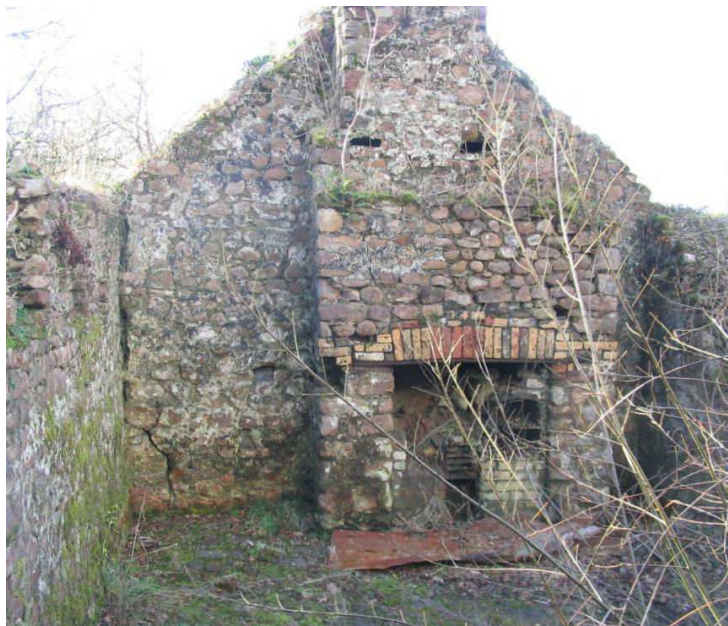
Plate 2- view of fireplace in west gable end.

A small fireplace, about a metre wide, is set into the west gable end. The fireplace is partially collapsed internally, although the wall stands to near full height.
