# **Tir Gofal Farm Visit Report**

**Bachygwyddil**

**W/12/2058**

**Report Number 2002/6**

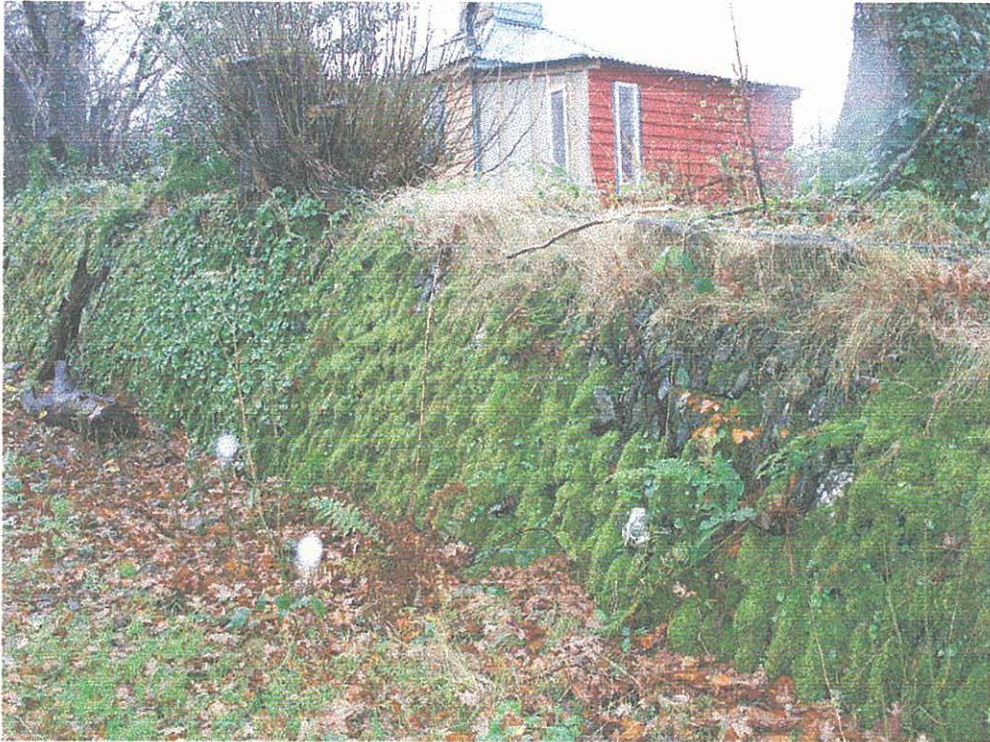
The farm boundaries have survived in the same layout as those shown on the tithe map with a pattern formed of regularly shaped fields. The boundaries themselves are commonly high banks topped with overgrown hedges. The banks themselves are usually constructed in earth. Where the banks enclose the track way to the north of the farm, they are constructed in stone, vertically laid, sometimes in a herringbone pattern, with high battered sides (plate 1).

Plate 1 – a boundary bank to the north of the farmyard, looking south east.

The farm boundaries and trackways, which form an important historical characteristic of the farm, should be maintained in a stable condition.

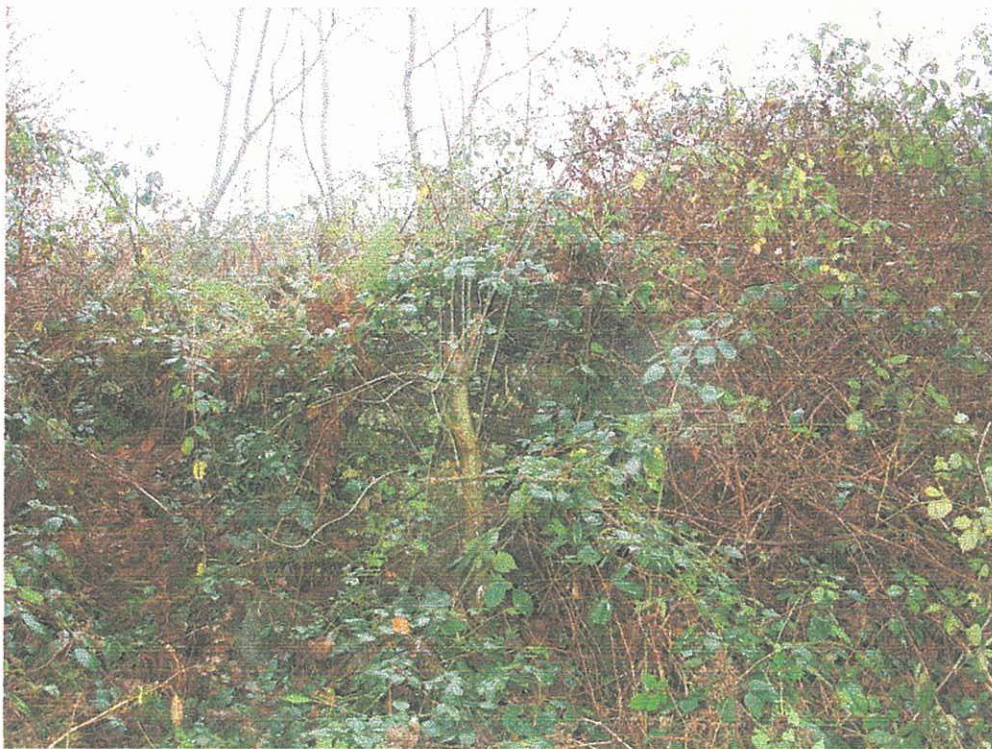
The remains of Pantgwyn cottage are currently overgrown with brambles and young trees and largely inaccessible, however the walls of the cottage still stand up to approximately 0.5 metre high (plate 2). The masonry appears to be roughly coursed slate with occasional limestone fragments and the bonding lime mortar is very eroded. The remains of the cottage indicate a rectangular building orientated on a north - south axis with an entrance visible within the west wall. The tithe map indicates the cottage was positioned within a roughly triangular enclosure in the south west corner of the field. The 1891 edition Ordnance Survey map indicates that the cottage was L-shaped, with extensions to the north, east and south; these features are not visible under current conditions. This edition also shows the cottage within an enclosure, but additionally with a separate rectangular enclosure, marked as an orchard, to the west. The 1907 edition Ordnance Survey map indicates the same layout, however the enclosure is no longer identified as an orchard.

Plate 2 – the south west corner of Pantgwyn cottage (PRN 35484)

PRN 35484. The site of Pantgwyn cottage should be carefully cleared of brambles and vegetation. The saplings that are becoming established on the site should be cut back and treated to prevent new growth.

The site of Pantgwyn cottage should be carefully cleared of brambles and vegetation. The saplings that are becoming established on the site should be cut back and treated to prevent new growth.

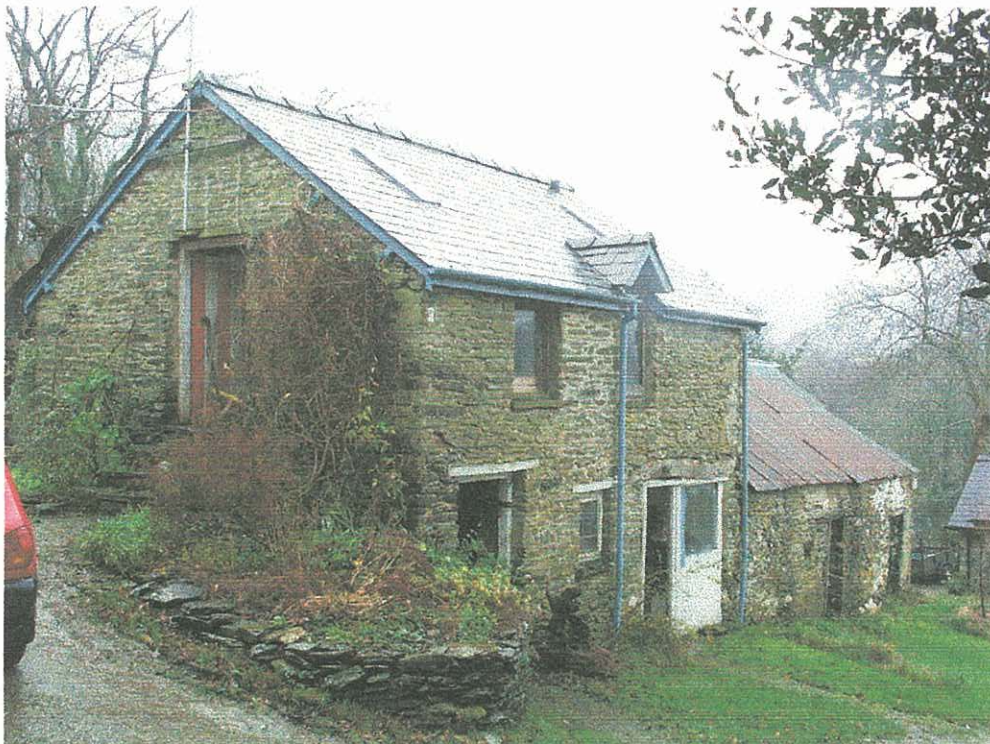
This long low one storey building is constructed in roughly coursed rubble with a corrugated iron roof (plate 3). It has two low doorways, with timber lintels, in the north elevation with a small square opening to the east. Internally the barn has four bays with timber pegged trusses. Some of the trusses are upper cruck construction, with curved feet to the principal rafters which are carried on the stone wall (plate 4). These trusses have been modified to raise the pitch to the existing height of the roof. At the lower, west end of the building, large tie beams span the building at a low level which provides a half loft. At the eastern end of the building a narrow slit which has been inserted into the adjoining building (PRN 43940). The existence of fixtures and fittings can not be ruled out although none were identified during the farm visit, since the building is currently used as a store. The current owners believe that this building was used for weaving and that the narrowing opening into the adjoining building may have been access for a drive belt. This may also tie in with the small square opening in the north wall beside the doorway. There is no longer any evidence for the machinery associated with this.

This two-storey building adjoins the weaving shed/barn (PRN 43939) to the east (plate 3). It is also constructed in coursed rubble and has a recently repaired pitched slate roof. The north elevation has a stable door to the east and a small square window, both with timber lintels, which open into a stable. Internally a feed trough and a hayrack still survive against the south wall. To the west is a large cart entrance which has a reused timber lintel.

Above is a granary which is accessed by external stone steps up the east gable wall. The first floor is lit by two glazed windows, one a dormer, on the north elevation. The owners believe that this floor provided accommodation for the labourers.

This building has been recently repaired and the roof and structure is in good condition.

Plate 3 - showing the stable and granary in the foreground (PRN 43940) and the weaving shed/barn beyond (PRN 43939)

The weaving shed/barn should be maintained in a stable condition using traditional materials.

This stable and granary should continue to be maintained in a stable condition using tradition materials. The internal wooden stable fittings should be retained as important historical features of the building.

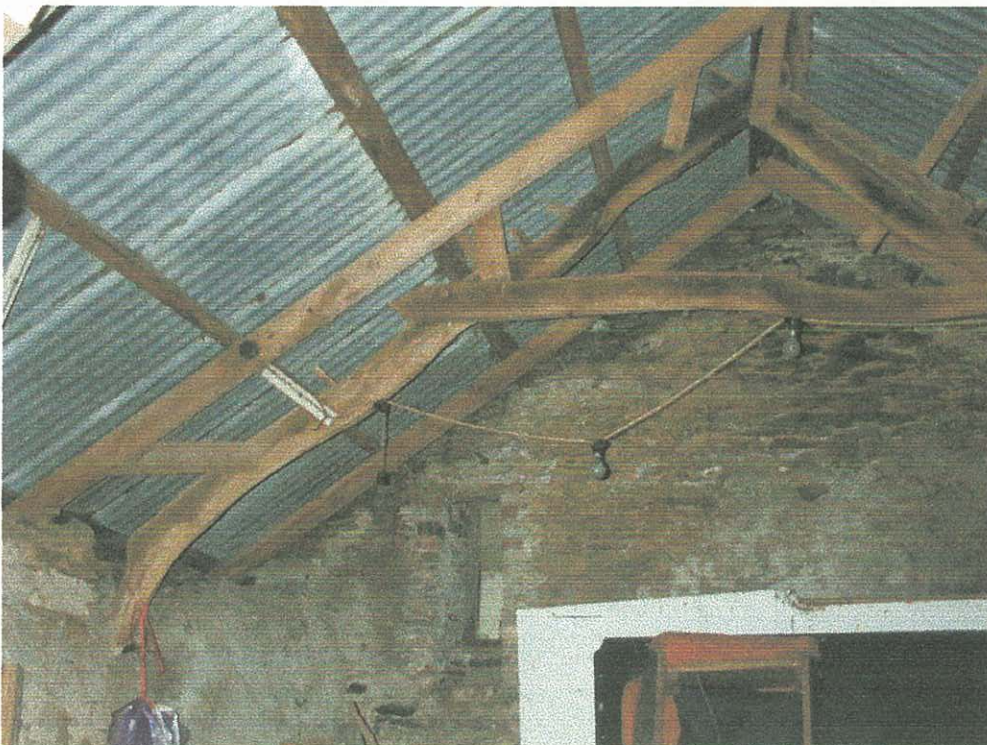
Plate 4 – the internal roof construction of the weaving shed/barn (PRN 43939)

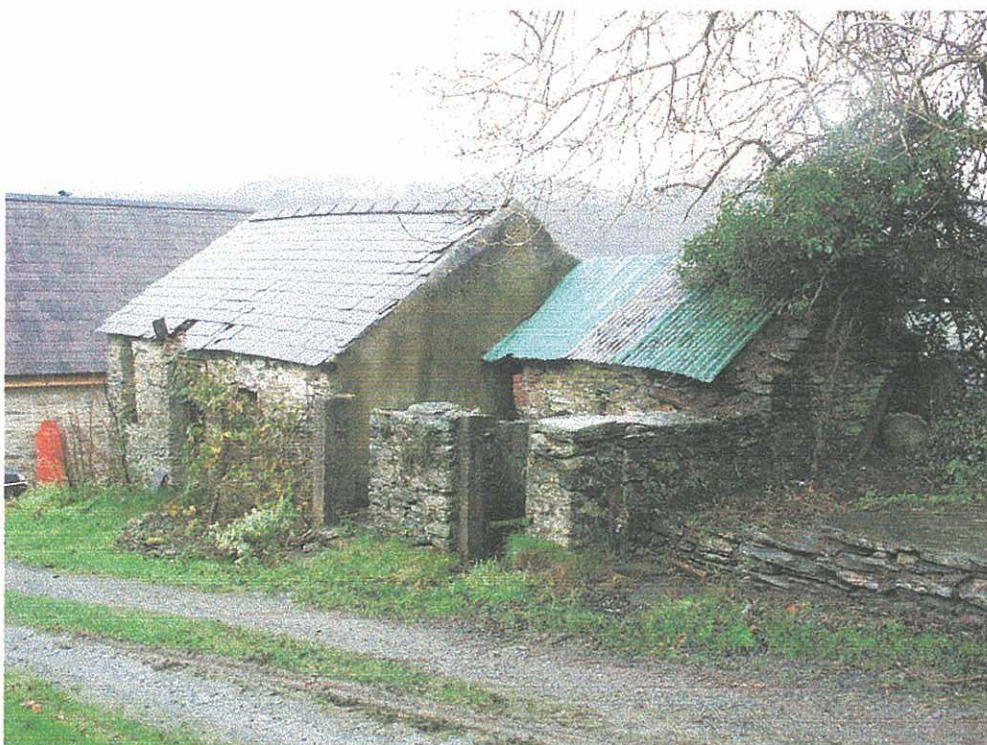
To the north side of the farmyard is a pair of pigsties constructed with coursed slate walls and a corrugated iron roof (plate 5). A monolithic slate wall divides the yard and the floors are also laid with slate. The feed trough to the west yard is cast iron, to the east it is concrete. The east end of the pigsty is very overgrown with ivy and the tin roof does not extend over the entire gable wall, here the masonry is beginning to deteriorate and the timber lintels over the doorways are also rotting.

To the west of the pigsties (PRN 43941) is a single cell one storey outbuilding, constructed with roughly coursed rubble, and pitched slate roof. There is a central doorway in the south elevation with a plank door, to the east is a small square window with a timber lintel and slate sill and to the west is a tall narrow window which extends up into the eaves. It is further lit by a large window in the west gable end. The current owners believe that this building is the dyeing shed. Internally there are no fittings or fixtures remaining which indicate its function. The roof is in poor condition and the slates are loose and missing in places, and the masonry at the north west corner has collapsed.

Plate 5 – showing the pigsties in the foreground (PRN 43941) and the dyeing shed beyond (PRN 43942)

PRN 43941. The roof of the pigsties should be repaired to prevent water ingress, and the masonry consolidated.

PRN 43942. The roof to the dyeng shed should be repaired to prevent further damage to the structure and the masonry walls should be repaired and consolidated using traditional materials.

The roof of the pigsties should be repaired to prevent water ingress, and the masonry consolidated.

The roof to the dyeing shed should be repaired to prevent further damage to the structure and the masonry walls should be repaired and consolidated using traditional materials.

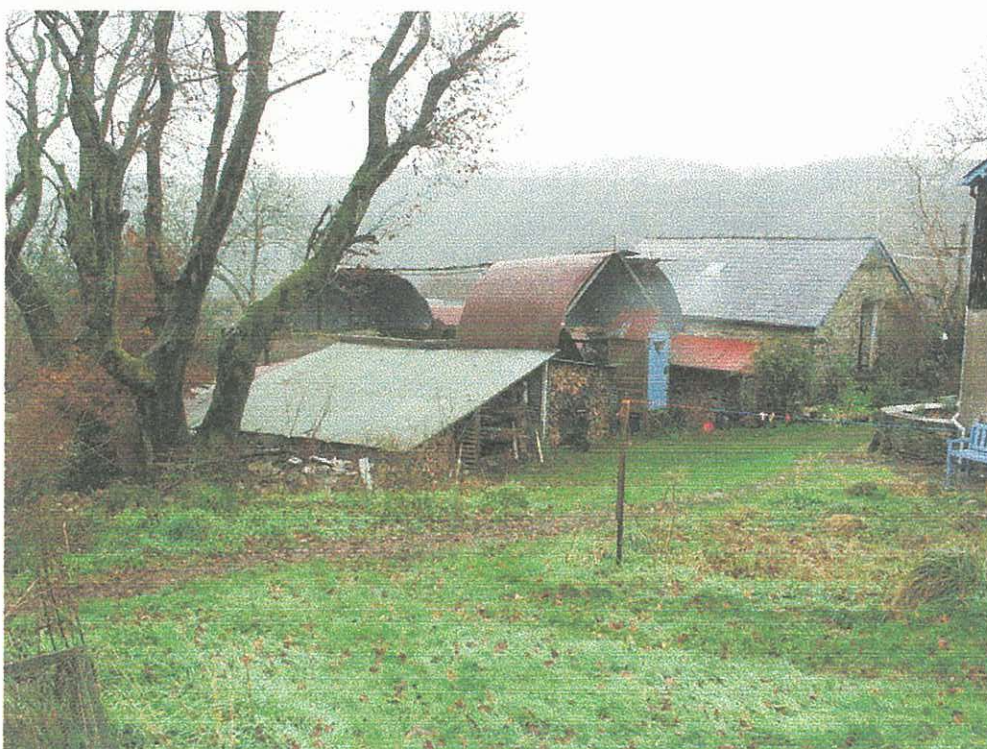
To the south of the farm buildings is a large dutch barn, constructed with a corrugated iron roof and an outshoot to the south. The central section of the roof is missing. A hoist remains suspended from the roof apex at the east end.

Plate 6 – the dutch barn to the south of the farmyard (PRN 43943)

PRN 43943. The dutch barn, although relatively modern in comparison to the other farm buildings, is also a historic feature of the farmstead and ideally the roof should be repaired and the building retained.

The dutch barn, although relatively modern in comparison to the other farm buildings, is also a historic feature of the farmstead and ideally the roof should be repaired and the building retained.
