Tir Gofal Farm Visit Report

Glanrheidol

W/11/2204

Report Number 2002/14

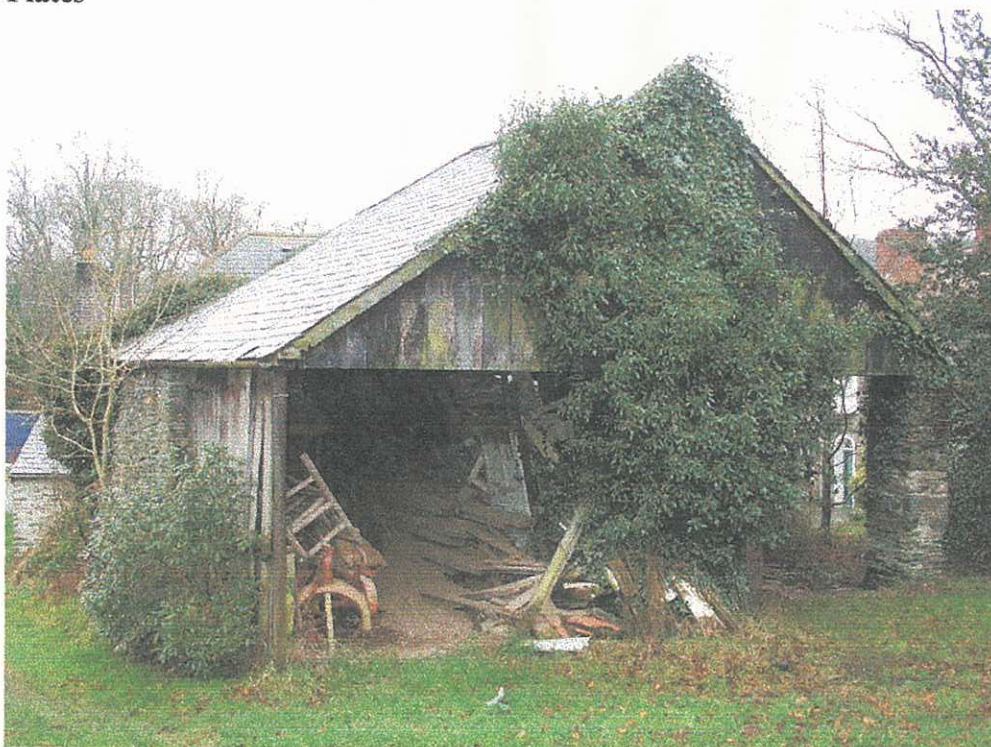
A stone built shed is situated up a bank to the north east of the house (plate 1). It is constructed with square stone piers at each corner (except at the north east corner which has a cast iron column) and at each midpoint including a central internal pier. The north end of the shed is open. The south end is infilled with rubble stone walling to eaves level. The gable ends are boarded over. It has a slate covered pitched roof supported by an A frame truss and the tie beam is supported by a central middle pier. The shed is currently in use as a store, however it may originally have been a cart shed or machinery shed. It is in a poor condition, overgrown with ivy in places and the south roof truss is starting to rot.

Plate 1 – an open shed (PRN 43954) to the north of Glanrheidol house

The vegetation which is engulfing the shed should be carefully cut back and allowed to die before removal, and the masonry consolidated using traditional materials.

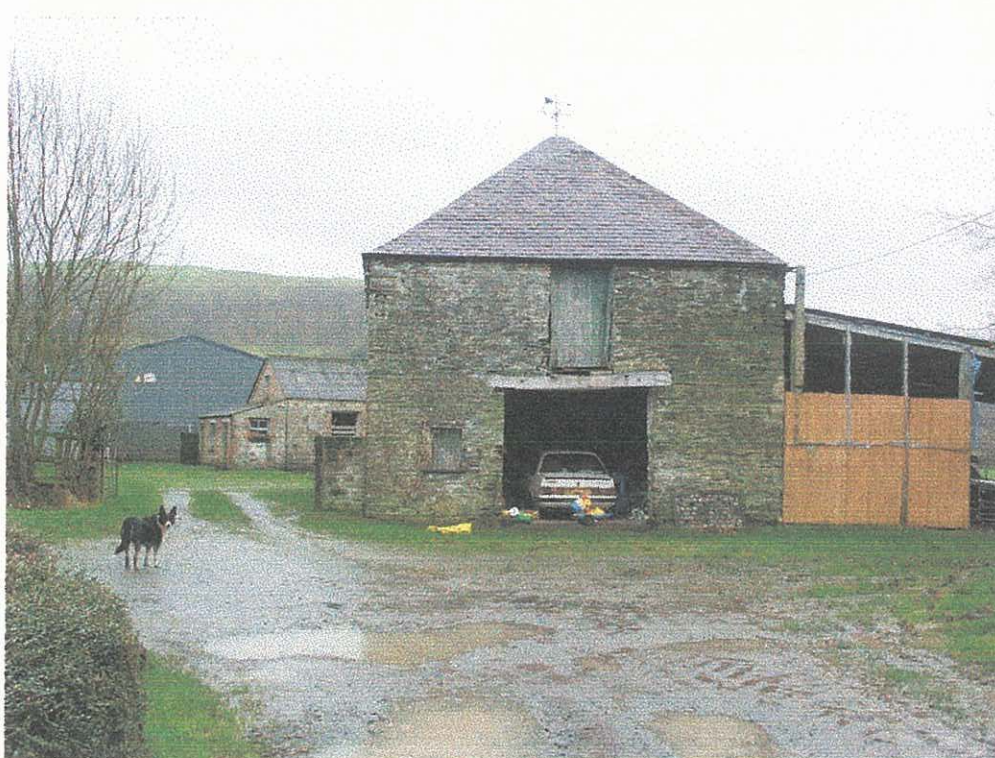
A cart shed is situated to the east of the house (plate 2). It is constructed in slate rubble walling with a slate covered pyramidal roof and a weather vane on top. The west elevation has a large double door entrance (although the doors do not survive) with a large timber lintel. To the south of the entrance a window has been inserted with a wooden lintel and slate sill. Above the entrance is a doorway with a plank door. The south elevation has two doorways at ground level. To the west is a doorway with a 6 panelled door with drilled ventilation holes. The east doorway is inserted. The roof is in good condition, however the west wall has large structural cracks above the double entrance.

Plate 2 – the cart shed (PRN 43955) to the east of Glanrheidol house

This cart shed needs structural repairs undertaking to support the west elevation above the entrance. These repairs should be carried out using traditional materials.

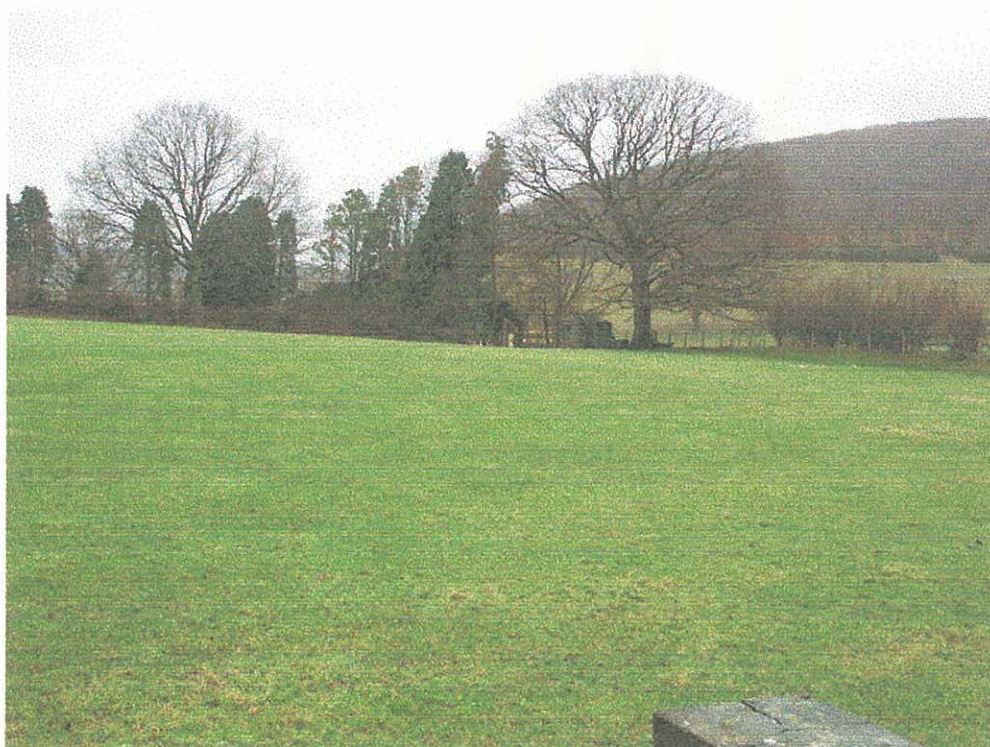
The Tithe map of 1845 records the walled garden as rectangular with a wide border (plate 3). Unusually it suggests that within the border, at each corner, is a large square structure. By the time of the 1st edition Ordnance Survey map (1891) the garden is recorded with paths dividing it into quadrants with a building at the north east corner (PRN 43960). The 2nd edition Ordnance Survey map no longer shows the axial paths but the four internal structures survive. There is also an indication of trees placed in the east and west border.

The garden is currently under pasture. There are no visible structures except part of a clom wall (PRN 43961) and a building (PRN 43960). The north and east boundaries are now largely hedged and fenced.

Plate 3 – the walled garden looking north east (PRN 43959)

This garden would appear to be the remains of an early 19th century (possibly earlier) formal walled garden. It is an important historical element in the setting of the Glanrheidol house and it would be very valuable to undertake a record of the garden. Although there is no visible indication of its' earlier layout, there are probably sensitive archaeological deposits surviving, therefore no ground disturbing activities should be undertaken in this area.

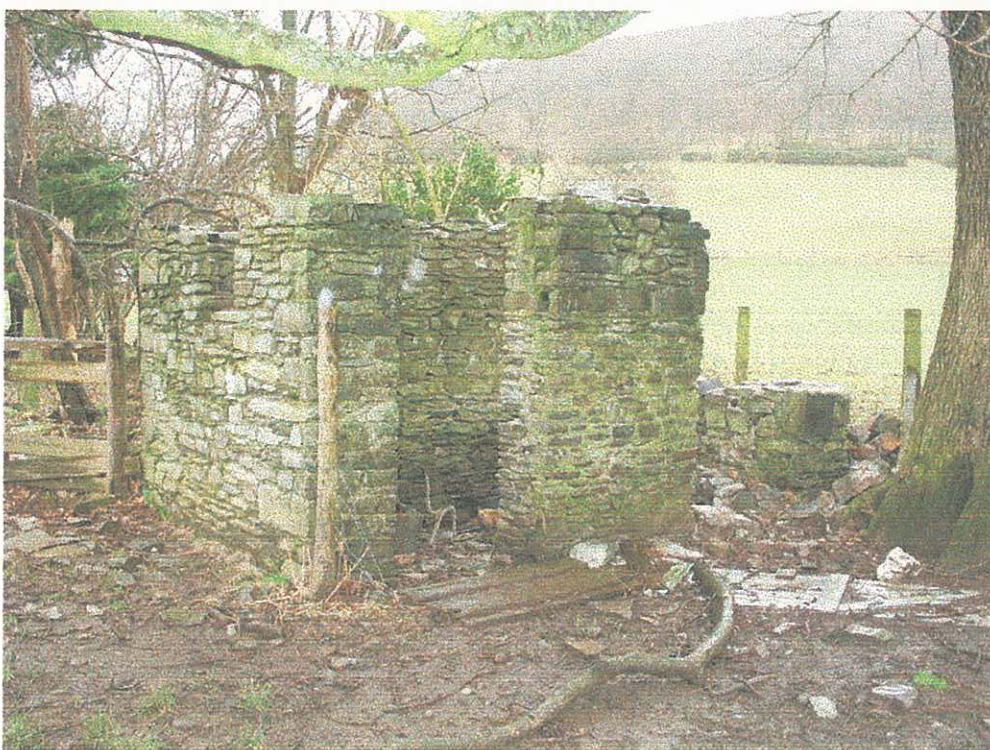
In the north east corner of the walled garden (PRN 43959) is a square built structure (plate 4), although not shown on the Tithe map of 1845 it appears on the 1st edition Ordnance Survey map of 1891. The structure survives to a height of about 1.8 metres except the east wall has collapsed much further. It is about 3.5 metres east-west and 2.2 metres north-south. It is constructed in slate rubble built to courses. There are two doorways in the south elevation and a small window high in the east wall. The structure is bonded with lime mortar and internally there are the remains of a lime finish on the south wall which also suggests the position of a partition. Together with the remains of two water tanks inside the evidence suggests that this was a privy house.

Plate 4 – the remains of a privy house (PRN 43960) in the north east corner of the walled garden

The privy house should be conserved to prevent further deterioration and maintained using traditional materials.

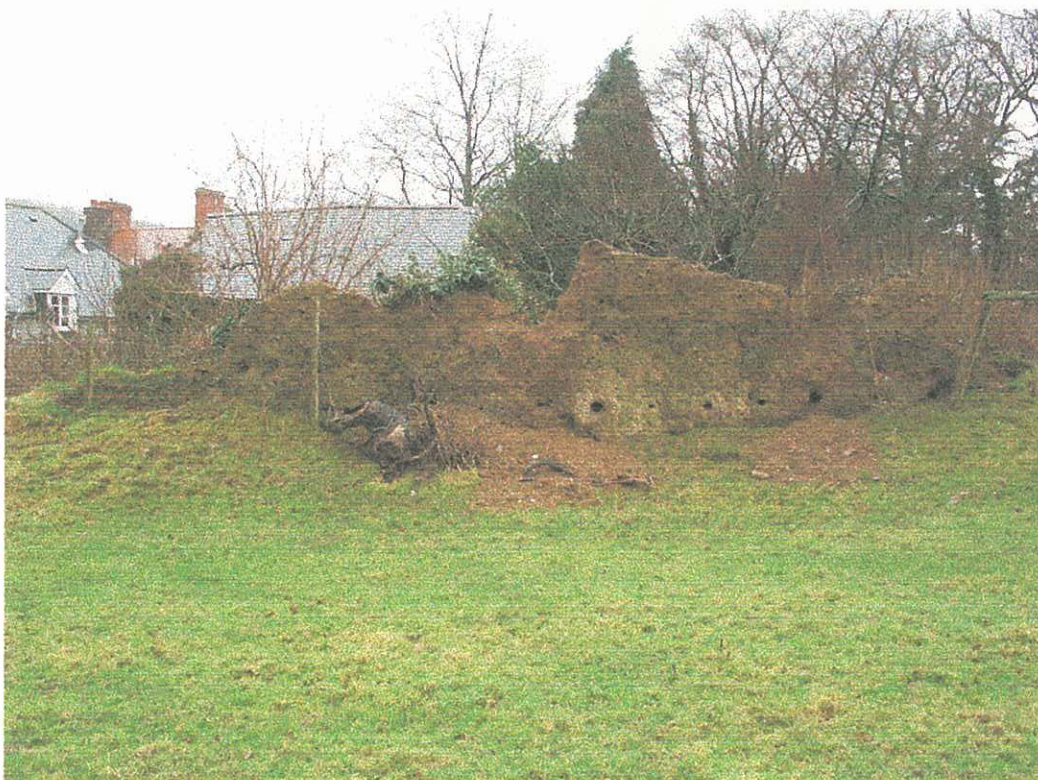
The remains of a clom or mud wall survive along the west edge of the walled garden (plate 5). The wall survives to a height of approximately 2 metres and in two sections, approximately 13 metres and 10 metres long. The ground level adjoining the wall is raised in relation to the surrounding ground surface, which appears to be due to the collapse of the wall. The wall is largely composed of mud with straw and stone inclusions. At a level of about 0.4 metre from the ground surface there is a horizontal row of round sockets, which in places penetrate the width of the wall. One socket at least has a wooden peg in situ, suggesting a structure was fixed against the wall.

Plate 5 – the remains of a clom or mud wall (PRN 43961)

This wall is a rare survival of the use of clom or mud construction in the context of a formal garden. The wall is degrading rapidly because the core construction is exposed to the elements and details, such as the sockets mentioned in the description, will inevitably be lost. Therefore it is recommended that a scheme of archaeological recording takes place as soon as possible.
